74419 I-15 TRUCK CLIMBING LANE PROJECT

**STRUCTURAL FINDINGS MEMO FOR:
QUADRUPLE CELL 10ft x 6ft RCB CULVERT
NORTH AND SOUTH BOUND LANES**

**PREPARED FOR:
STATE OF NEVADA
DEPARTMENT OF TRANSPORTATION**

**PREPARED BY ATKINS
SITE OBSERVATION PERFORMED BY:
MICHAEL NA-O
ON MAY 25, 2022**

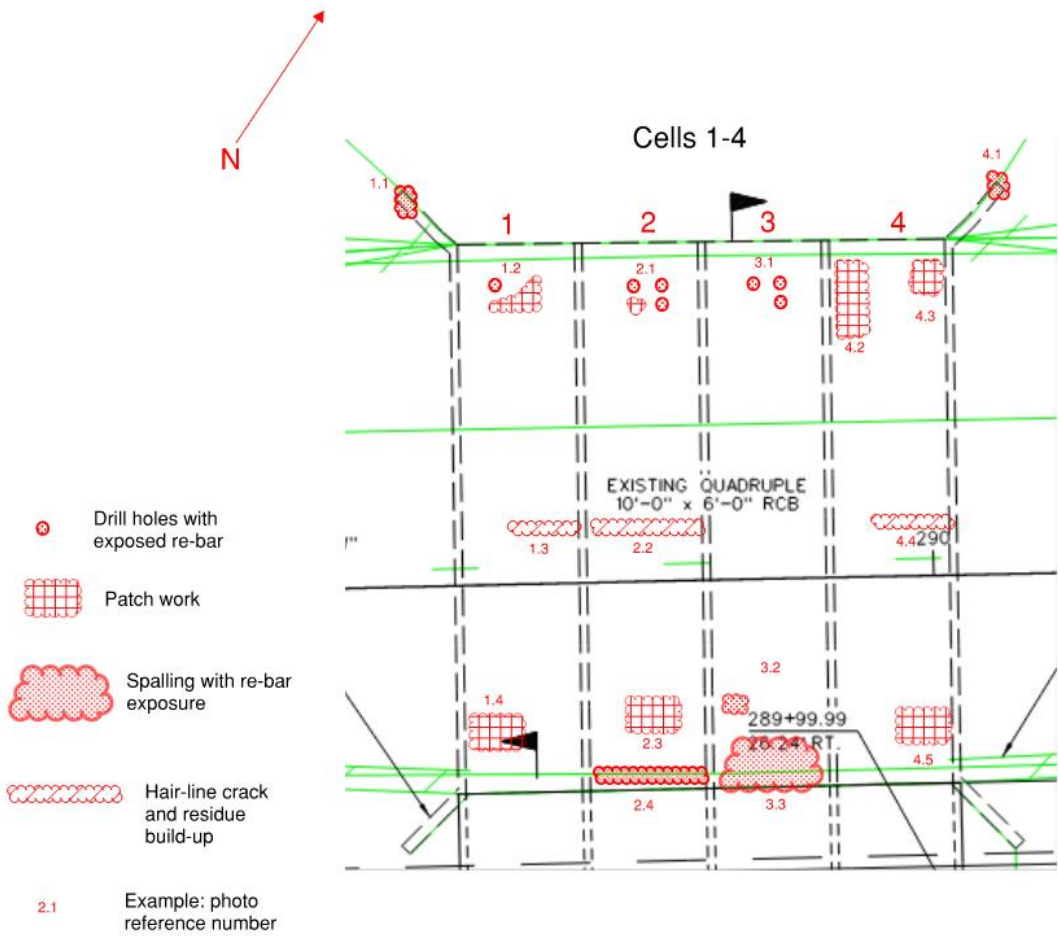
Diagram 2. Existing Structure conditions

The depicted diagram 2. shows areas of the culvert that have been recently repaired, and areas of concern. Each are identified with a reference number (diagram to image) showing the location and concern or previous work done on the structure. The following field data include pin-point locations determining condition of each cell for both North and South bound lanes. The information gathered is in conjunction with NDOT bridge report will help estimate the restoration cost amounts for culverts B691S and B690N.

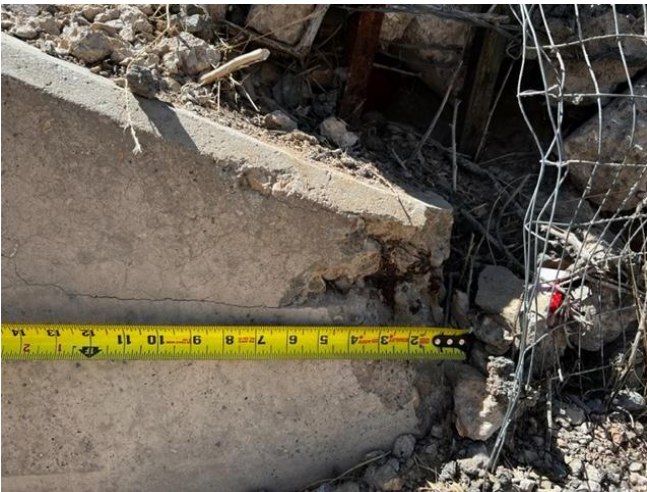
1.1 (6" x 6" Spall concrete)

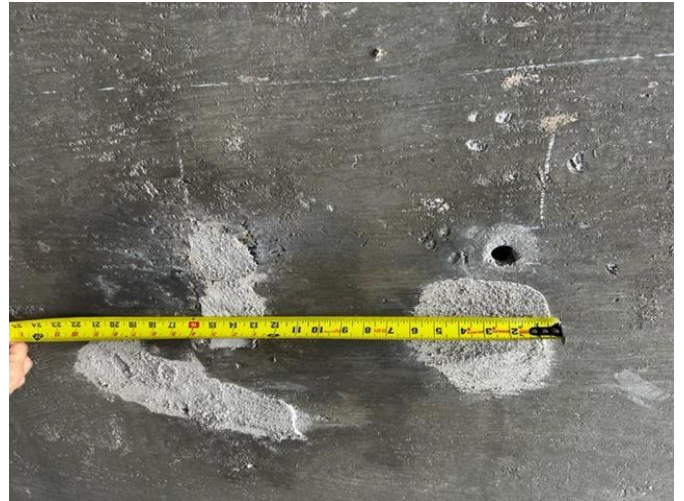
1.2 (1.5" dia. drill hole x 1)

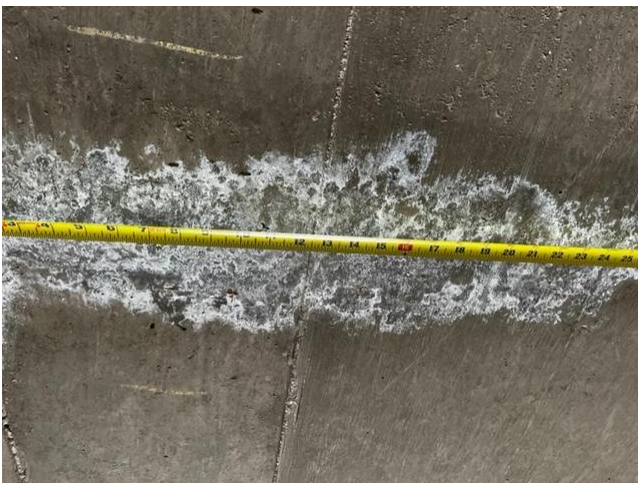
1.3 (26" Efflorescence)

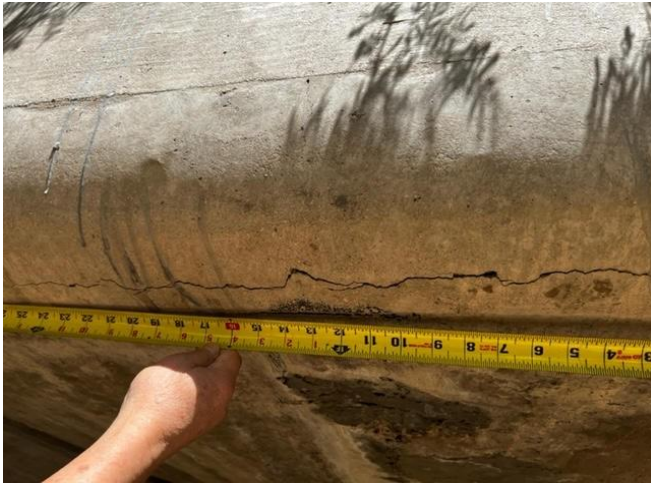
2.4 (26" Spall)

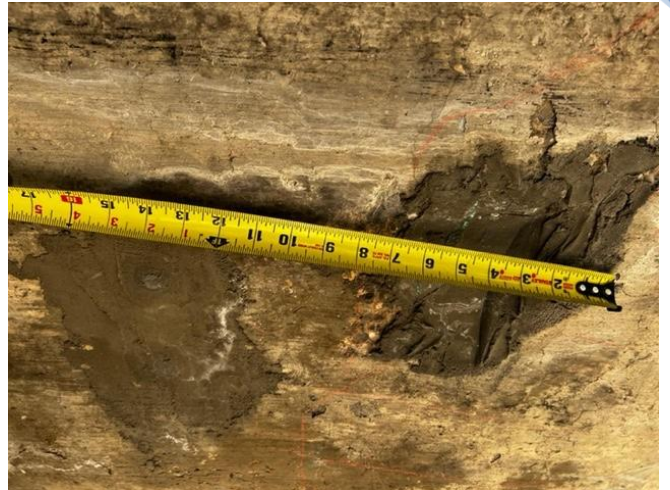
2.3 (Patch work)

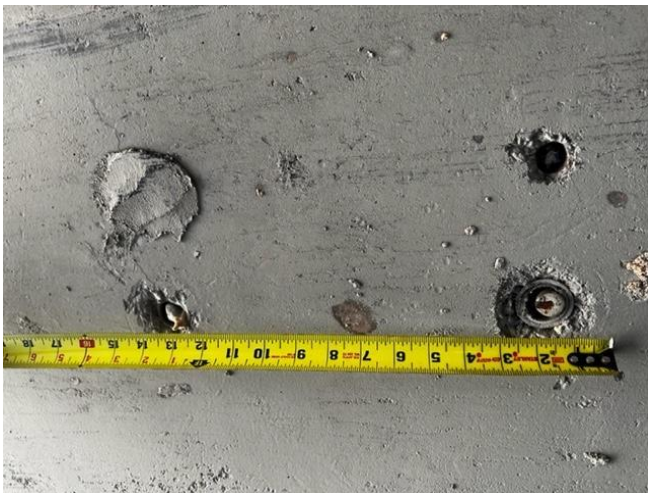
2.1 (2" dia. drill hole w/ exposed re-bar x 3)

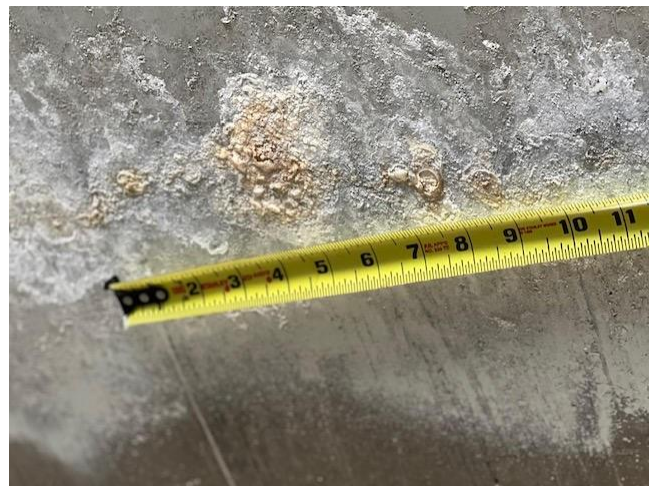
2.2 (4' Efflorescence)

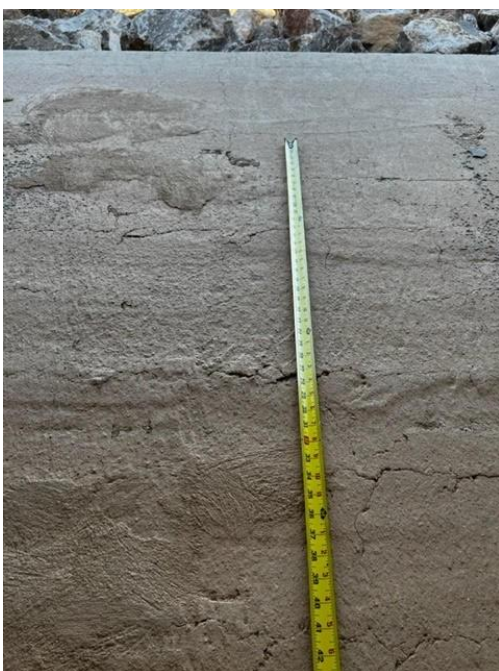
4'x4' delaminated floor west end of cell 2

- Remove vegetation from east opening of RCB (SB Lane)
- Seal/Patch cracks and drill holes in culvert
- Remove and replace corroded rebar
- Seal cracks in wingwalls
- Resurface culvert floor in delaminated area

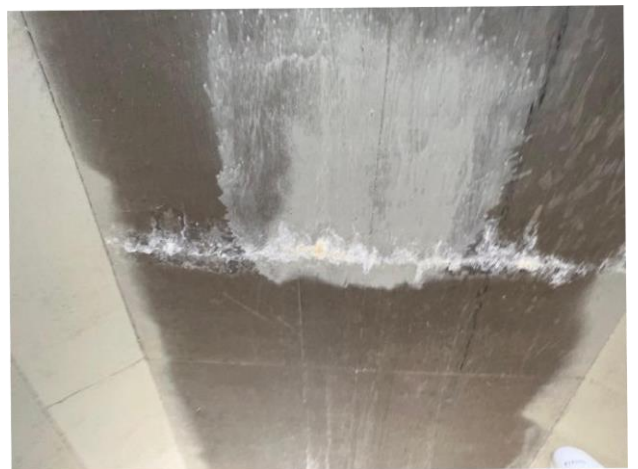
2.2 (4' across the top slab wide view)

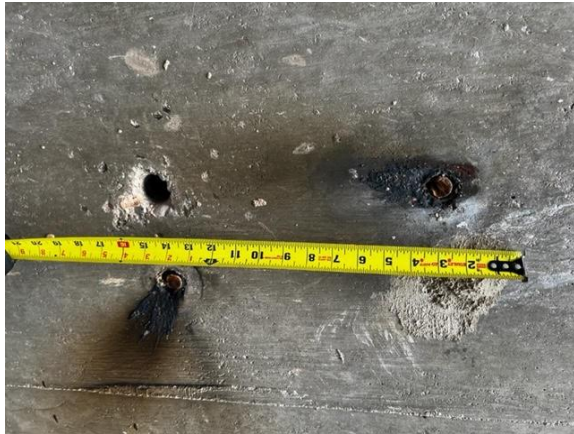
3.1 (2" dia. drill hole w/ exposed re-bar x3)

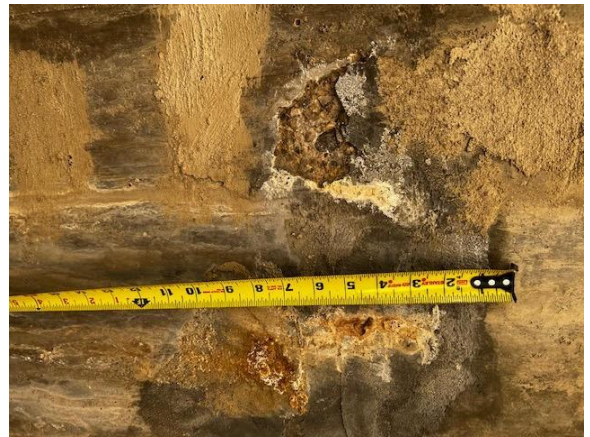
3.2 (4"x4" Spall)

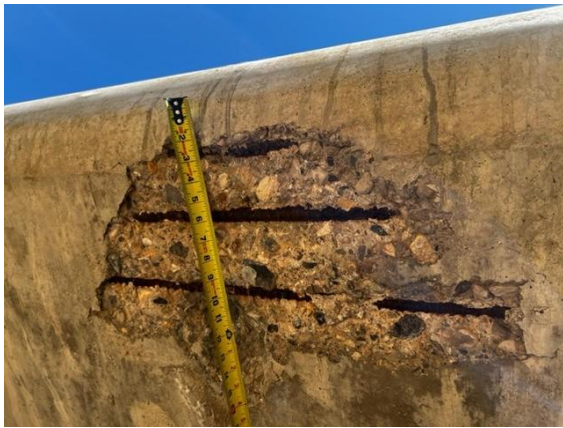
3.3 (1'x 2' spall with exposed re-bar)

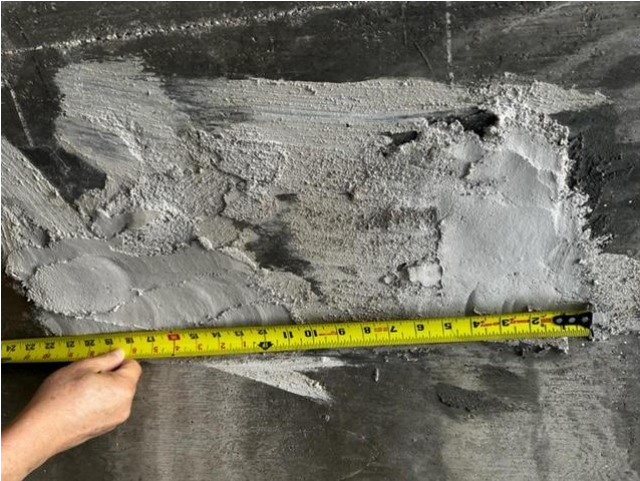
4.2 (patch work)

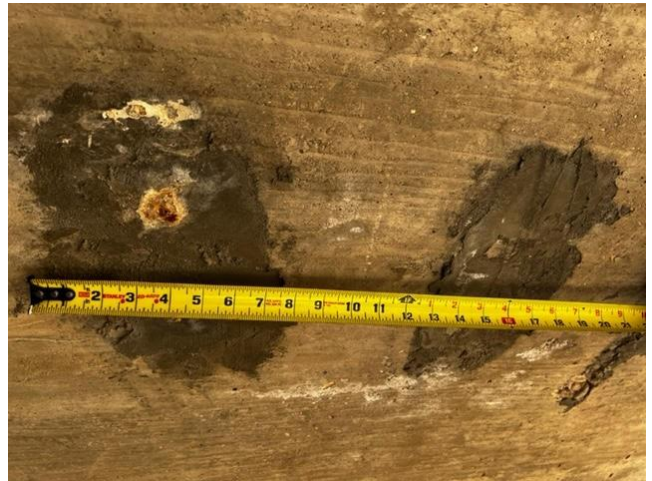
4.5 (patch work)

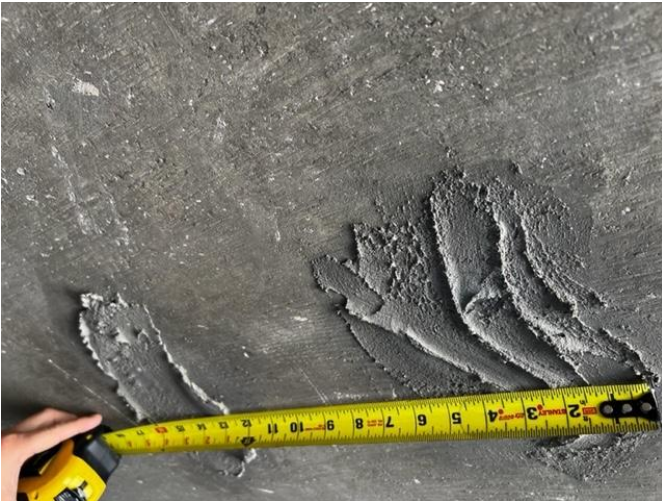
4.3 (patch work)

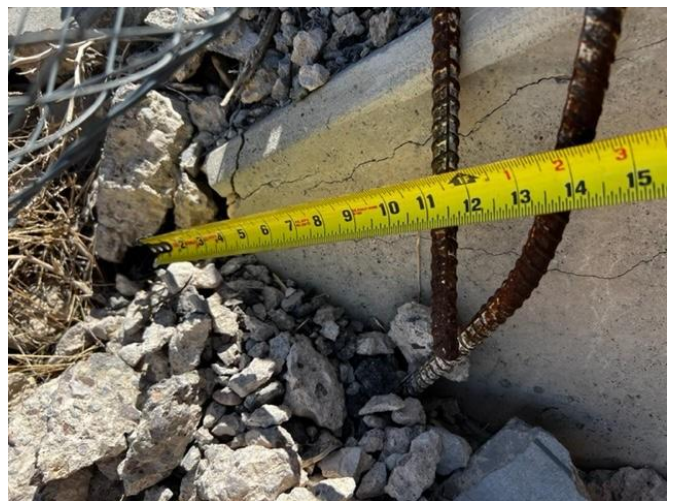
4.1 (15" spall at wing wall corner)

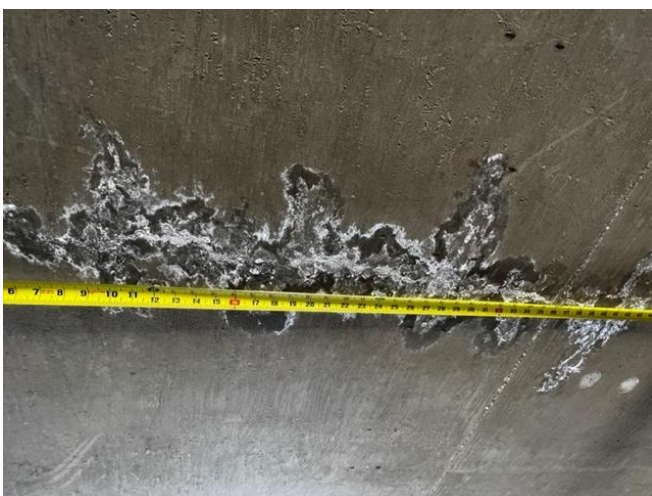
4.4 (4' Efflorescent)

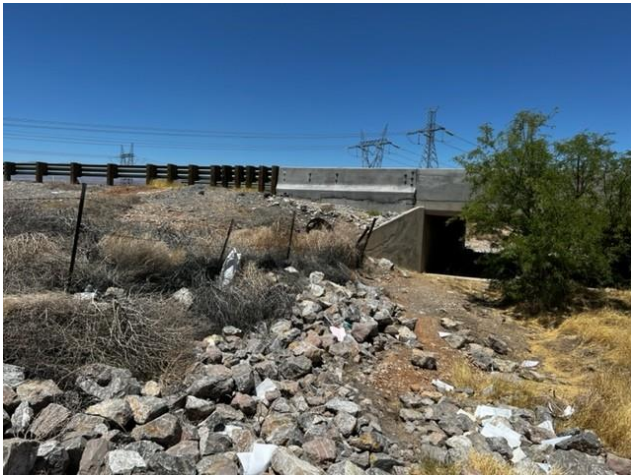
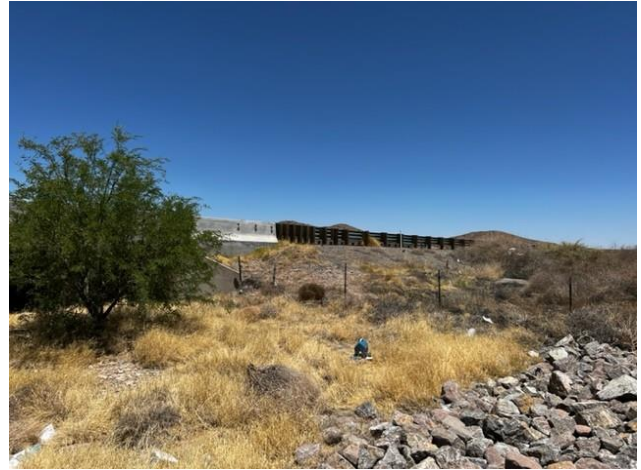
East barrier rails (construction side: to be replaced)

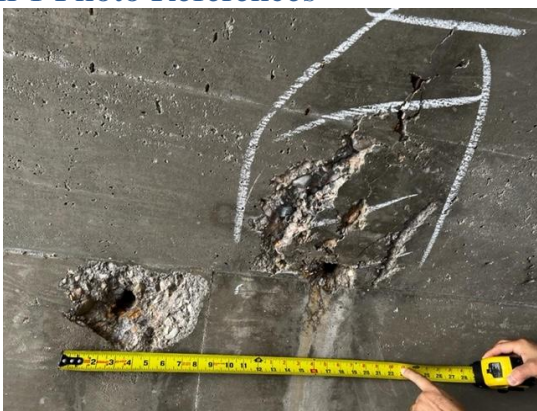
1.2 (8" x 6" drill hole (left) and 18"x12" Spall

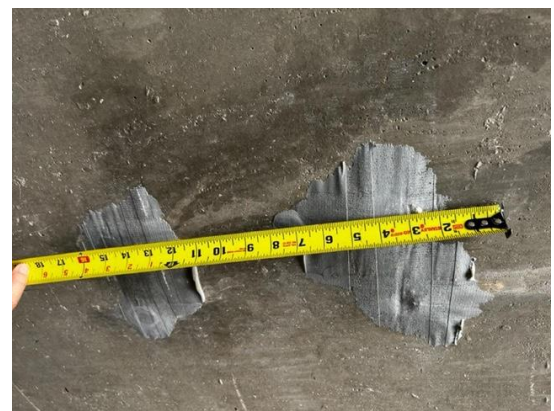
1.1 (Patch work)

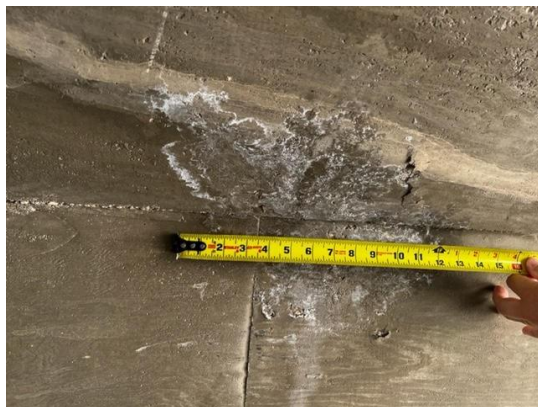
1.3 (Shrinkage cracks less than 1/64")

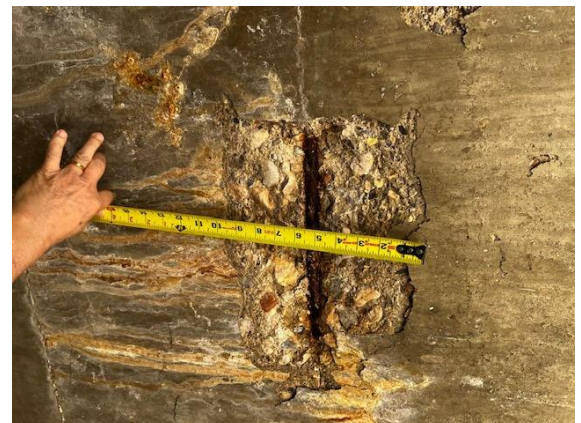
1.4 (10" x 16" spall and corroded rebar)

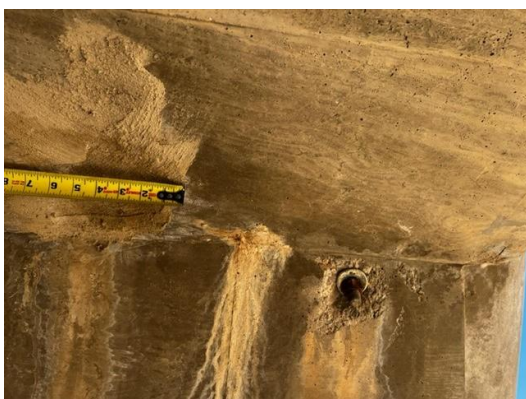
1.5 (shrinkage and exposed bolt)

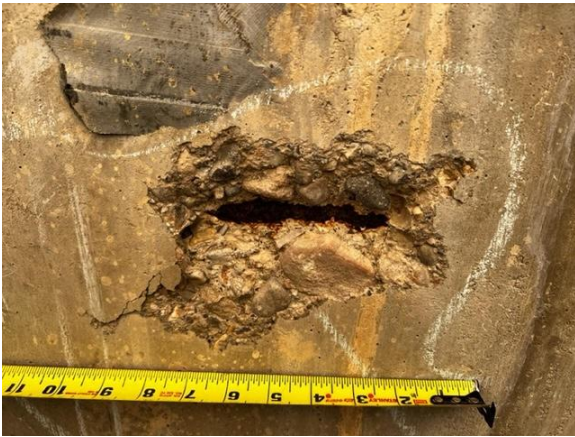
2.1 (9" x 5" spall and corroded rebar)

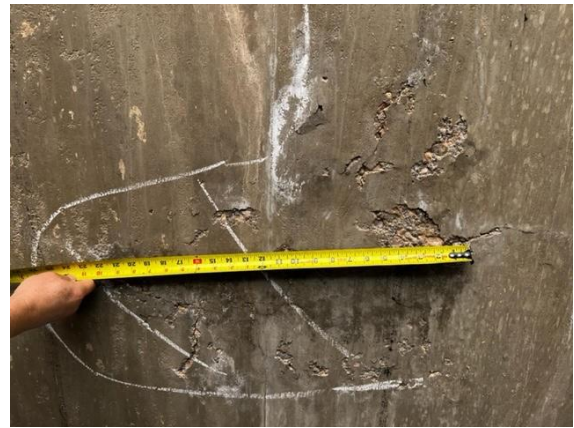
2.2 (24" x 20" spall)

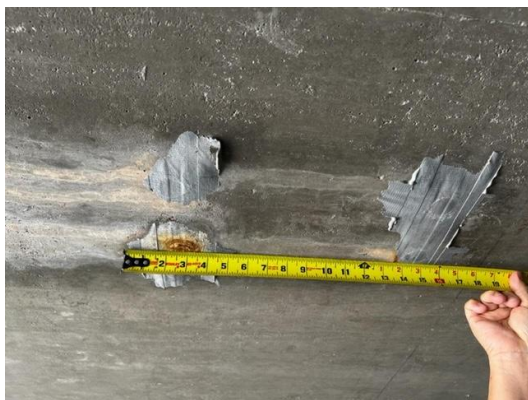
3.1 (Patch work)

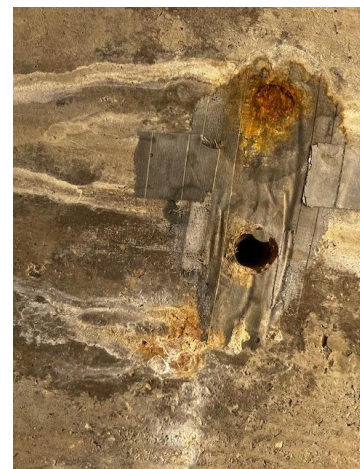
3.2 (2" dia. drill hole and corroding rebar through patch work)

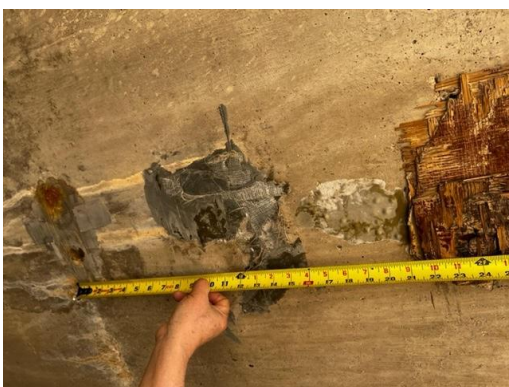
3.3(Patch Work)

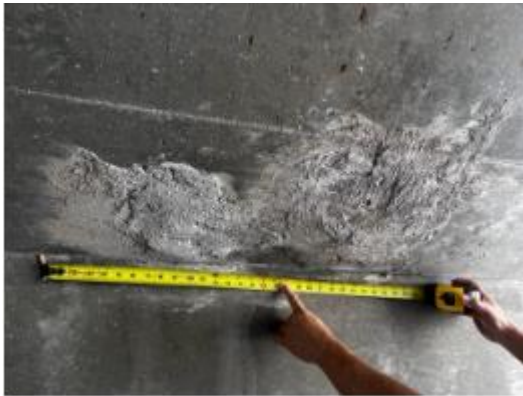
4.4 (patch work)

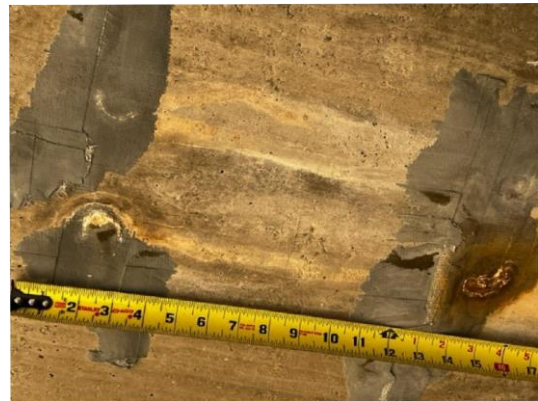
4.3 (Patch work)

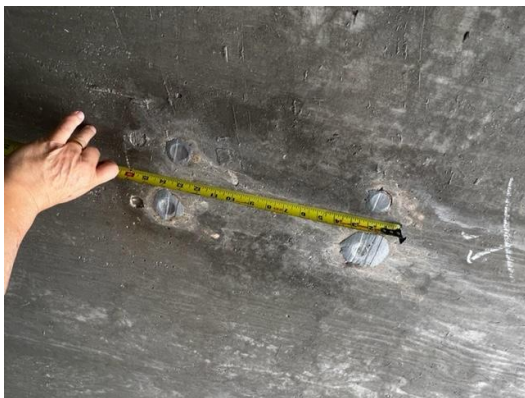
4.2 (Patch work)

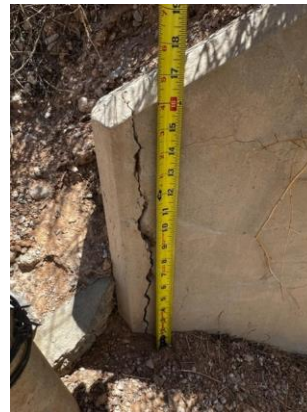
4.1 (16" spall -NW Wingwall)
