**ASBESTOS AND LEAD PAINT SURVEY  
HAZARDOUS MATERIAL BRIDGE INSPECTIONS 2024  
P083-22-013 – TASK ORDER 08  
BRIDGE B-303 (Truckee River – Downtown Reno)  
KLEINFELDER PROJECT NO. 20232595.008A**

**September 16, 2024**

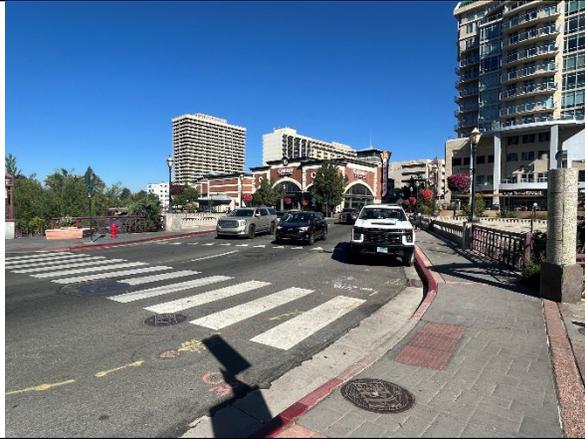
- Asphalt
- Cementitious Coating
- Concrete (Abutment)
- Concrete (Parapet)
- Concrete (Sidewalk)
- Parapet Sealant – White
- Sidewalk Sealant – Black
- Sidewalk Sealant – White
- Sealant – White

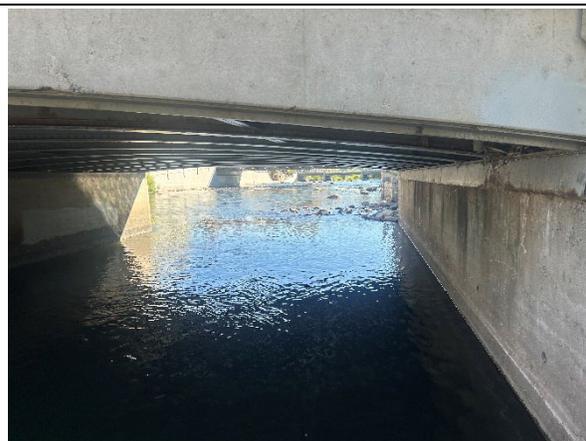
- Grey Paint on Concrete Abutment
- White Paint Striping on Asphalt Road
- Yellow Paint Striping on Asphalt Road

Concrete (Abutment & Deck)  
Grey Paint on Concrete

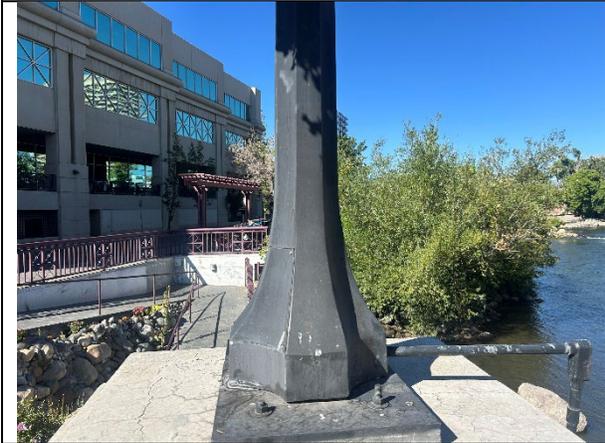
The following paint was found to be **lead-containing** by XRF analysis:

- Black Paint on Metal Light Post

Workers that impact paints containing any detectable amount of lead must use lead-safe practices and have valid training for the method of impact to comply with OSHA, 29 CFR 1926.62. To comply with best work practices, any disturbance to paints or coatings that contain lead should be completed within a contained area to prevent the creation of a lead hazard. To ensure compliance with US EPA and Nevada Division of Environmental Protection regulations for waste, any waste streams containing lead should be profiled prior to disposal to determine the correct waste characterization.

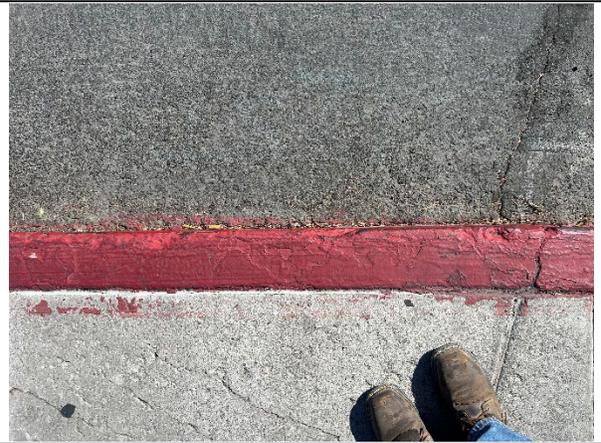
- Black Paint on Concrete Sidewalk
- Red Paint on Concrete Curb
- White Paint on Concrete Curb
- Yellow Paint on Concrete Curb

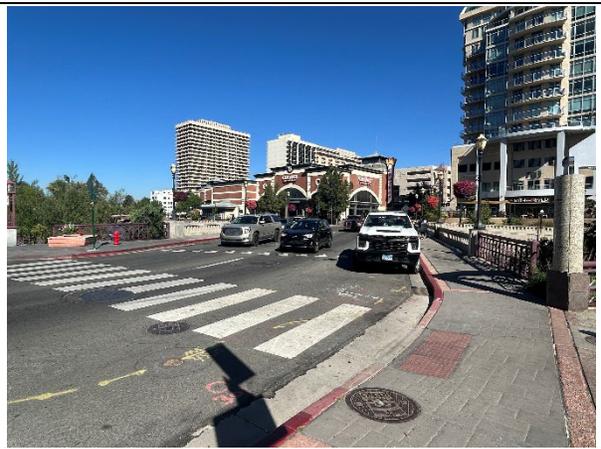
Yellow & White Paint Striping on Roadway

As noted above, certain areas of the bridge structure were inaccessible. The following paints were observed visually during this survey but not sampled and must be handled as lead-containing unless sampled to confirm lead-content:
