**HEADLIGHT GLARE SCREEN PANELS
COLD TEMPERATURE PERFORMANCE
IMPACT TEST**

Dorothy J. Tate,
Engineer of Physical Research

Nevada Department of Transportation
Materials Division
Research Section

May 1993

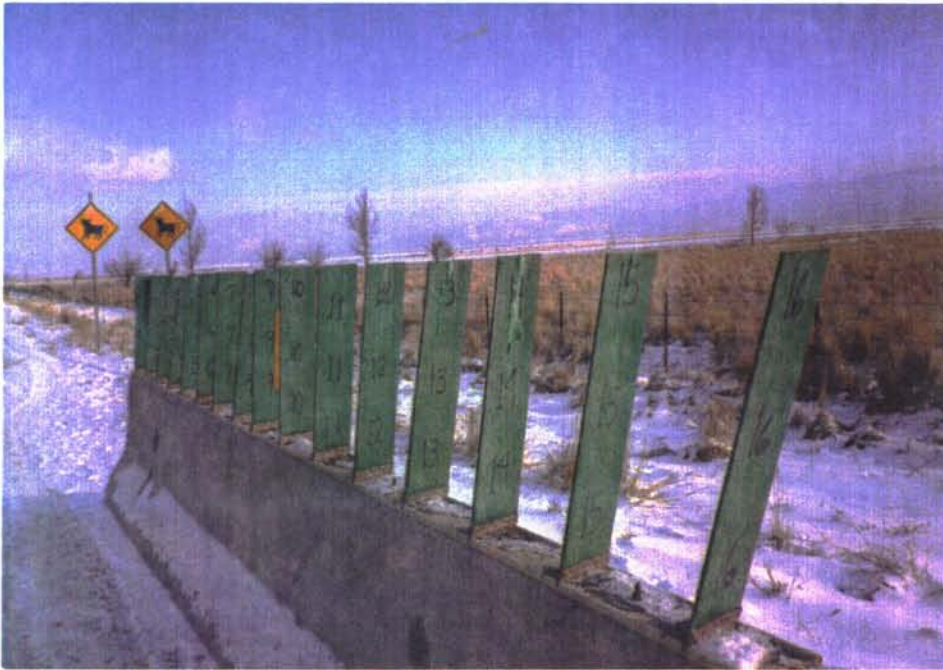
PHOTO #3

Impact Number 1: The panels split, or sheared, from the top down, 2 to 6 inches. All the panels remained in place and standing, but the bracket-base rail connection bent, causing the panels to lean, slight to moderate. See picture #3.

CARSONITE 2-17-1993

The split of the panels and the lean, due to the bend in the bracket

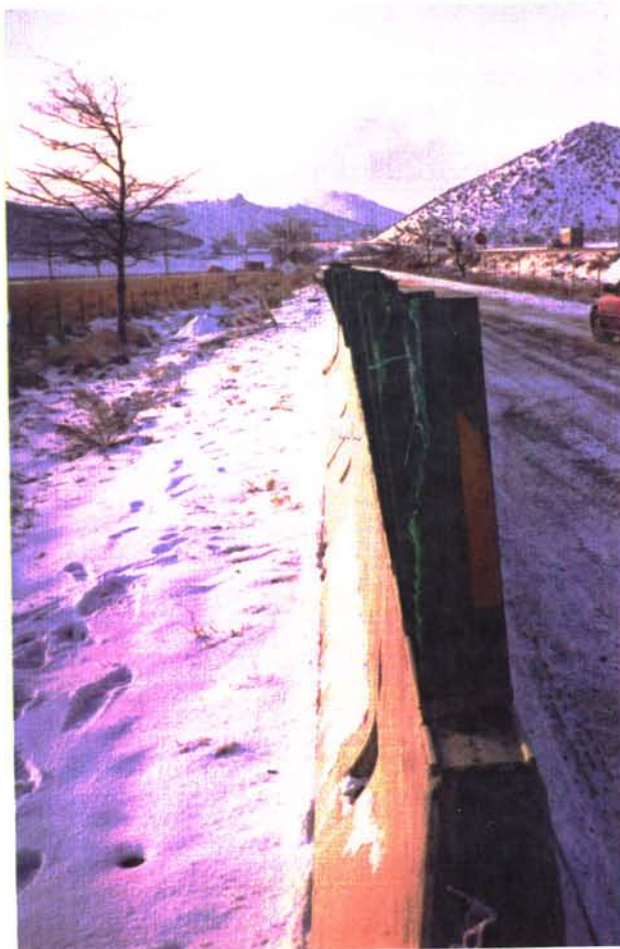
PHOTO #4

Impact Number 2: The splits or shear failure on the panels lengthened, from the top down, as shown in picture #4. Three of the panels split to full length. A small split developed at the bracket of panel #16. Although the panels remained attached, the bracket bent, causing them to lean. It must be noted that although the panel material split, the product remained attached and could be considered functional, until replaced, if it were in an "in-service" situation.

CARONITE 2-17-1993

The split of the panels and the lean, due to the bend in the bracket

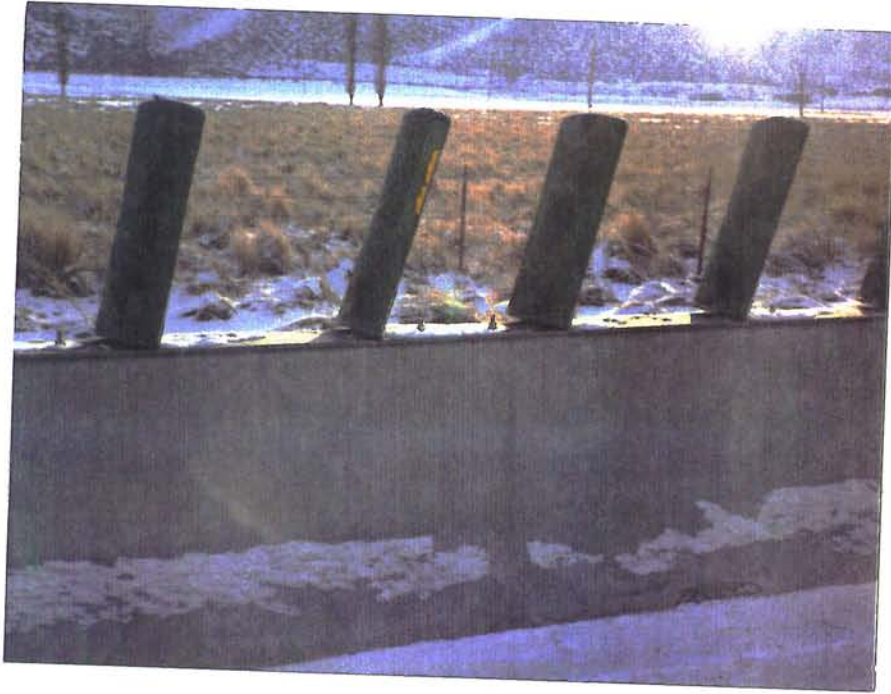
PHOTO #5

Impact Number 1: Of the two carriage anchor bolts attaching the panel to the base rail, nine panels tore at this bolt, on the impact side. Additionally, five of those nine panels also split at the top and panel #1 was dislocated. See pictures 5 and 6.

SYRO STEEL 2-17-1993

The detachment
and looseness of
the panels after
one impact.

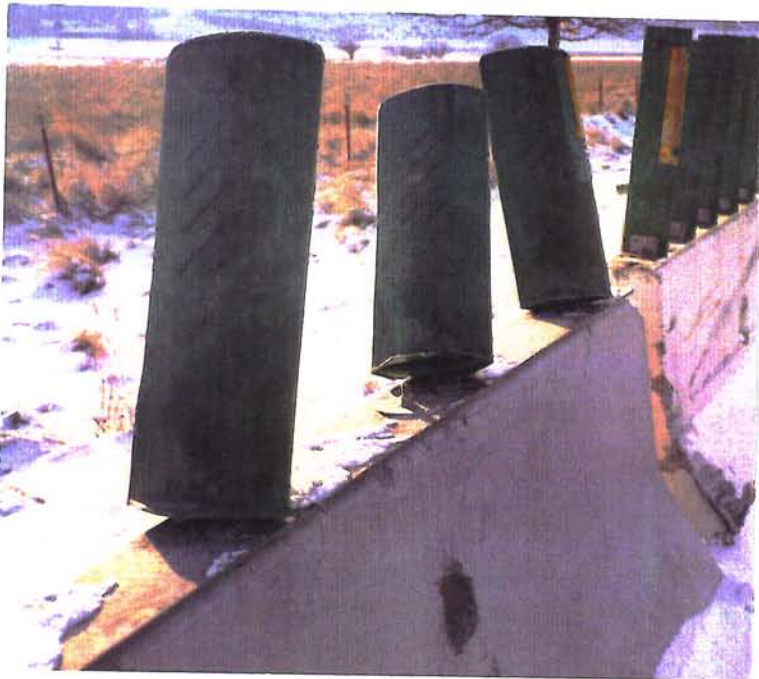
PHOTO #6

SYRO STEEL 2-17-1993

The tear in the
panels, at the anchor
bolt, on the impact
side.

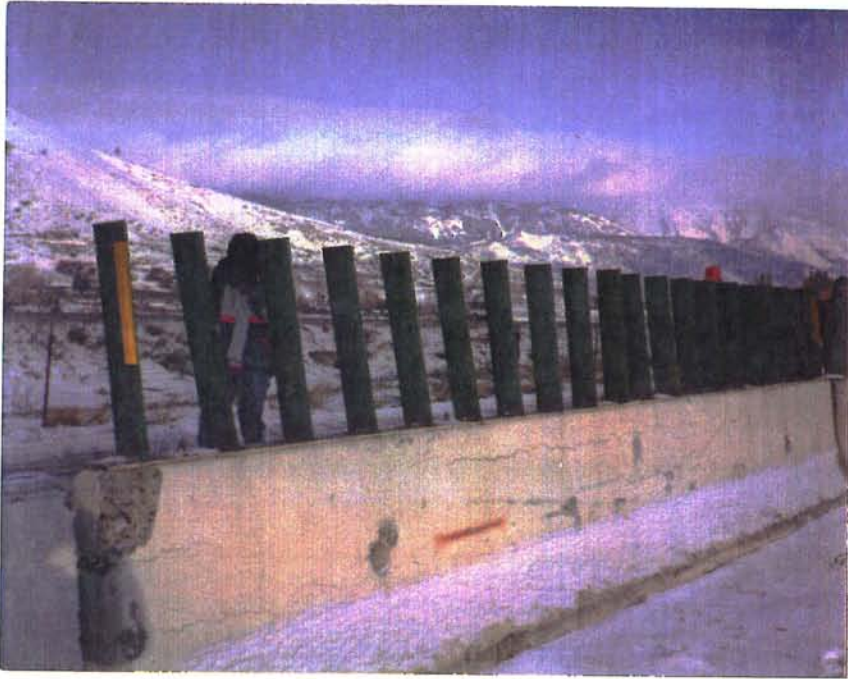
PHOTO #7

Impact Number 1: Panels #1 through #19 were still standing, with no damage to the panel material, however the bracket bent, causing them to lean slight to moderate. See picture #7 A small split, on panel #20, developed at the bracket. The panel material of #1 sustained no damage, but the bolt started pulling through the base rail, see picture #8.

GLASFORM 2-17-1993

The lean of the panels, due to the bend in the bracket.

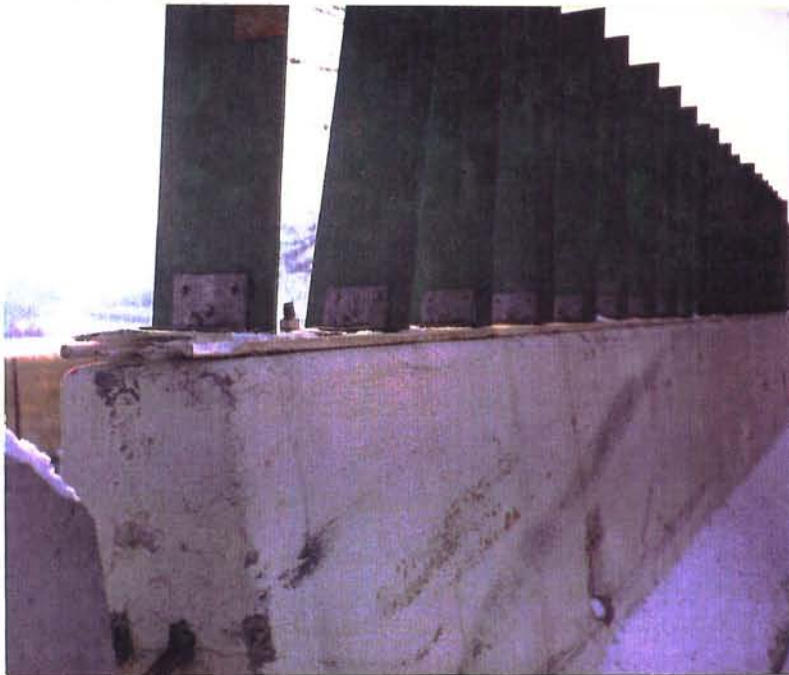
PHOTO #8

GLASFORM 2-17-1993

The base rail delaminating, causing the bolt to pull through.

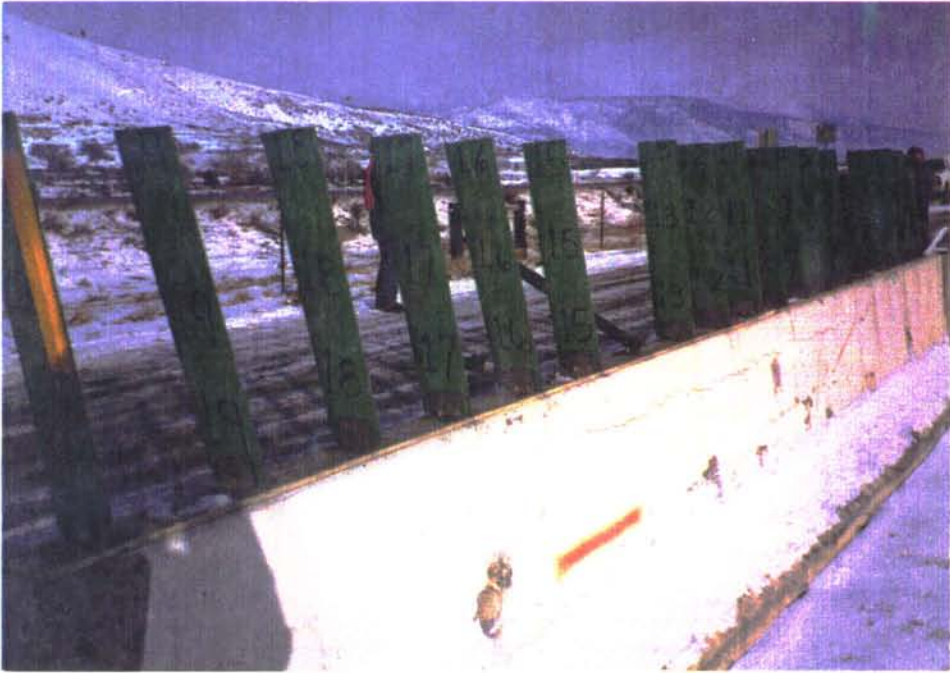
PHOTO #9

Impact Number 2: All the panels were leaning due to the split running through the entire length of the base rail. Panel #1 was dislocated due to the bolt pulling through the base rail. Panels #6 and #14 remained attached, but were leaning severely due to the bolt pulling through the base rail, see picture #9. Sixteen of the twenty panels remained fully functional

GLASFORM 2-17-1993

Panels #6 and #14
leaning, due to the
bolt pulling through
the base rail.

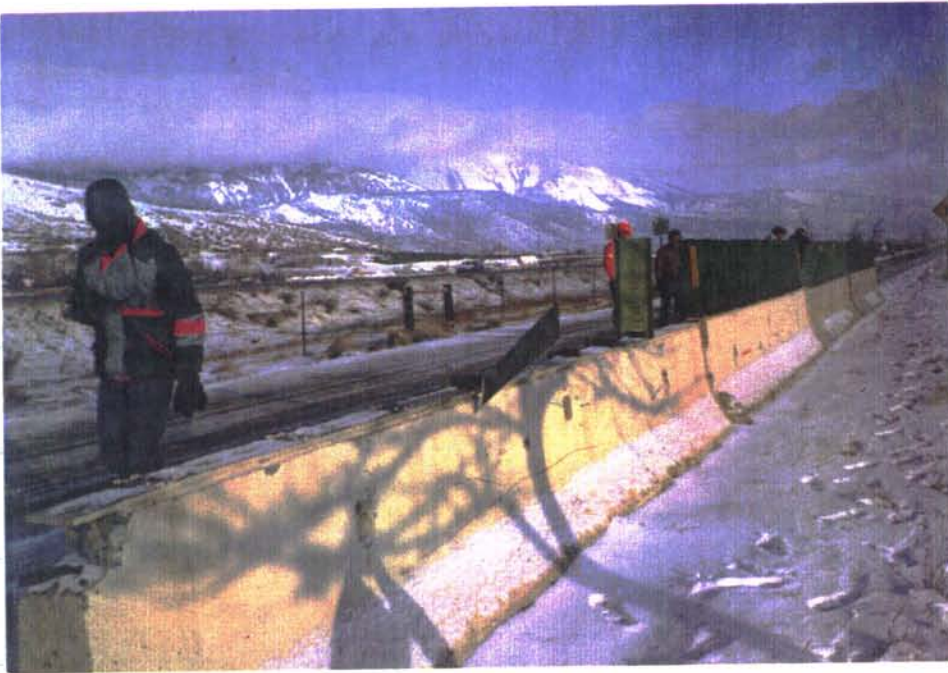
PHOTO #10

Impact Number 1: Out of 10 panels, 6 were dislocated due to the blade base shearing off at the base rail. Three were dislocated due to the panel shearing off at the top of the blade-base. Panel #7 was barely attached and fallen over and was non-functional, see picture #10. Panel #3 was still in place with no damage to any part of the assembly. See pictures #11.

SAFE-HIT 2-17-1993

Broken blade base
and panel #7 sheared
at the top of the
blade base.

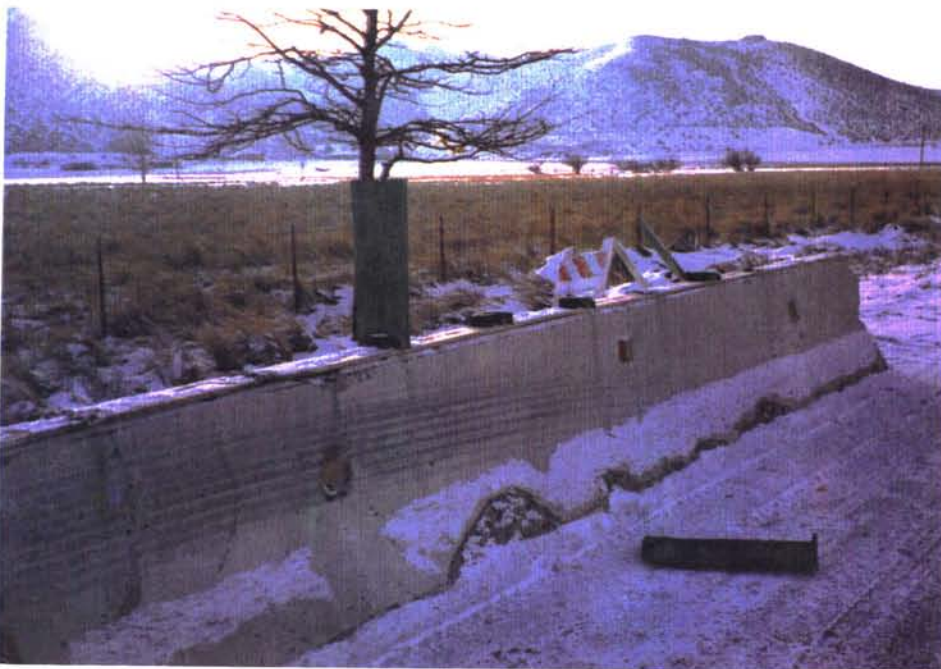
PHOTO #11

SAFE-HIT 2-17-1993

Panel #3 is
undamaged and intact.

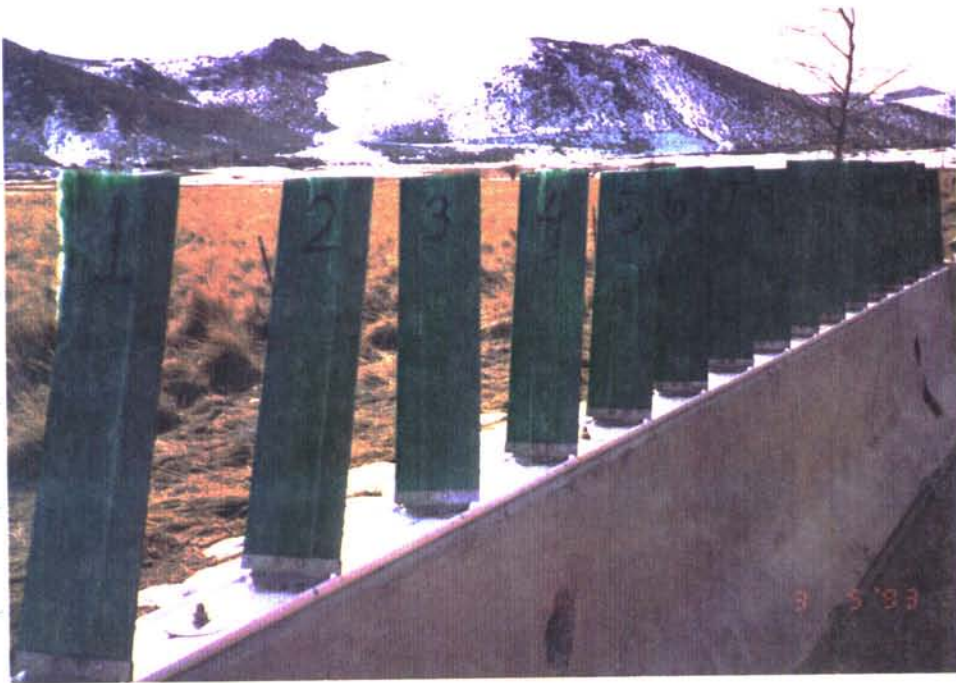
PHOTO #12

Impact Number 2: All panels remain in-place and functional. The bracket to base rail connection bent, causing the panels to lean. The angle of lean is more severe and the shearing (splitting) of the panels lengthened after the second impact. The damage to the panels was not as severe as the February test. (See pictures 12 and 13)

CARSONITE 3-05-1993

The split of the panels and the lean, due to the bend in the bracket

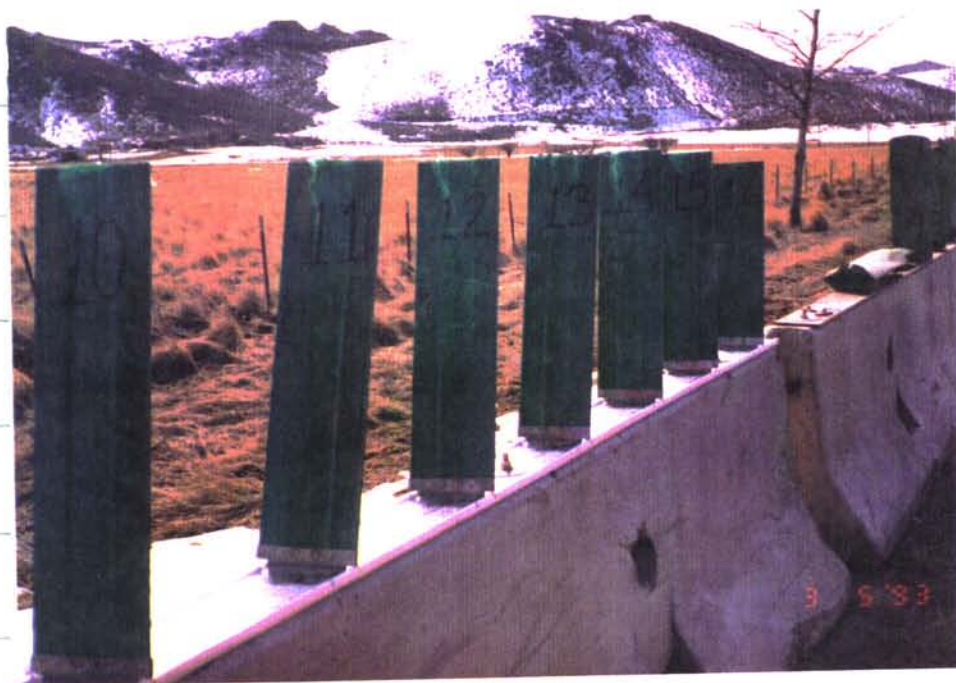
PHOTO #13

CARONITE 3-05-1993

The split of the panels and the lean, due to the bend in the bracket

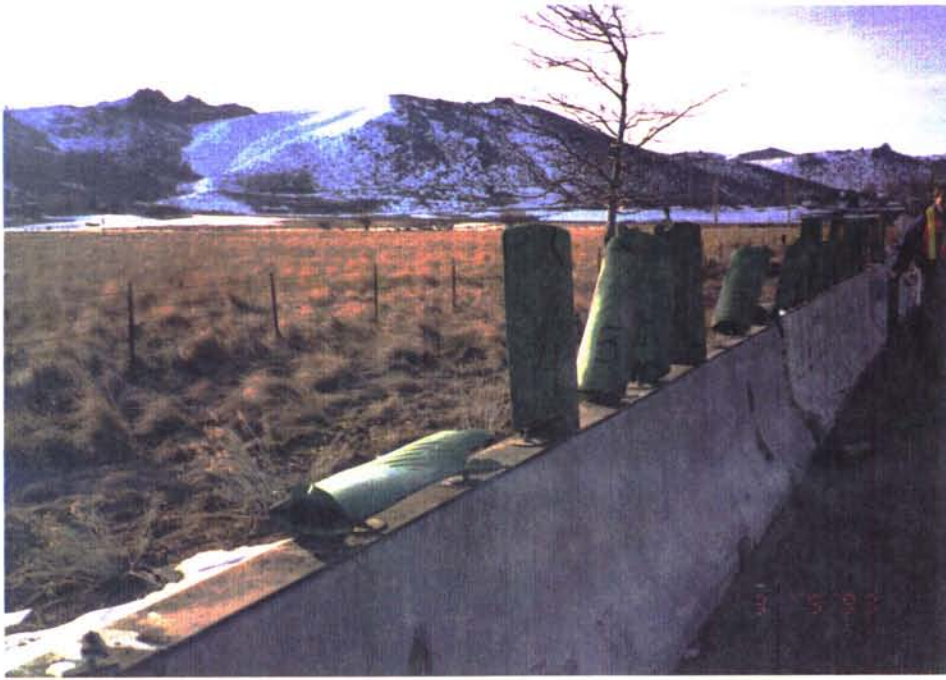
PHOTO #14

Impact Number 2: Three additional panels were dislocated. All the panels were cracked and torn, five were shattered. The impact side of the anchor bolts tore and the panels were loose and falling over. This product was evaluated as non-functional, due to the dislocation of the panels and failure to self erect. See pictures 14 and 15.

SYRO STEEL 3-05-1993

The shattered top
of the panels and
the tear at the
anchor bolt.

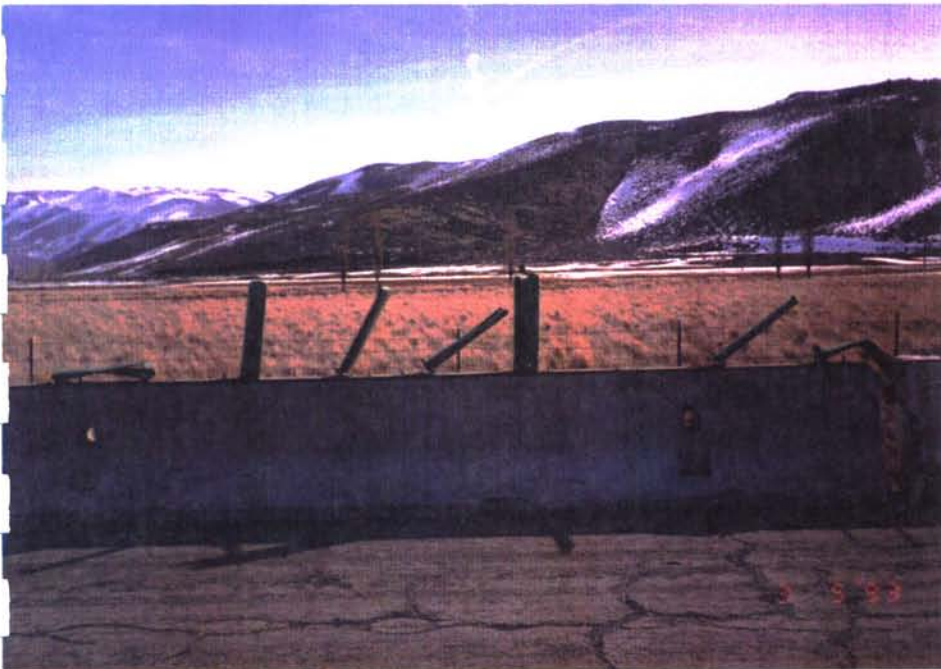
PHOTO #15

SYRO STEEL 3-05-1993

The looseness of the
panels, due to the
panel tearing at the
anchor bolt

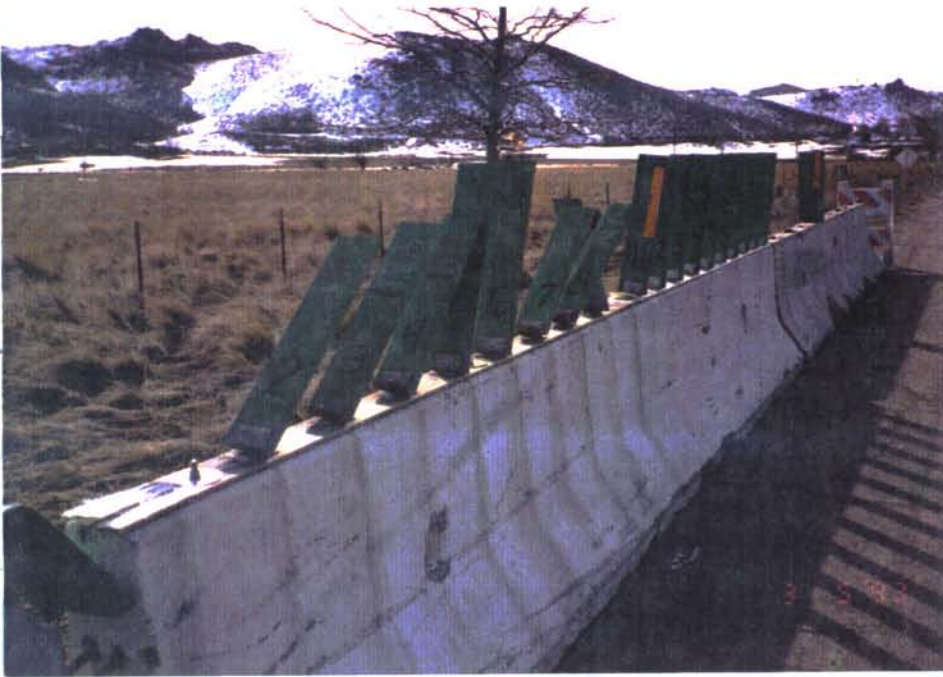
PHOTO #16

Impact Number 2: Panels #1 and #10 were dislocated due to the bracket anchor bolt pulling through the base rail. Due to the dislocation and the severe lean of panels, this product was evaluated as non-functional. See pictures 16 and 17.

GLASFORM 3-05-1993

The bolt pulling through the base rail, causing the panels to lean.

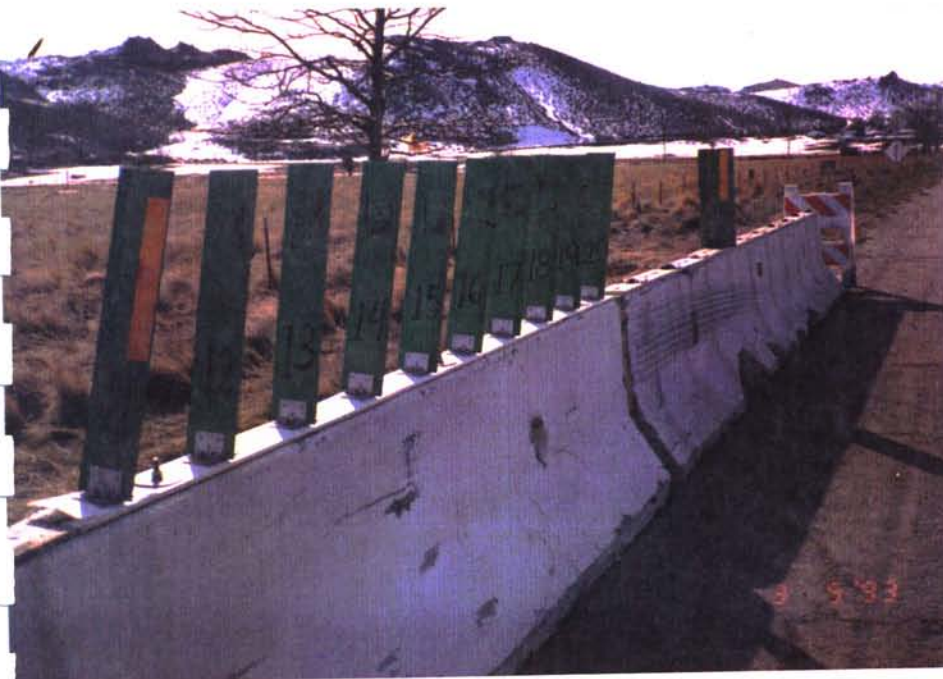
PHOTO #17

GLASFORM 3-05-1993

The base rail delaminating and the bolt pulling through.

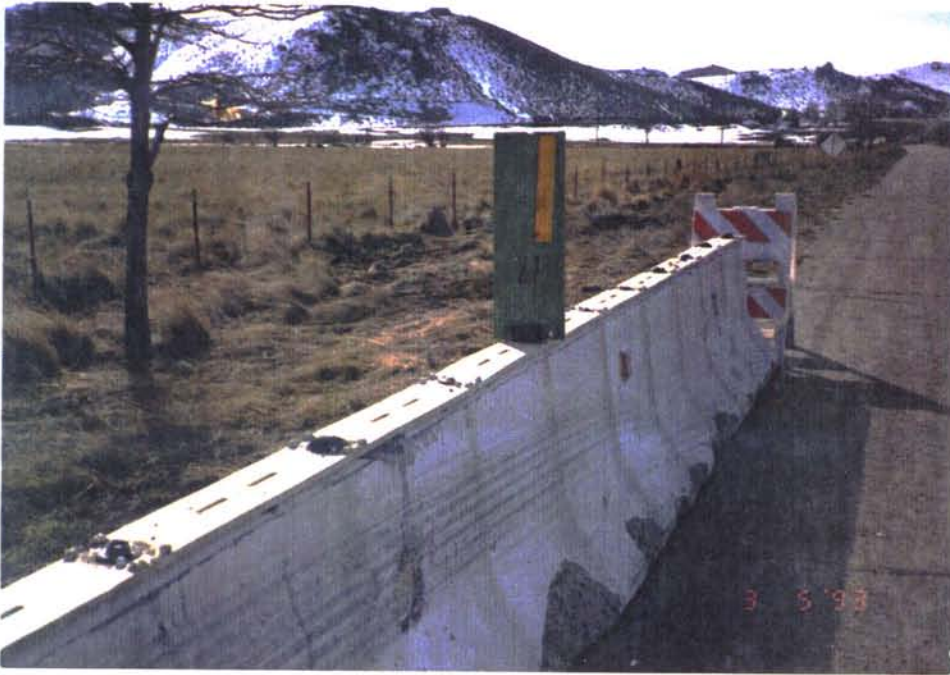
PHOTO #18

Impact Number 2: Panel #4 was still attached with no damage to any part of the assembly. See pictures 18 and 19. Due to the dislocation of the panels, this product was evaluated as non-functional. The panel material proved to be very durable, with no evidence of splitting.

SAFE-HIT 3-05-1993

Broken blade base,
panel #4 undamaged
and intact.

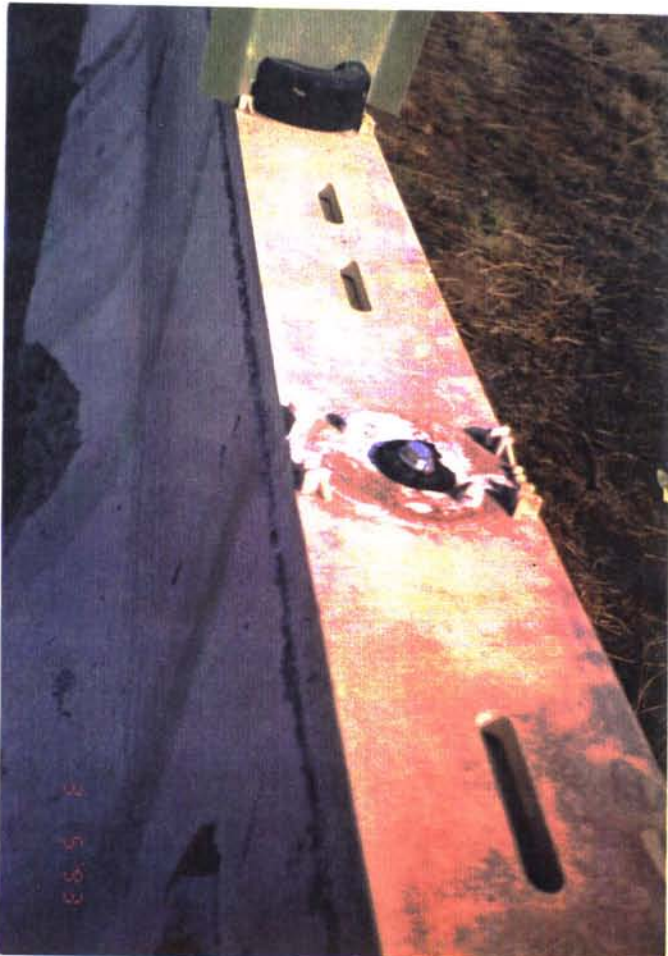
PHOTO #19

SAFE-HIT 3-05-1993

Broken blade base.
