GEOTECHNICAL INVESTIGATION

**ASSESSMENT OF ROCK SLOPE CONDITIONS
ALONG KINGSBURY GRADE ROAD - SR 207
DOUGLAS COUNTY, NEVADA**

MARCH 1996

Subject: Assessment of rock slope conditions along Kingsbury
Grade Road, SR 207. E.A. 72028-9.

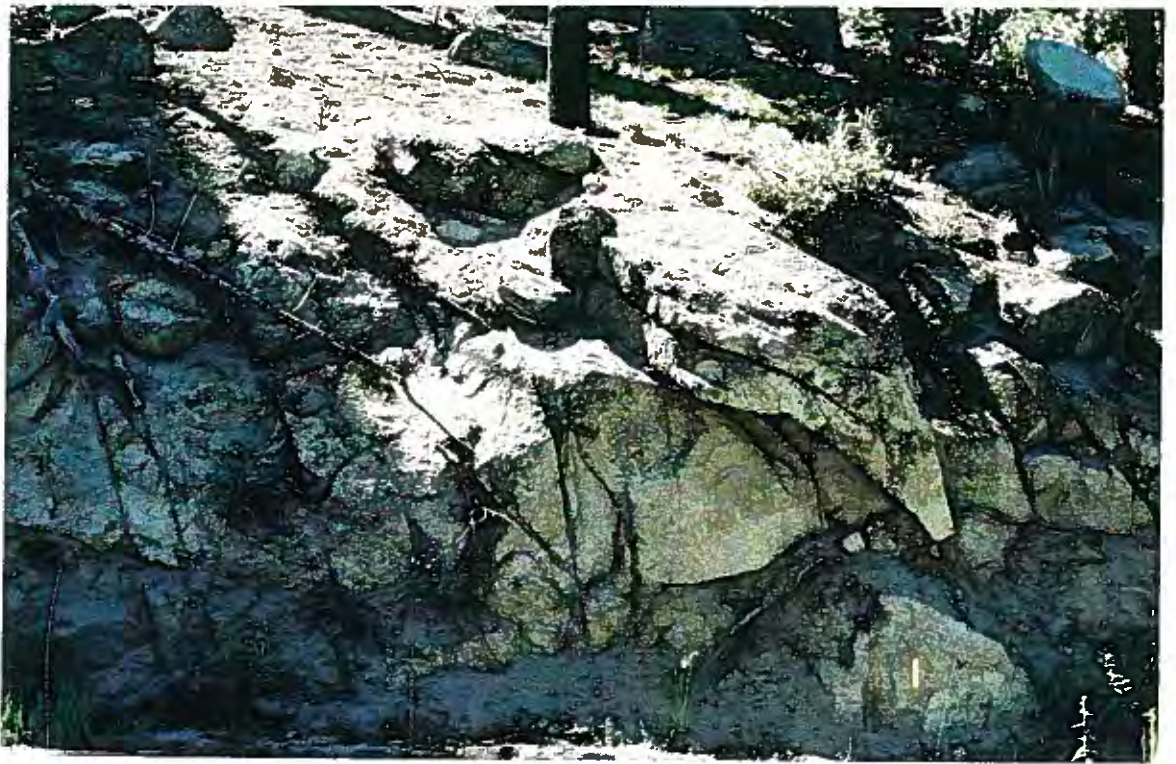
#1 (Lakeside)

Slope scale (photo 1) loose boulders and rocks and clean catchment area. Consider removing granite nose (photo 2) to improve roadway drainage and help reduce water erosion of roadway. This granite outcrop is located about 15' downslope and across from Hall Court road.

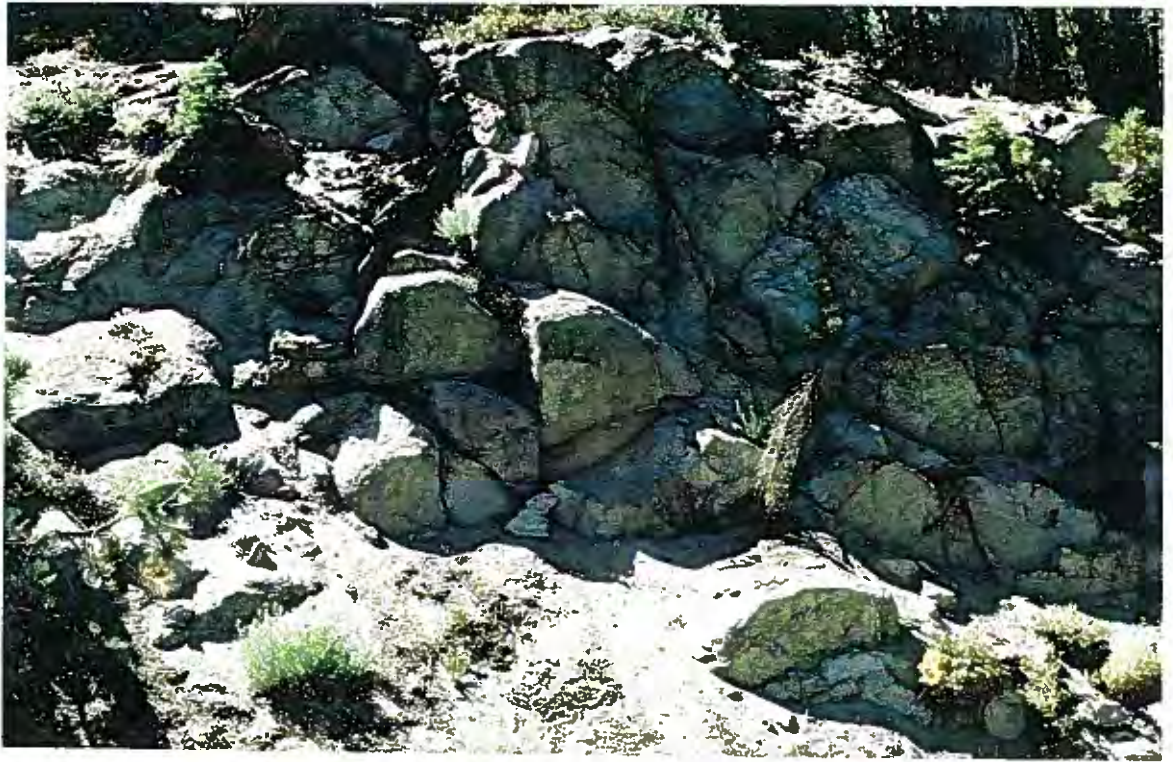
3 (Lakeside)

Slope scale loose rocks and boulders (photo 3), remove dead trees which may fall onto roadway, and clean catchment area.

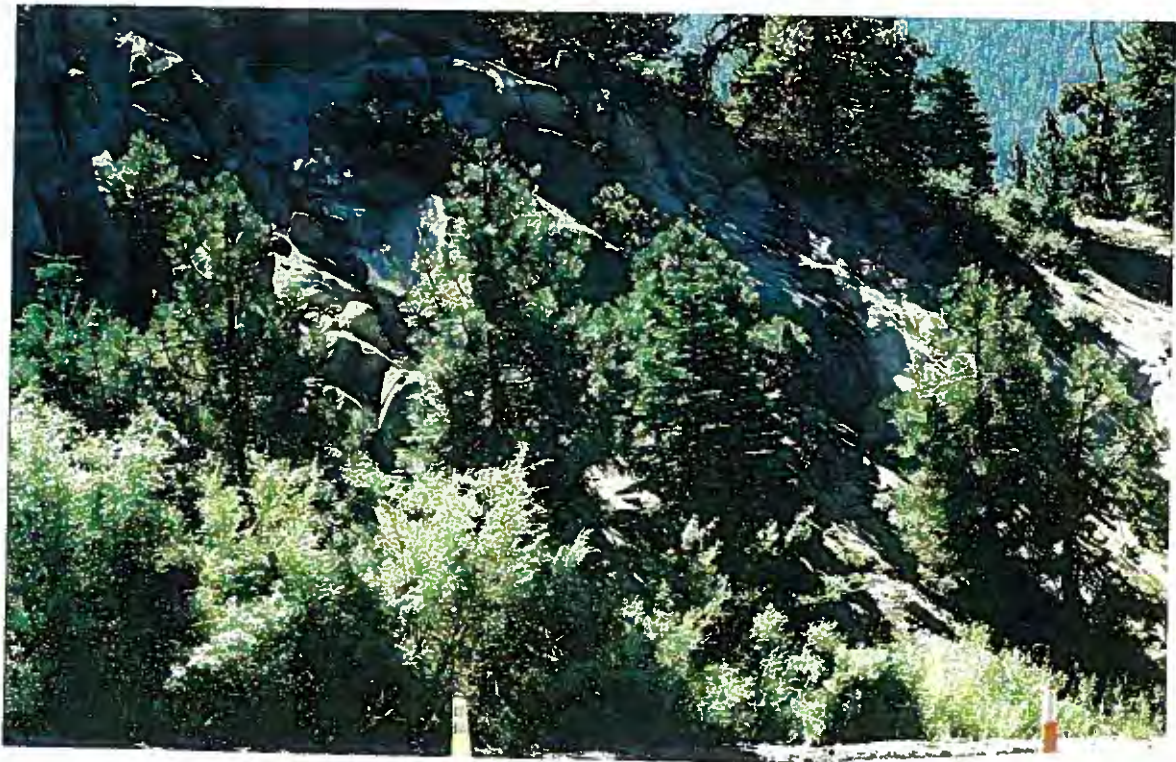
4

Slope scale loose rocks, clean and reshape catchment area, keep trees on slope intact (photo 4). Should address drainage erosion along south side of roadway (photo 5), suggest using asphalt paved ditch if Hydraulics agrees.

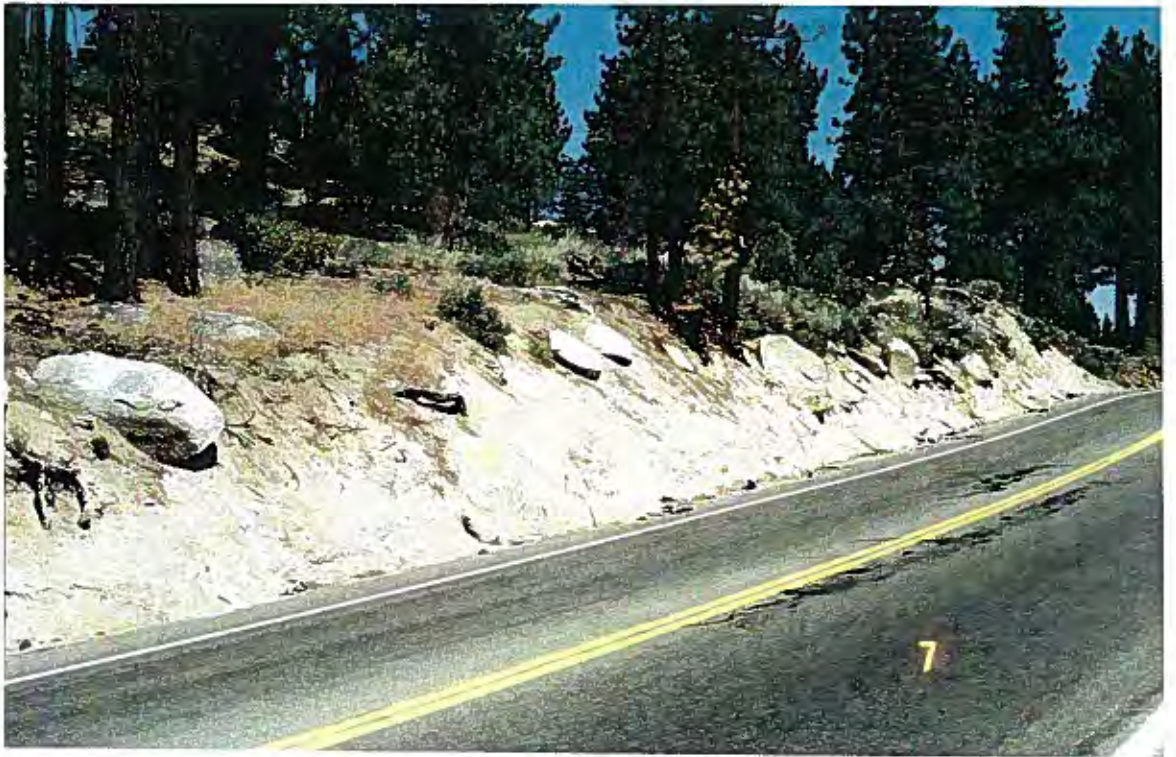
#7 (Lake side)

Remove loose rocks and boulders (photo 7) from top of slope face. Clean, reshape, and pave catchment ditch.

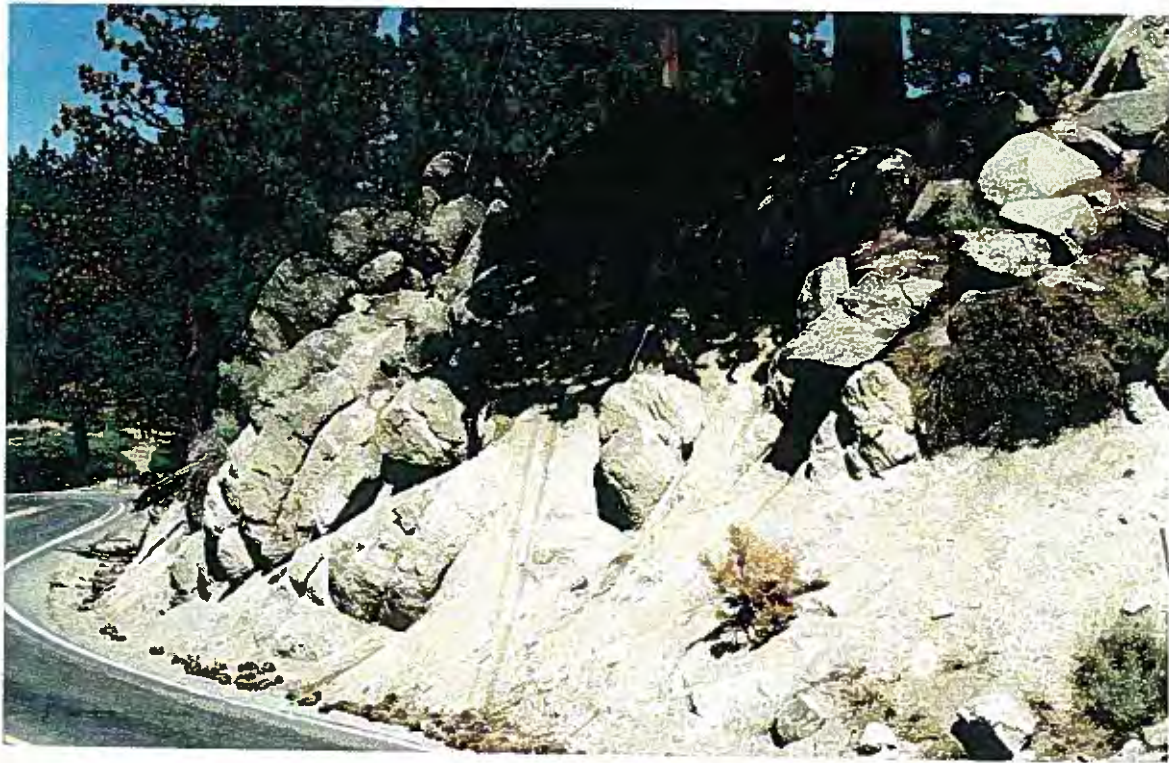
#8

Poor sight distance exists around slope from westbound lane. Very little catchment area for debris. Should remove all loose rocks, boulders, and corestones from slope (photos 8,9,10). It might be necessary to blast to remove large boulders with unfavorable fracture plane orientations. If necessary, care should be used to insure that the house sitting above the cut is not endangered by blasting procedures.

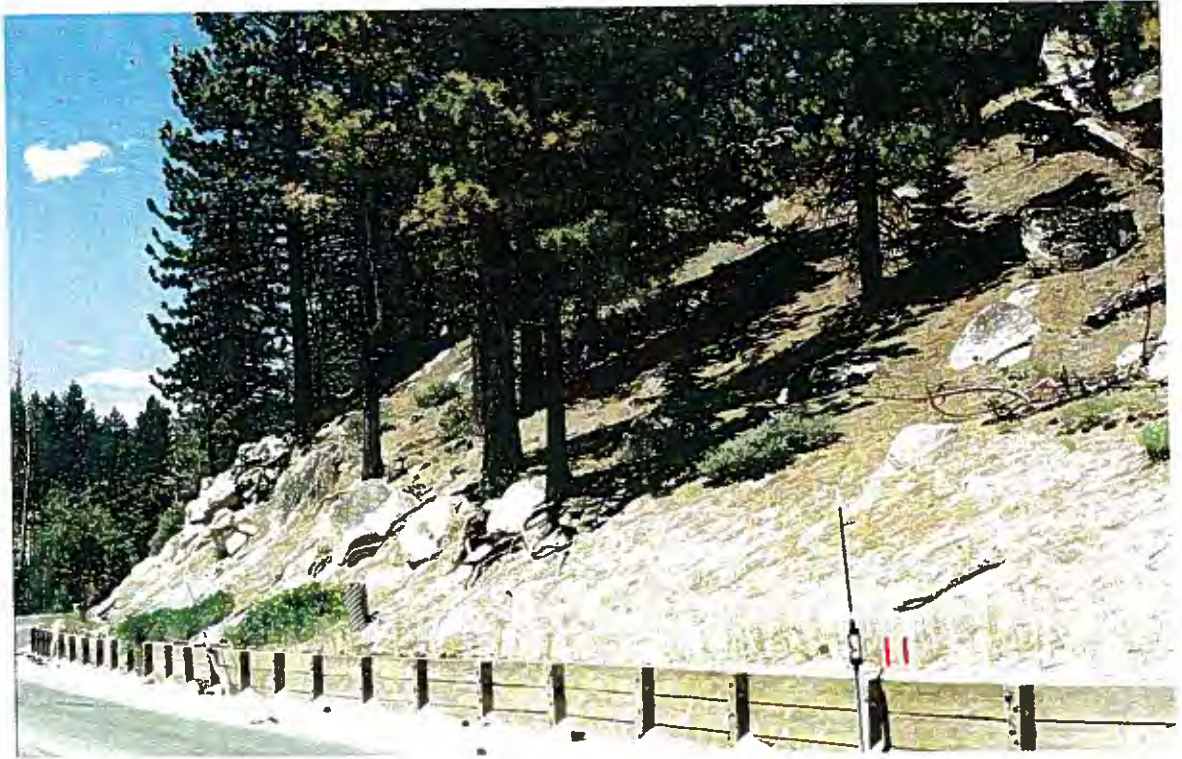
#11 (Lake side)

Clean material from behind retaining wall, slope scale loose boulders and rocks (photo 11), and remove any dead undermined trees which could fall onto roadway.

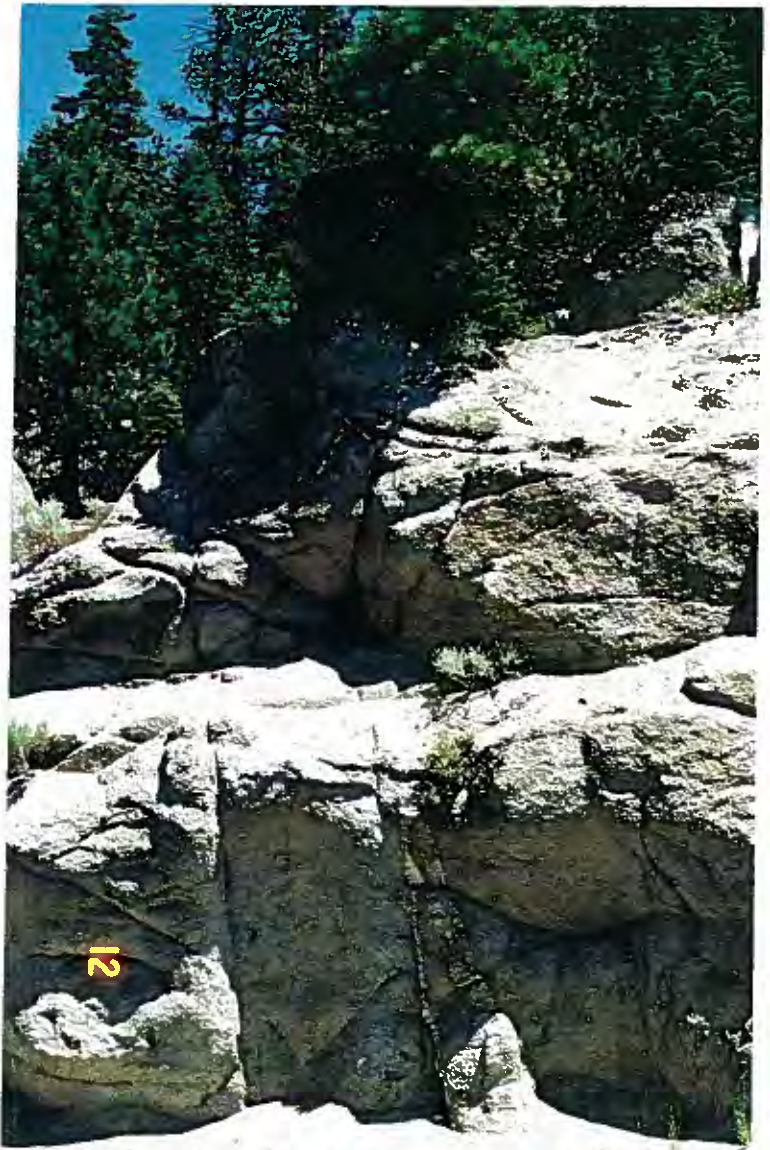
13

Scale loose rocks from slope, remove talus from catchment area. Large perched boulder should be removed (photos 12 & 13). Boulder will probably require blasting to move. A 6 to 8 inch sand cushion should be used to protect the existing roadway surface from the falling boulder. Fill slope erosion (photo 14) at the beginning of the curve on the westbound lane needs to be addressed. Should provide drainage structure to allow downslope flow without fill erosion. Hydraulics should be consulted on this design.

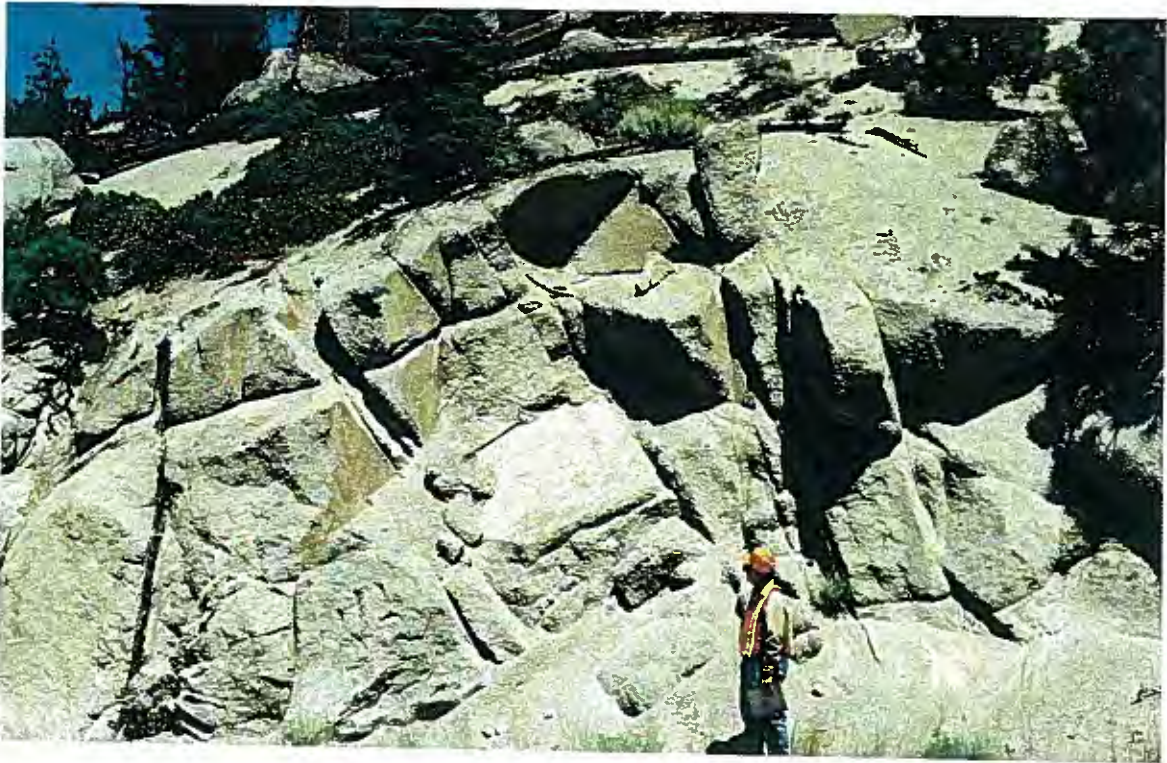
#15

Slope scale loose rocks, boulders, and corestones (photo 15). Clean material from behind retaining walls.

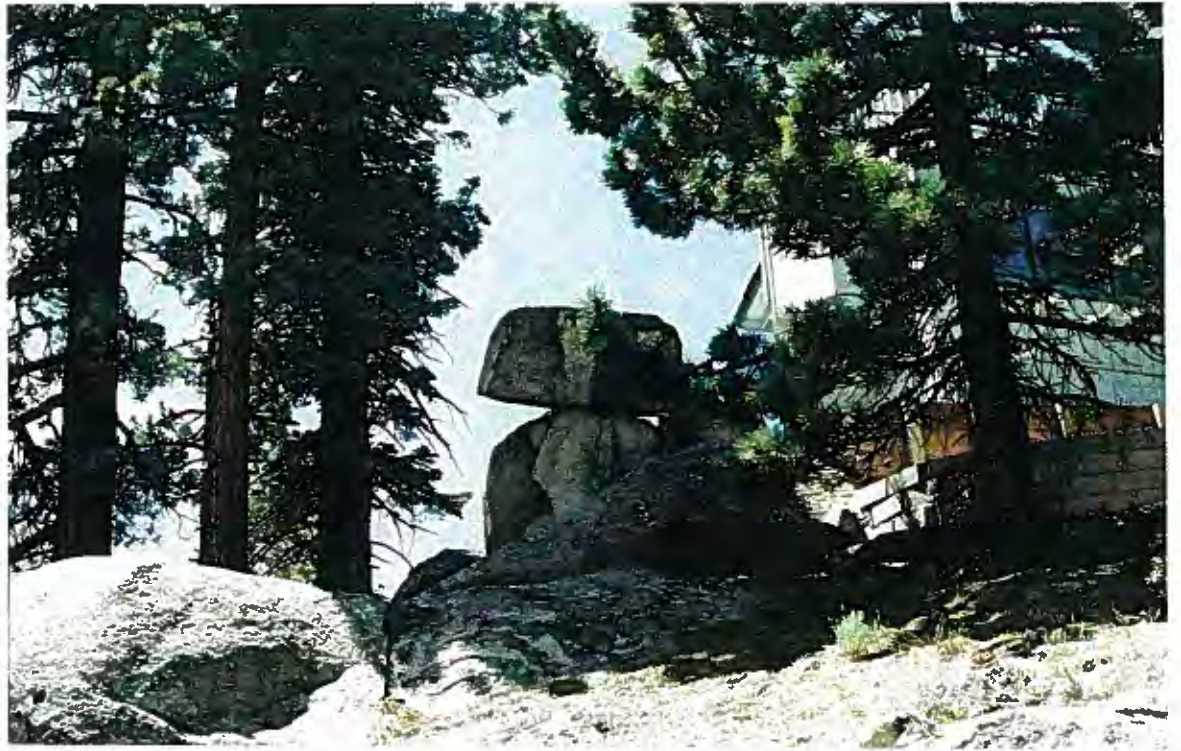
#16 (Lake side & Summit)

Shotcreted portion of slope is ok. However there is a large precariously (can move boulder with bare hands) perched boulder above the slope (photos 16 & 17). There is a good possibility that this boulder could slide off its perch and bounce onto roadway. The boulder appears to be on private property. We should consider removing this rock if property owner has no objections. Should be

able to drag boulder downslope to a more stable position with winches or heavy equipment. Blasting is not recommended due to the close proximity of the house.

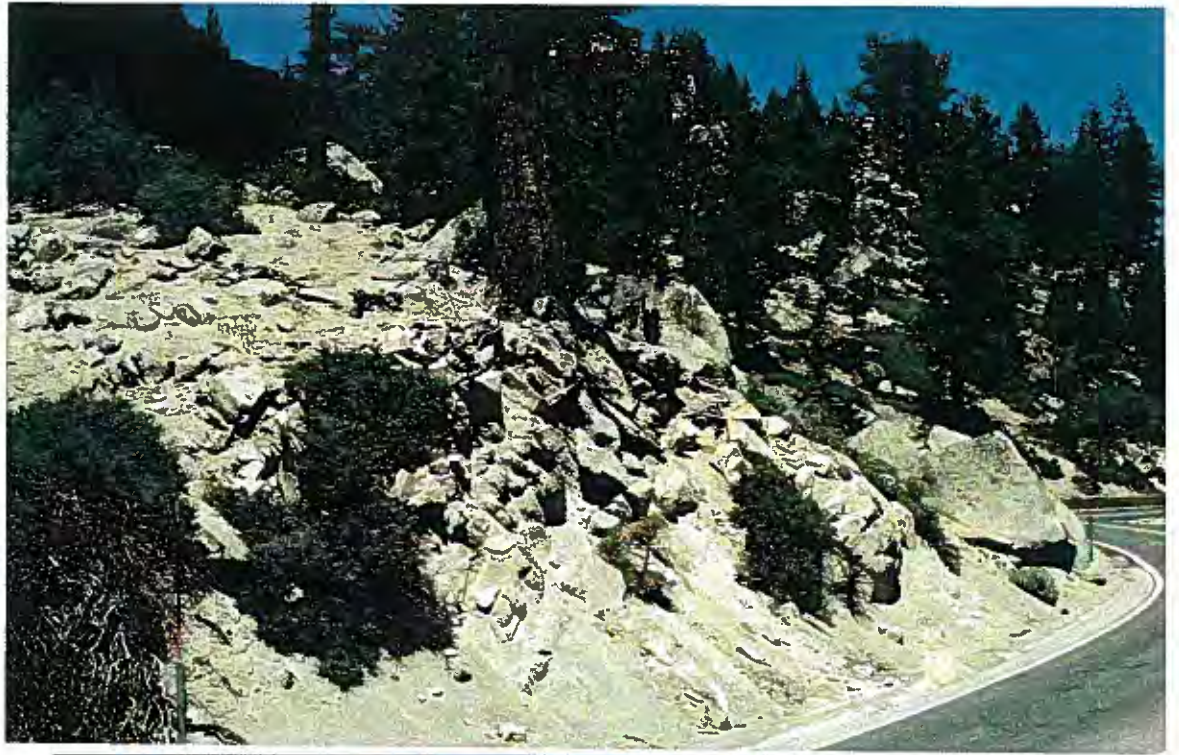
#18 (Lakeside & Summit)

Scale loose rocks from slope (photo 18). Remove large dying undercut tree (marked with blue stripe) to keep it from falling across roadway.

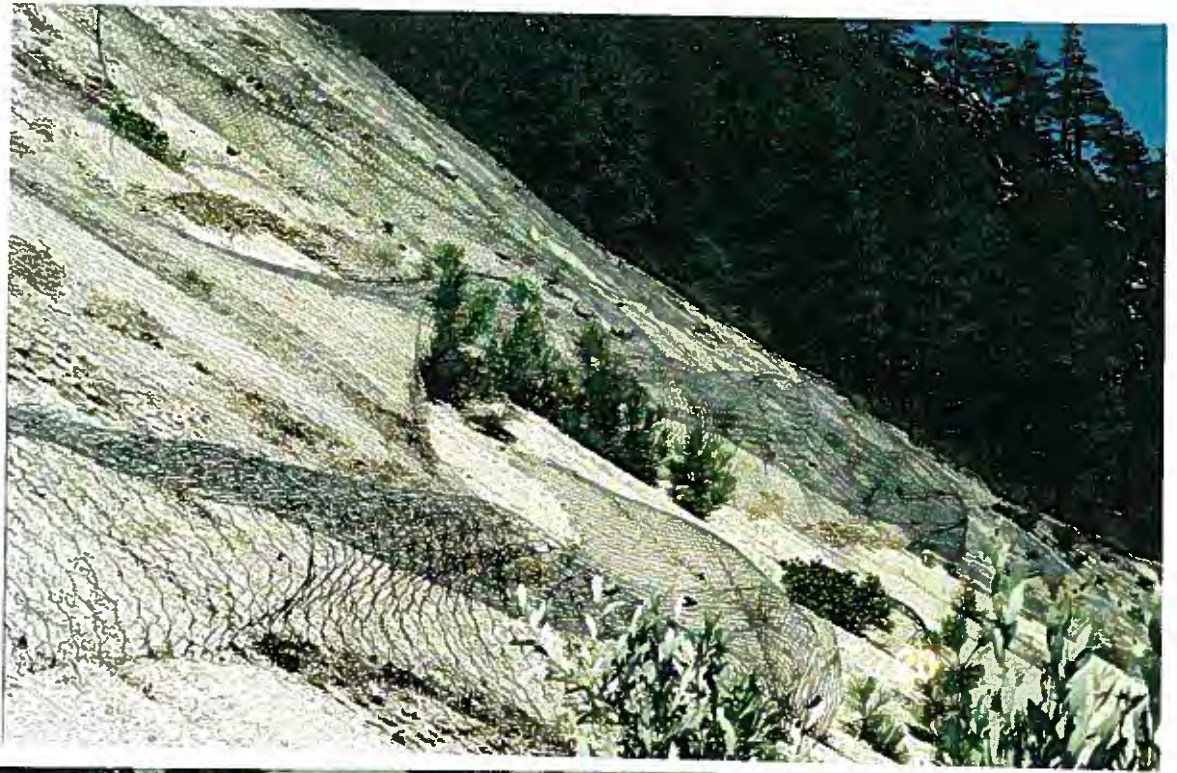
#20 (Lakeside & Summit)

Slope condition is acceptable in most areas. We need to replace missing bottom weights as needed. But from about MP 3.8 to 3.95 (photos 20,21,22) most of the upper row of anchors supporting the mesh have failed (probably due to snow and ice loads). Some of the lower row anchors have also failed. As a rule the 1" diameter anchor rebar failed in shear about 2 to 6 inches below the metal plates used to secure the wire rope tendons. None of the anchor piles experienced pullout failure. We could repair the mesh by increasing the number of anchors and retensioning the mesh. The diameter of the rebar may also have to be increased. Bridge Division would need to evaluate this. It appears that anchors are spaced on about 50' centers at least on the upper row.

A better option would be to remove the damaged mesh from this area entirely. The present condition of the slope doesn't require meshing in our opinion. We also need to clean catchment area behind jersey barriers.

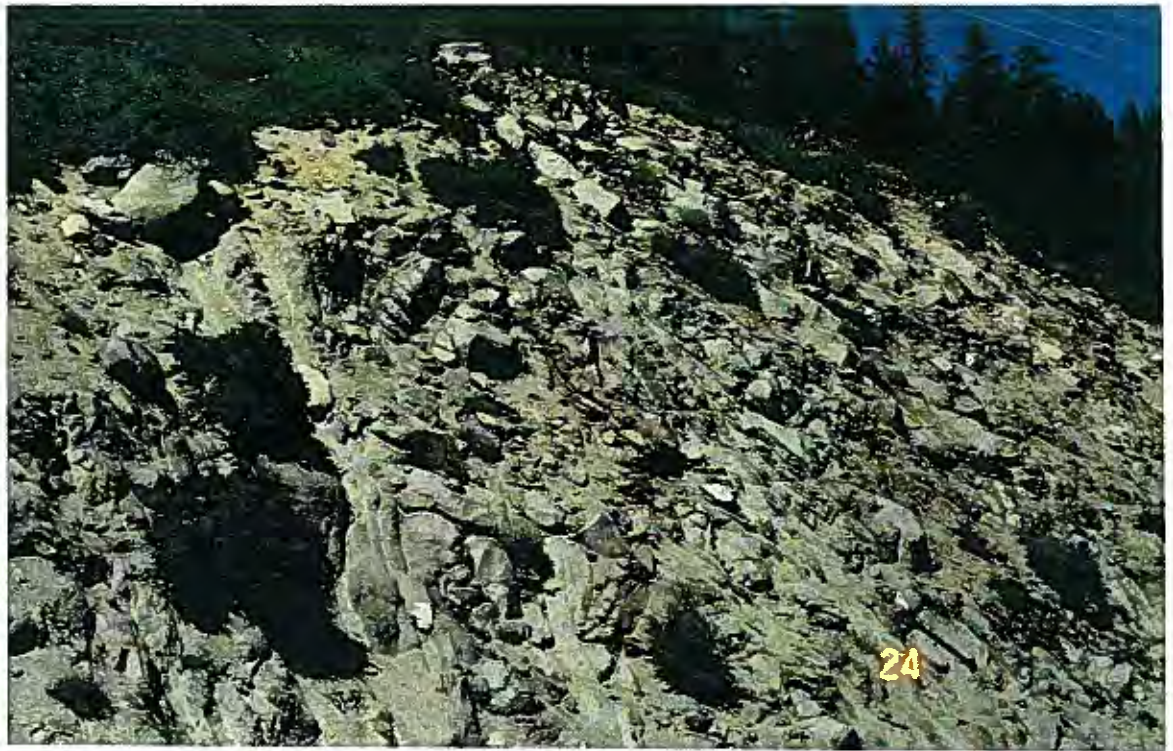
#24 (Lake side & Summit)

Lots of loose rock, boulders, and corestones exist on this slope (photos 24,25,26). We need to scale all loose rock from slope as a minimum. Consider meshing this slope and placing jersey barriers to help control rockfalls for long term solution.

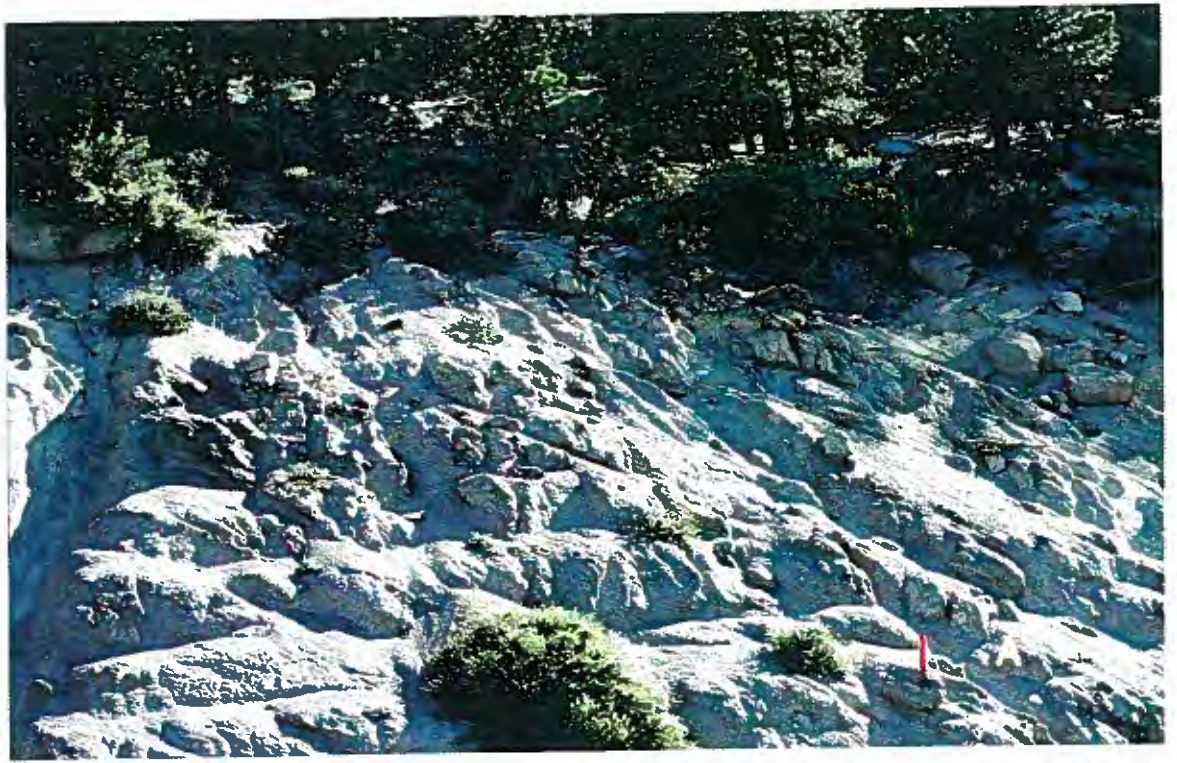
#1A (Minden side)

Scale loose rocks, corestones, and boulders from slope (photos 1A & 2A).

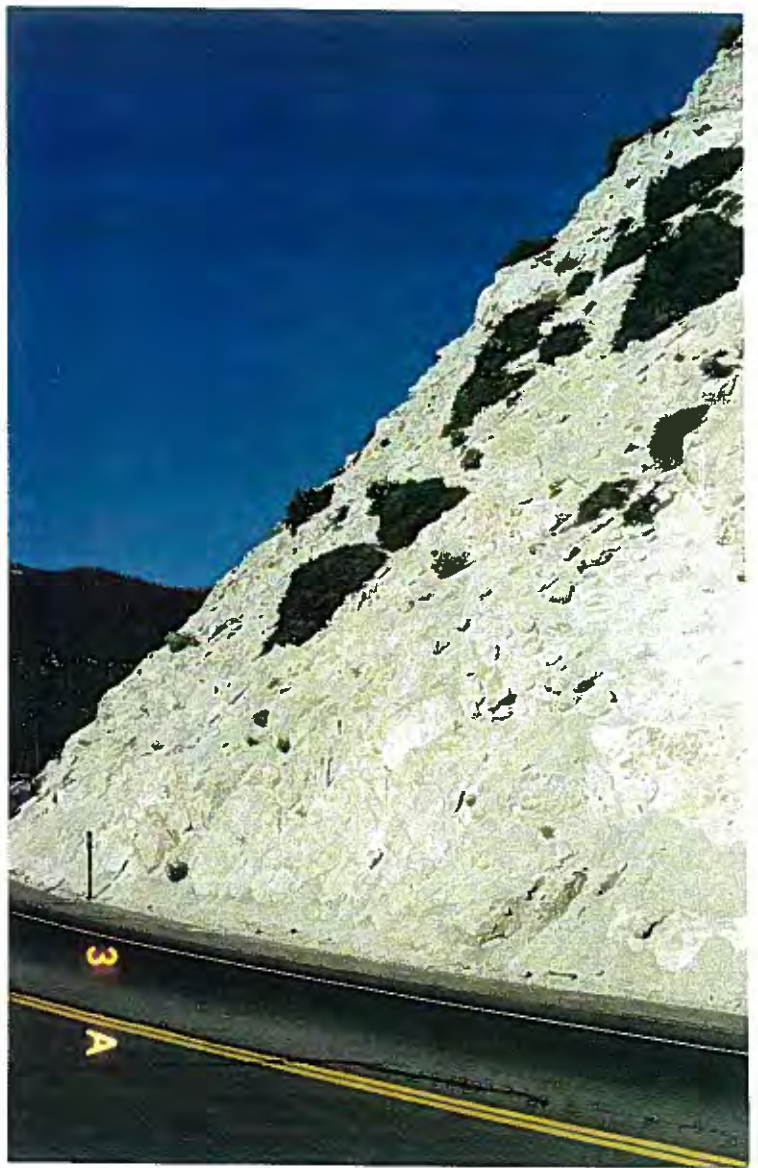
#4A

According to Mr. Lopez Maintenance has lots of trouble with this slope, especially with the western portion. It appears that both ripping and blasting techniques were used to construct this cut. Slopes should be scaled of all loose rocks and boulders as a minimum for short term.

For long term mitigation we might consider wire meshing slope as well as realigning roadway curve away from slope face to provide a better catchment area (photos 3A through 7A). Reshaping the slope face, placing rock fall fences, and constructing a "Ritchie" type catchment ditch at the slope toe might also be good design alternatives. These types of solutions will require more extensive field investigation and related office work. Accurate cross sections of the existing slope face will also be needed for such designs. Currently, this information is not available.

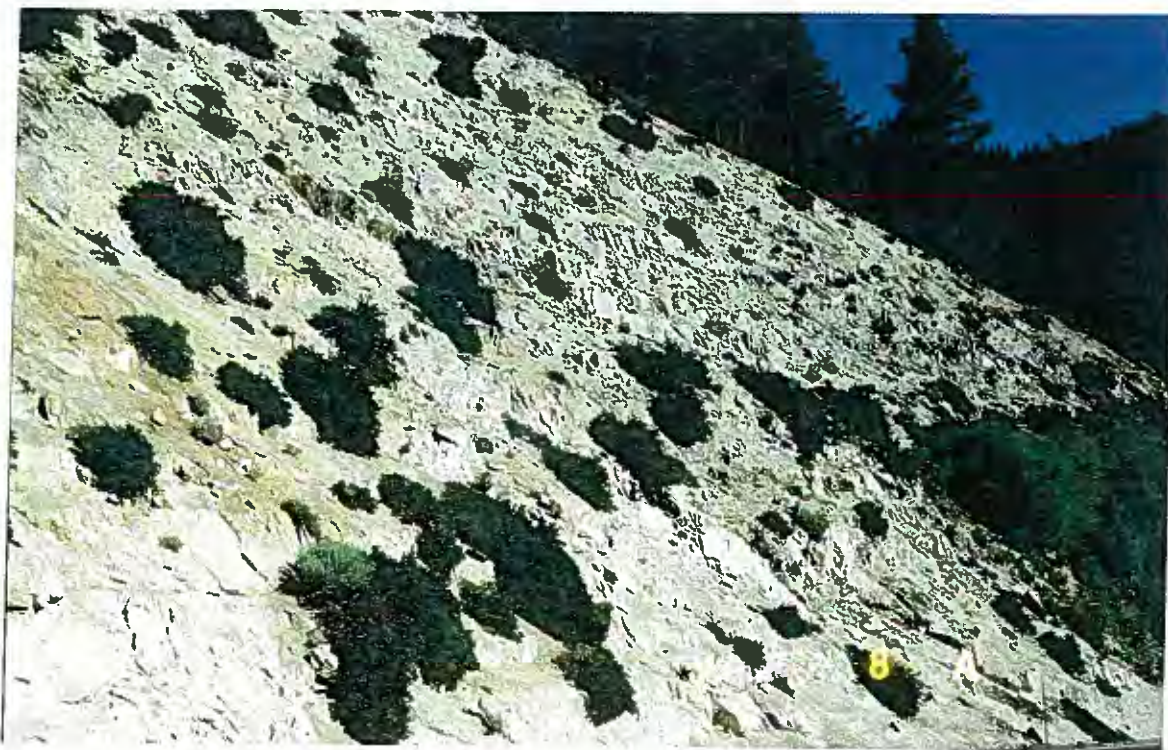
8A

A spring area exists near toe of slope. Scale loose rocks and place jersey barriers to contain ravelling material (photo 8A).

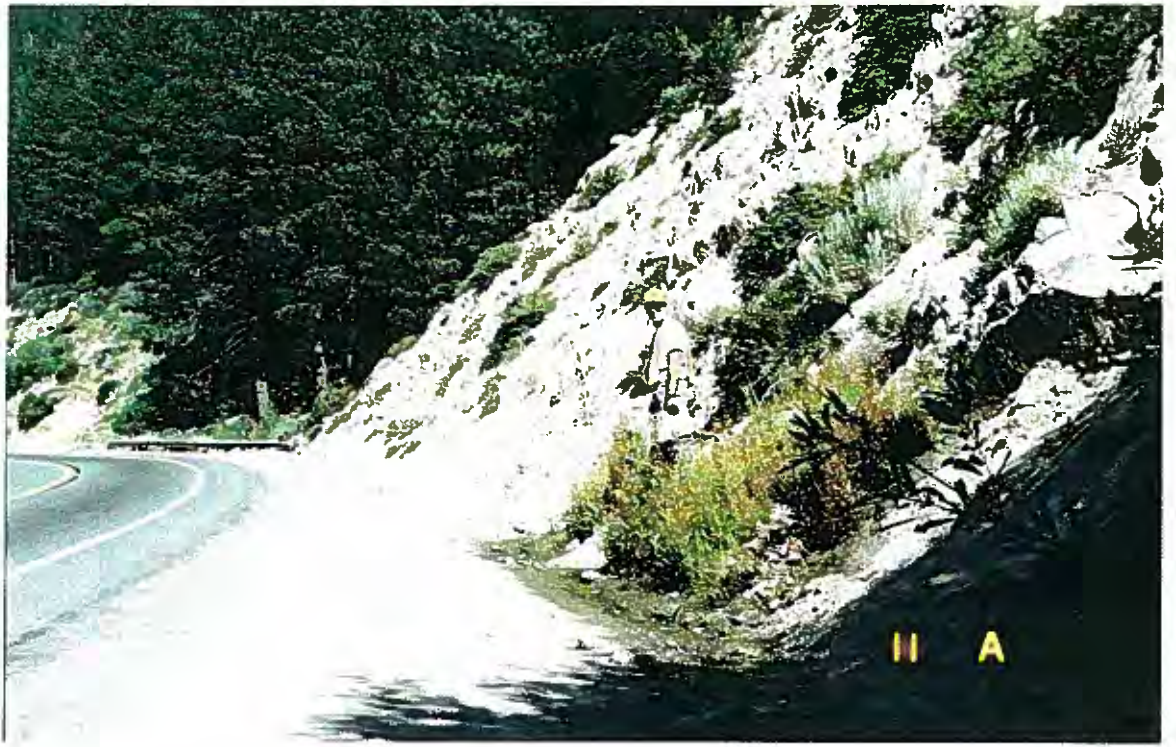
11 A (Minden side)

A spring exists in slope toe which is fitted with a PVC pipe for a water supply. West of spring slope is highly fractured and weathered. Lots of cobble sized material reaches roadway (photos 9A, 10A, & 11A). Material is so broken up scaling won't help much.

Recommend containing material by placing wire mesh on slope, cleaning up catchment area of debris, and placing jersey barrier rail along edge of oil.

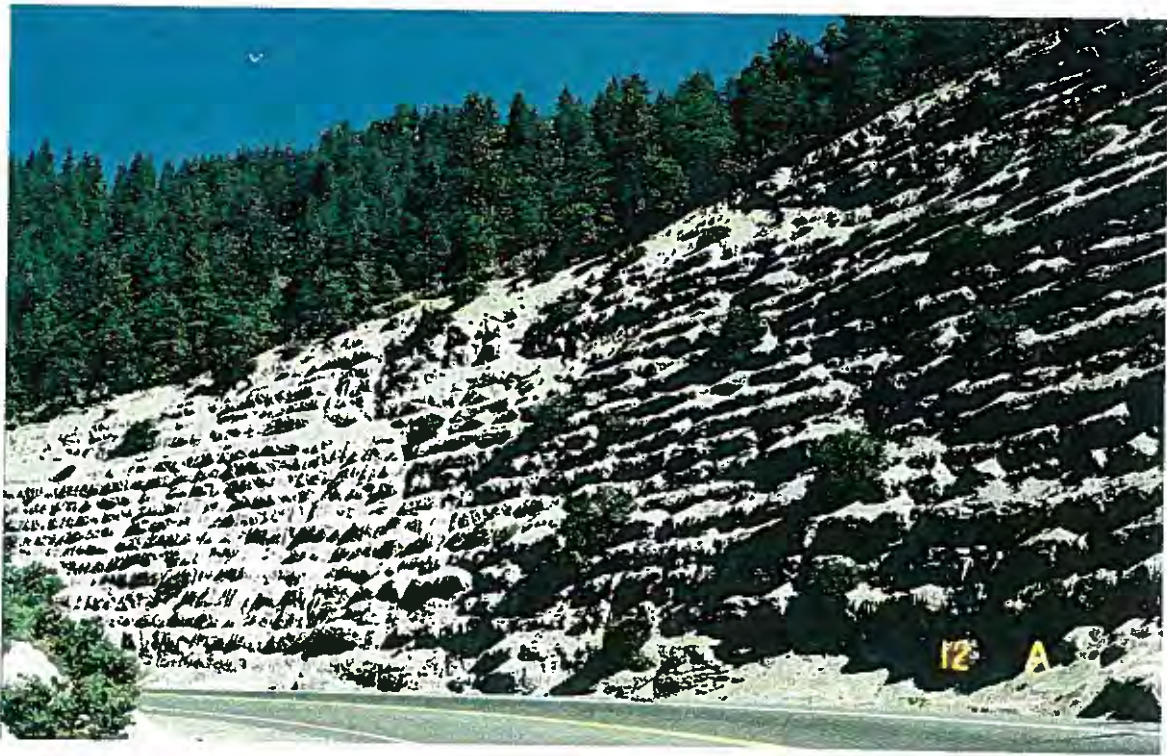
12 A

Serrated stepped ripped slopes (photo 12A). Clean catchment areas, and scale loose rocks and boulders from face.

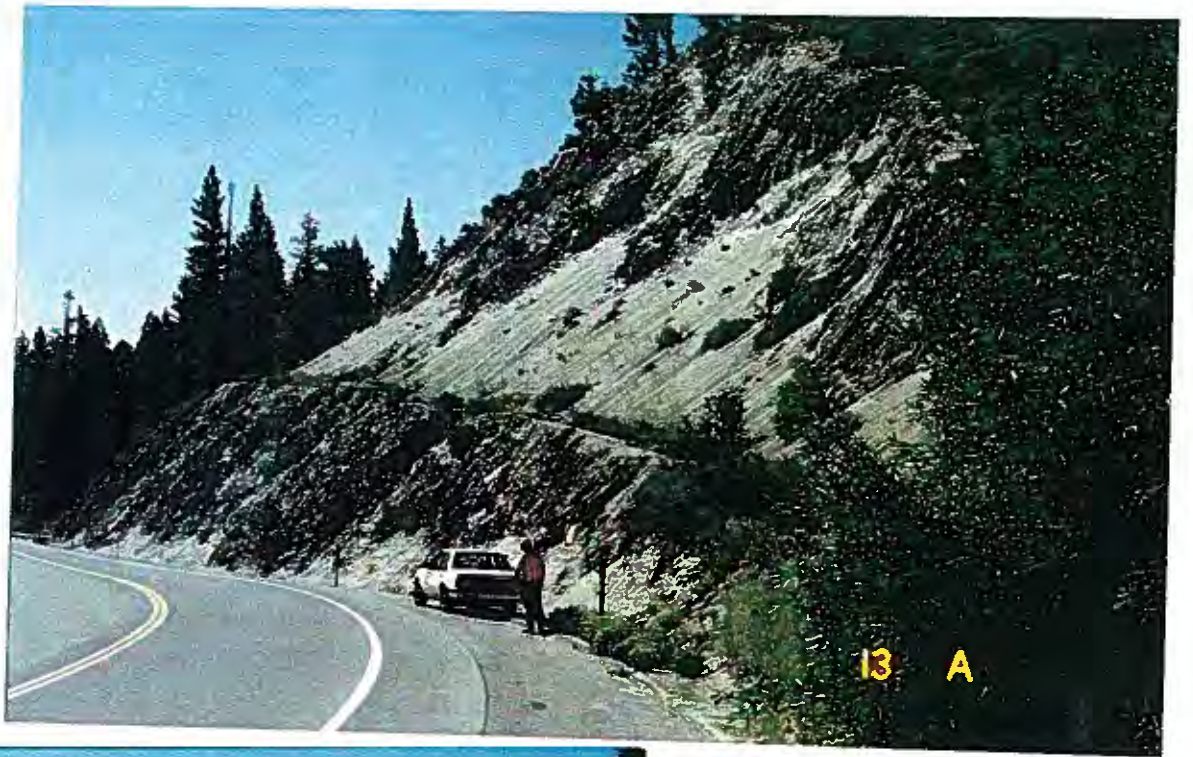
13 A

Single benched slope (photos 13A, 14A, & 15A). Bench is full of talus. As a minimum talus should be removed from bench and slopes should be scaled of all loose rock, catchment area should also be cleaned. Good access to bench is available from west side. Wire mesh could be used to control rockfalls for long term, especially on the cut face below the bench. Placement of rock fall fencing on bench might also be a good option.

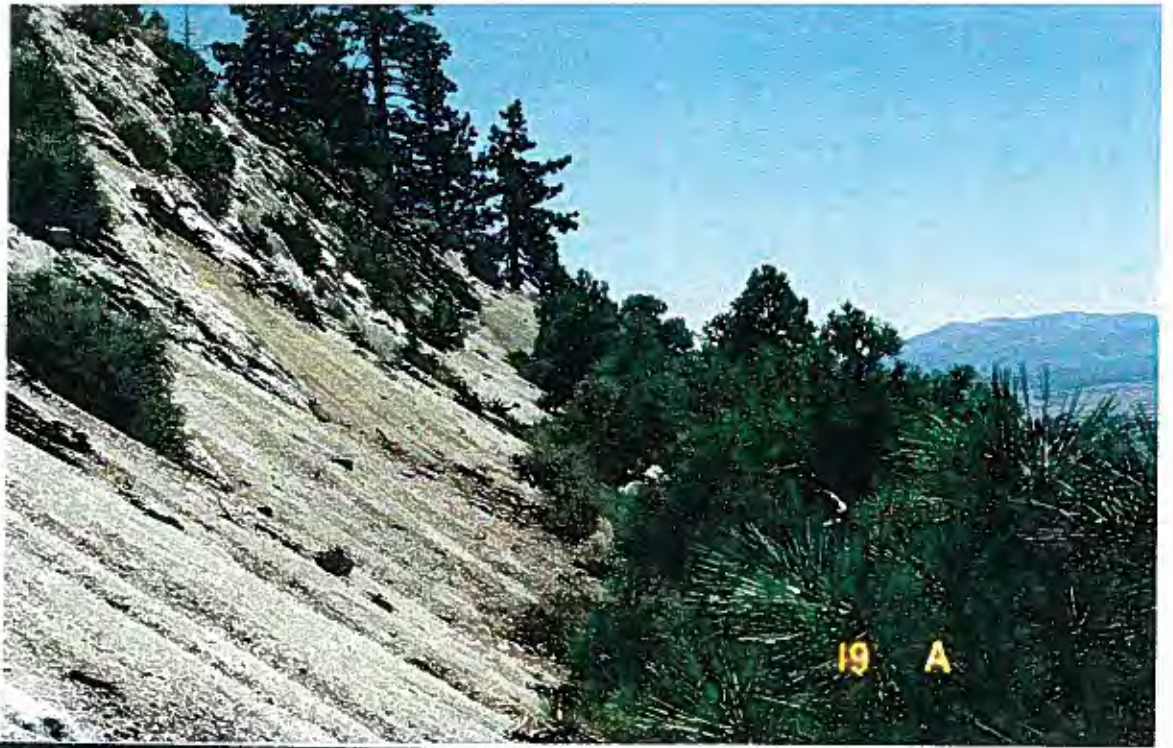
#19A (Minden side)

Single benched slope (photos 18A & 19A). Bench has no access but doesn't need to be cleaned because trees on bench form natural rock barrier. Only really need to scale loose rocks from portion of slope below bench. If bench is cleaned the existing trees and brush should be left as undisturbed as possible.

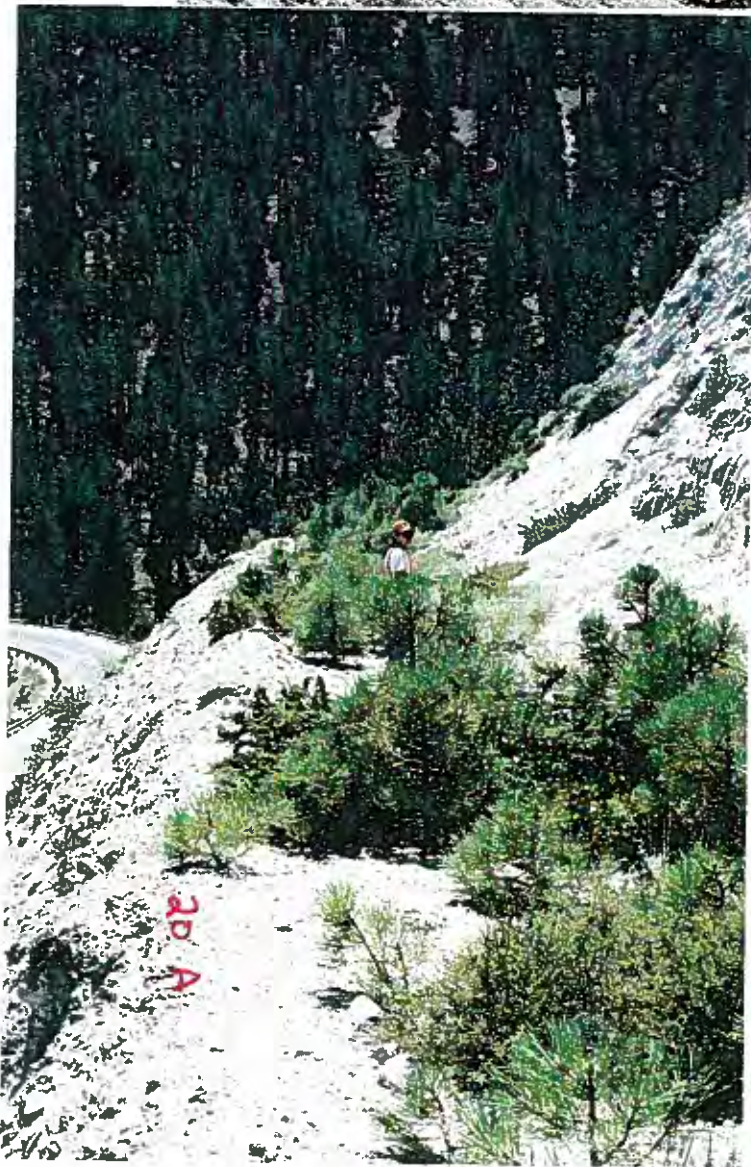
#20A

Single benched slopes (photos 20A, 21A). A very steep access exists on the south side of the west bench. A gas line crosses and a water line is buried on west bench. Quite a bit of talus has built up on west bench. Bench also has trees and brush which form natural rock barrier. Recommend cleaning talus from bench but should try to retain as many trees and bushes as possible.

We should slope scale loose rocks off both cut faces below benches. Recommend placing jersey barriers along edge of oil to prevent debris from reaching roadway.

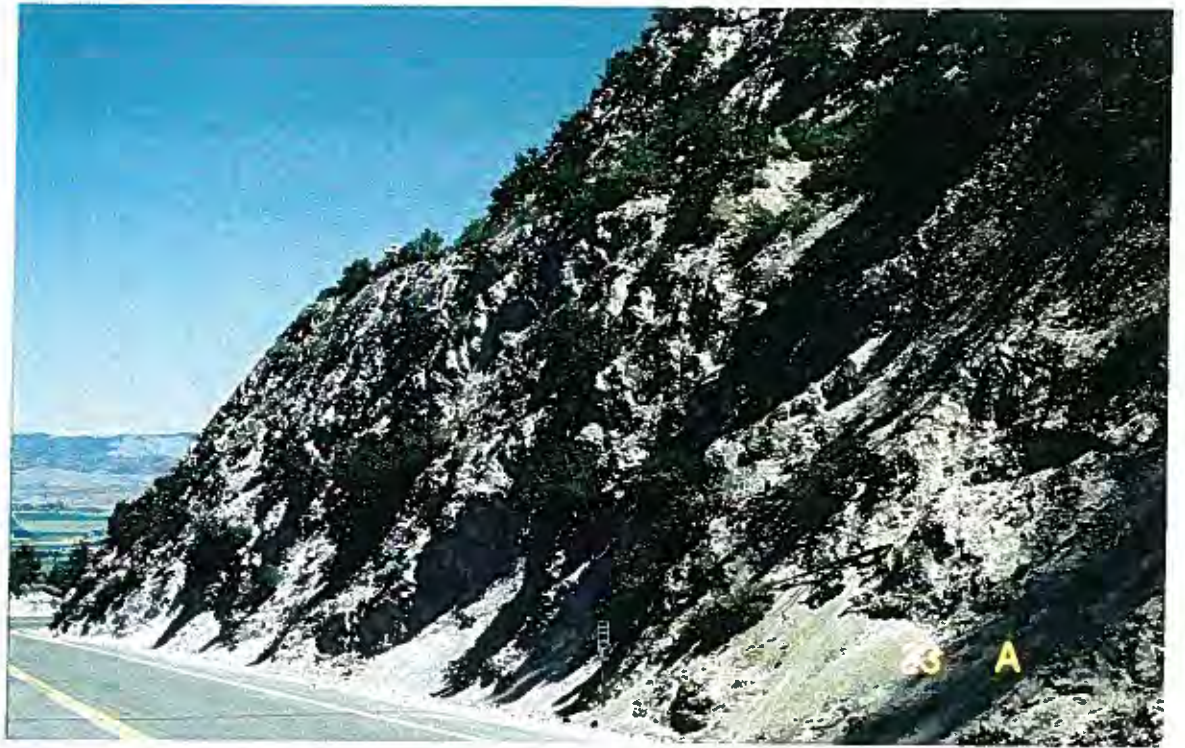
23 A (Minden side)

A difficult access exists to south side bench at east end of cut (photos 22A, 23A). Should clean bench and slope scale both sides of cut.

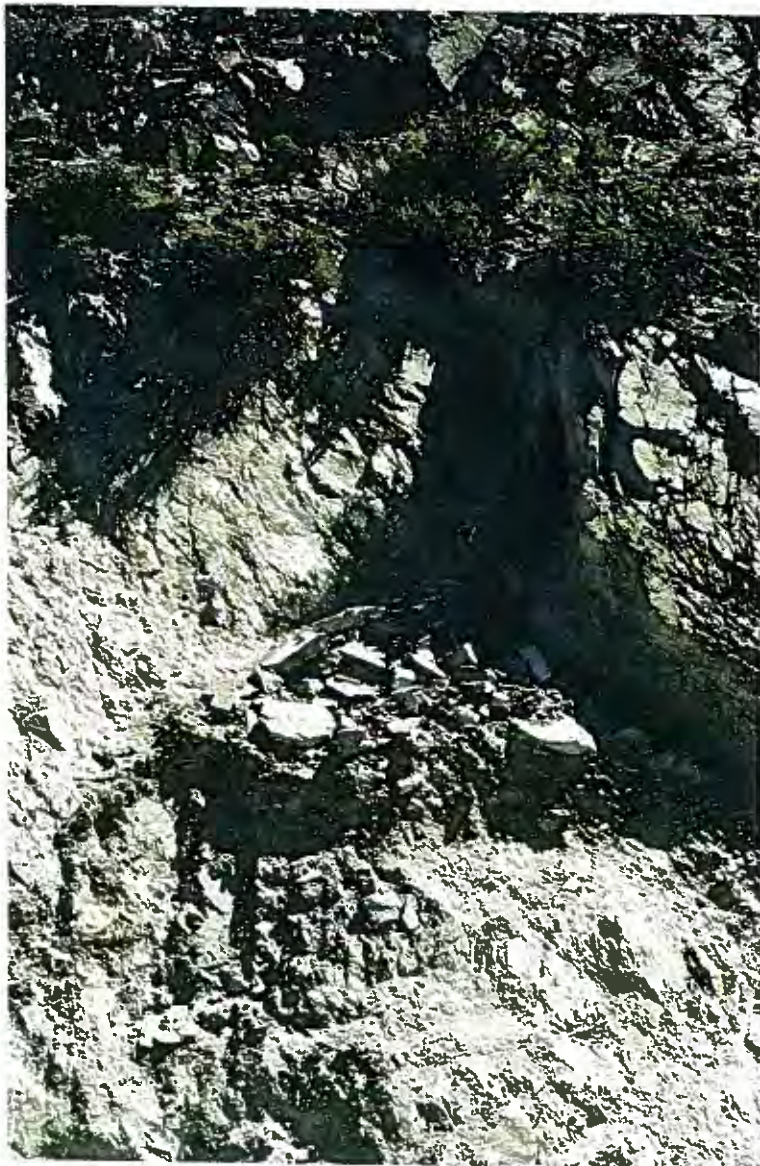
#2 B

West bench is inaccessible and full of talus (photo 25A) which needs to be cleaned. Rocks dropped to roadway surface as we crossed it. Cut slopes above benches should be ok after benches are cleaned (photo 26A). Cut slopes below benches are badly broken up, weathered, and have evidence of large wedge failures (photo 2B). Due to the badly eroded and fractured nature of these slopes

wire meshing probably would not help without first scaling and reshaping the slope faces. Construction of a catchment ditch below these slopes would also be prudent. In order to provide proper design recommendations for these slopes more extensive field work will be necessary. For the short term we recommend slope scaling the existing slopes of all loose rock and placing jersey barrier rails along edge of cut to help intercept rock fall debris. These slopes will require frequent monitoring and maintenance until long term mitigations are designed and constructed.

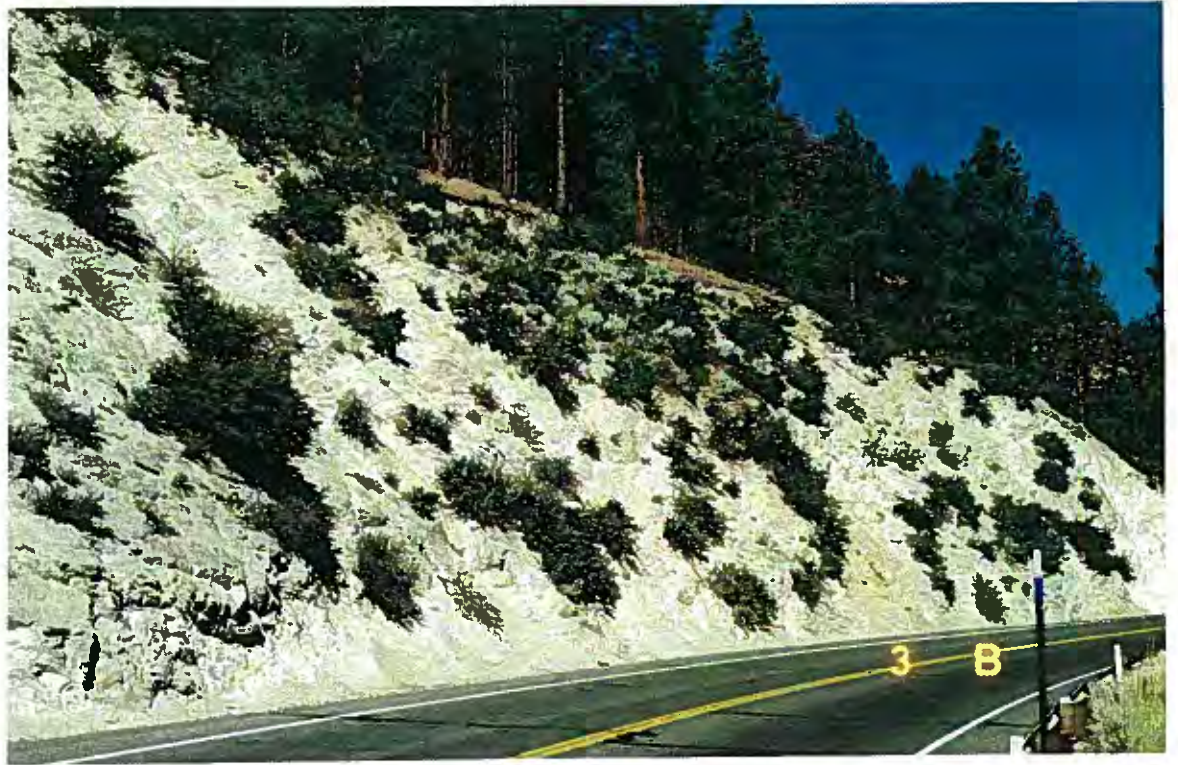
3B (Minden side)

Massive weathered granite cut which is soil like in places (photo 3B). Single bench supports dirt road which begins at green gate near MP 8.1. Need to slope scale loose rocks, corestones, and boulders from lower slope. Should also clean ditch of debris. No work needed on bench or slope above bench.
