GEOTECHNICAL INVESTIGATION

**ASSESSMENT OF ROCK SLOPE CONDITIONS
ALONG KINGSBURY GRADE ROAD - SR 207
DOUGLAS COUNTY, NEVADA**

MARCH 1996

Subject: Assessment of rock slope conditions along Kingsbury
Grade Road, SR 207. E.A. 72028-9.

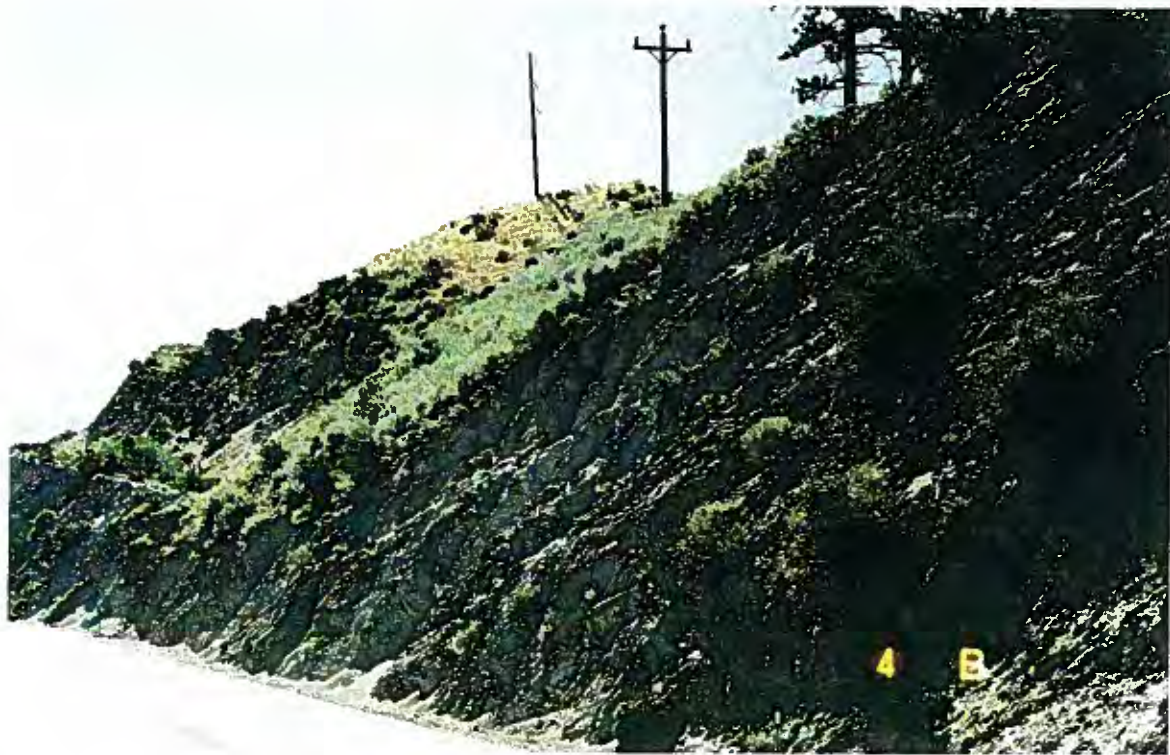
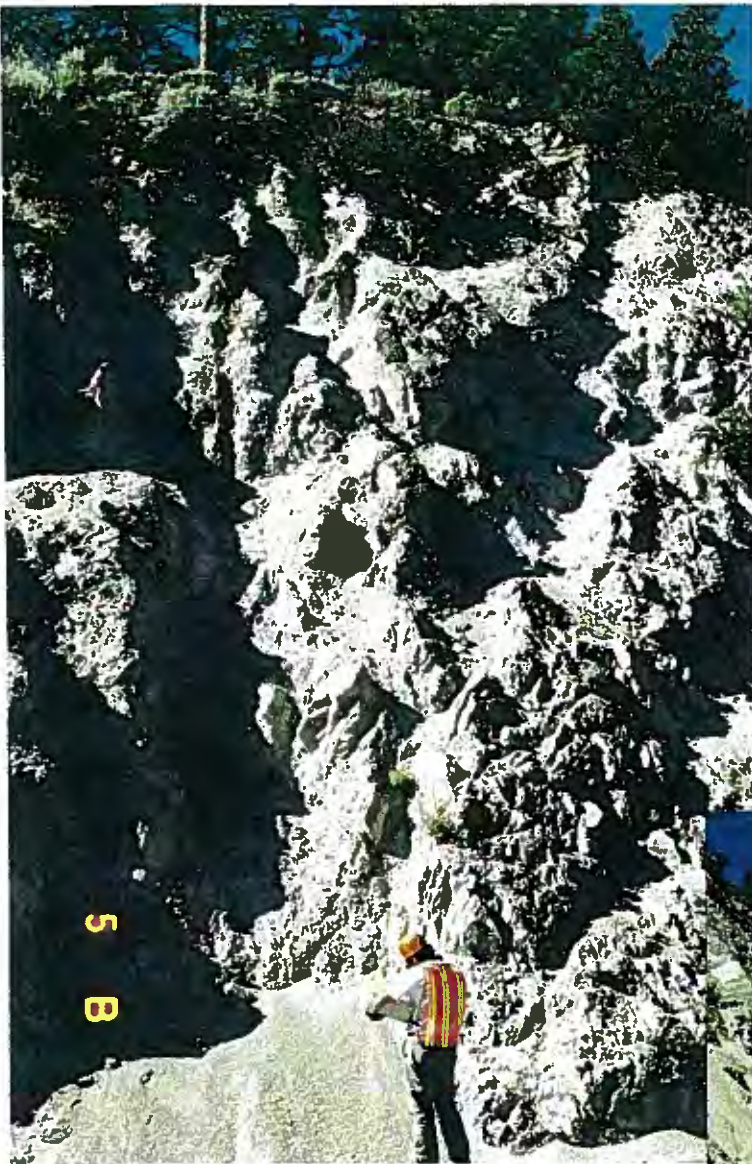
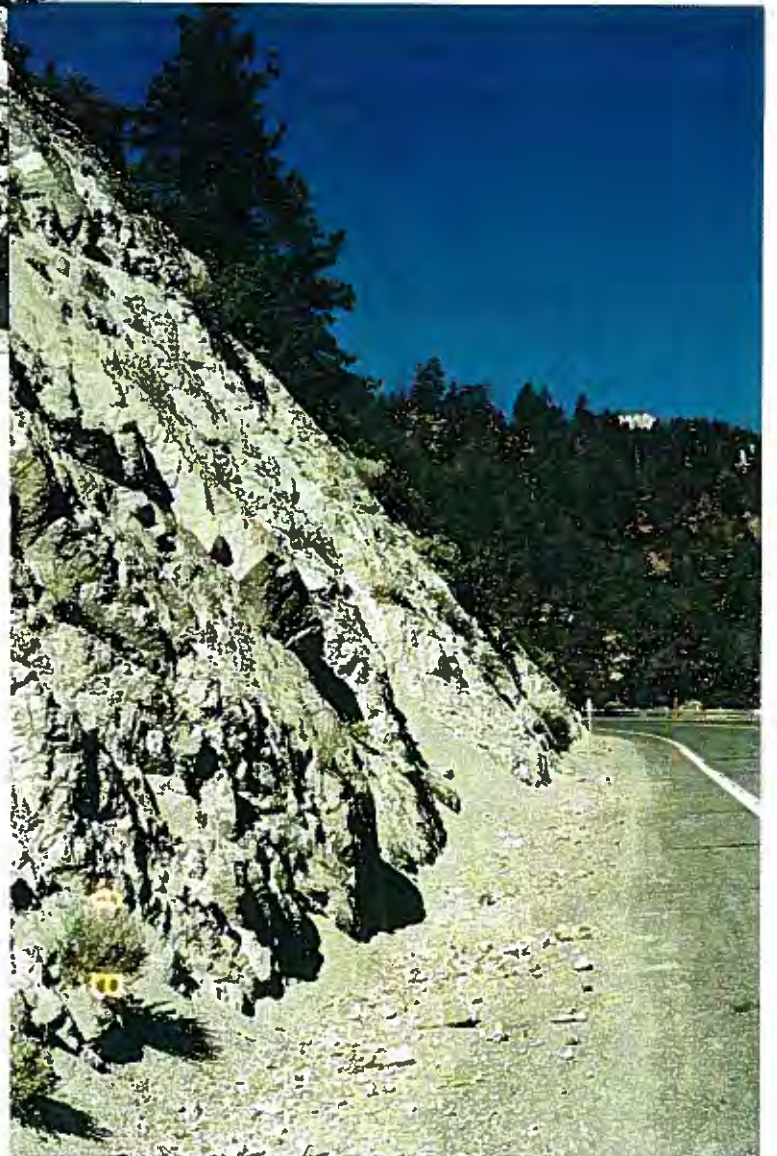
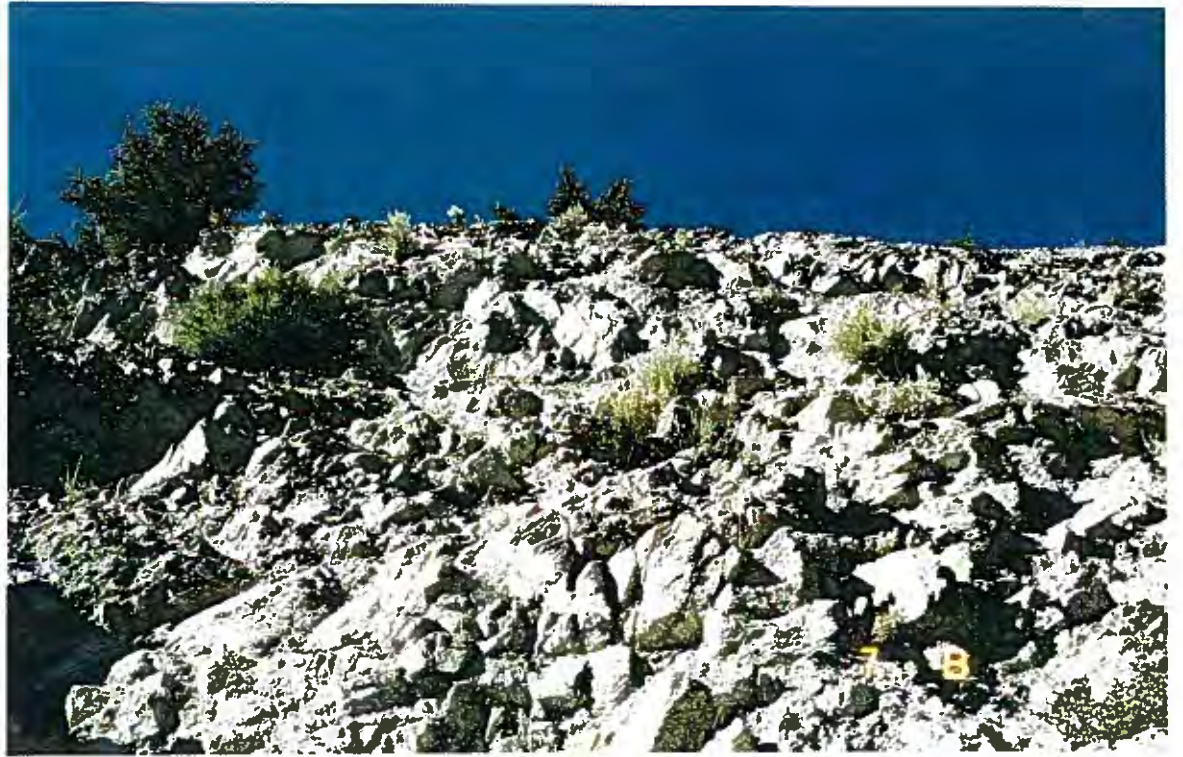
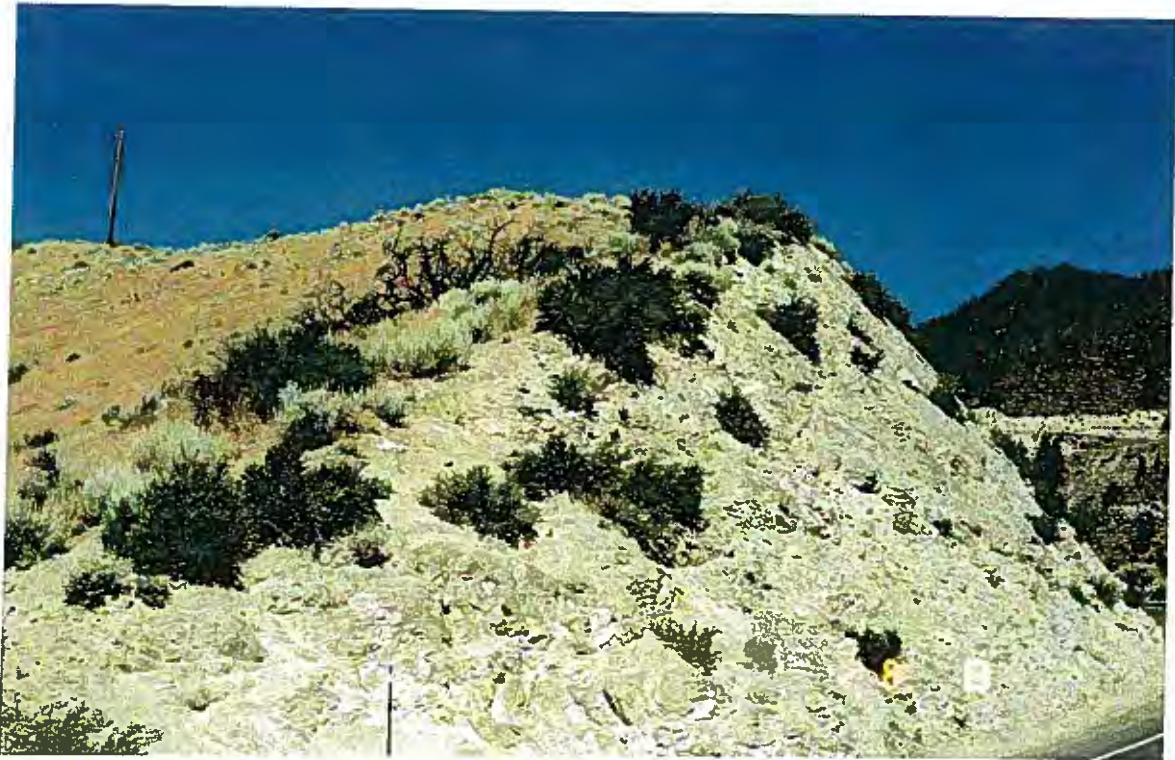
Slope is blocky, rough and ravelling. Face has developed gullies due to erosion processes (photos 4B through 8B). Overhead power lines are supported on crest along western portion of cut. Eastern portion of slope has single bench which wraps around corner. A spring/seep is located about halfway up the slope below the bench. At a minimum all loose rock should be scaled from cut faces, and the bench should be cleaned of debris. Access to bench is available from the east side via a dirt road located above the cut. A good long term solution would be to widen the cut by 10 to 15 feet to provide a catchment area. Wire mesh could also be useful here but there is very little catchment area at the toe of the cut.

The northside cut should also be scaled. The ditches along both sides should be cleaned.

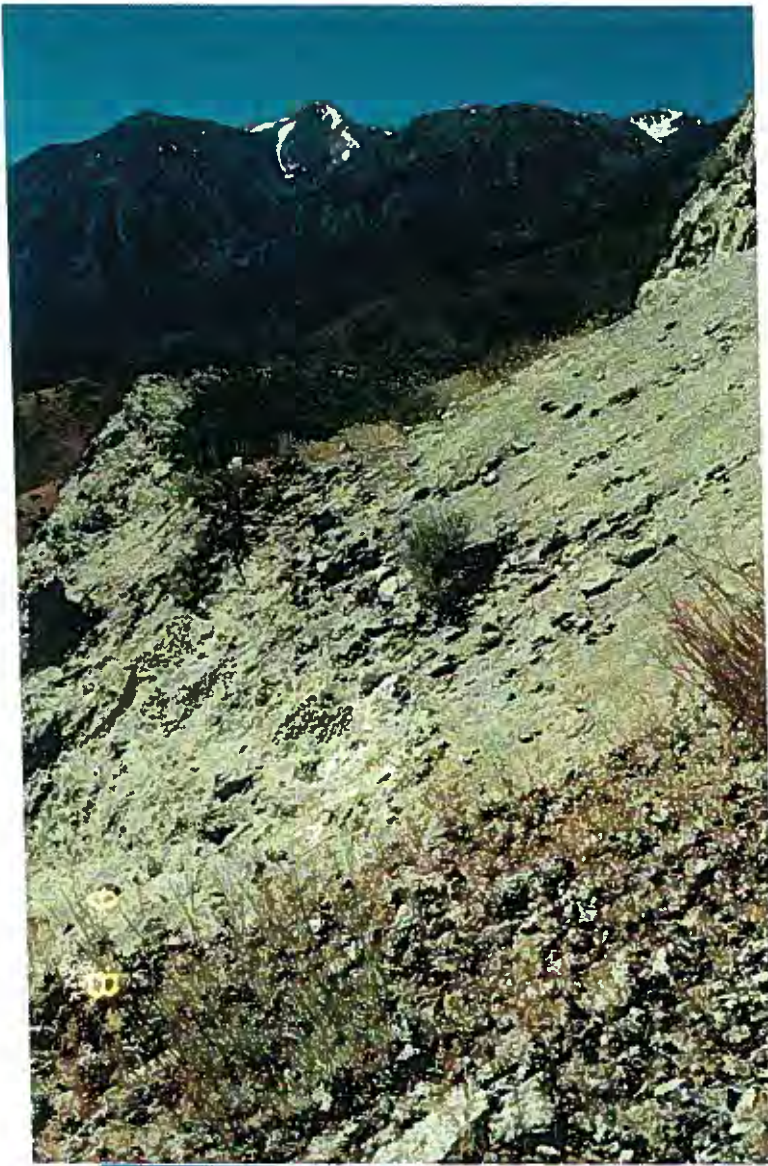
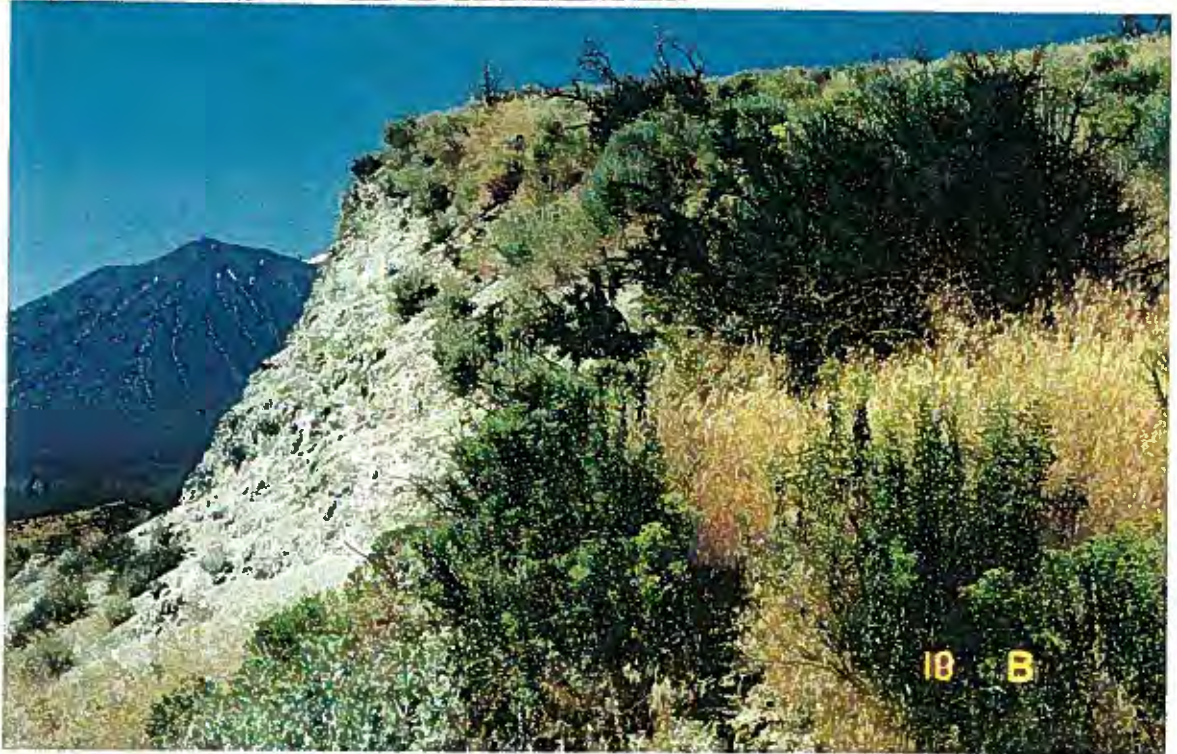
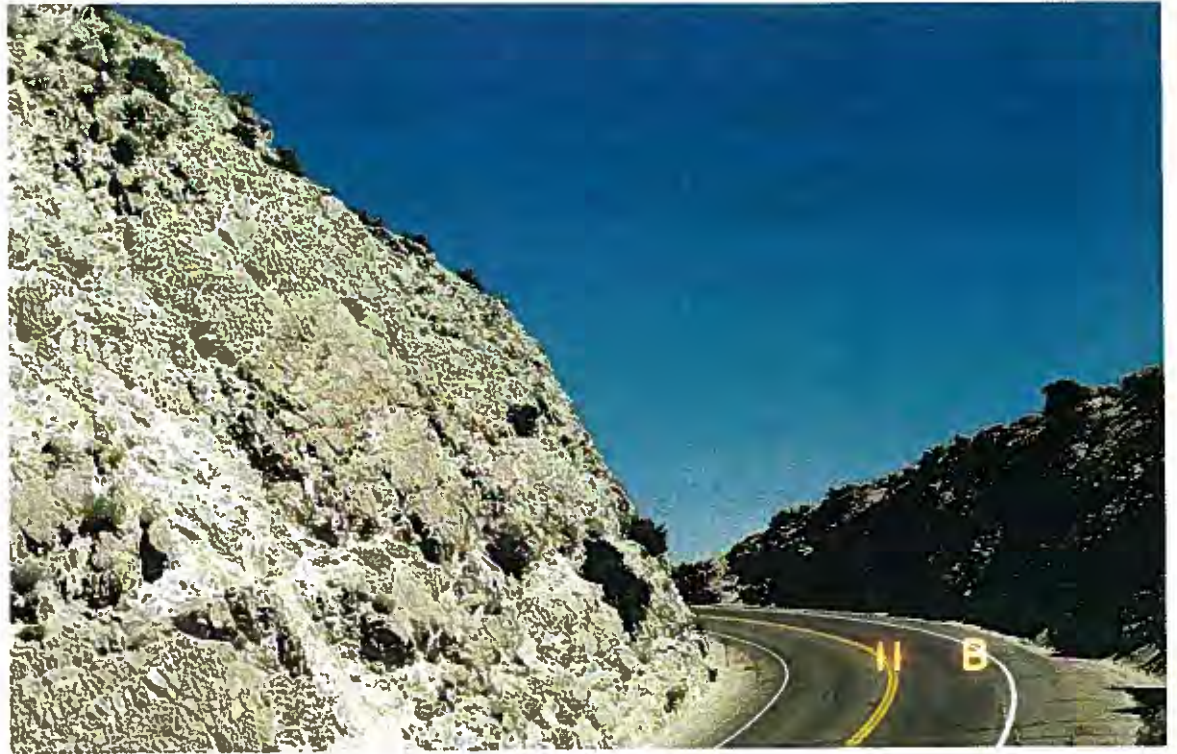
Single benched slope (photos 9B, 10B, & 11B). About midway into the cut the bench has failed all the way back to the upslope face. Best short term solution would be to slope scale above and below bench. Bench should also be cleaned of debris. Placement of jersey barriers below the failed bench would help contain debris.

A good long term solution could be to cut the slope back to eliminate the bench along with constructing a catchment ditch at

the toe of the new cut face. As before more detailed field investigations\office work will be needed to provide design recommendations for these types of solutions.

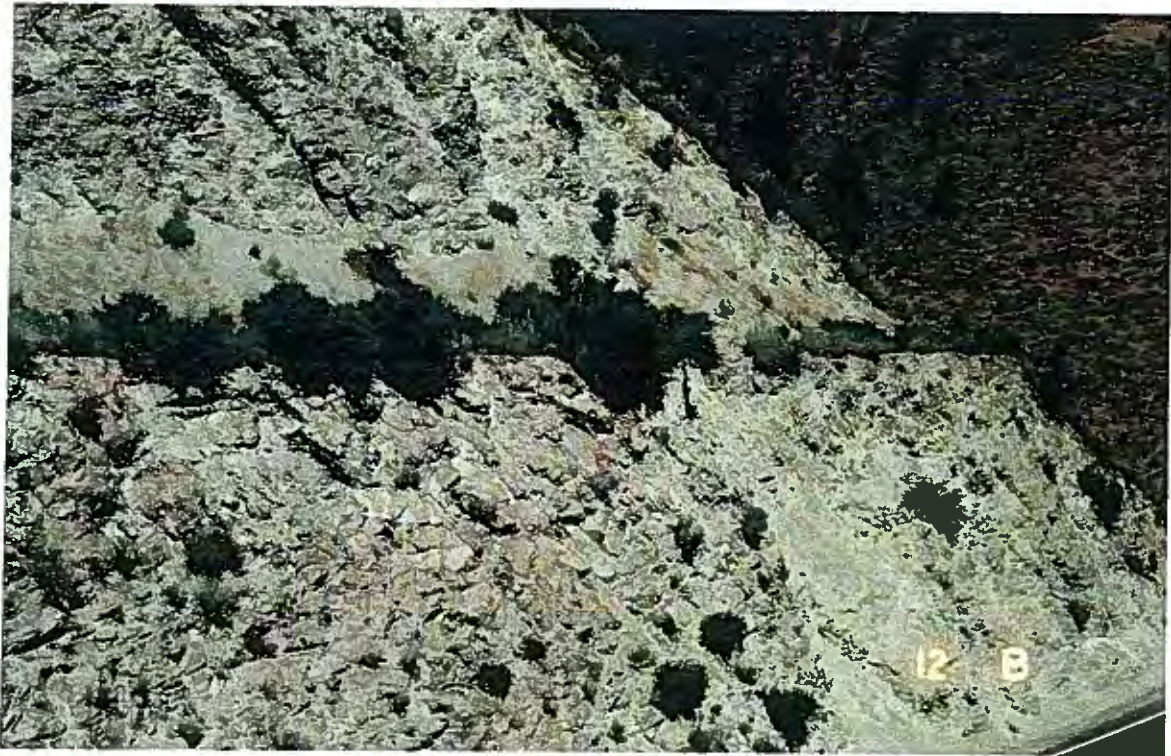
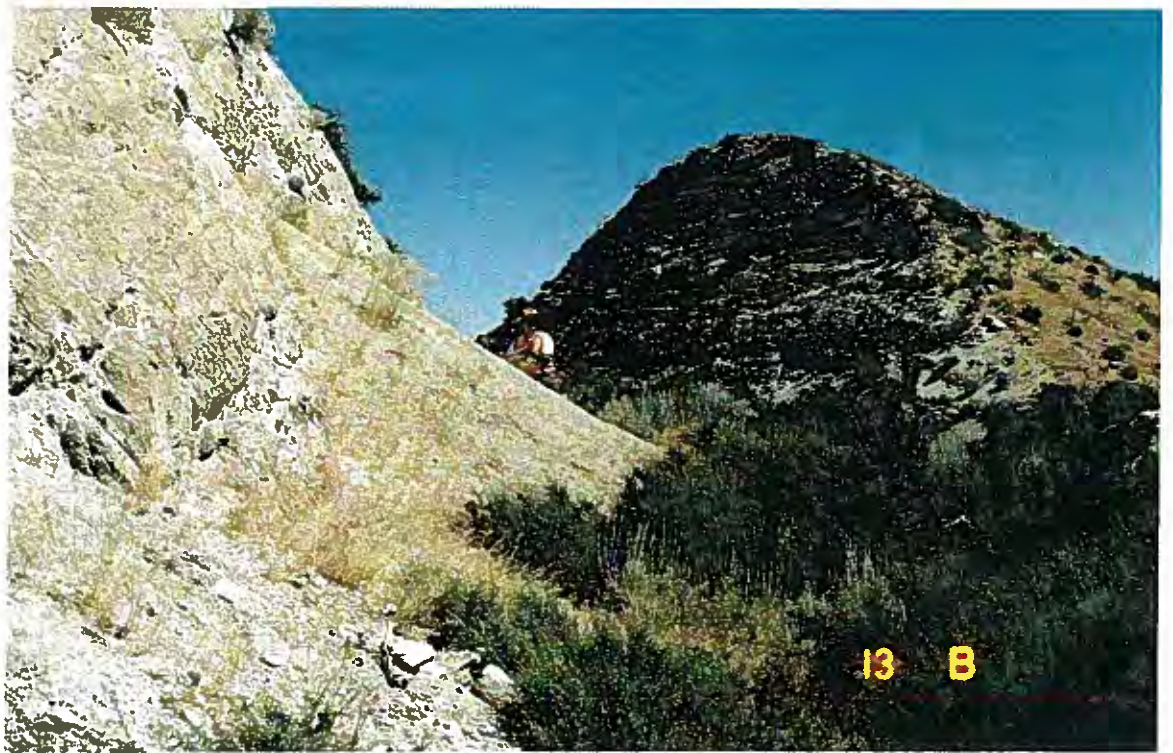
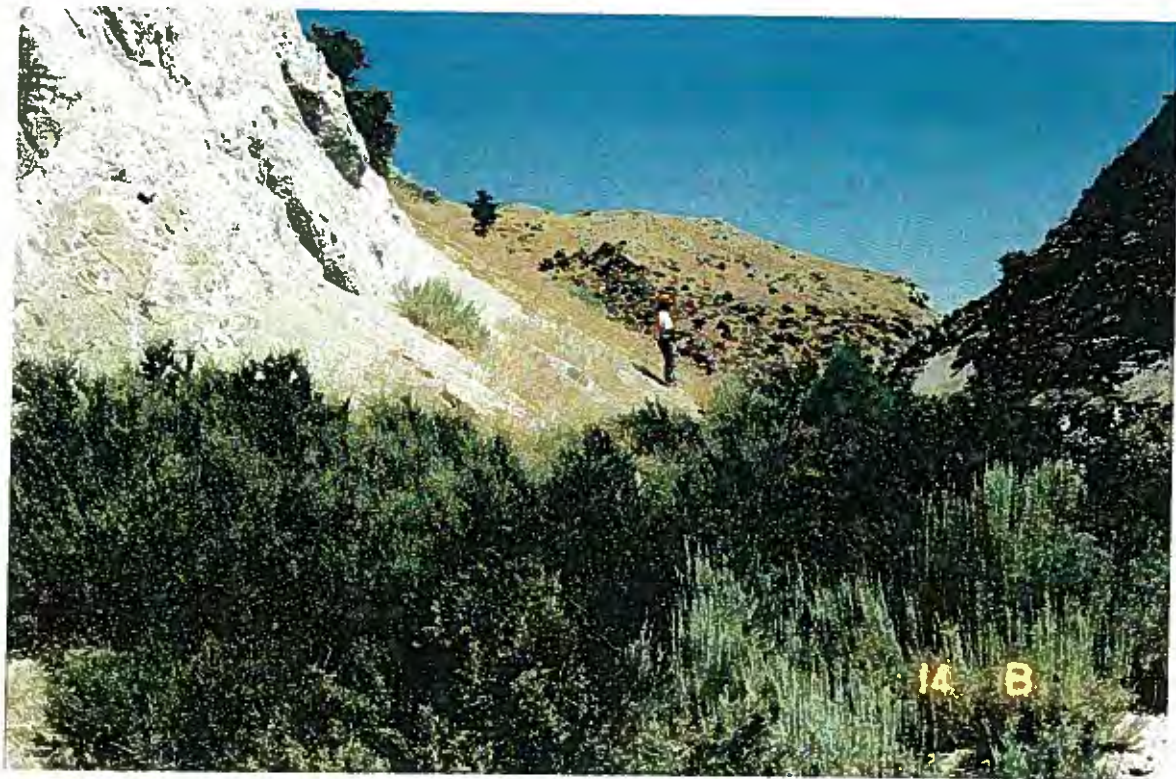
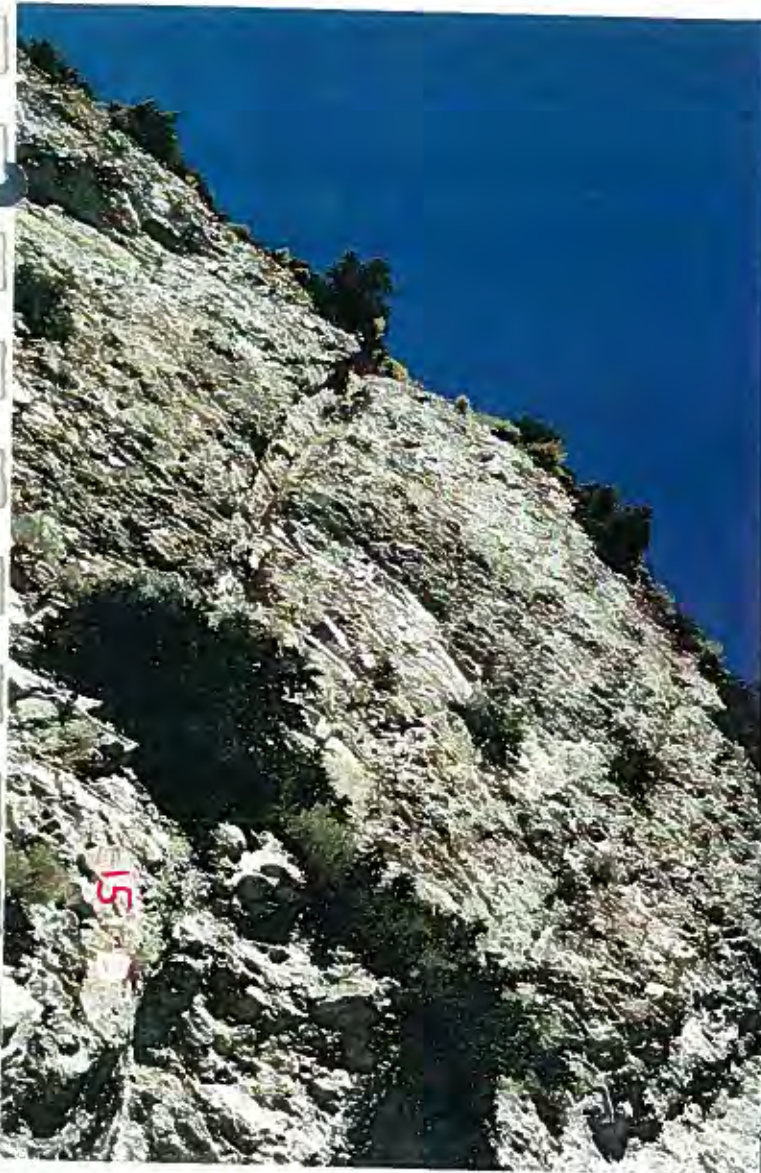
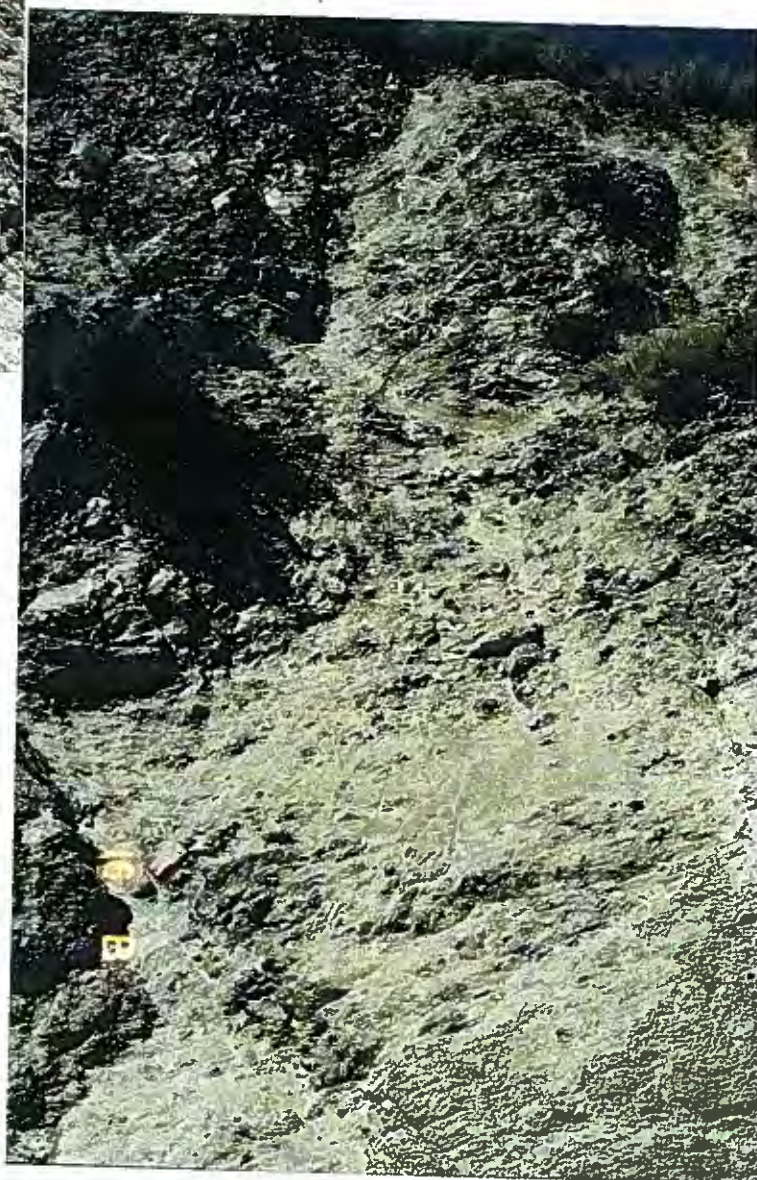
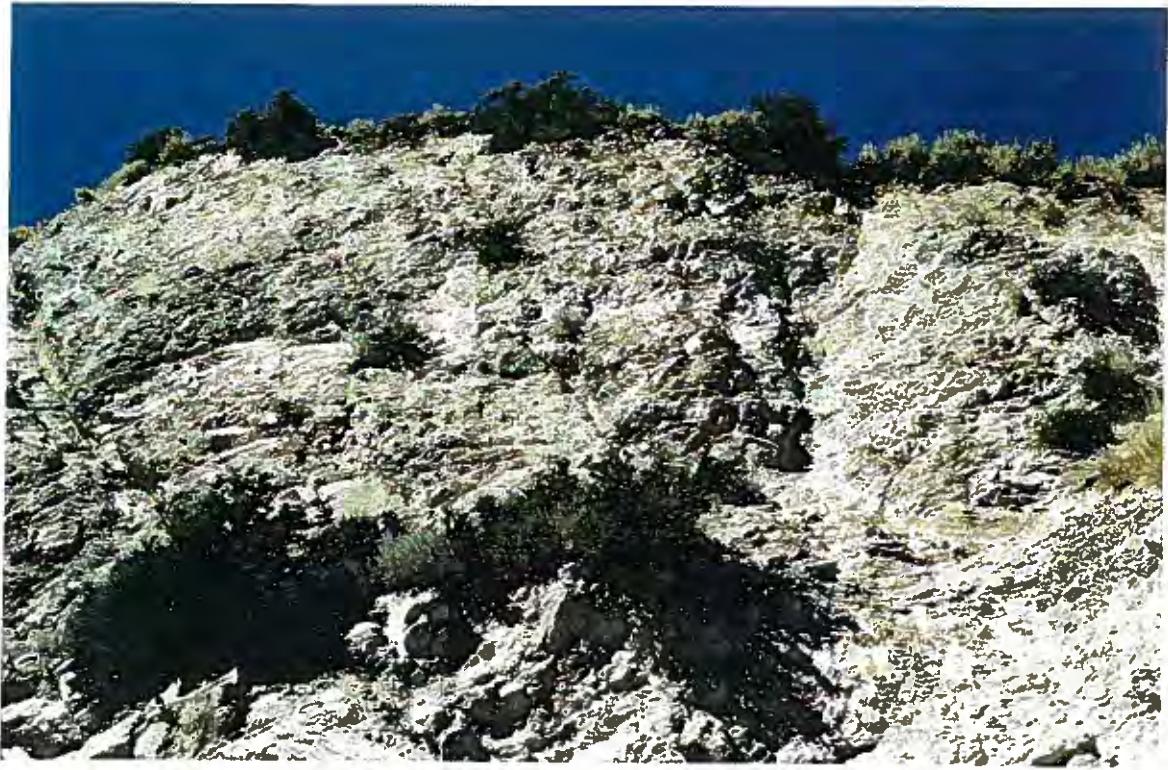
Bench has several large talus cones which have nearly covered it (photos 12B through 17B) especially along the north half of the bench. These should be removed. Bench has also failed near the north end of the cut. Best short term solution would be to slope scale cut faces and remove talus cones from bench. Placing jersey barrier rails along the toe of the cut where the bench has failed would help contain debris. Best long term solution would probably be removal of bench and construction of a properly design catchment ditch. More field and office work would be needed for this design.

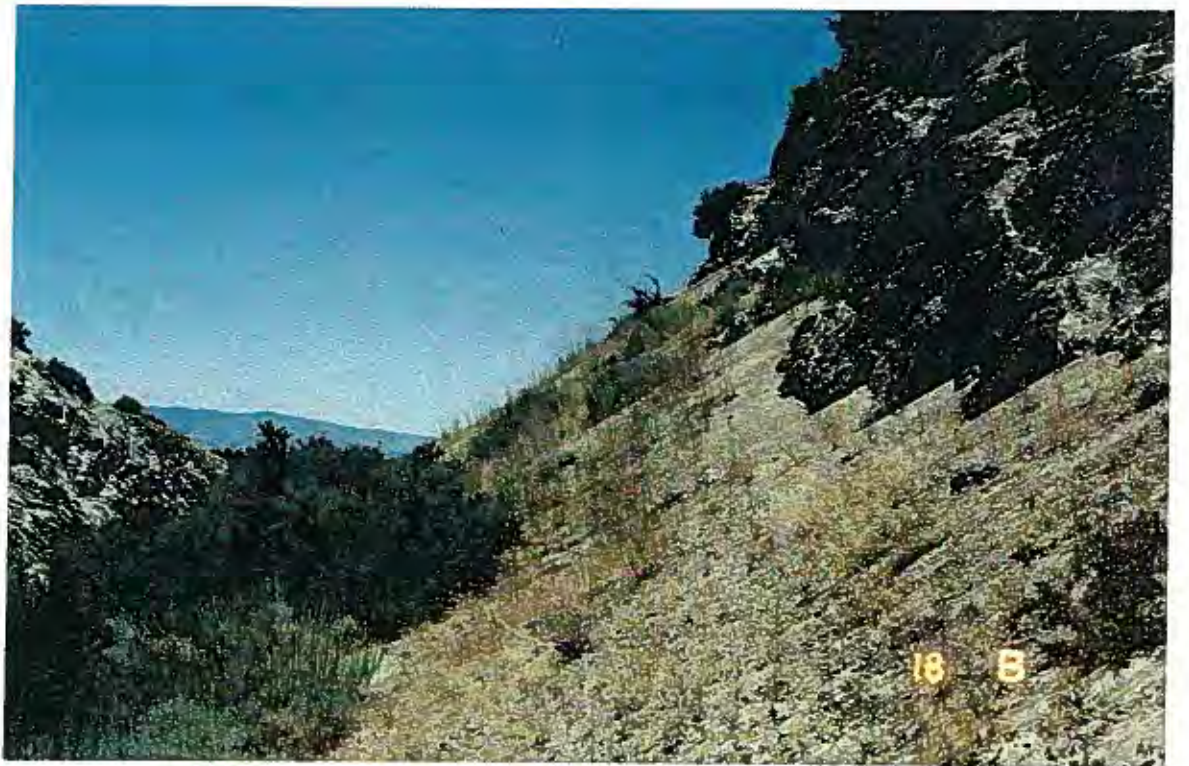
#18B

Large talus cones have built up on bench (photo 18B). These should be removed. Good access to bench from both sides. Slope scale cut face below and above bench (photos 19B, & 20B) and clean catchment ditch.

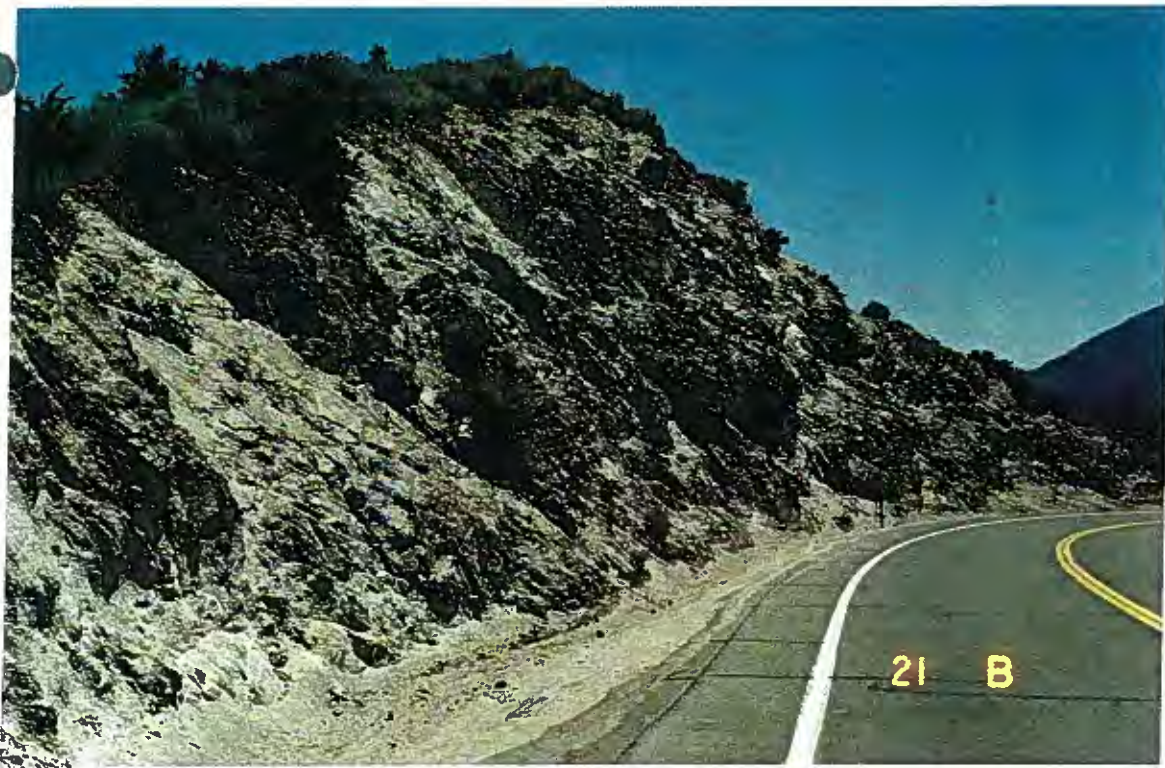
#21 B (Minden side)

East cut slope has no bench. For short term slope scale loose rocks and boulders (photo 21B). Slope has evidence of large slip outs. But to solve these problems long term we would probably have to reshape entire face and construct a catchment ditch. As before more field and office work would be needed to provide proper design recommendations.

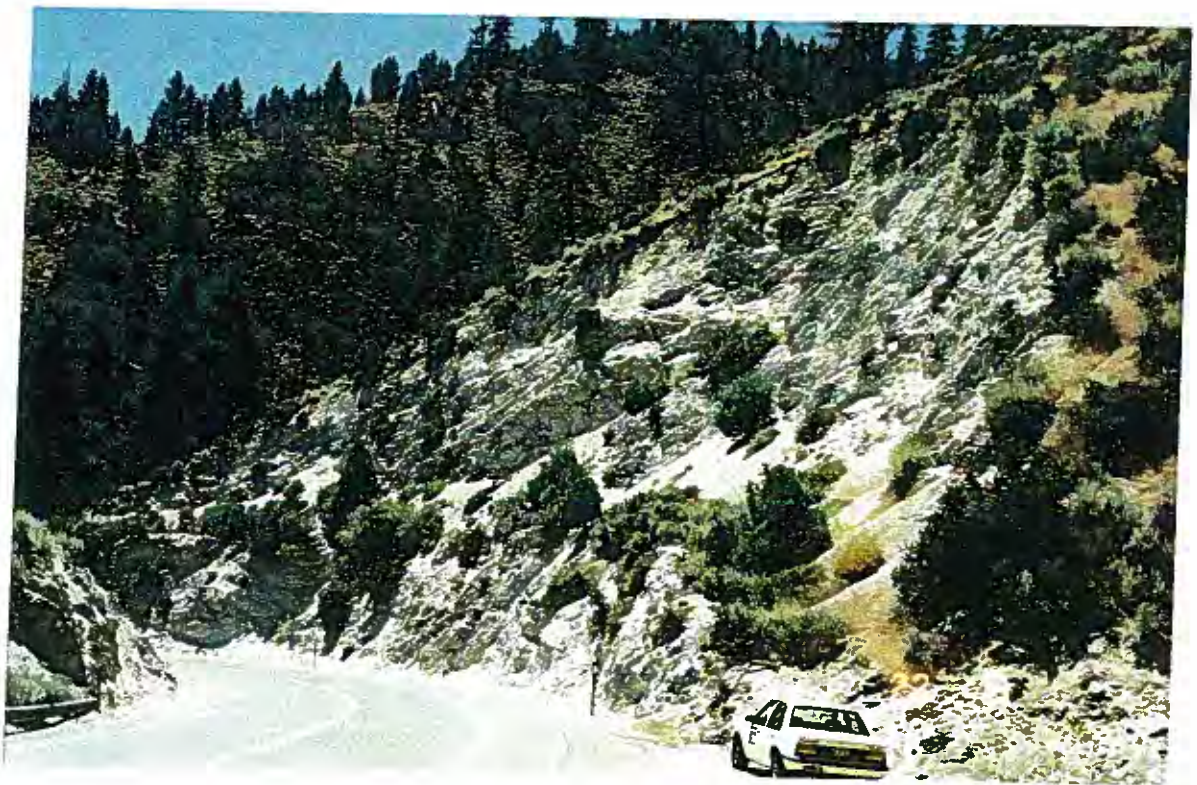
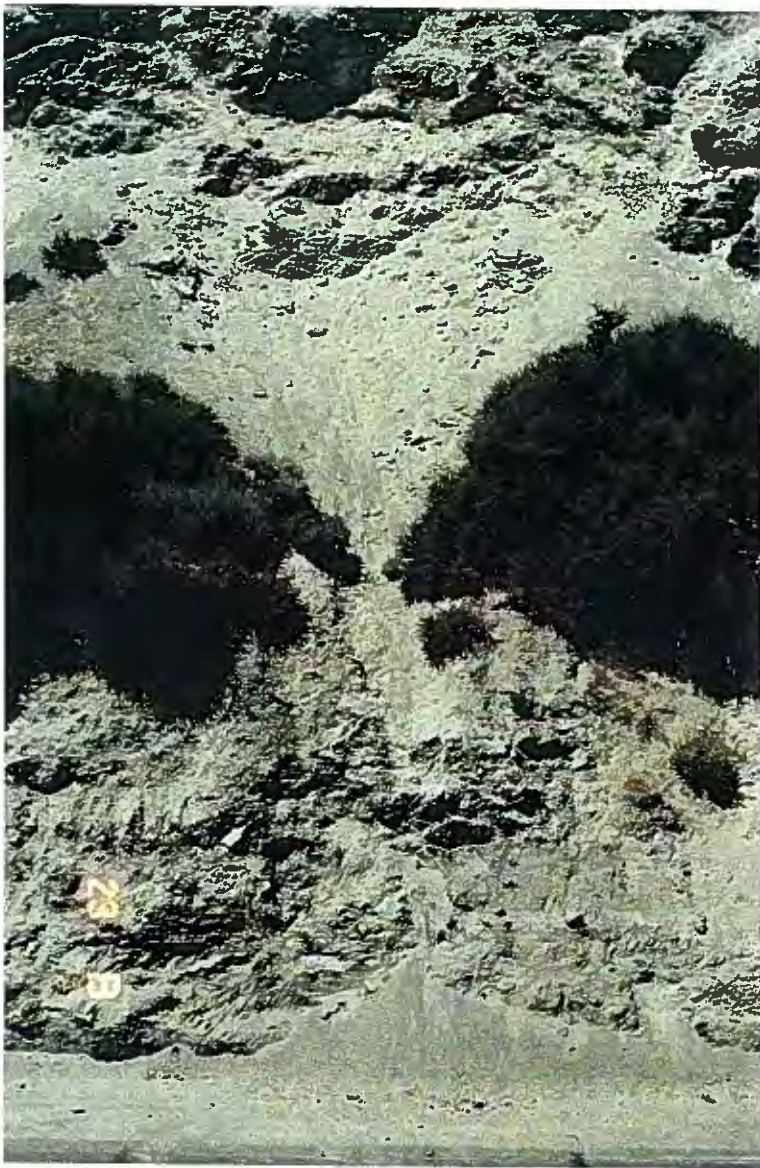
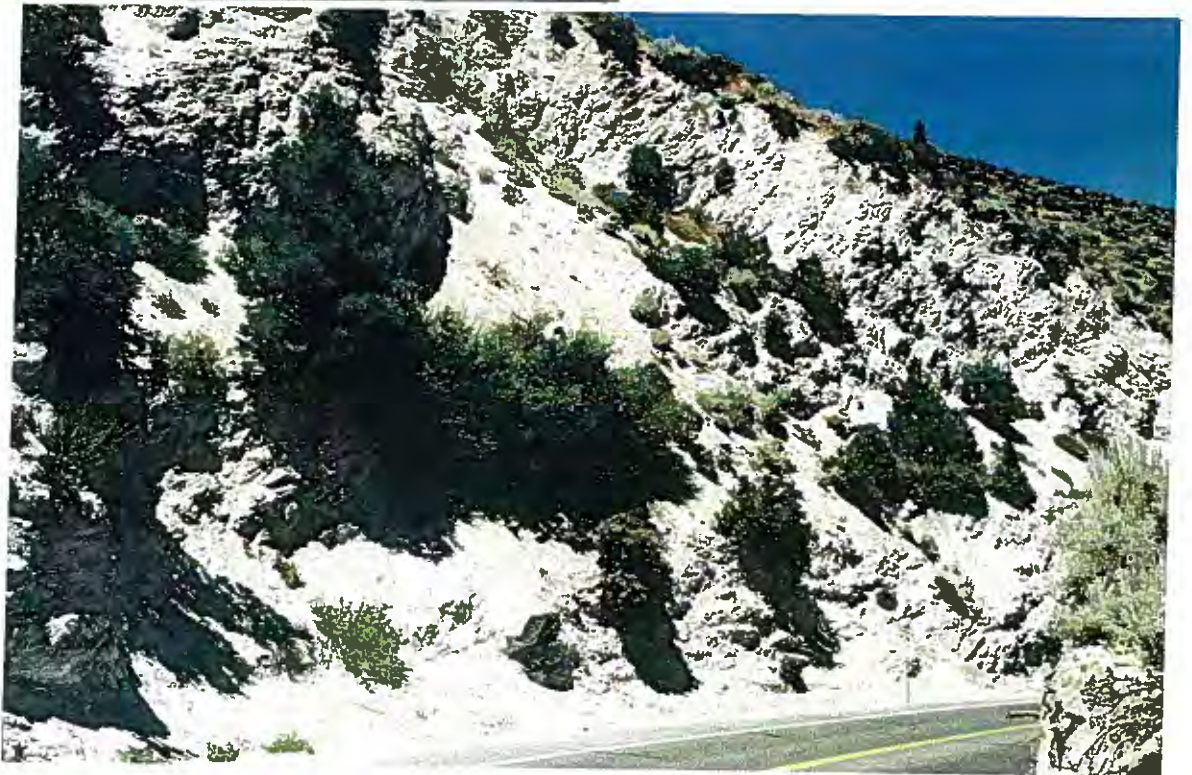
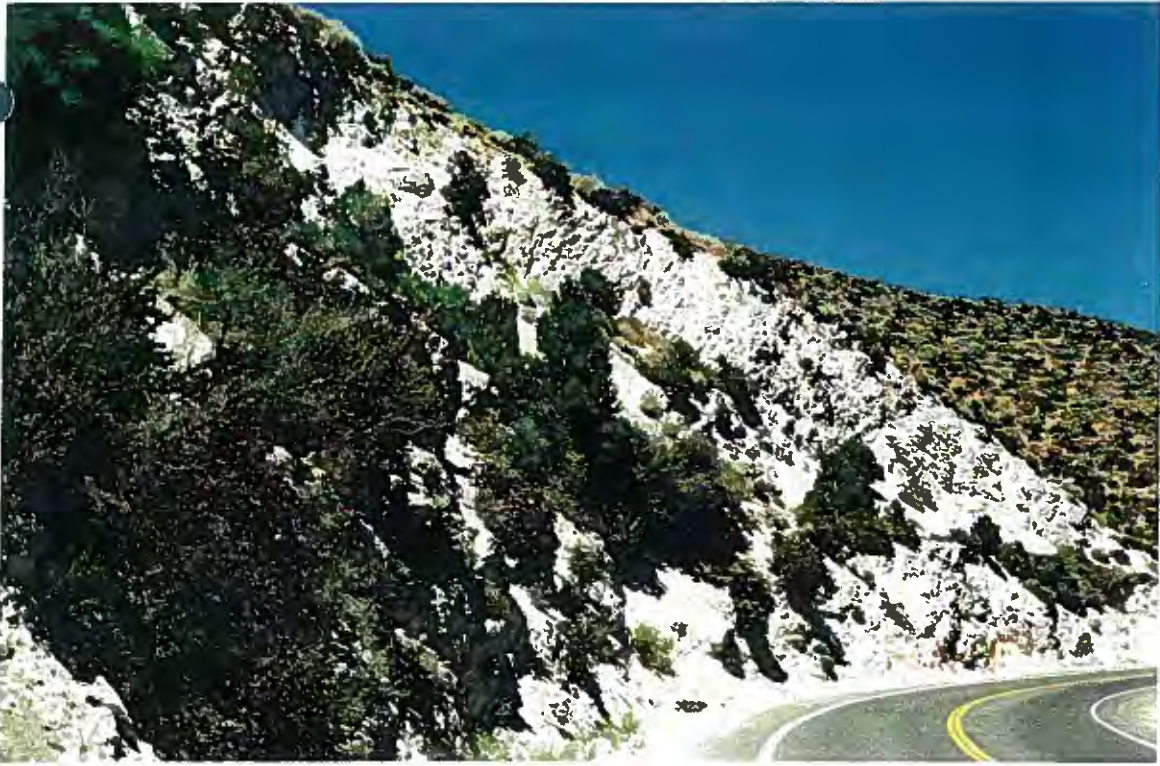
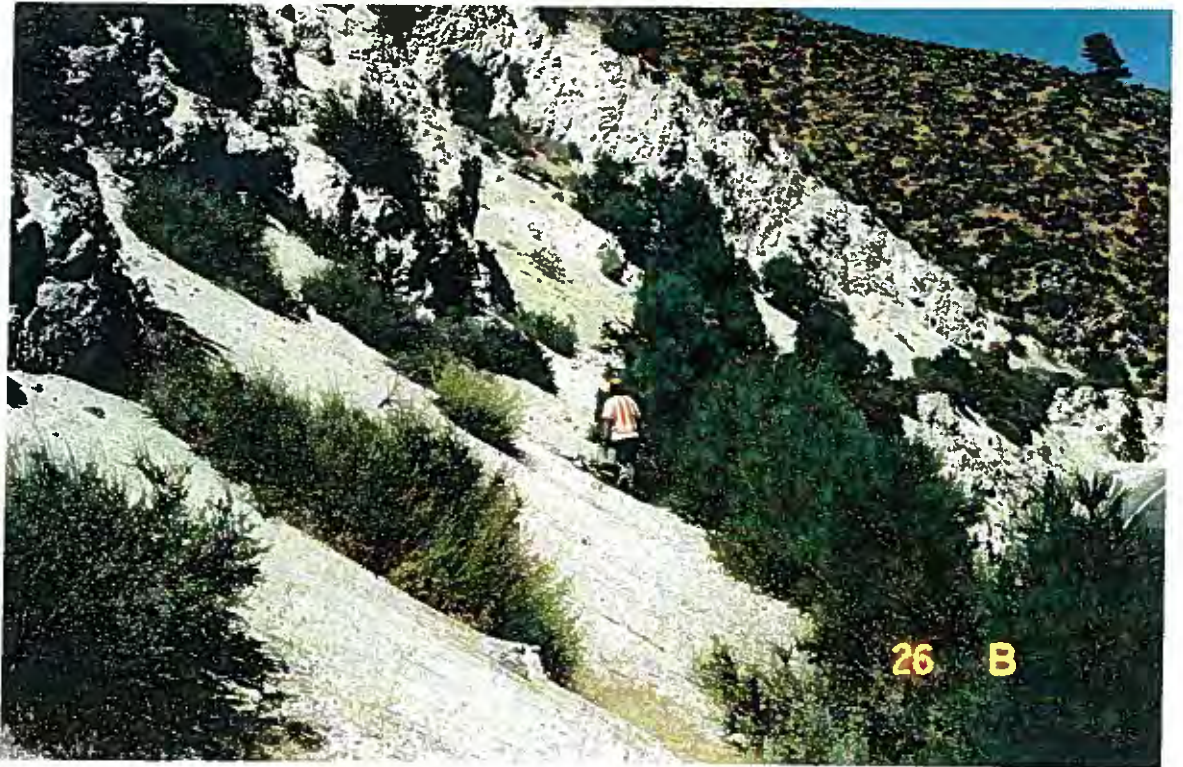
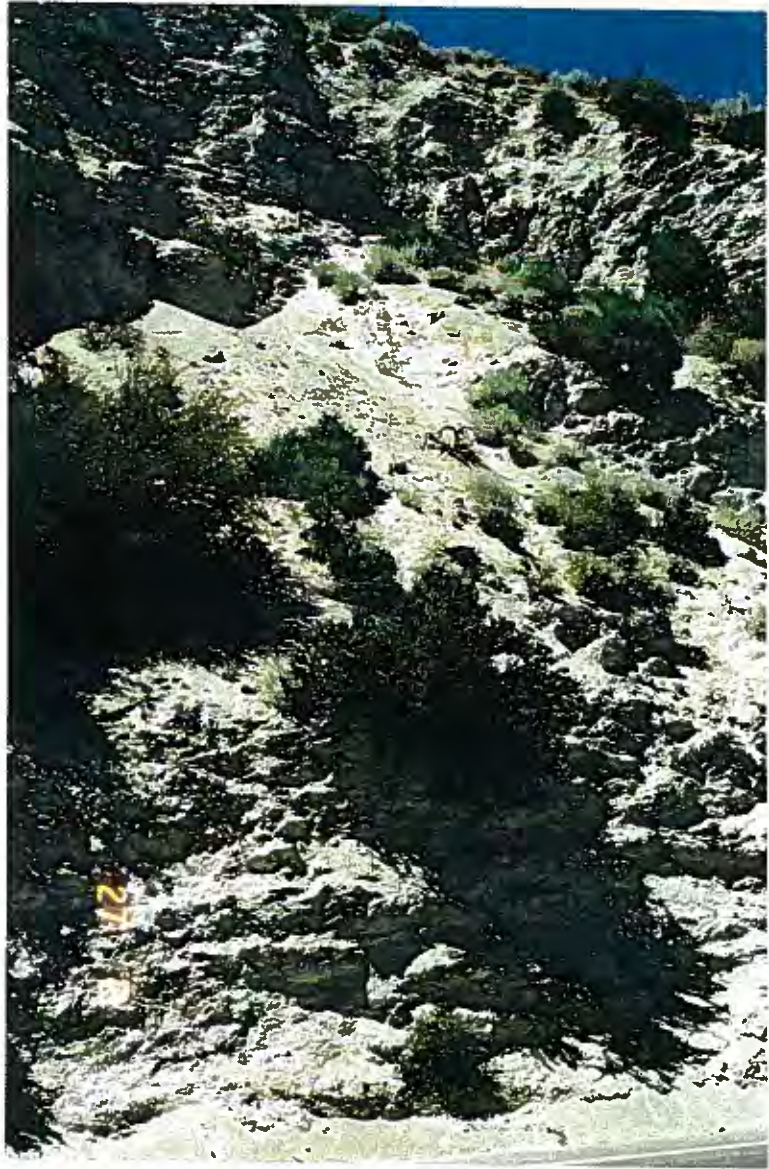
Single benched slope. Heavy talus has built up on bench (photos 22B through 27B). Upper cut slope face is very irregular, weathered, and broken up. Bench has failed approximately halfway into cut but is salvageable in most places. For short term solution we need to remove the debris from the bench and slope scale all loose material from the cut faces. Long term solutions could entail cutting back the upper slope to provide a larger catchment bench, placement of rock fall fences, and construction of a catchment ditch at the slope toe. As before more field and office work would be needed to complete such designs. There is good access to the bench from the north side.

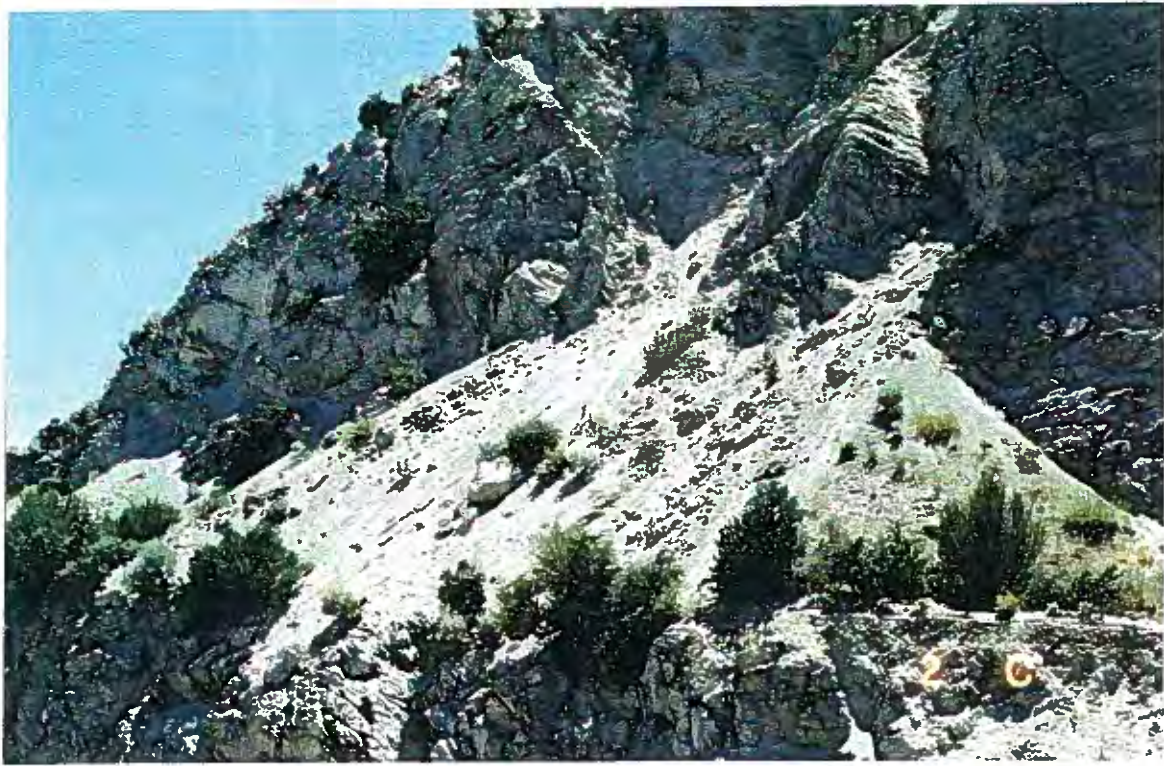
#2C (Minden side)

The west side of this cut has a lower bench that is full of talus (photos 2C & 6C), and a small upper bench of which the middle third has failed. For short term slope scaling and removal of the talus on the lower bench is recommended as a minimum. Long term solutions could entail reshaping the entire slope face, possibly rebenching the slope, placing rockfall fencing, and constructing a catchment ditch at the toe.

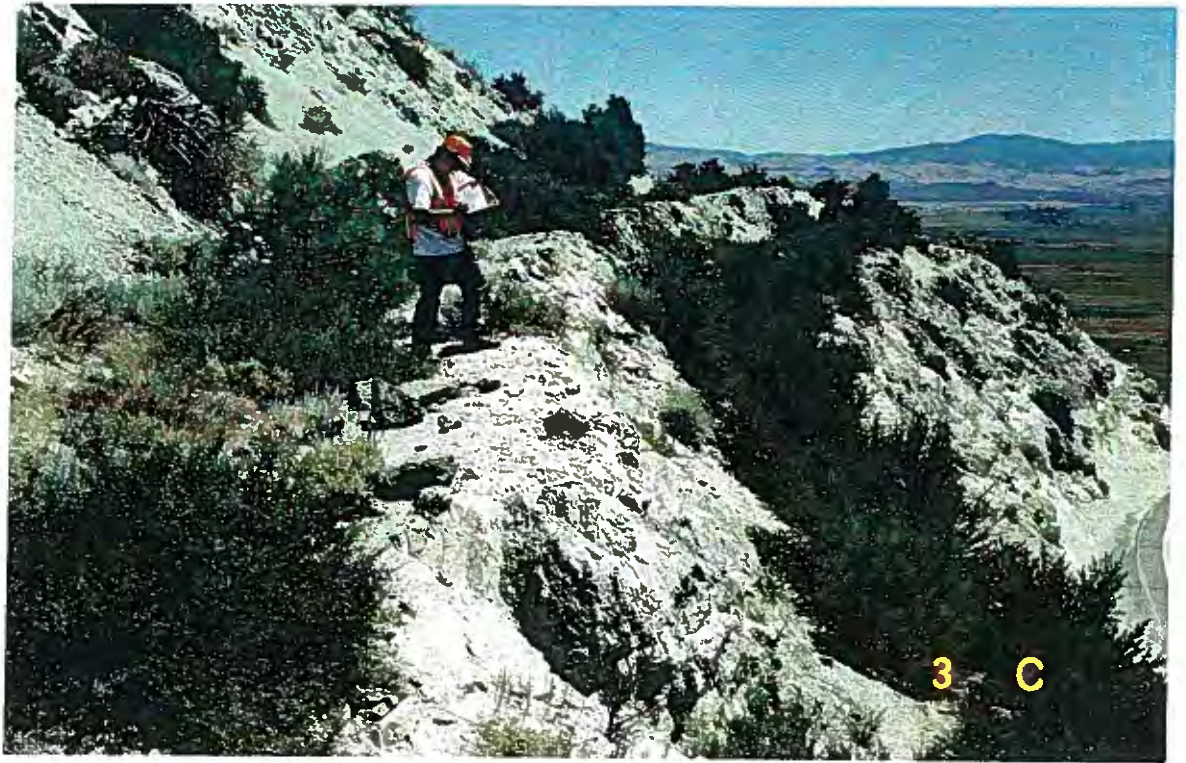
#3C

This cut has a small double bench (photos 3C, 4C, 5C, & 7C). Neither bench is wide enough to efficiently catch rock fall debris. Long term solutions would probably entail reshaping entire face of cut, eliminating one of the benches, placing rock fall fencing, and providing a catchment area at the toe of the cut. As before more detailed office and field work would be needed to provide good design recommendations.

For the short term slope scaling and removal of the debris present on the benches is recommended. There is a narrow steep access to the benches from the south side.
