GEOTECHNICAL INVESTIGATION

**ASSESSMENT OF ROCK SLOPE CONDITIONS
ALONG KINGSBURY GRADE ROAD - SR 207
DOUGLAS COUNTY, NEVADA**

MARCH 1996

Subject: Assessment of rock slope conditions along Kingsbury
Grade Road, SR 207. E.A. 72028-9.

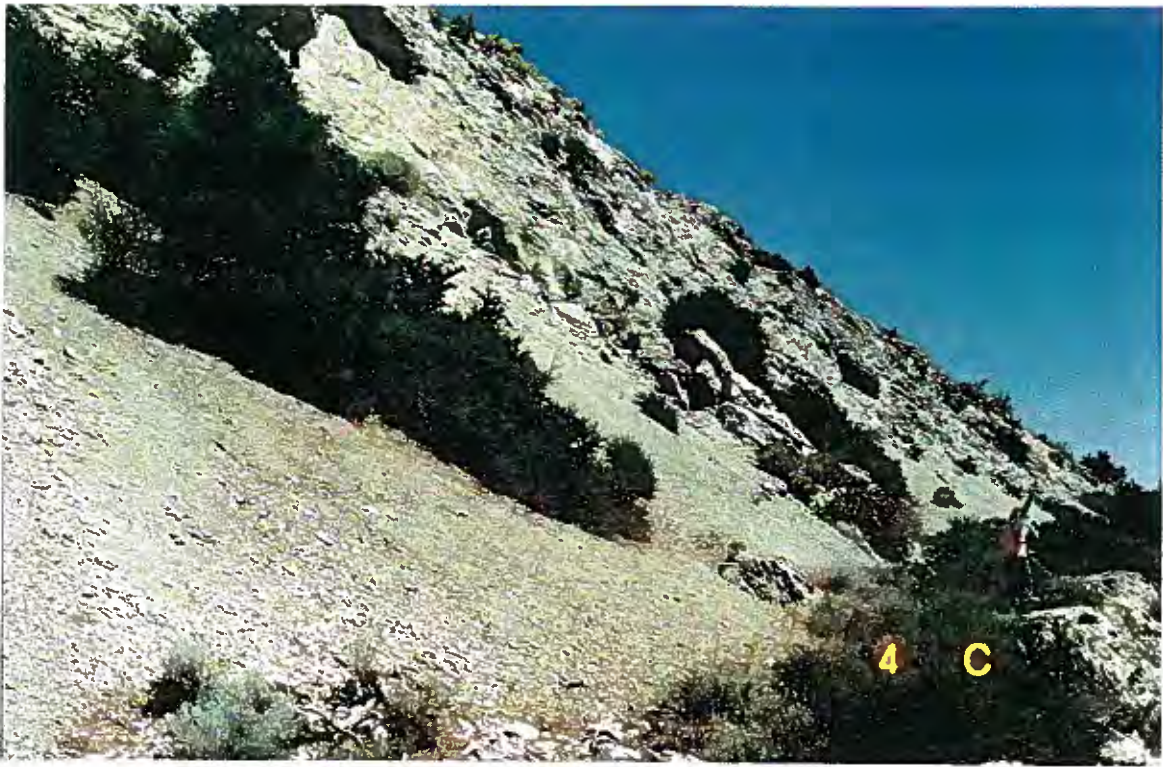
#4C (Minden side)

This cut has a small double bench (photos 3C, 4C, 5C, & 7C). Neither bench is wide enough to efficiently catch rock fall debris. Long term solutions would probably entail reshaping entire face of cut, eliminating one of the benches, placing rock fall fencing, and providing a catchment area at the toe of the cut. As before more detailed office and field work would be needed to provide good design recommendations.

For the short term slope scaling and removal of the debris present on the benches is recommended. There is a narrow steep access to the benches from the south side.

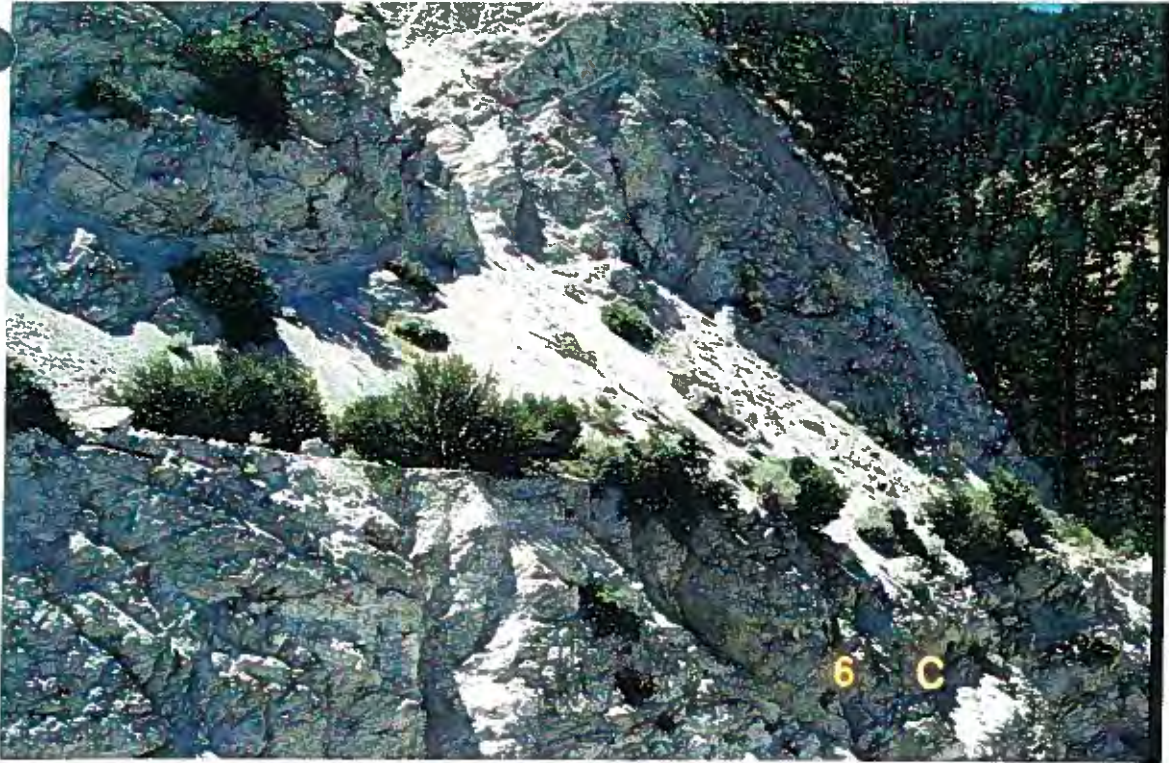
#6C (Minden side)

The west side of this cut has a lower bench that is full of talus (photos 2C & 6C), and a small upper bench of which the middle third has failed. For short term slope scaling and removal of the talus on the lower bench is recommended as a minimum. Long term solutions could entail reshaping the entire slope face, possibly rebenching the slope, placing rockfall fencing, and constructing a catchment ditch at the toe.

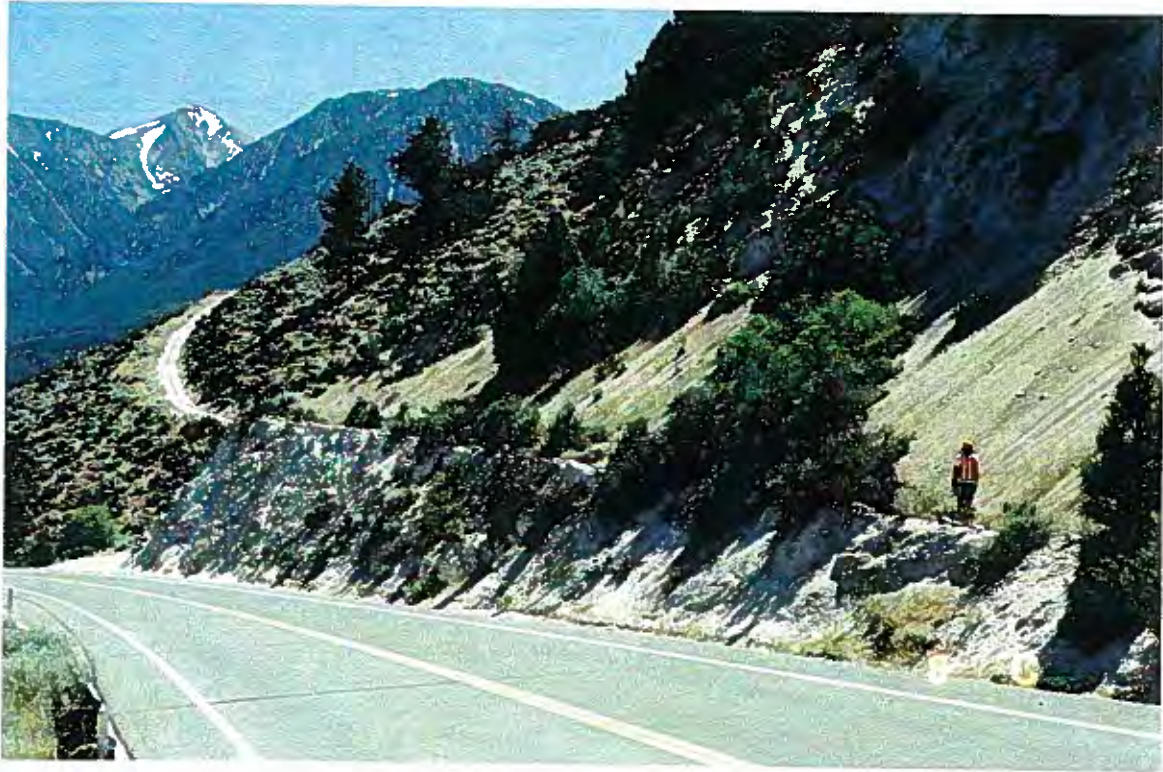
#8C (Minden side)

Single benched slope. Clean talus from bench. Try to retain as many trees and brush as possible (photo 8C).

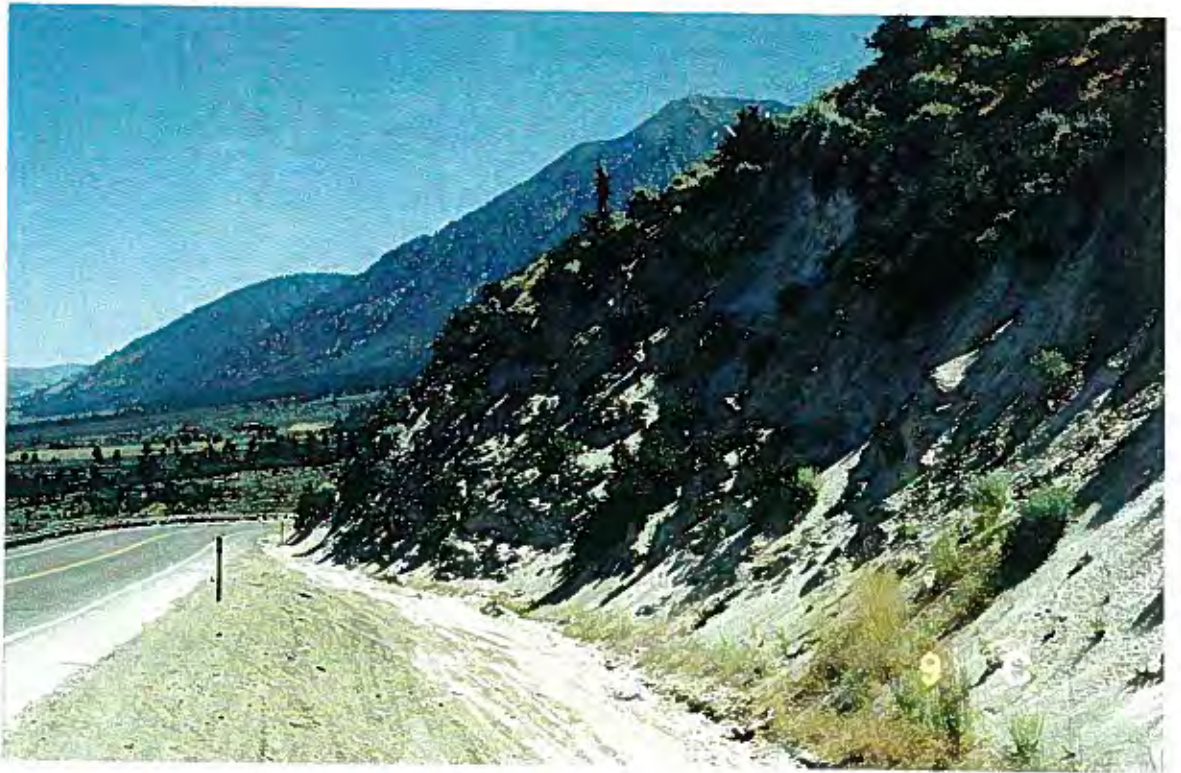
#9C

Cut has large catchment area. Only needs to be slope scaled especially at bend in road to end of cut where catchment area is narrow (photo 9C).

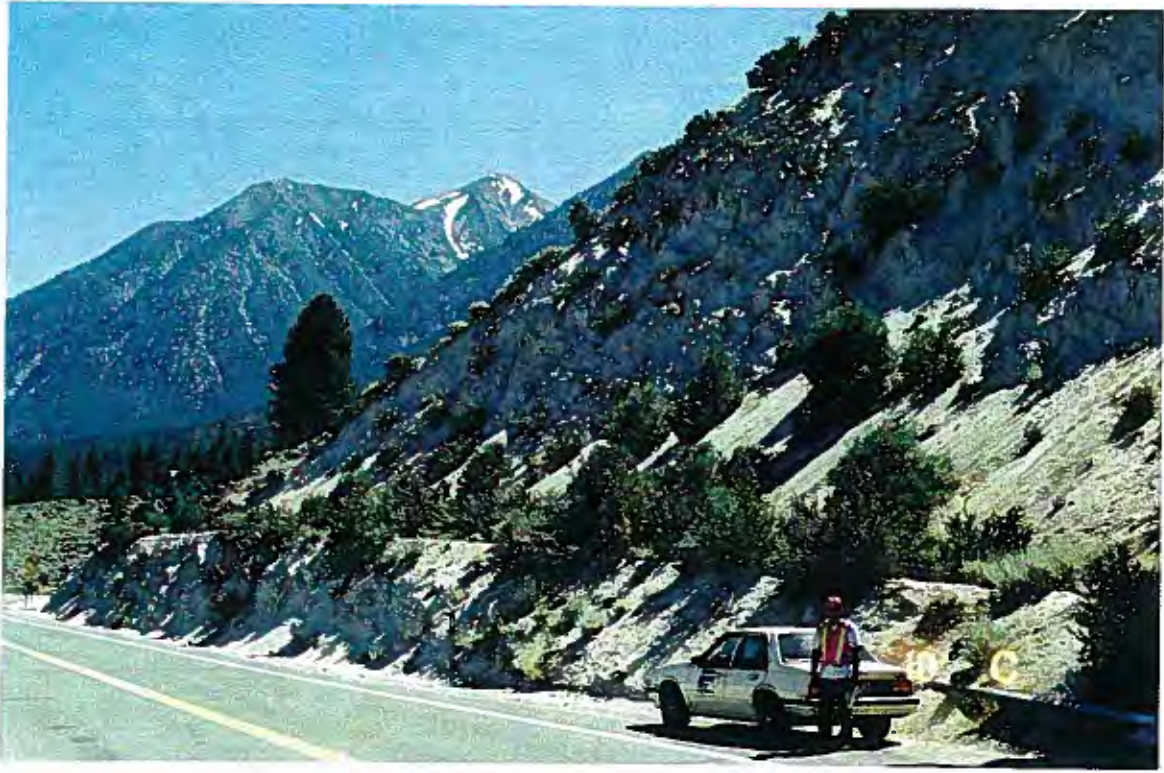
#10C (Minden side)

A single low bench exists at toe of cut (photos 10C & 11C). The upper slope face is irregular and broken up. Recommend removing talus from bench. Also should slope scale loose rock from upper slope and clean ditch at toe of cut.
