ROCK SCALING RECOMMENDATIONS

U.S. 95: MILEPOST 62.8 TO 64.10 MINERAL COUNTY, NEVADA

December 2004

E. A. 72964-9

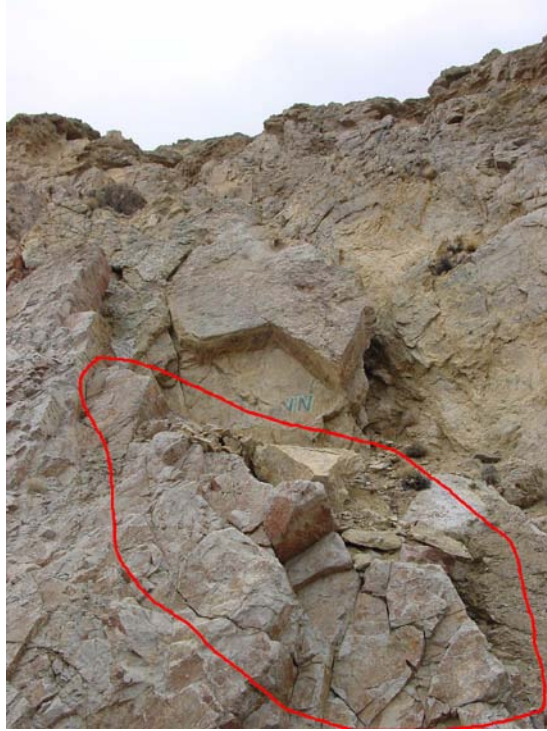
Fig 1. Milepost 62.8 showing loose rocks and fractured rock to be scaled.

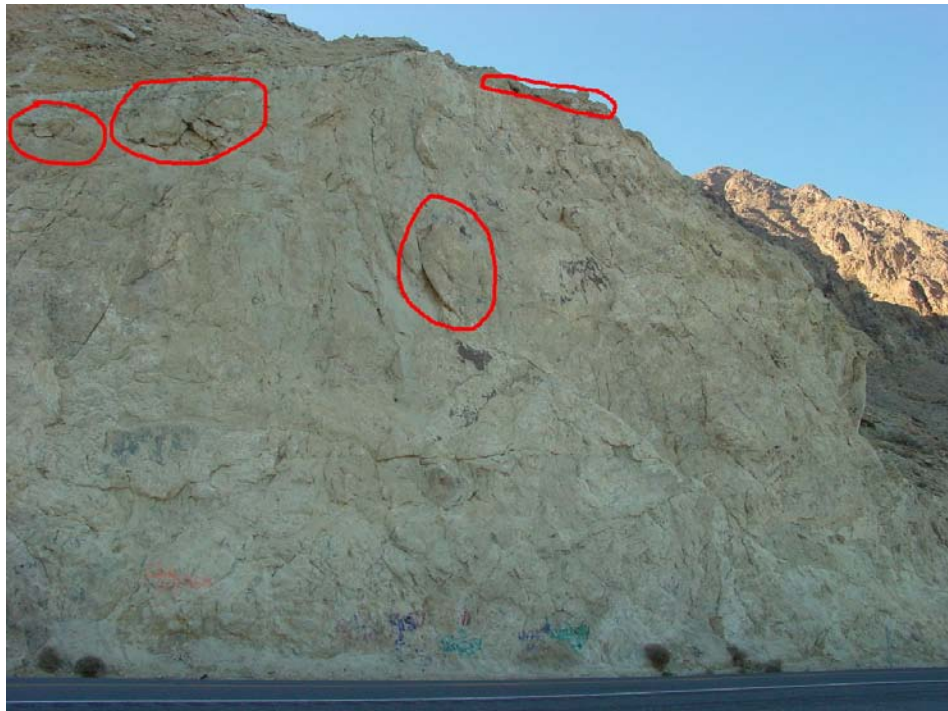
Fig 2. Milepost 62.9 showing fractured rock and overhanging material.

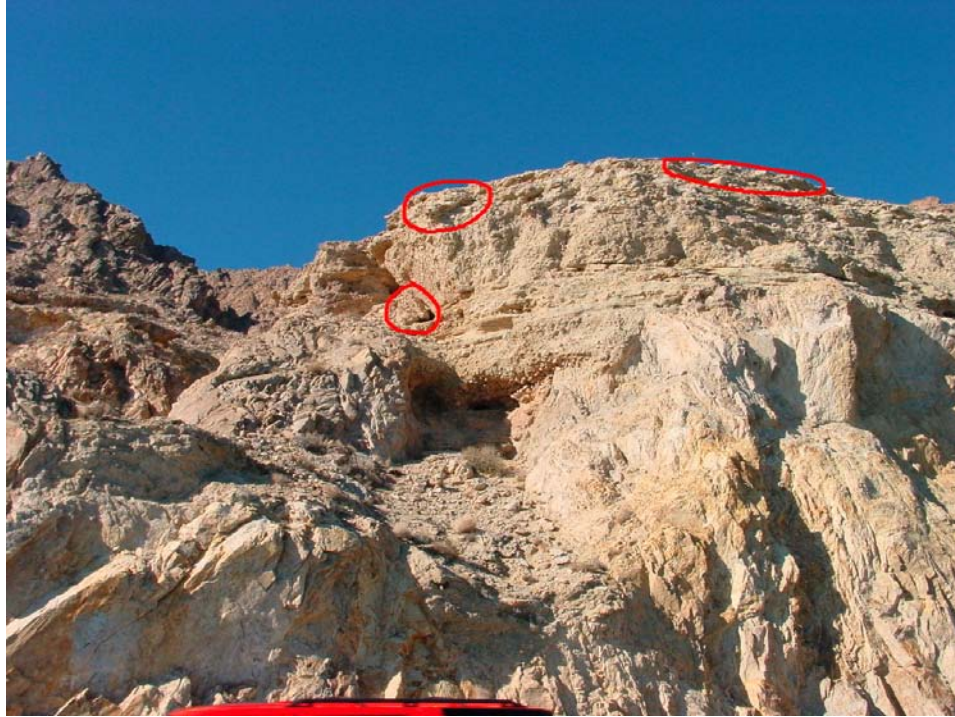
Fig 3. Milepost 63.2 showing loose rock and alluvium overhang.

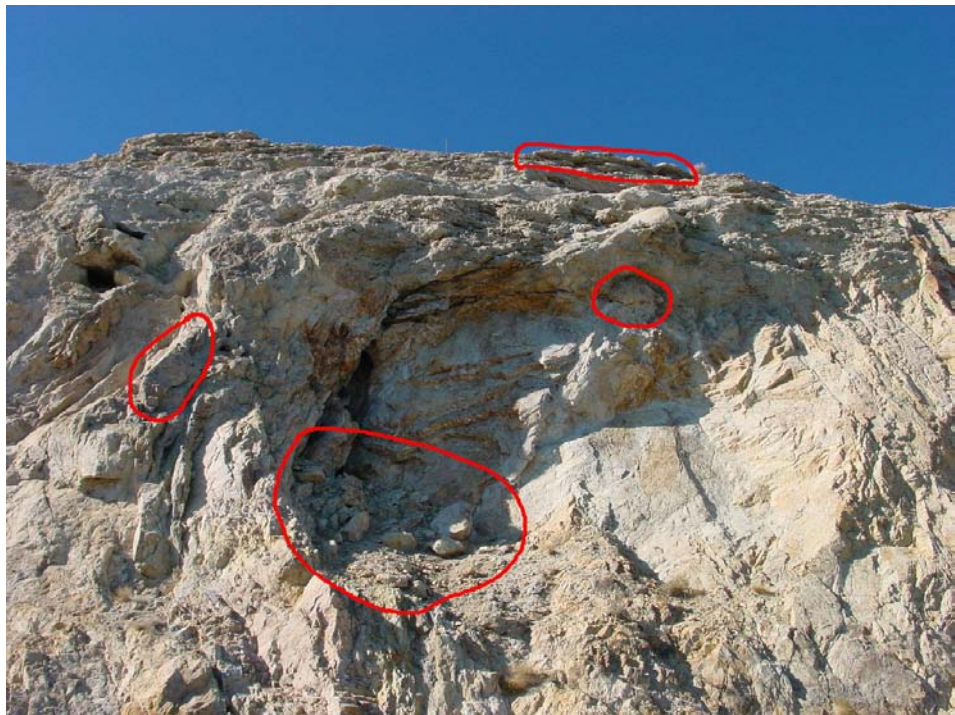
Fig 4. Milepost 63.23 showing loose rocks, fractured rock and overhangs.

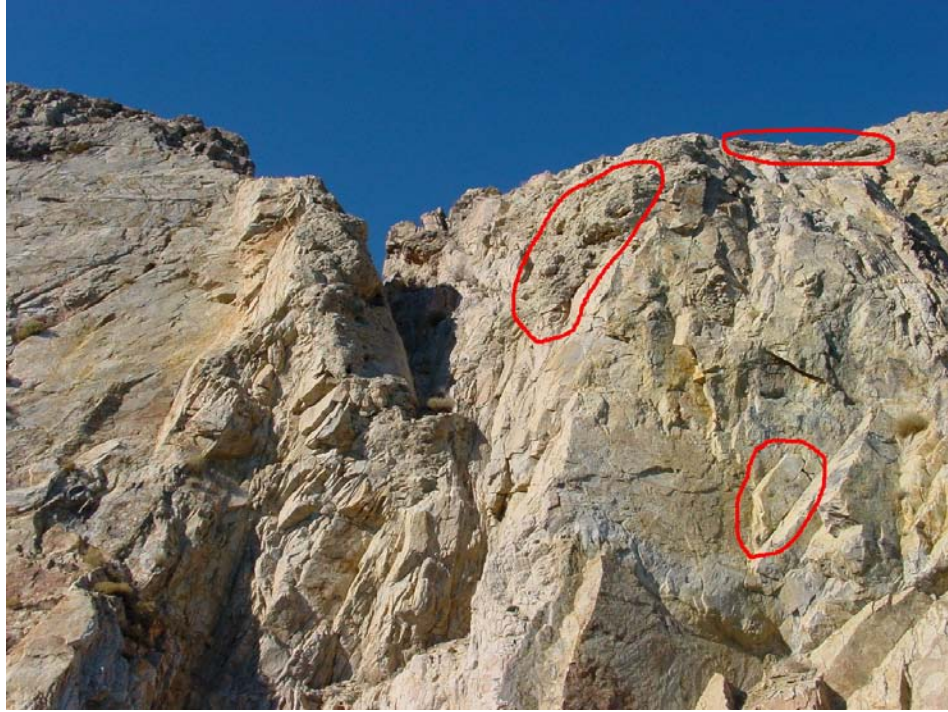
Fig 5. Milepost 63.29 showing cemented soil attached to bedrock, rock fracture and soil overhang.

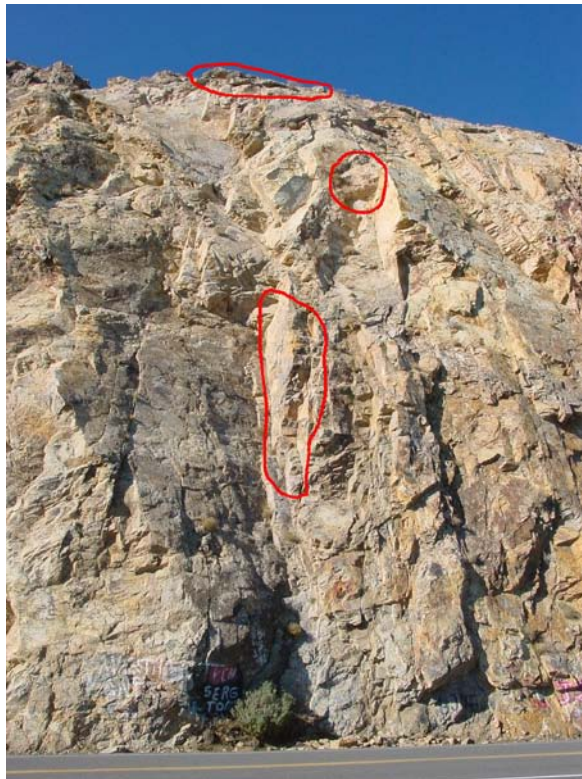
Fig 6. Milepost 63.33 showing fractured rock wedges and soil overhang. Note rock debris in roadside ditch from recent rock fall.

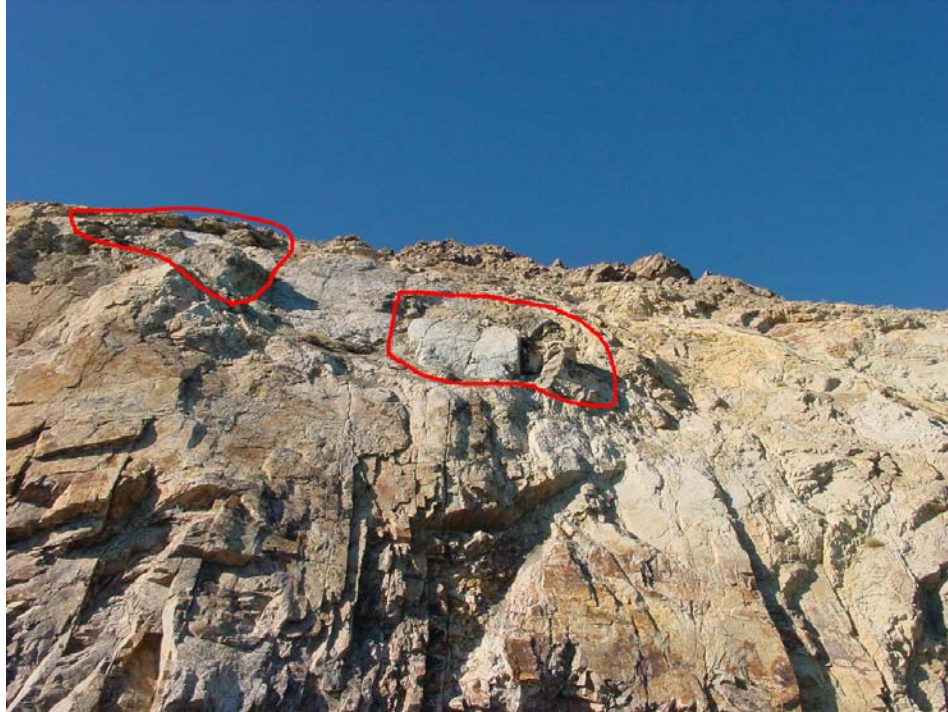
Fig 7. Milepost 63.36 showing failed rock mass perched on rock face and overhang at top of cut slope.

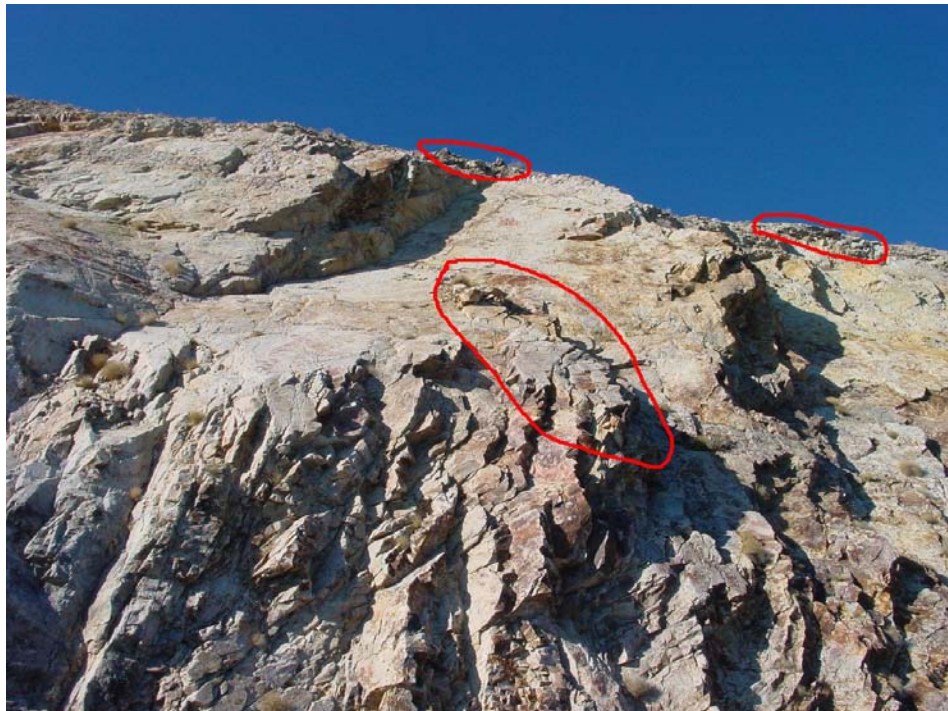
Fig 8. Milepost 63.38 showing highly fractured rock and soil overhang. Note highly fractured bedrock in foreground with many loose wedges.

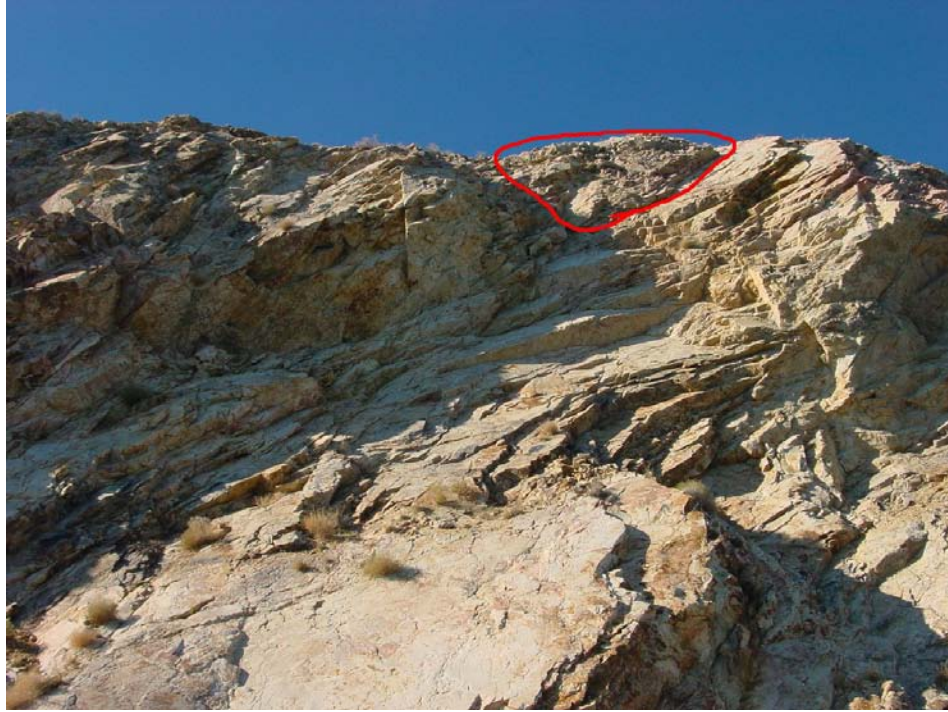
Fig 9. Milepost 63.48 showing poorly cemented soil mass at top of slope. Note many rock fractures across cut face.

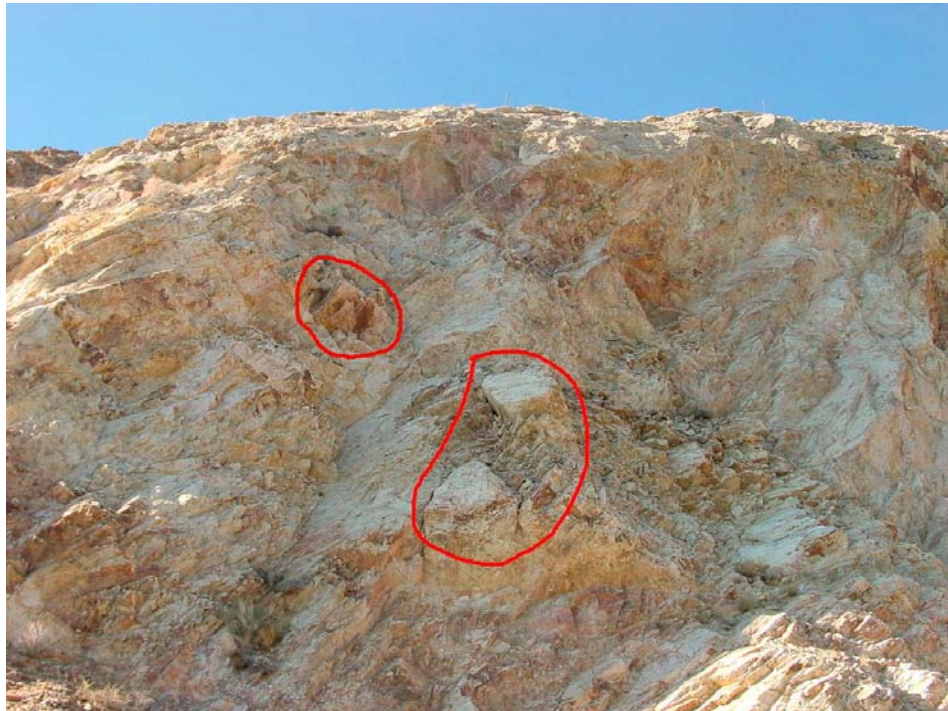
Fig 10. Milepost 63.50 showing larger blocks of fractured rock.

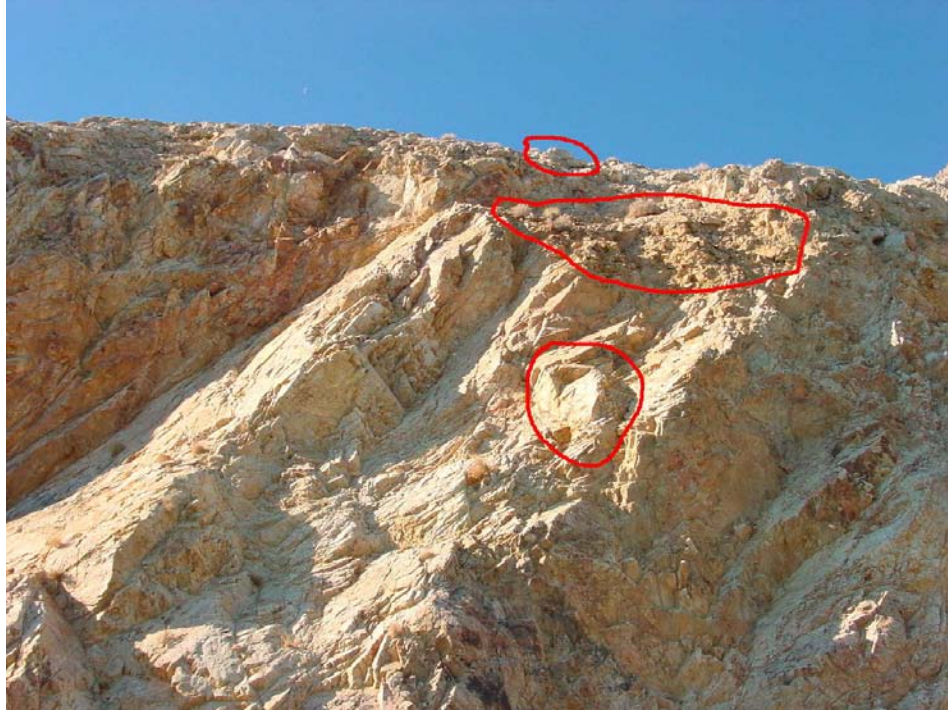
Fig 11. Milepost 63.53 showing large rock wedge, loose rocks perched on slope face and large rock at top of slope.

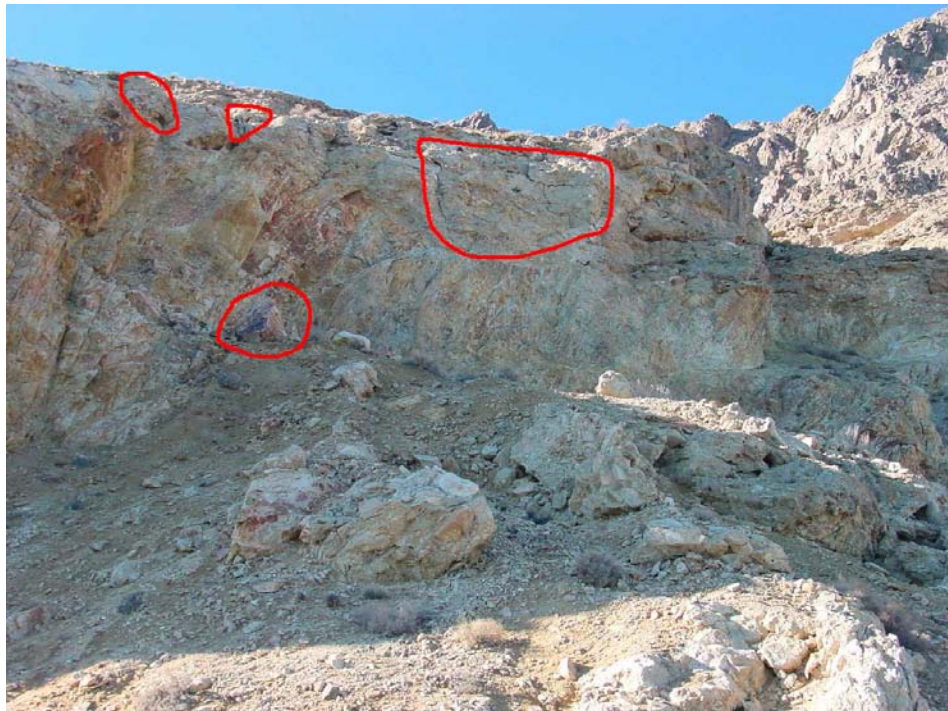
Fig 12. Milepost 63.55 showing fractured cemented soil on top of cut and large rock perched on slope.

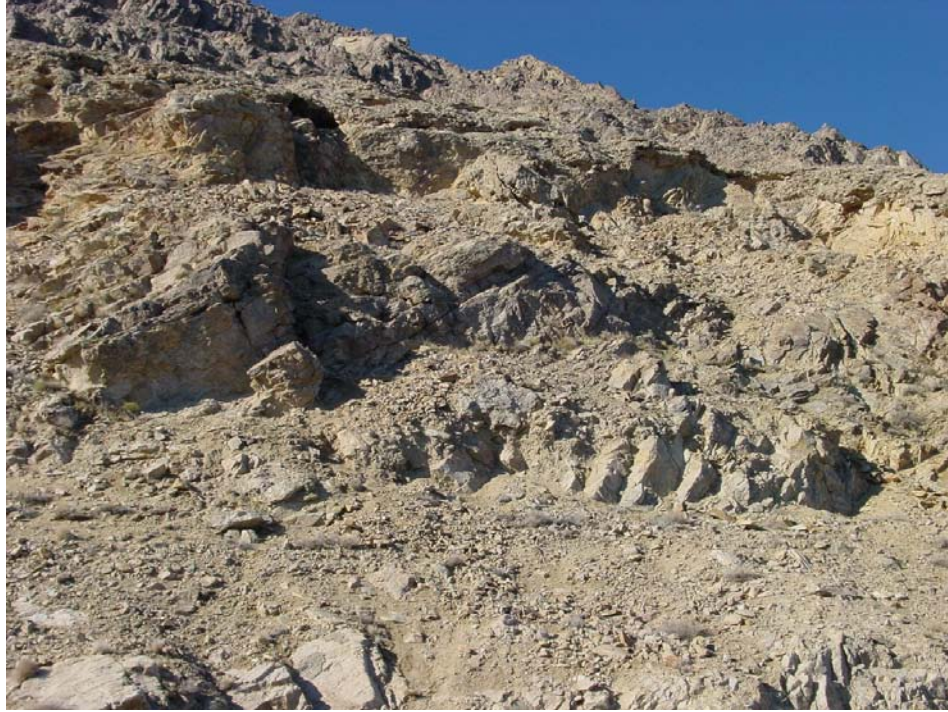
Fig 13. Milepost 63.61 showing large volume of unstable rocks perched on slope.

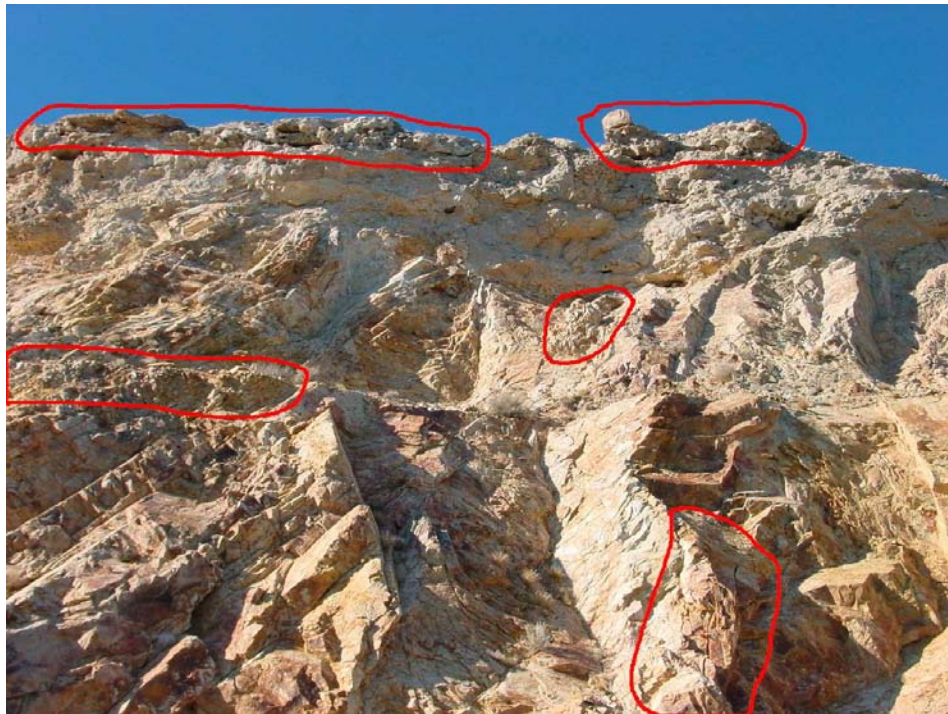
Fig 14. Milepost 63.67 showing fractured rock wedge, over steepened degraded bedrock and cemented soil overhangs.

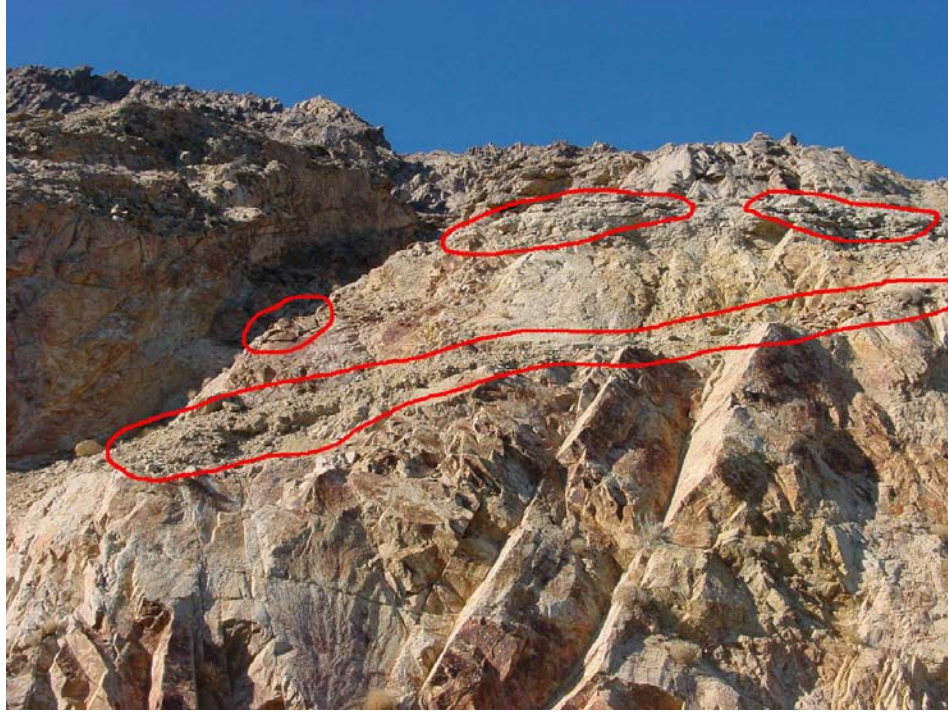
Fig 15. Milepost 63.70 showing perched rocks and soil mass at midslope bench and soil overhangs at crest.

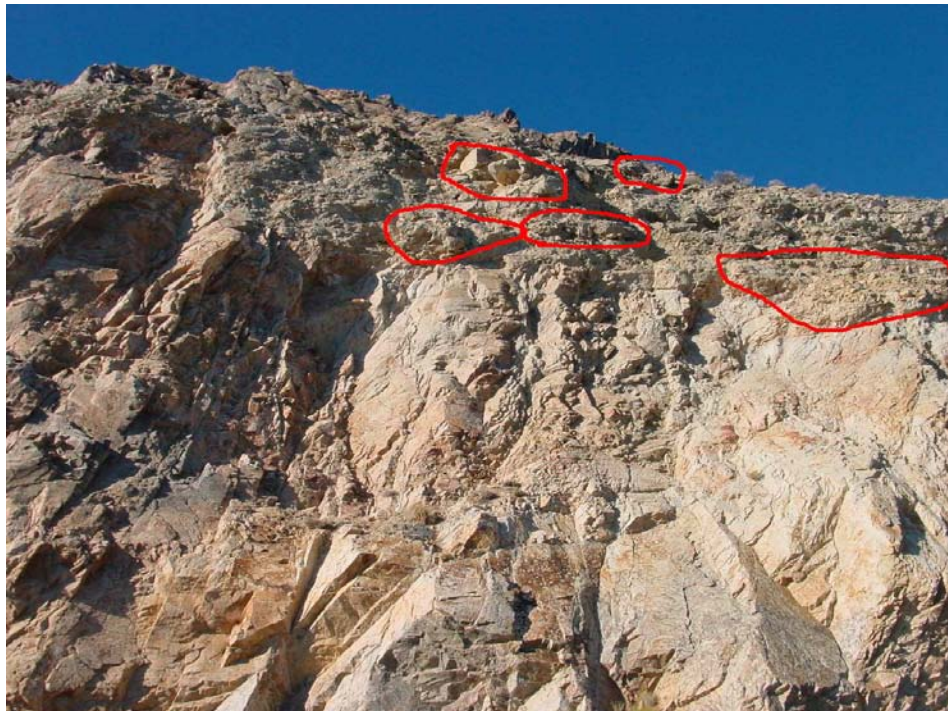
Fig 16. Milepost 63.72 showing cemented soil overhangs. Note highly fractured bedrock across cut face.

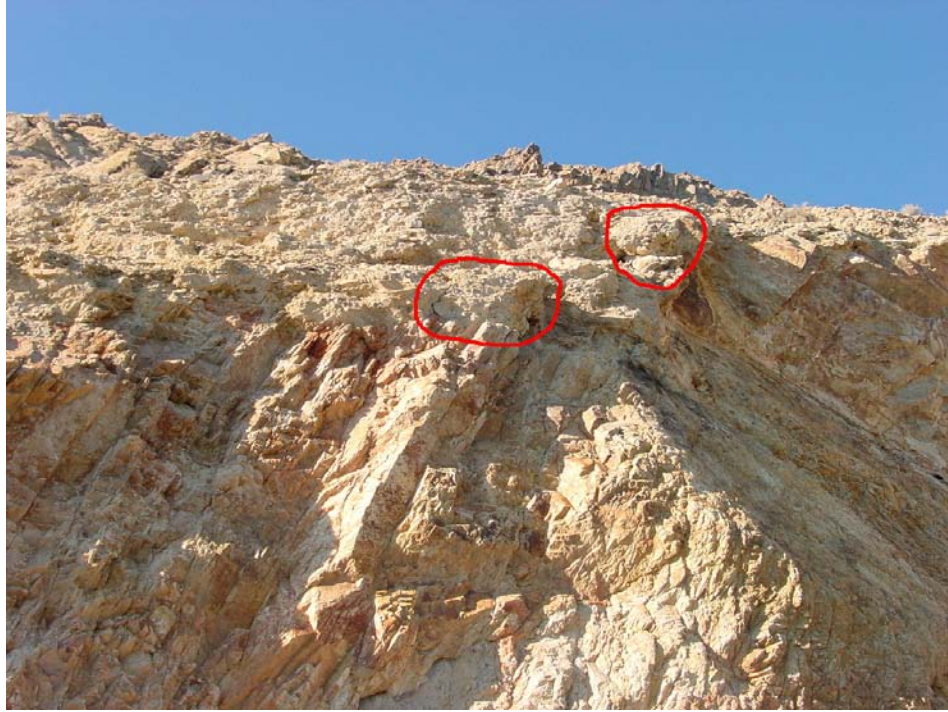
Fig 17. Milepost 63.74 showing fractured soil overhangs. Note intense fracturing of bedrock across cut face.

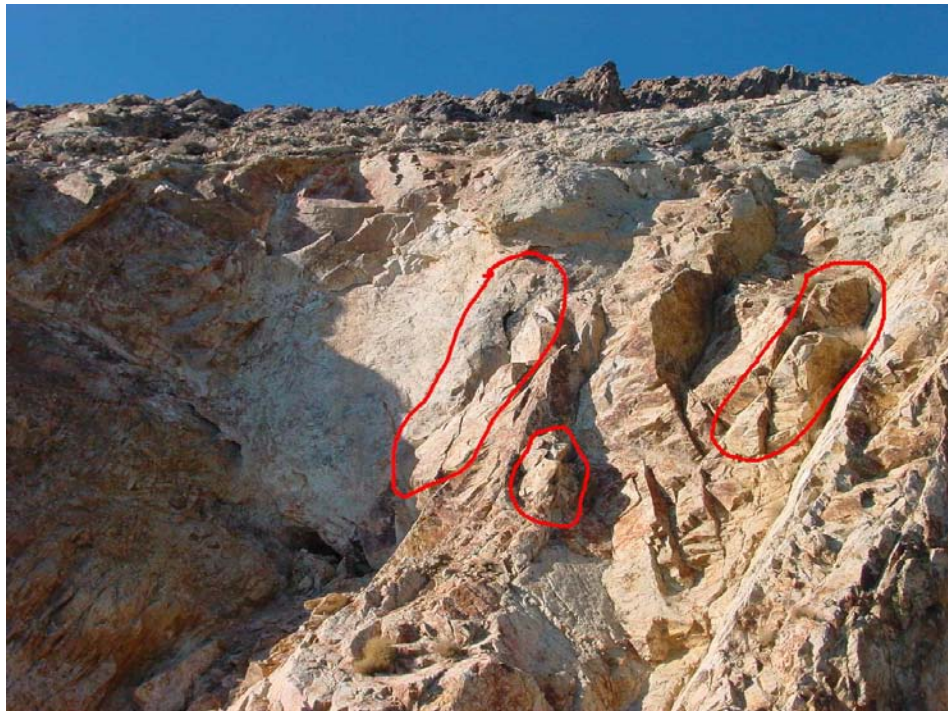
Fig 18. Milepost 63.75 showing open fractures in rock creating unstable wedges of rock.

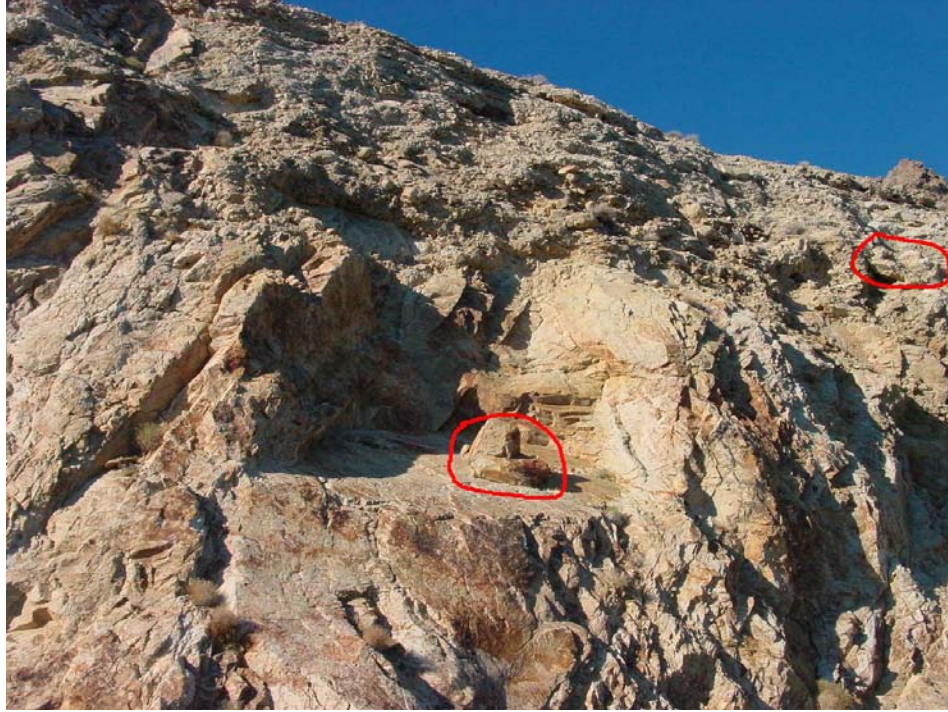
Fig 19. Milepost 63.76 showing perched loose rock and unstable wedge of cemented soil.

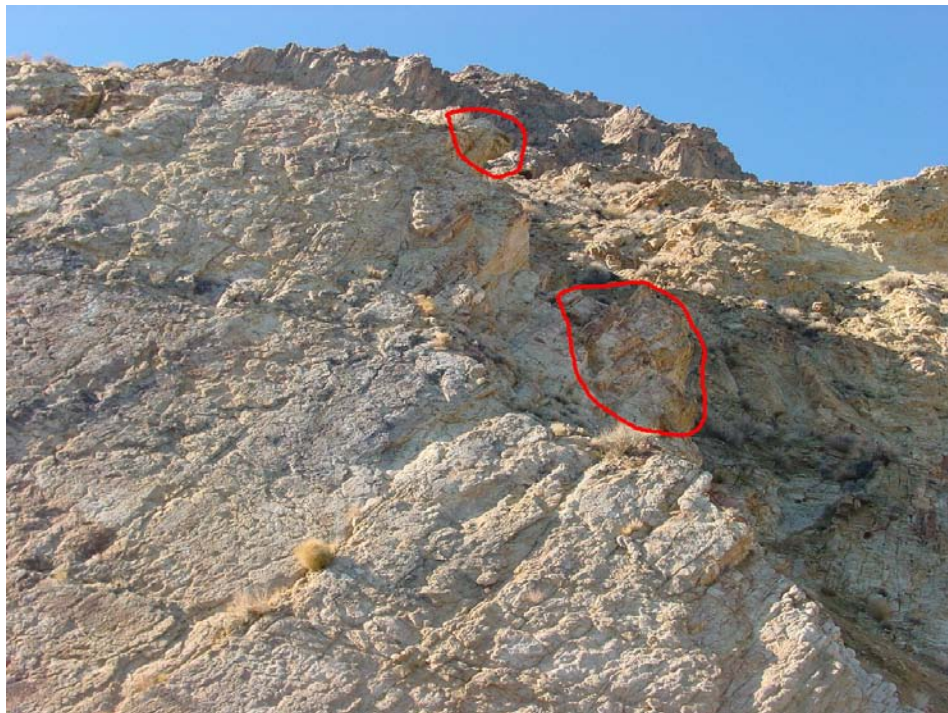
Fig 20. Milepost 63.83 showing large, overhanging, fractured bedrock.

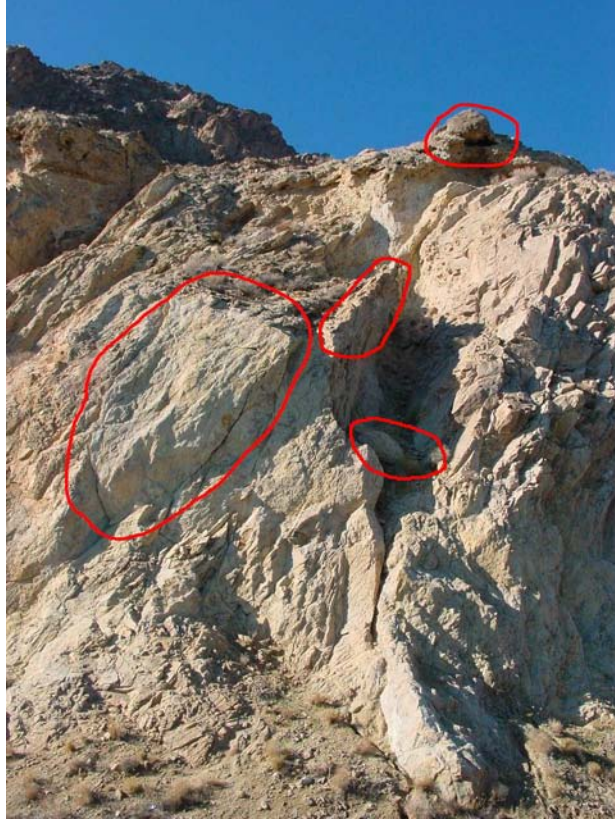
Fig 21. Milepost 63.85 showing large fractured bedrock wedge, overhanging bedrock, perched boulder and cemented soil overhang.

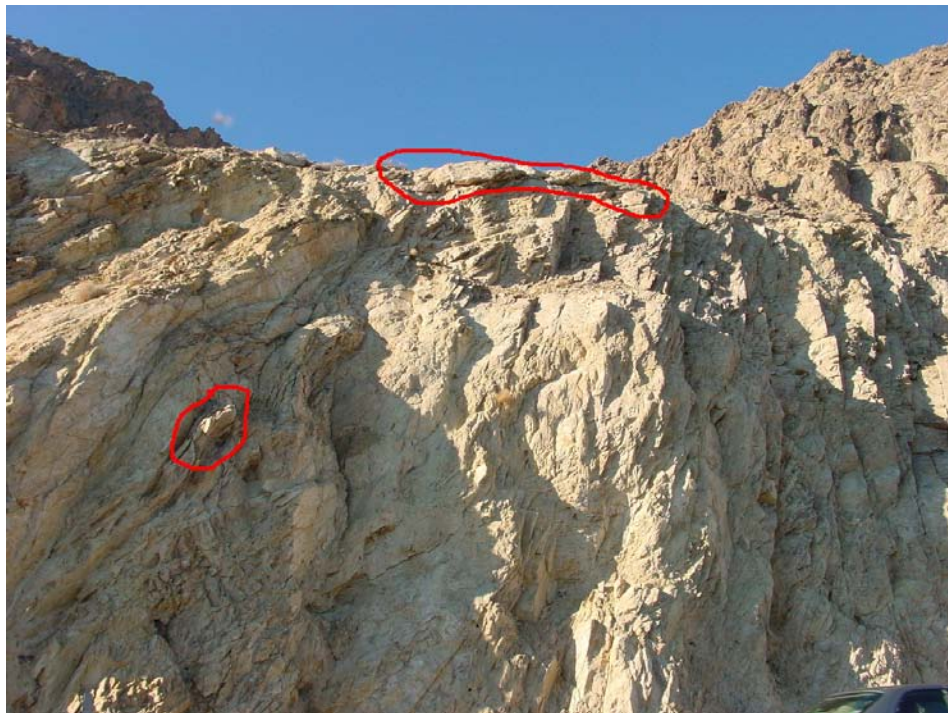
Fig 22. Milepost 63.89 showing fractured bedrock wedge and soil overhang. Note highly fractured bedrock across cut face.

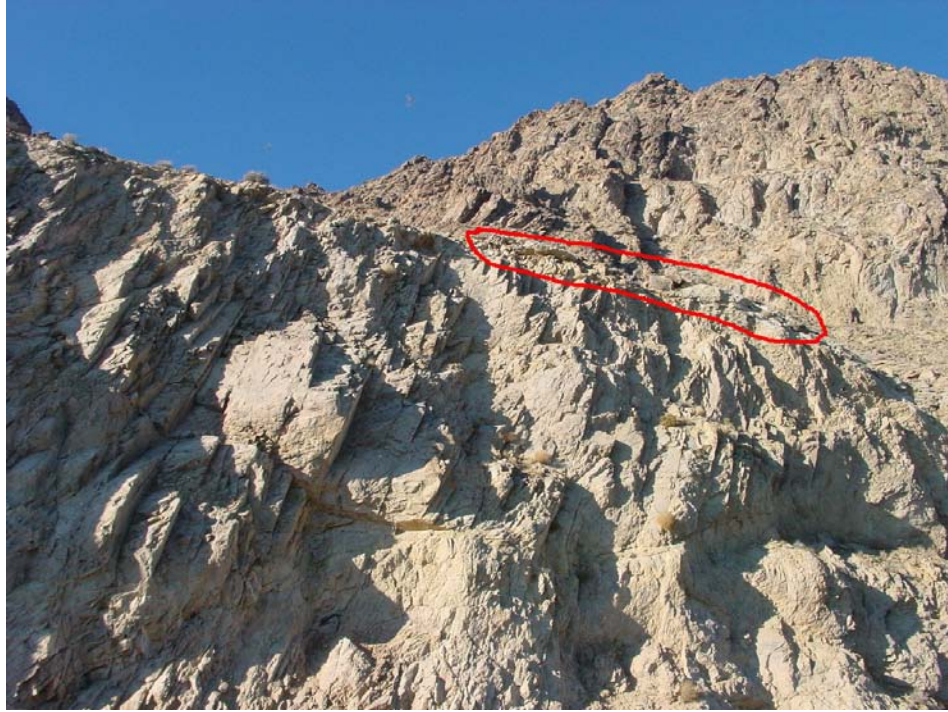
Fig 23. Milepost 63.91 showing loose rocks perched at top of slope. Note highly fractured bedrock with many open fractures across cut face.

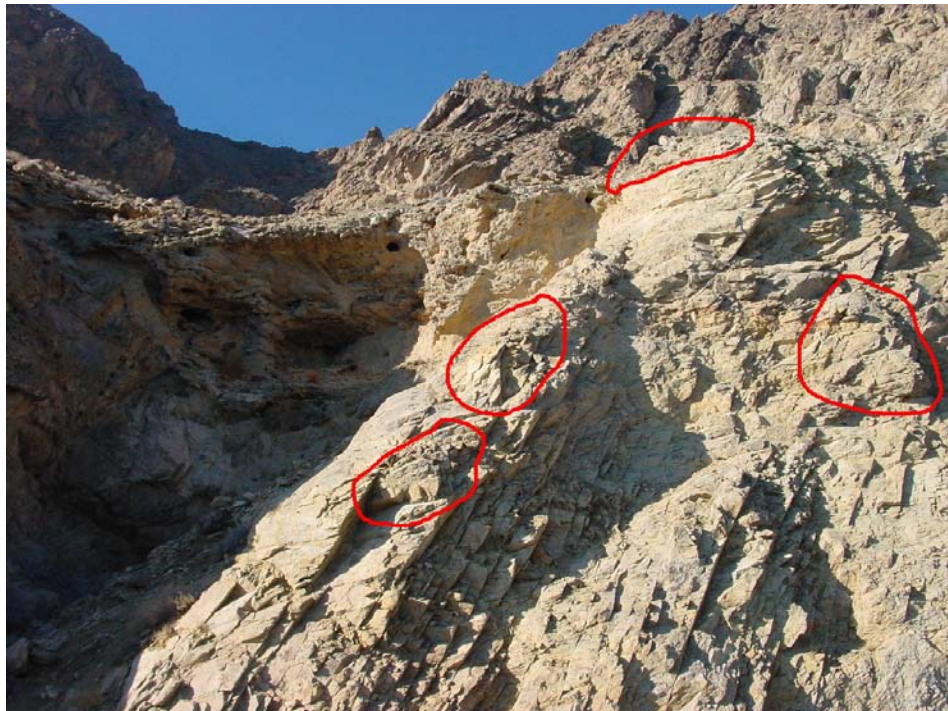
Fig 24. Milepost 63.93 showing intensely fracture bedrock wedges and soil overhang.

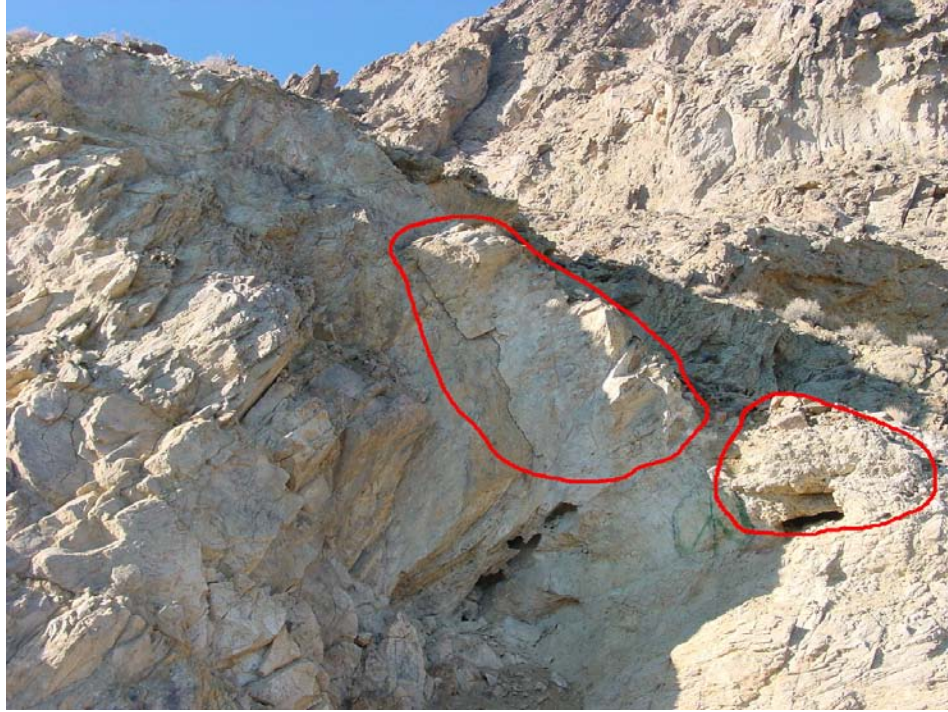
Fig 25. Milepost 63.96 showing large bedrock wedge and soil overhang.

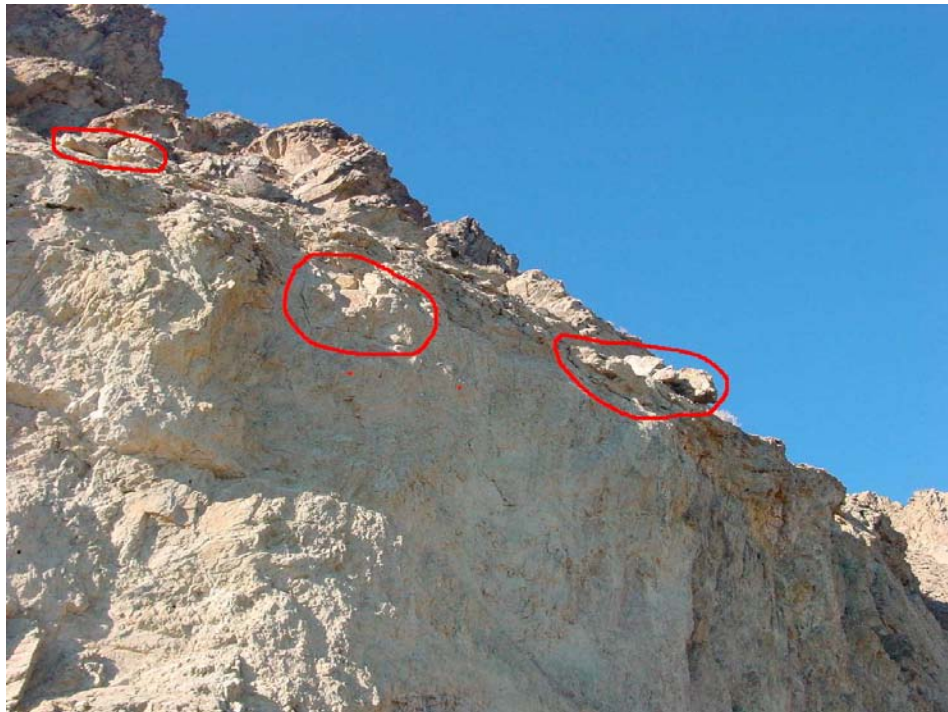
Fig 26. Milepost 64.07 showing fractured rock and large loose rocks on top of cut slope.
