**CONSULTANT'S REPORT
CORROSION EVALUATION OF MSE WALLS
I-515/FLAMINGO ROAD
LAS VEGAS, NEVADA**

NDOT AGREEMENT NO. P068-04-020

**The Nevada Department of Transportation
Materials Division
Carson City, Nevada**

**May 2005
File: 04-005**

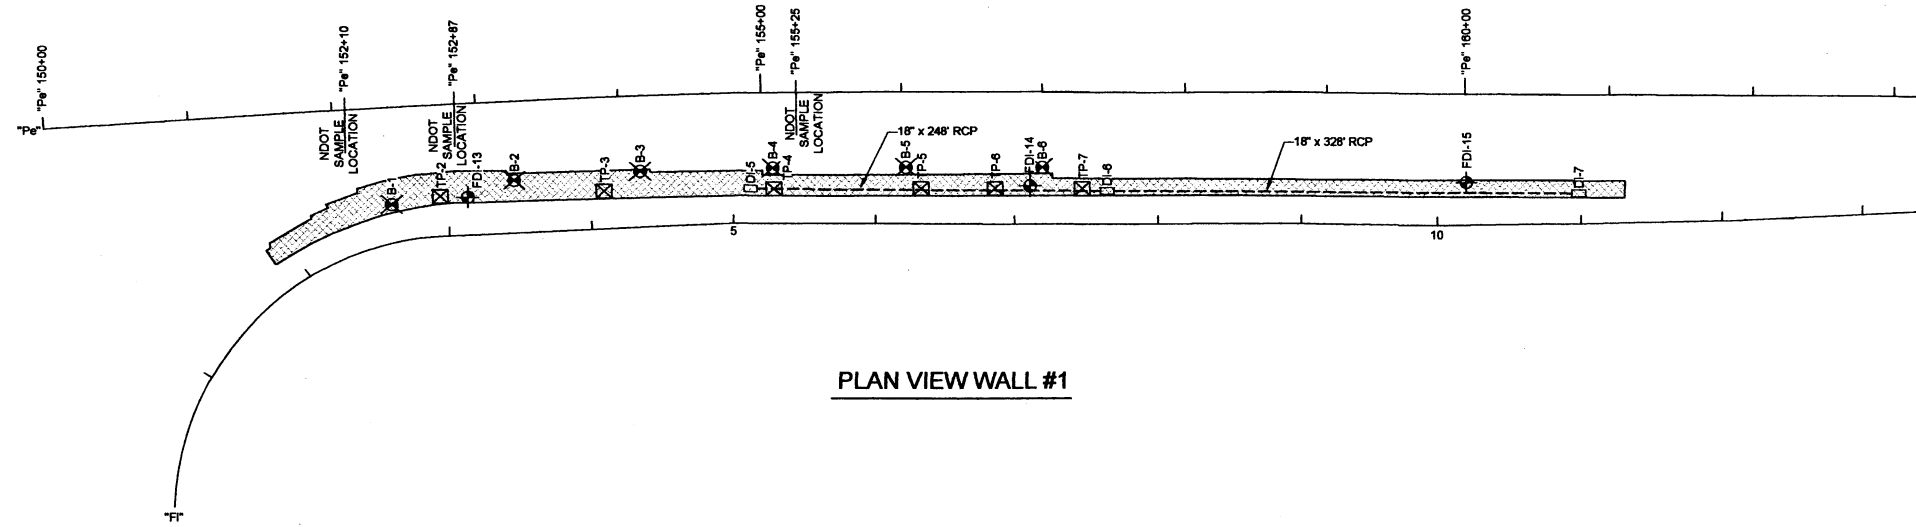
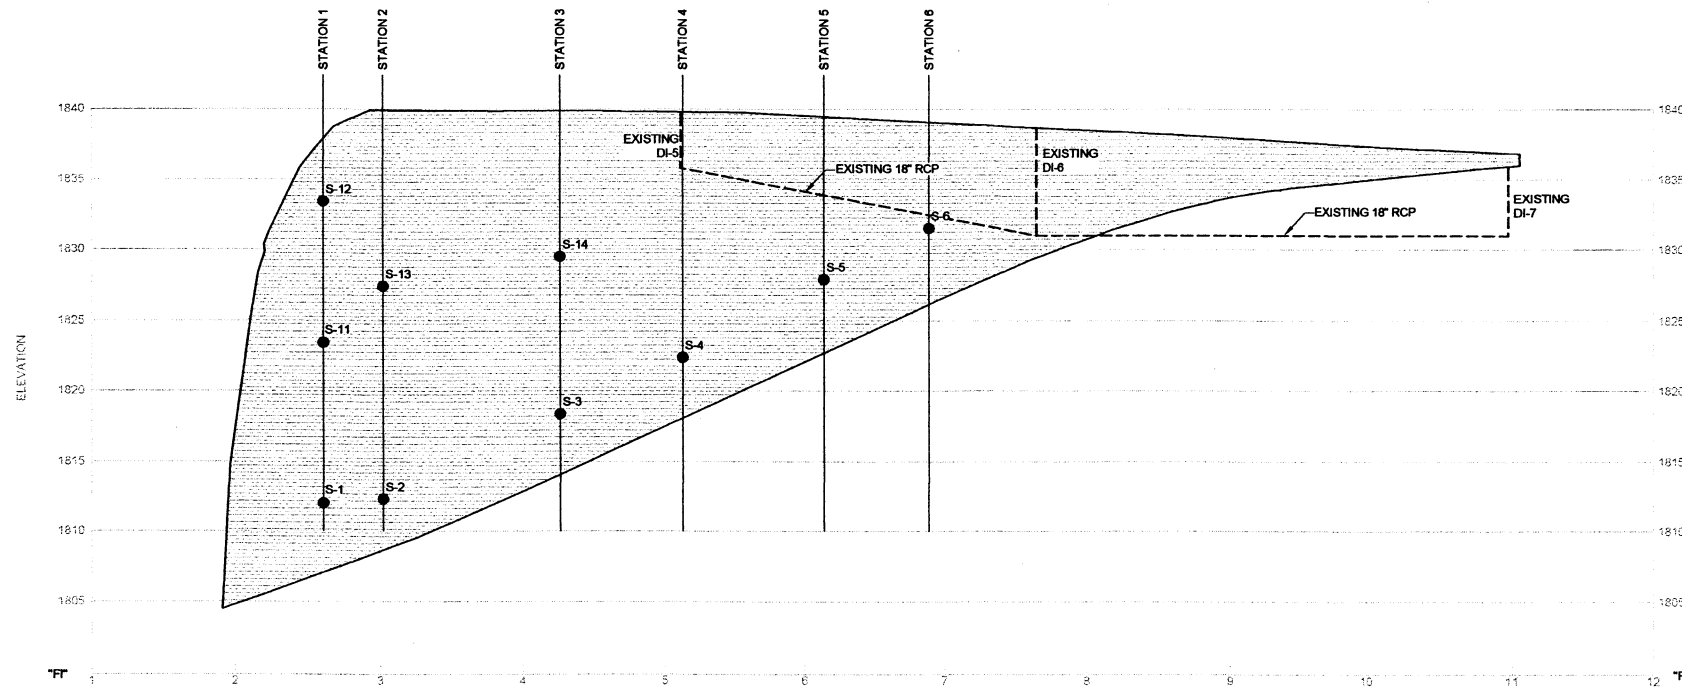
PLAN VIEW WALL #1

In particular, significantly higher rates of corrosion were observed during March in the vicinity of drainage facilities located within the backfill behind Wall #1. The area behind Wall #1 was capped with flowable fill in February 2004 and may have still been relatively moist in March of 2004. However, by August 2004 the backfill may have lost moisture, due to lack of recharge, increasing the transient resistivity of the backfill and affecting a lower corrosion rate. Higher corrosion rates were also observed behind Wall #2 in the vicinity of a drainage inlet (DI-4).

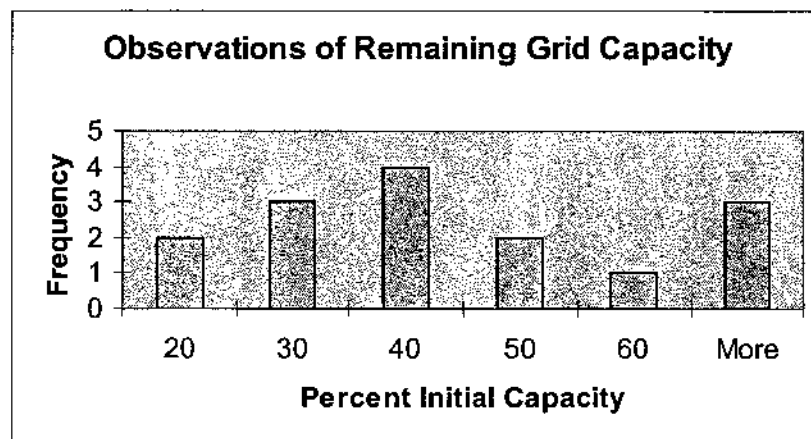
Figure III-2. Histogram of Remaining Capacities Observed from Exhumed Samples of Reinforcements
