**Geotechnical Investigation for  
Lake Tahoe Environmental  
Improvement Program**

**Phase III**

**US 50**

**January 2010**

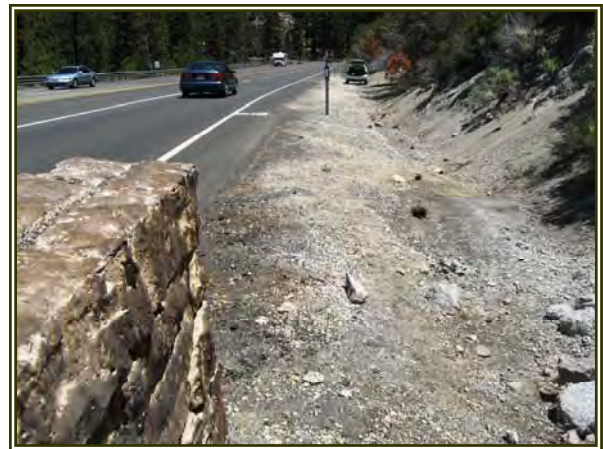
**Figure 7 – Slope 13**

Slope 13 is a relatively gentle slope comprised primarily of deeply to moderately weathered rock. Granitic in nature, the rock in this area typically weathers to non-plastic sands and gravels. The slope is approximately 15 feet high at its maximum and generally faces west. As evidenced by the cobbles and sediment in the toe ditch in the adjacent photograph, cobbles within the slope face and overburden become locally undermined and come to rest in the toe ditch which serves as both a catchment area and conveyance for runoff. Recommendations are presented to address isolated rockfall potential and surface erosion.

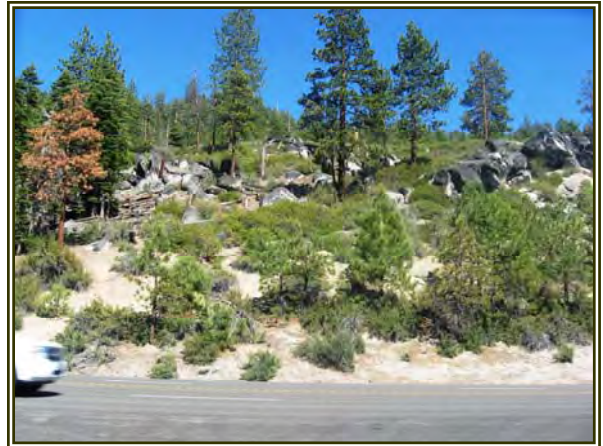
**Figure 8** – Slope 16

Slope 16 is relatively stable and presents fewer issues from a geotechnical perspective. This area has been mapped as being comprised of granodiorite of Zephyr Cove. Bedrock outcrops are evident in the upper hillsides of Slope 16 and the bedrock has a tendency to weather to dense, non-plastic sand to sandy gravel consistency. Some scaling may be required along the ridgeline of the slope where the outcrops and residual knobs and boulders can present isolated rockfall issues. Vegetation is fairly well established along the slope face adding to its stability and aesthetics. Recommendations are presented to address surface erosion.

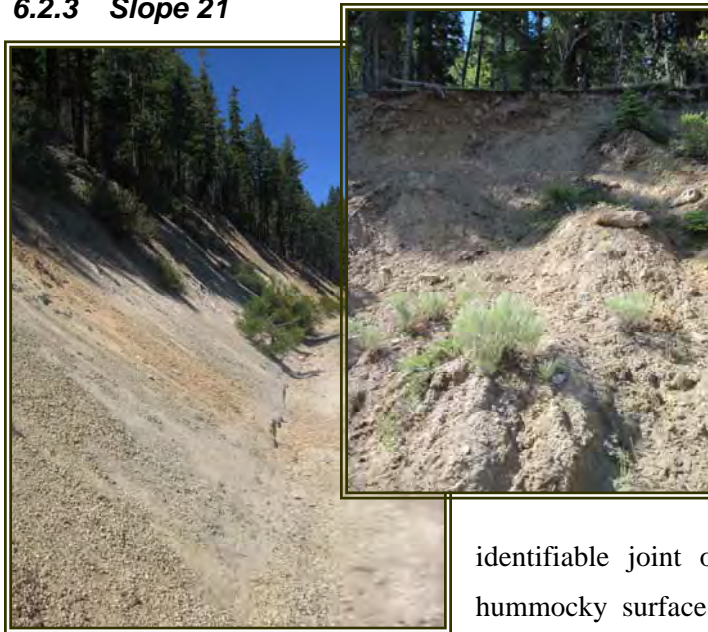
**Figure 9** – Slope 21

Slope 21 is a moderately steep slope (~ 1 ¼ :1 (H:V)), and comprised primarily of deeply to moderately weathered rock. However, more competent rock outcroppings are also evident across the slope. The cut slope is approximately 40 feet high at its maximum and generally faces northwest. The rock in this slope is a gray to green metamorphosed tuff that is moderately weathered with very few to no identifiable joint or fracture patterns. As evidenced by the hummocky surface indicated in the insert, isolated small slope failures have occurred in the western portion of the slope. These failures appear to be induced by springs, and are likely triggered as surface runoff and snowmelt increase in late spring and early summer. Recommendations are presented to address surface erosion and protection of the slope surface particularly where isolated surface failures have led to development of a cornice which accelerates weathering along the crest where head cutting is evident.

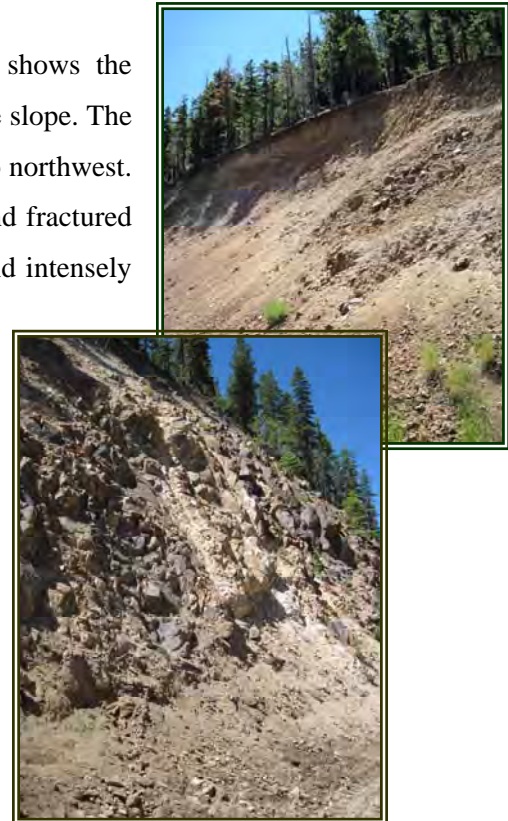
**Figure 11** – Slope 27

Slope 27 is a relatively steep rock/soil slope. Figure 11 shows the variability in material quality and physical properties along the slope. The slope approaches 50 feet in height and generally faces north to northwest. The host rock is deeply weathered, altered, heavily jointed and fractured biotite monzogranite presenting strong competent outcrops and intensely weathered and decomposed soil slopes. Previous work indicates that the more competent rock associated with Slope 27 exhibits planar and wedge failures in conjunction with some toppling failures. A spring is also present within the northern portion of the slope. Of the slopes under current consideration, Slope 27 presents the most significant and difficult profile to address. Recommendations are presented herein to address the continued weathering and erosion at the crest and further encroachment upon the right-of-way boundary. Rockfall potential associated with the steeper outcrops and proposed mitigation measures are addressed in the McMillen report presented in Appendix E.

Two approaches are recommended to address the significant variations in slope conditions evident along 27. A Vegetated Reinforced Soil Slope (VRSS) is recommended for the western and eastern ends of the slope, along with a rockfall netting/drape system for the central portion. Ultimately the planned improvements must stabilize the existing slope surface, establish acceptable design grades, and meet NDOT's vegetation goals.

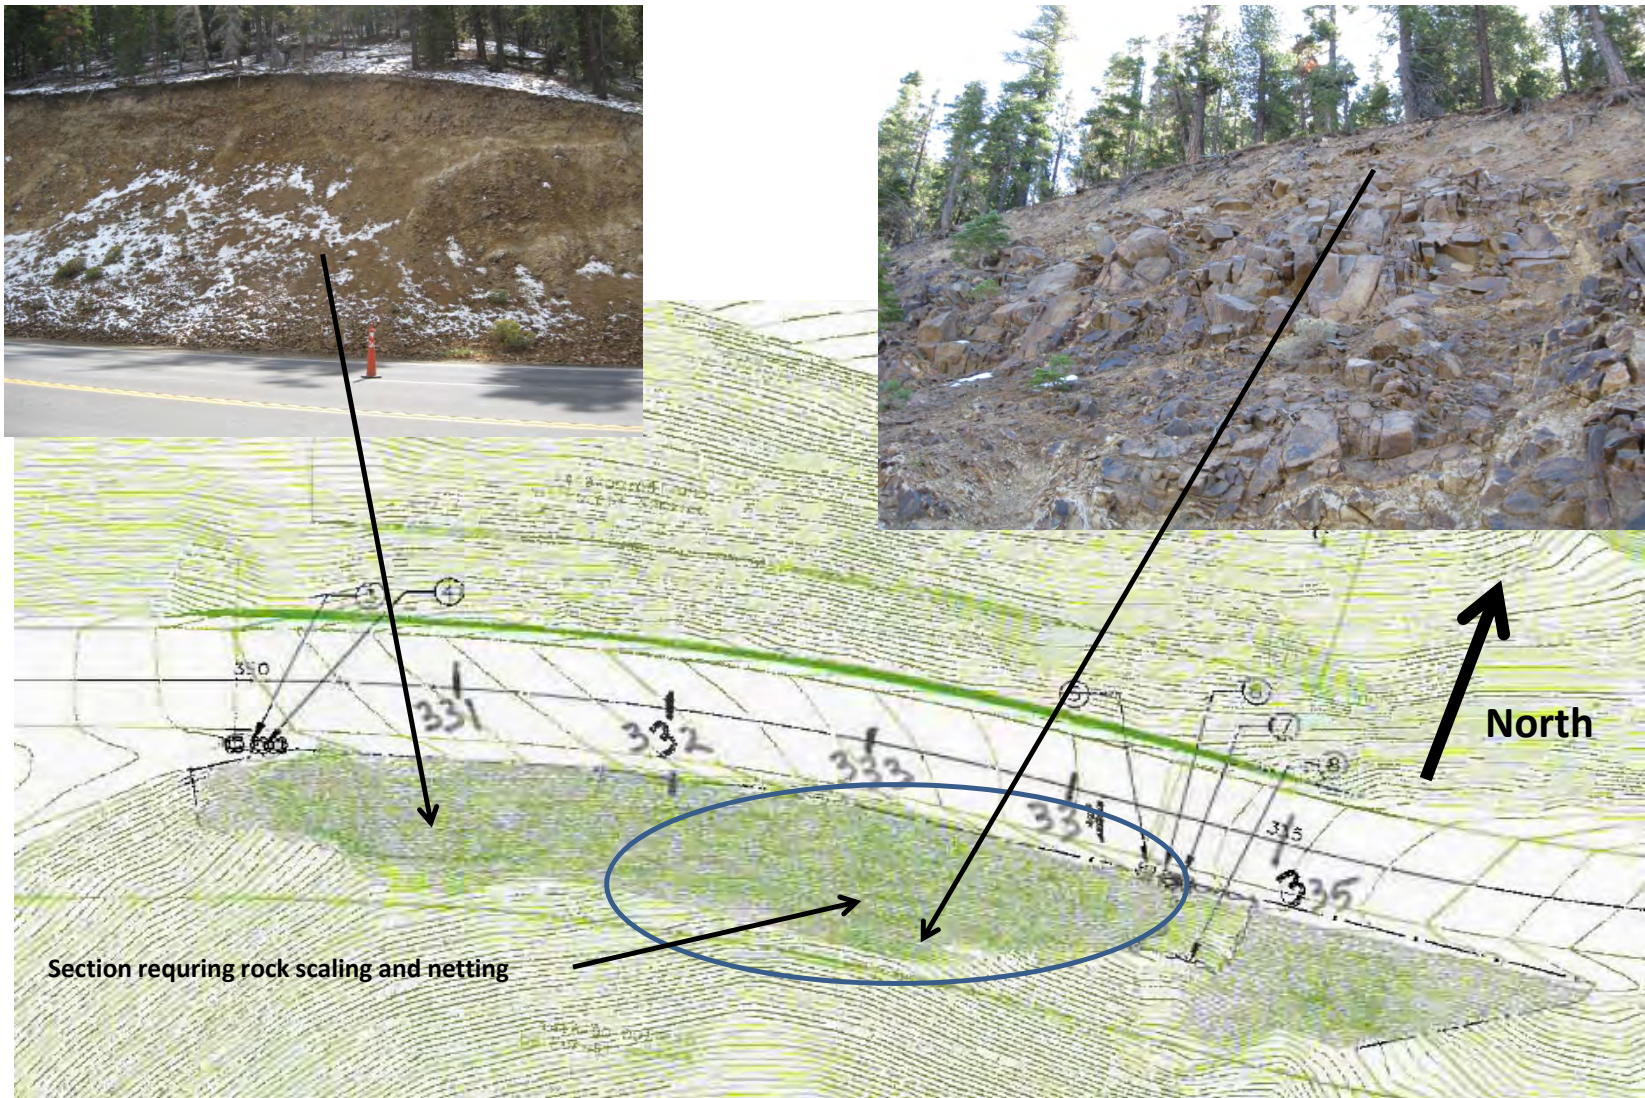
**Figure 6 - Slope 27 Zone requiring rock scaling and netting**

Based on Figure 6, a conservative estimate of loose rock that can be removed in the area by scaling is approximately 650 to 1,000 cubic yards (see calculation on Figure 6). The

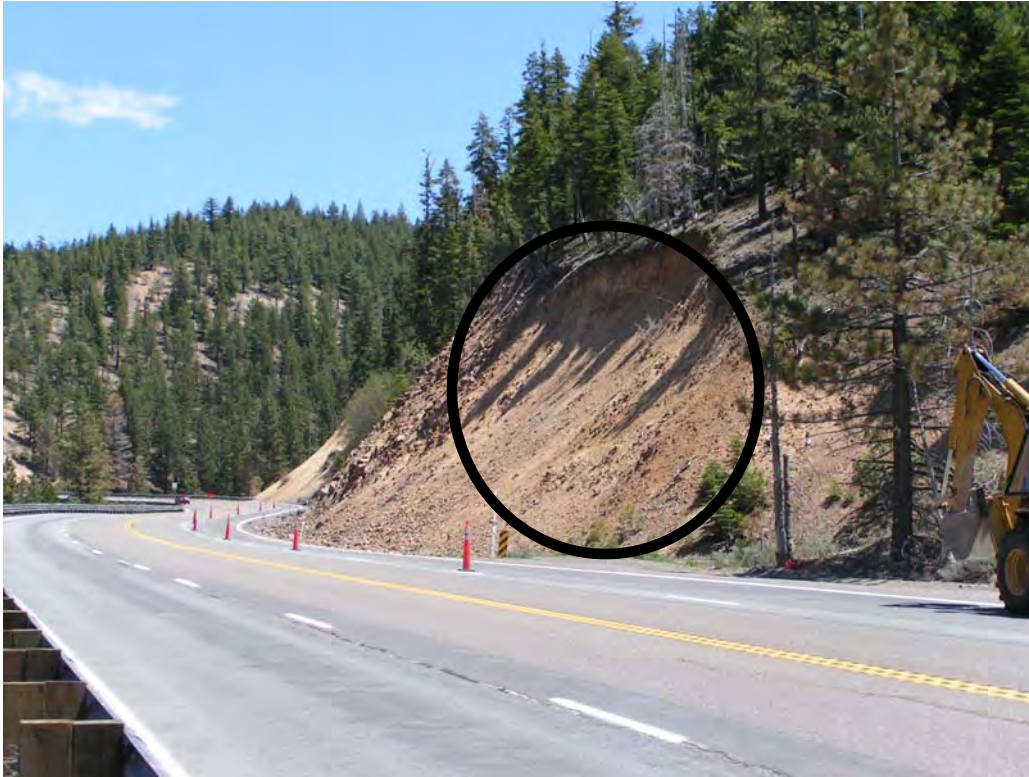
Slope 27 looking east along Hwy 50 – circled area exhibits slide failures

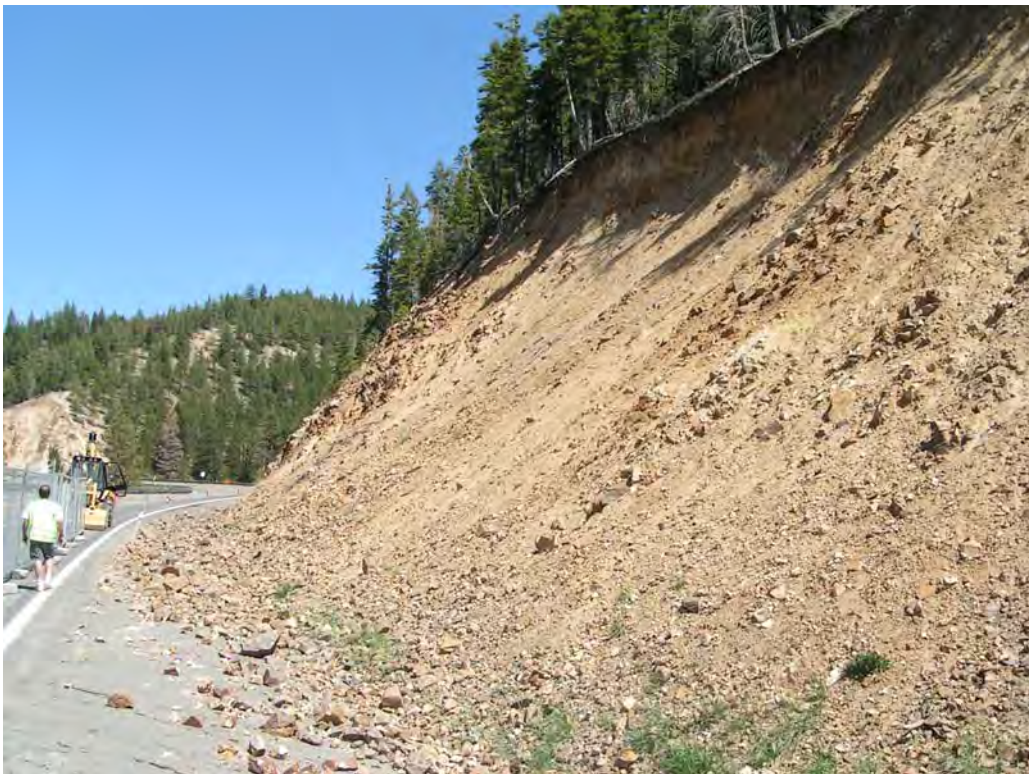
Debris along the toe of Slope 27

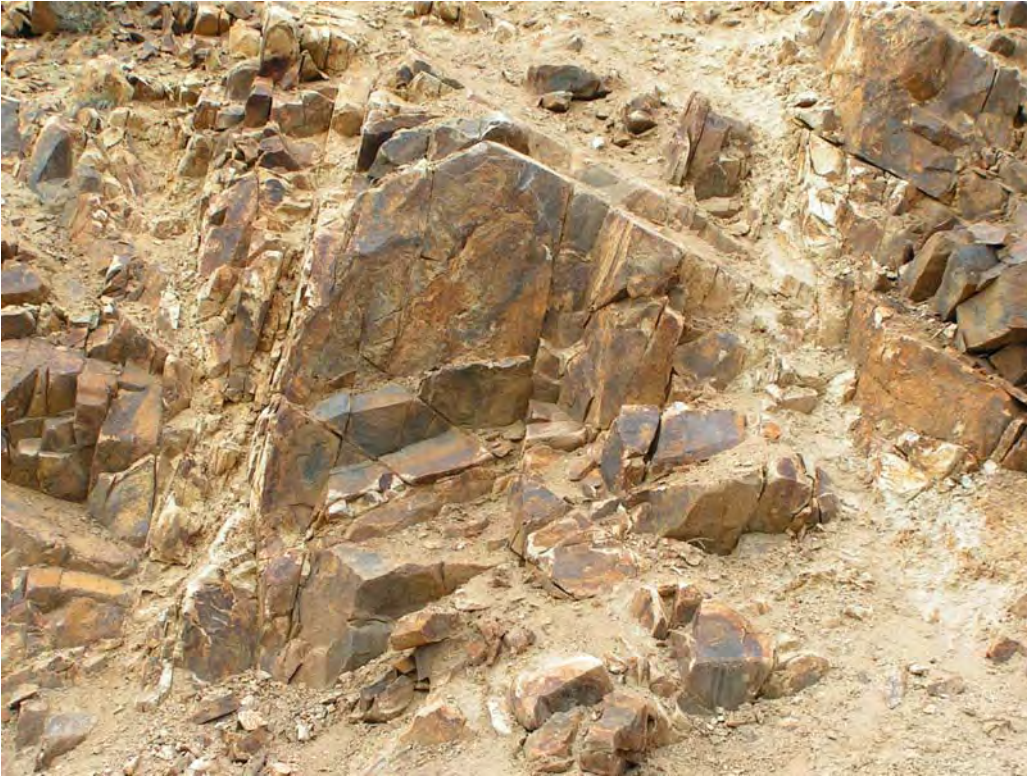
Slope 27 exhibits wedge, sliding and topple failure fracture sequences

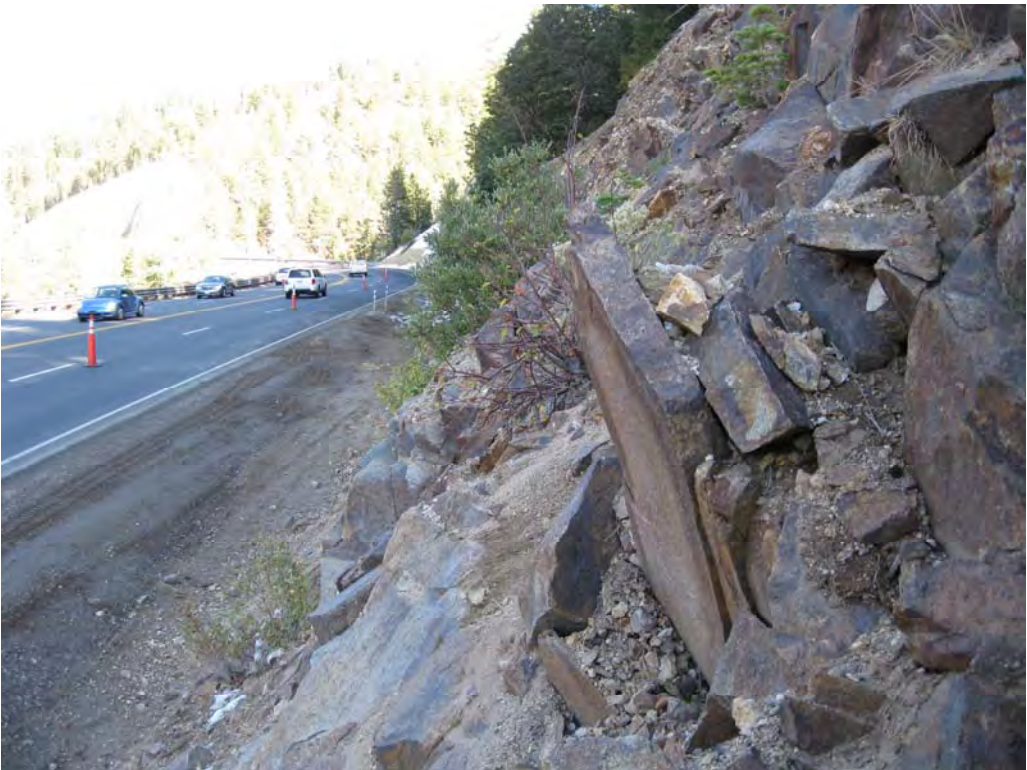
Example of toppling failure in Slope 27

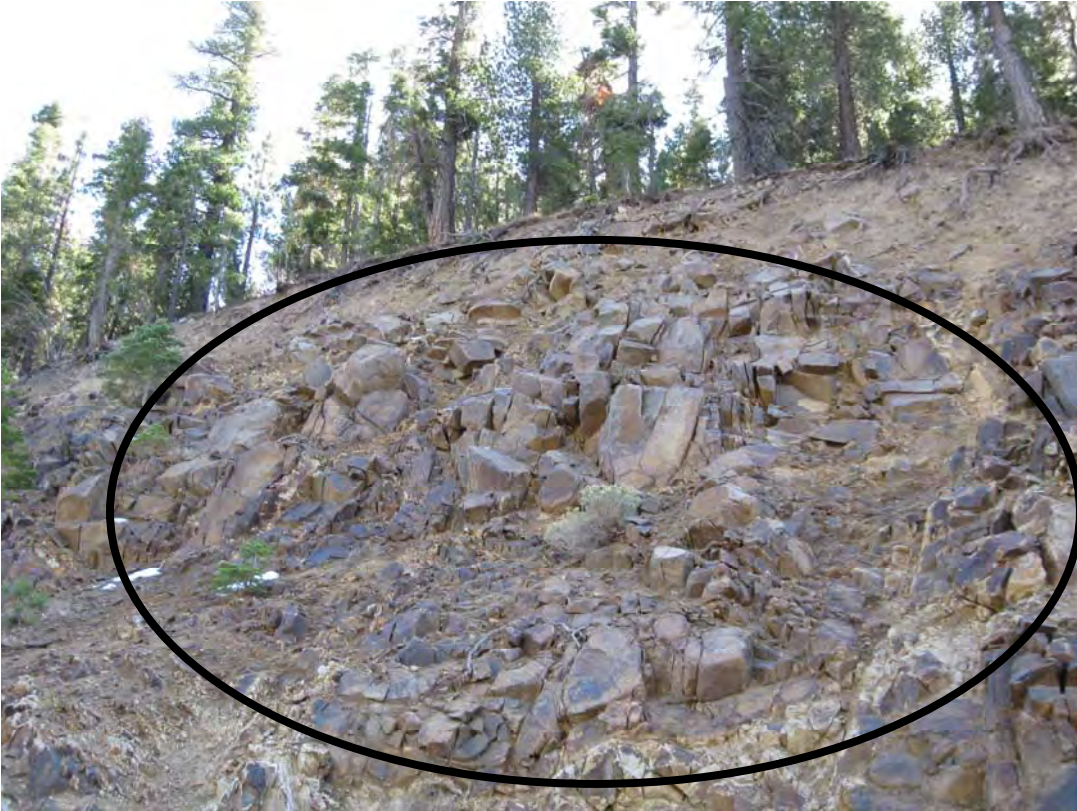
Rock will be required to be scaled from portions of Slope 27

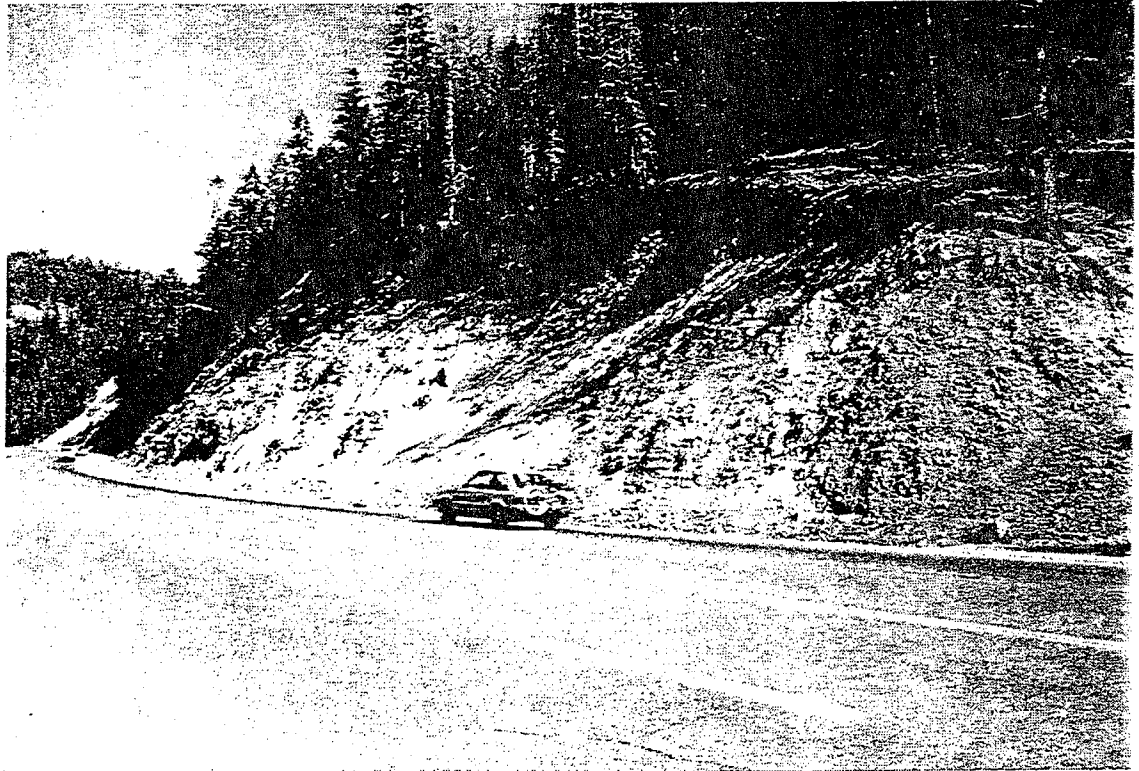
## SLOPE 27

Slope 27 is a 70 ft. high, north facing slope composed of moderately to highly weathered monzogranite and altered trachyte. The ditch is well shaped and 14 ft. wide, and is consistently filled with rock debris. Historical evaluation indicates that large quantities of small sized rockfall debris frequently reach the roadway. In 1984 an automobile suffered minor damage in an accident resulting from rocks on the roadway.
