**Geotechnical Engineering Design Report
I-80 Bridge and Tunnel Rehabilitation –
Scope B
Rock Stabilization Analysis
Elko County, Nevada**

October 5, 2012
Kleinfelder Project No. 124637

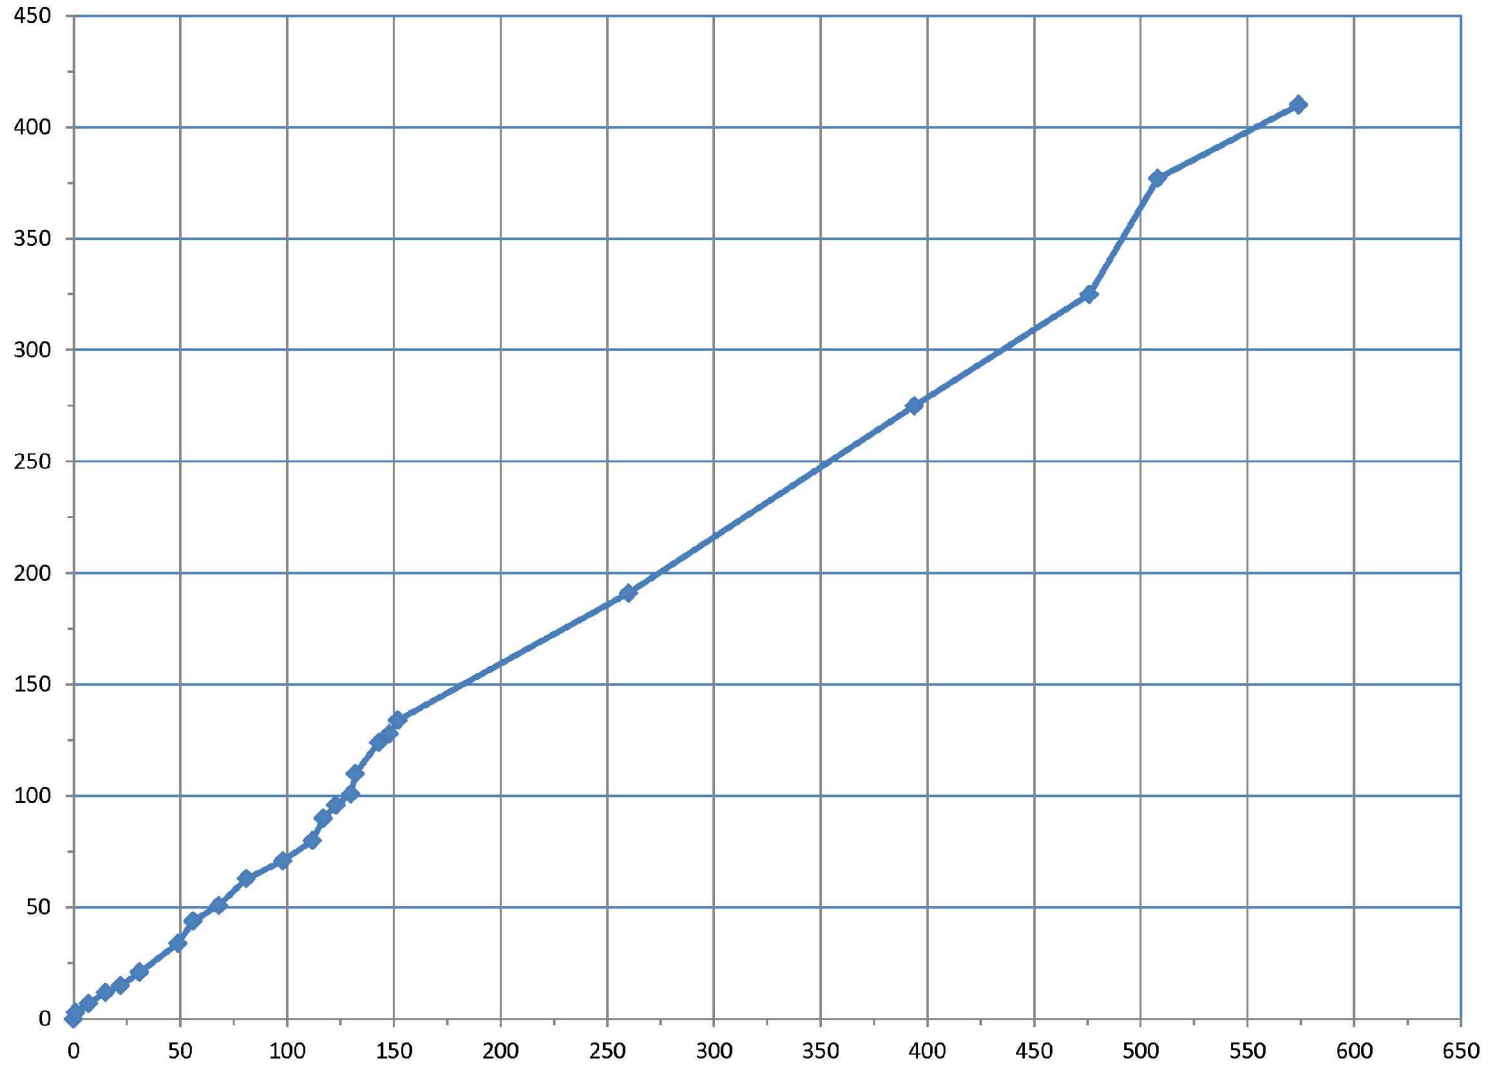
West End Portal Slope - Profile 1

For the West End Slope Profile 1, we completed multiple analyses in the talus/colluvium to assess sensitivity to phi angle and cohesion on the calculated factor of safety. The existing slope is composed of talus that was eroded from the partially cemented colluvium higher in the slope. The talus slope ranges in inclination from 35 to 40 degrees. As shown by the results in Table 2, the safety factors for the range of material properties evaluated are approaching or below 1.0 for static conditions. The failure surfaces predicted by the models are shallow failures (erosion, sloughing, raveling), which are consistent with field observations and the information regarding sediment accumulation and maintenance provided by the NDOT worker. We did not observe signs of potential deeper, large failures in the talus/colluvial materials. We expect shallow surficial sloughing, raveling and erosion to continue on this slope. NDOT Maintenance annually cleans up material from this section of the slope and has built a berm at the toe of the slope to contain the eroding material.

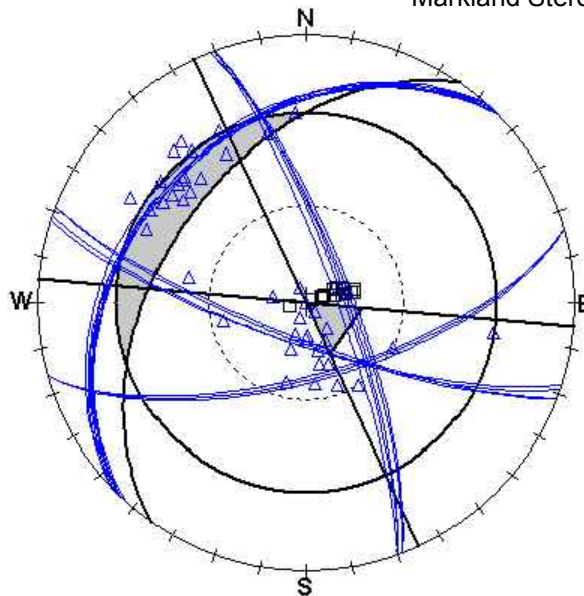
Markland Stereonet Analysis

The lower portion of Figure 13 displays the Markland Analysis completed for the existing west end cut slope. We estimated a dip direction of 305 degrees and a dip angle of 45 degrees (1H:1V) for the existing cut slope above the portal. Based on the data collected, the Markland Analysis indicates the potential for a planar-type failure from the cut slope at an inclination dipping out of slope at about 33 degrees. Additionally, there is a low potential for toppling-type failures from the cut slope. Based on the mapping, the RQD of the cut slope ranged from 0 to 36, indicating intensely to highly fractured

rock mass. We did not observe large scale planar-type failures in the field. The sedimentary rock layers dip steeply to the east or into the slope. However, we did observe small planar fracture faces dipping out of the cut slope. It is our opinion that the potential planar and toppling type failure will result in small-scale rockfall and not large failures. We estimate that these will typically be less than one-foot in diameter and can be controlled by the cut slope catchment area (see Section 3.7).
