NDOT Research Report

Report No. 101-10-803

**Effectiveness of Wildlife Crossing Structures
to Minimize Traffic Collisions with Mule Deer
and Other wildlife in Nevada**

April 2015

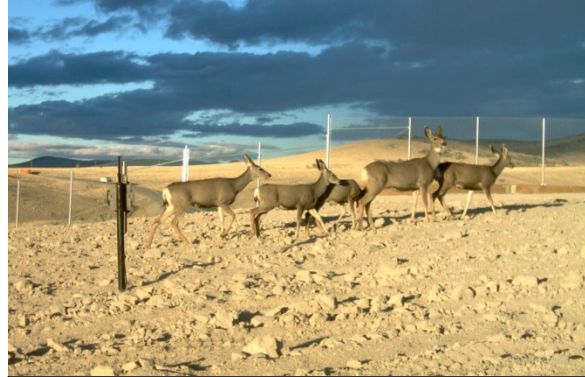
Figure 3. Mule deer on overpass at 10-mile Summit during autumn migration 2010. Note remote camera mounted on t-post in foreground. (Simpson 2012).

(Figure 3). Other mammal species that we observed in photos using the structure included: American badger (*Taxidea taxus*), American pronghorn (*Antilocapra americana*), bobcat (*Lynx rufus*), coyote (*Canis latrans*), North American elk (*Cervus elaphus*), blacktailed jackrabbit (*Lepus californicus*), desert cottontail (*Sylvilagus audubonii*), red fox (*Vulpes vulpes*), domestic cattle (*Bos taurus*), domestic horses (*Equus caballus*), dogs (*Canis sp.*), and cats (*Felis sp.*).

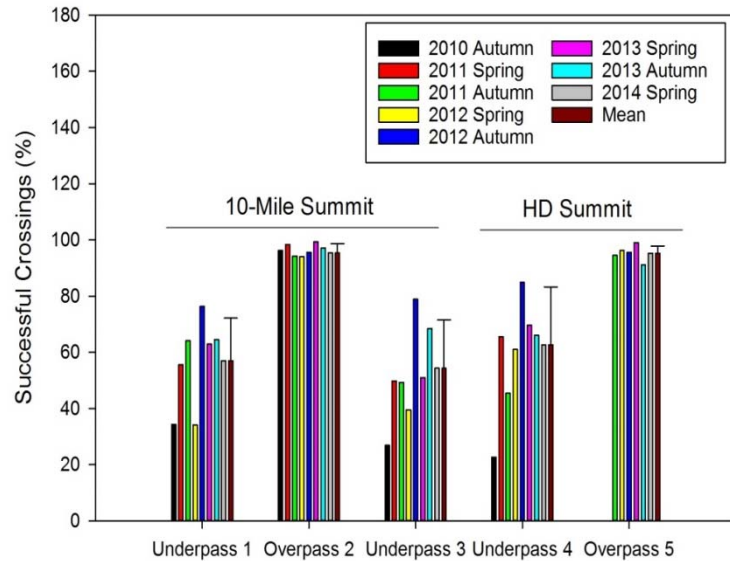
Figure 4. Percentage of successful crossings during migratory periods by mule deer on Highway 93 between Wells and Contact, Nevada, 2010-2014. Each crossing structure has a unique identifier (Structure #) consistent with Fig 2. Final bar in each group is mean ± SD of deer that used that structure during migrations (Simpson 2012).

30,259 mule deer used a crossing structure at 10 Mile Summit and 5,110 mule deer used the crossing structures at HD Summit (Table 4). During autumn 2011 through spring 2014 migrations when both sites were available for use, 85.6% of the mule deer population that used a structure crossed at 10 Mile Summit and 14.4% crossed at HD Summit (Table 4). Throughout the duration of the study the percentage of approaches that resulted in successful crossings was highest at the overpasses compared with the underpasses (Figure 4). We observed a high percentage (> 94%) of successful crossings at the overpasses the first migration they were open for use, and their success rate remained high (>94%) throughout the duration of the study (Figure 4). The percentage of successful crossings at the underpasses was low the first year they were available and increased with each subsequent migration or maintained the same level as the previous migration, with the exception of the underpasses at 10 Mile Summit where we detected a decrease in the percentage of successful crossings during the fourth migration (Figure 4).

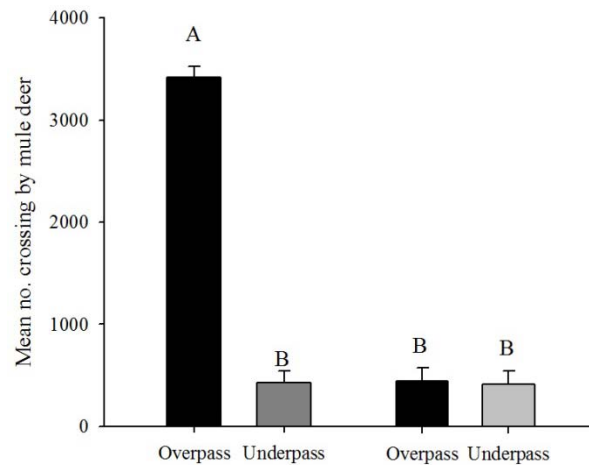
Figure 5. Least squared mean \pm SE number of mule deer that crossed each structure. We observed an interaction between study site and structure (*Wald Chi Square*=907.92, $P < 0.0001$) at 10-Mile and HD Summits, Nevada, 2011-2014. Similar letters indicate means that were not significantly different.(Simpson 2012)

Overall the majority of mule deer crossed the overpass at 10-Mile, which differed from all of the other structures and locations (Figure 5). Although season entered our models and a trend indicated more mule deer used the structures during autumn than spring (*Wald Chi Square* = 298.37, $P < 0.0598$); those confidence intervals included 0. We observed an interaction between study site and structure (*Wald Chi Square* = 907.92, $P < 0.0001$), because we observed greater number of crossings at the overpass at 10 Mile Summit but no differences between the structures at HD Summit (Figure 5).

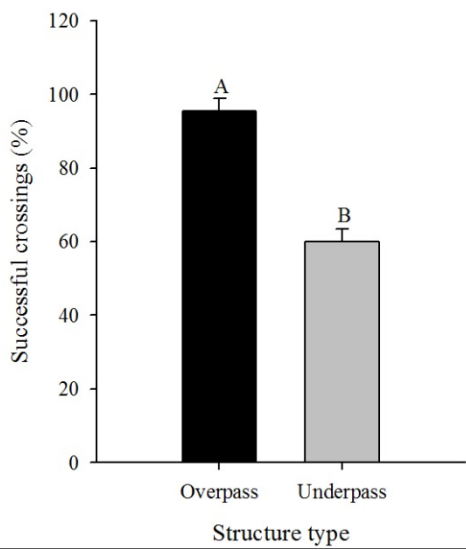
Figure 6. Least squared mean \pm SE percent of approaches by mule deer that successfully crossed overpasses versus underpasses (*Wald Chi Square*= 72.25, $P < 0.0001$) at 10-Mile and HD Summits on Highway 93 between Wells and Contact, Nevada, 2011-2014. (Simpson 2012)

Our top model for the proportion of successful crossings by mule deer only included year and structure type. We observed a higher percentage of successful crossings by mule deer at the overpasses when compared with the underpasses (*Wald Chi Square* = 72.25, $P < 0.0001$; Figure 6). At HD Summit, when both types of structures were available to mule deer, approximately 44.2% of the successful crossings occurred at the overpass and 55.8% occurred at the underpass (Figure 6).

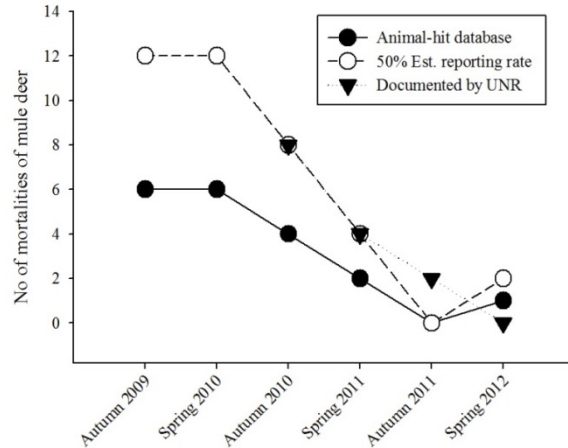
Figure 7. Documented and estimated mortalities of mule deer caused by vehicle collisions within the boundaries of the 10 Mile study site on U.S. Highway 93 between Wells and Contact, Nevada, 2010-2012. We documented 50% more mortalities than the numbers reported in the Animal-Hit Database maintained by NDOT during the first three migrations the crossings were available for use by mule deer and other wildlife. (Simpson 2012)

We observed a decrease in the number of mortalities of mule deer caused by collisions with vehicles within the boundaries of our study site at 10 Mile Summit. We documented a 50% decrease in mortalities with each subsequent migration that the safety crossings were available for use, even though the total number of deer using the structures continued to increase throughout the study. Although we did not have intensive monitoring of the study site prior to construction of the safety crossings and exclusionary fencing, we detected 50% more mortalities than what were reported in the Animal-Hit Database maintained by NDOT. All of the reported mortalities in the database within the study boundary occurred in the same vicinity of our marked locations, and we detected 50% more than the state reports. Collisions between vehicles and wildlife often are not reported (Sawyer et al. 2012), but we are confident, that we detected the majority of the mortalities caused by collisions with vehicles in our study area. With this decrease in the number of mortalities from vehicle collisions with subsequent migrations, the cost of the construction should be recuperated with time, because of the decrease in infrastructure damage, and importantly decrease in human injuries or potential fatalities (McCollister and Van Manen 2010).
