**GEOTECHNICAL REPORT  
WELLS TRUCK CLIMBING LANE**

**ELKO COUNTY**

**August 23, 2018**

**EA 73793**

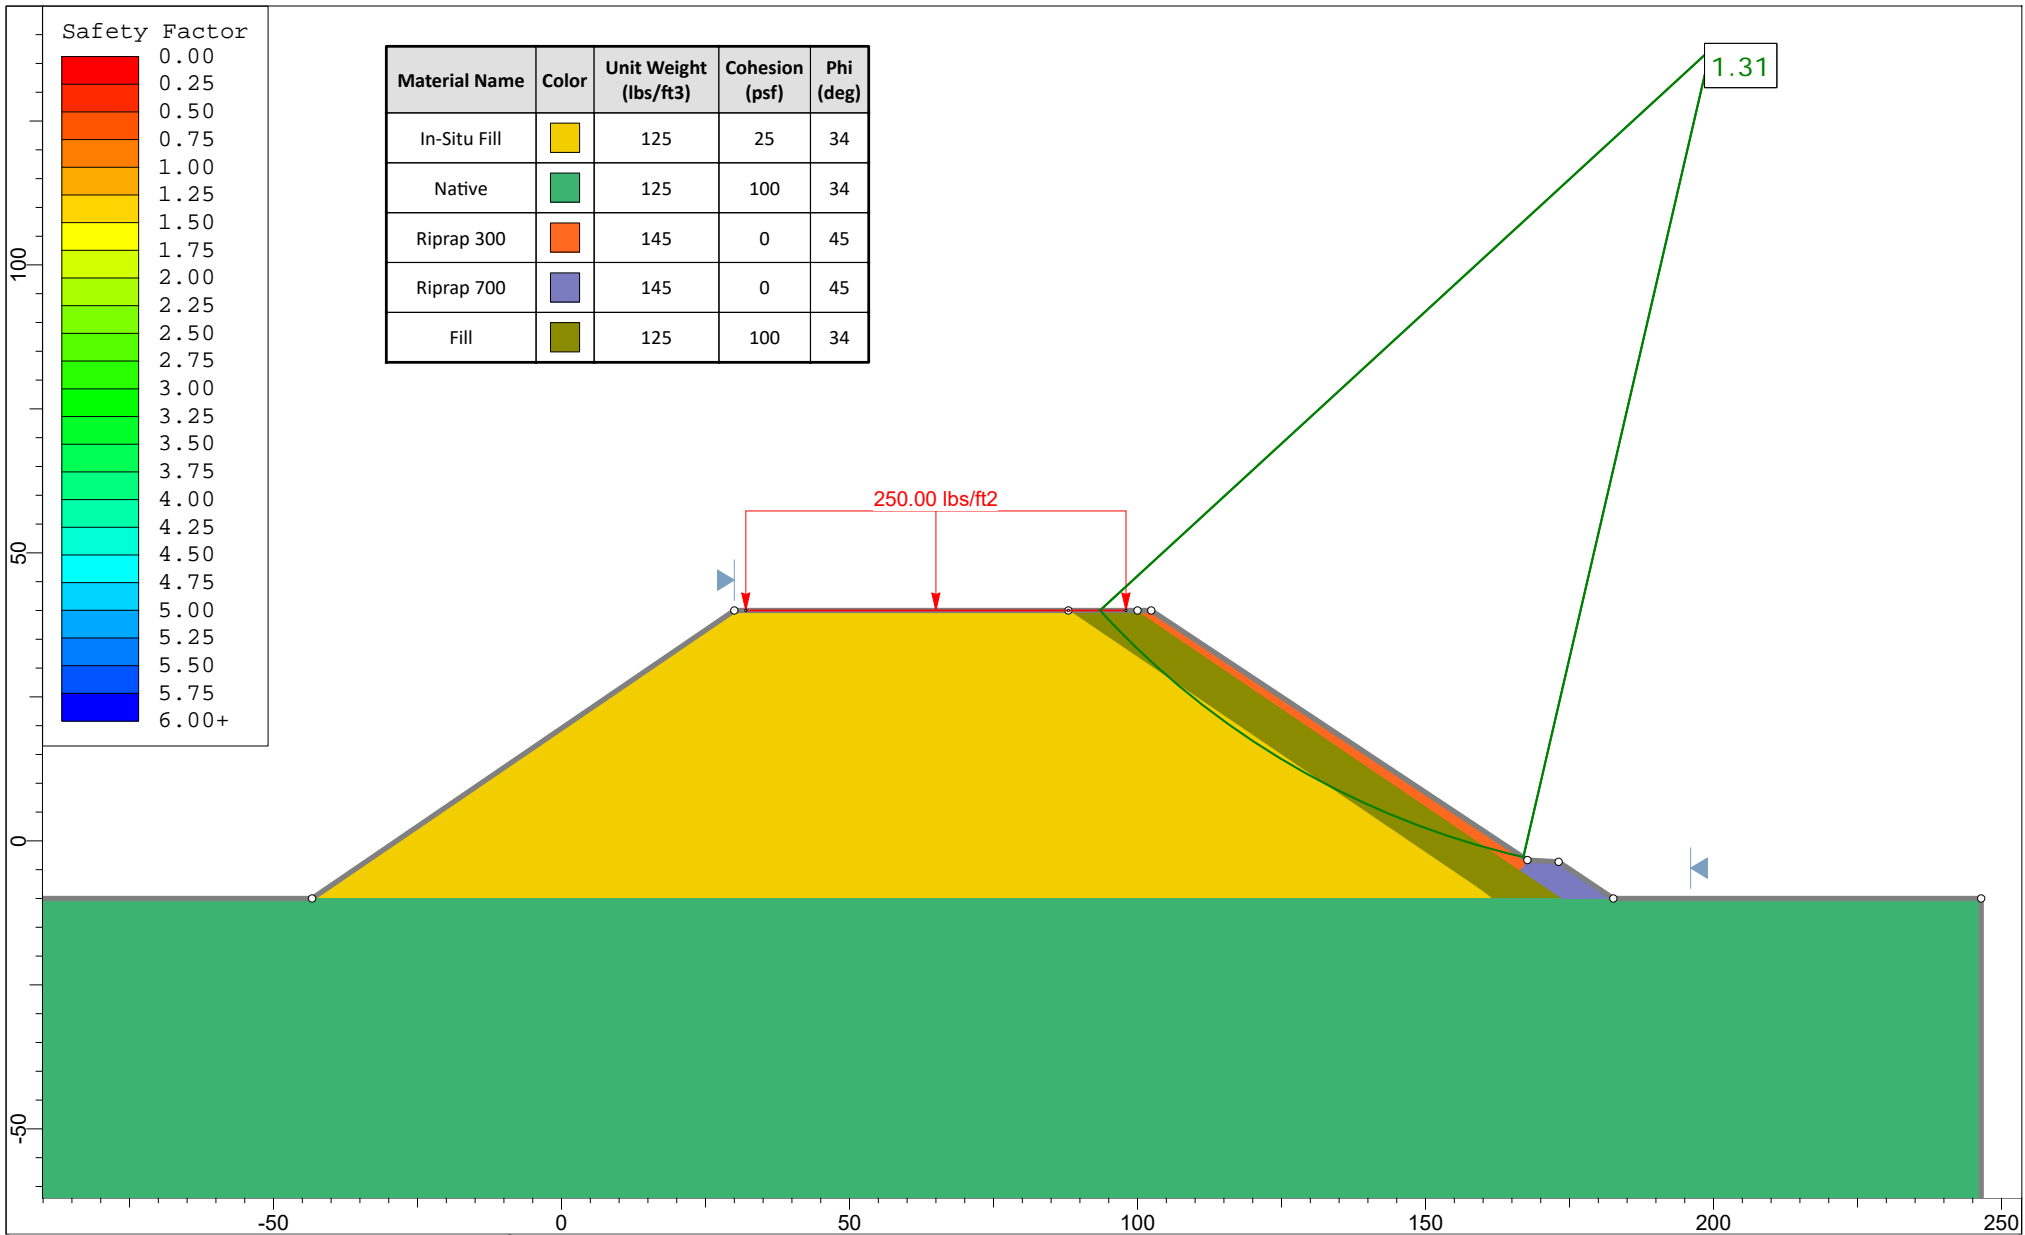
Material Name	Color	Unit Weight (lbs/ft3)	Cohesion (psf)	Phi (deg)
In-Situ Fill	Yellow	125	25	34
Native	Green	125	100	34
Riprap 300	Orange	145	0	45
Riprap 700	Purple	145	0	45
Fill	Olive	125	100	34

<i>Project</i> Wells Truck Climbing Lane EA# 73793		
	<i>Analysis Description</i> Static Analysis of 1.5:1 Embankment Fill Slope: Station "PEC" 664+00 to "PEC" 703+00		
	<i>Drawn By</i> S. Jensen	<i>Scale</i> 1:400	<i>Company</i> NDOT
	<i>Date</i> 6/11/2018, 2:07:58 PM		<i>File Name</i> EmbankmentFill_1.5to1_Static.slim

Two embankment fill slope configurations have been modeled. The first incorporates a 2:1 slope, and the second incorporates a 1.5:1 slope with the slope protection consisting of a Class 700 riprap surfacing along the bottom nine feet of slope (measured parallel to the slope) and Class 300 riprap surfacing along the remaining slope. Material properties of the modeled fill are summarized in Table 1 below.

<b>Global Stability Model</b>	<b>1.5:1 Slope</b>	<b>2:1 Slope</b>
Static Minimum Factor of Safety	1.31	1.58
Pseudo Static Minimum Factor of Safety	1.14	1.33

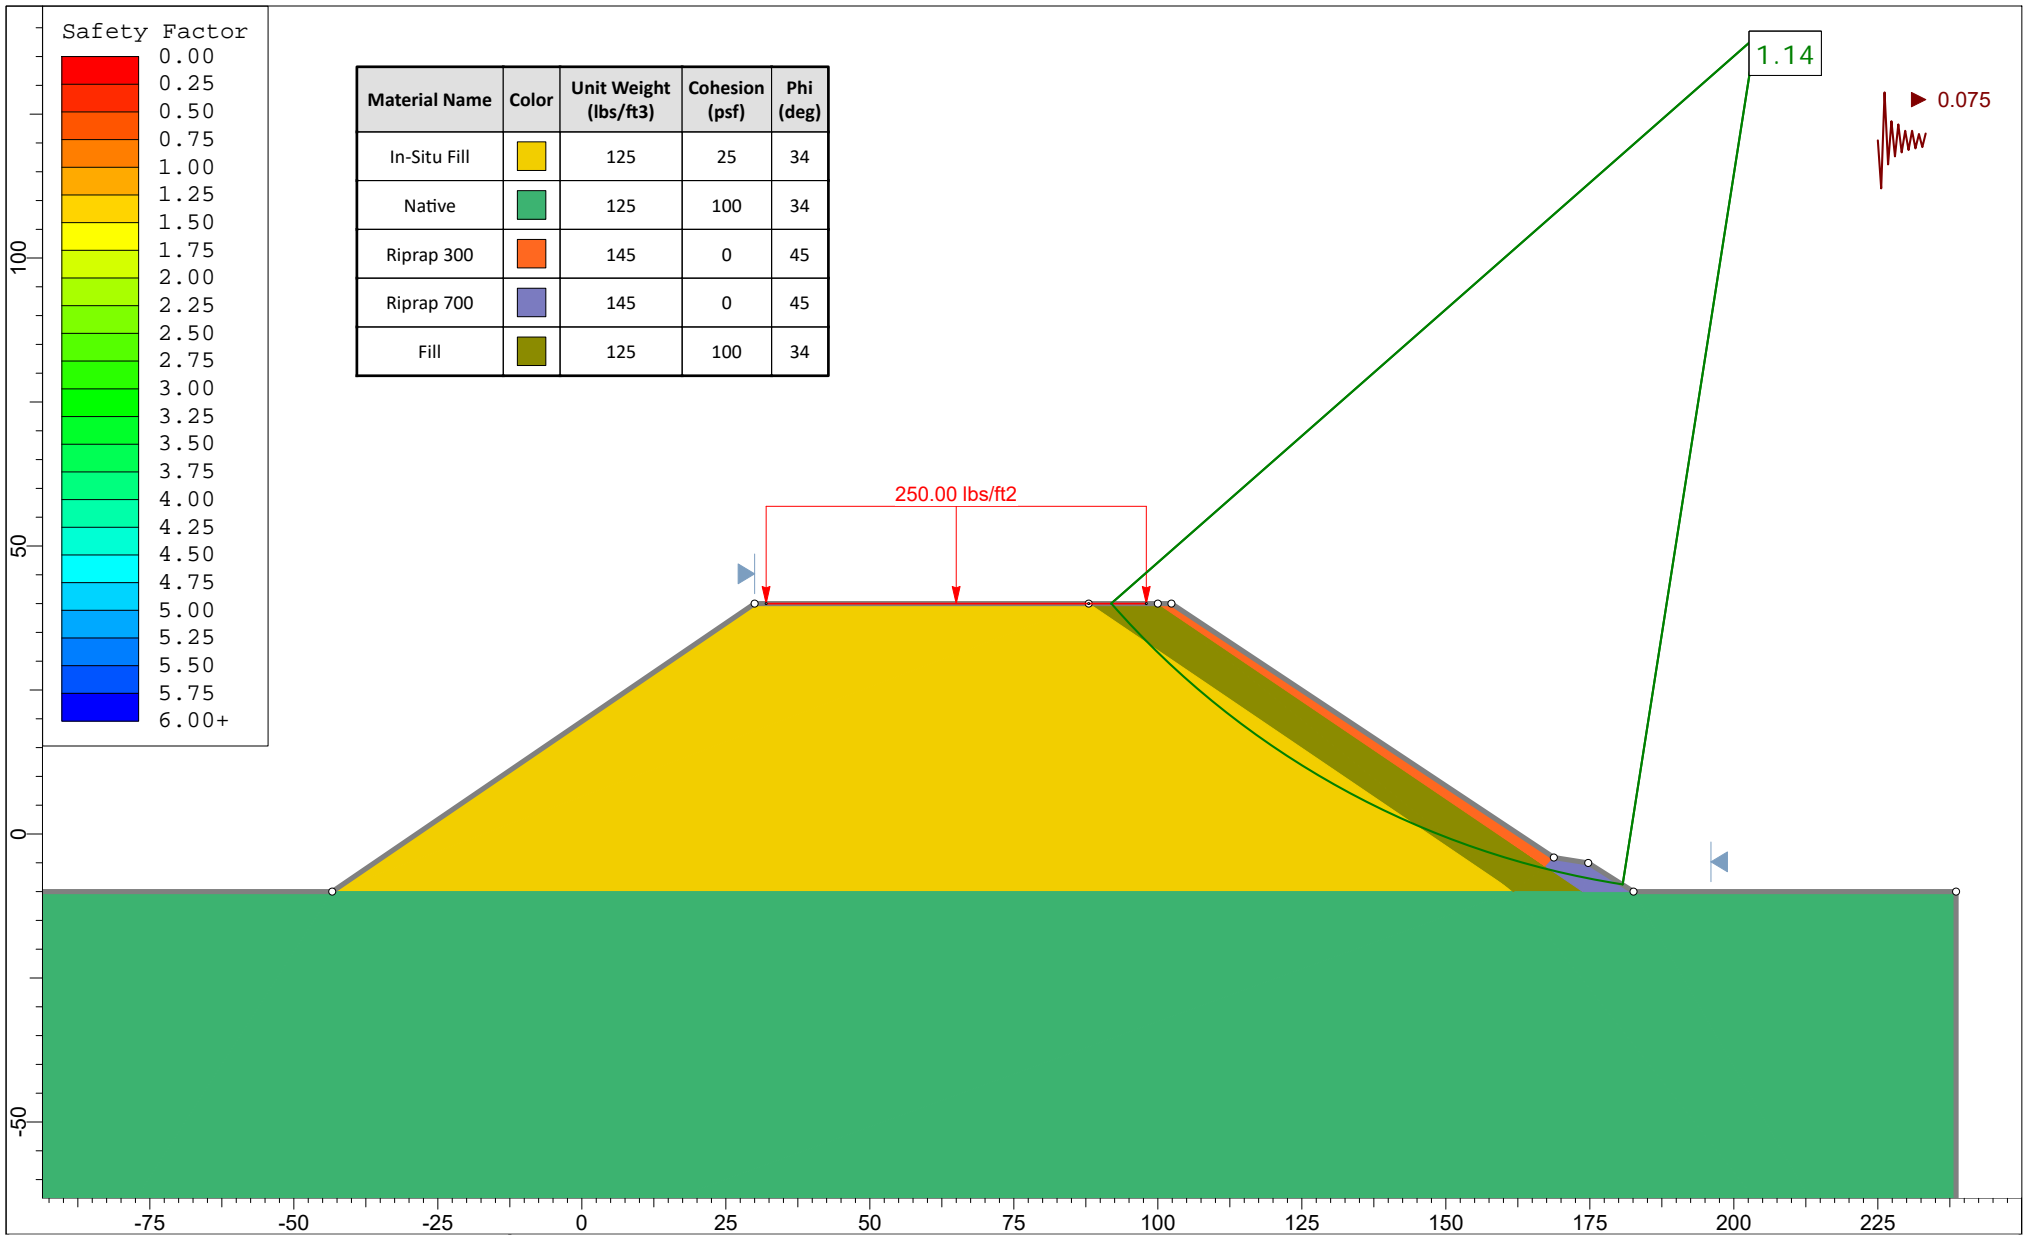
<i>Project</i> Wells Truck Climbing Lane EA# 73793		
	<i>Analysis Description</i> Pseudo Static Analysis of 1.5:1 Embankment Fill Slope: Station "PEC" 664+00 to "PEC" 703+00		
	<i>Drawn By</i> S. Jensen	<i>Scale</i> 1:400	<i>Company</i> NDOT
	<i>Date</i> 6/11/2018, 2:07:58 PM	<i>File Name</i> EmbankmentFill_1.5to1_PseudoStatic.slim

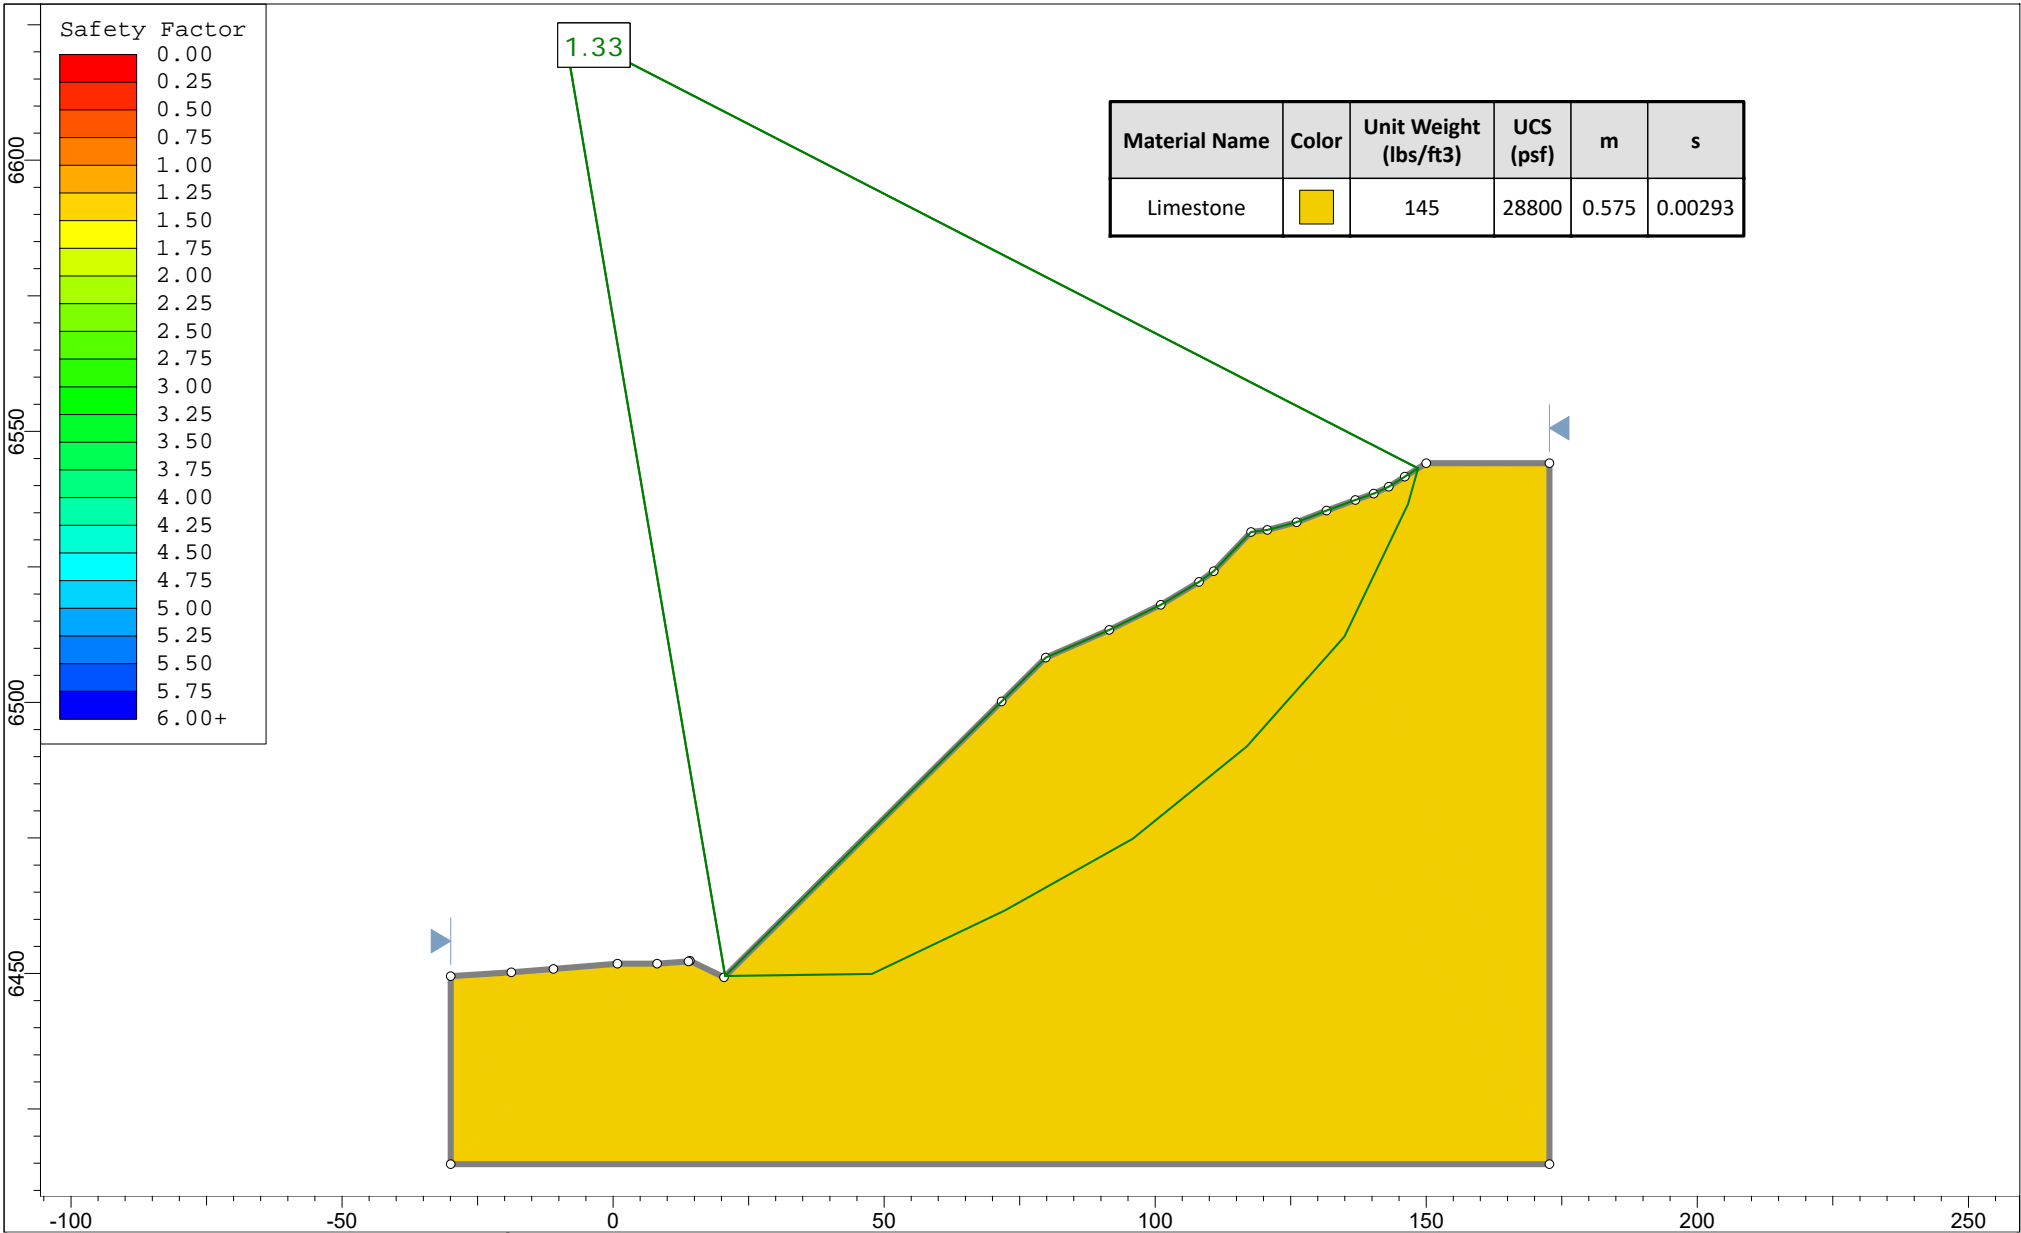
Project				
	Wells Truck Climbing Lane EA# 73793				
	Analysis Description				
	Static Analysis of Cut Slope 1: Station "PEC" 648+00 to "PEC" 654+00				
Drawn By	S. Jensen	Scale	1:425	Company	NDOT
Date	7/11/2018, 3:34:38 PM			File Name	CutSlope1_StaticAnalysis.slim

Global stability analyses of the modeled cut slope were conducted using a path search method for determining non-circular failure surfaces. The modeled cut slope is defined by relatively large vertical relief (60 feet) with undulating natural topography and a drainage ditch at the toe of the slope. This cut slope section is directly impacted by the widening construction and is modeled with a 1:1 inclination.

<b>Global Stability Model</b>	<b>Value</b>
Static Minimum Factor of Safety	1.33
Pseudo Static Minimum Factor of Safety	1.17

The modeled cut slope returned a static and pseudo static Factor of Safety above the suggested minimums (Table 4). Detailed results from these analyses are provided in Appendix C.

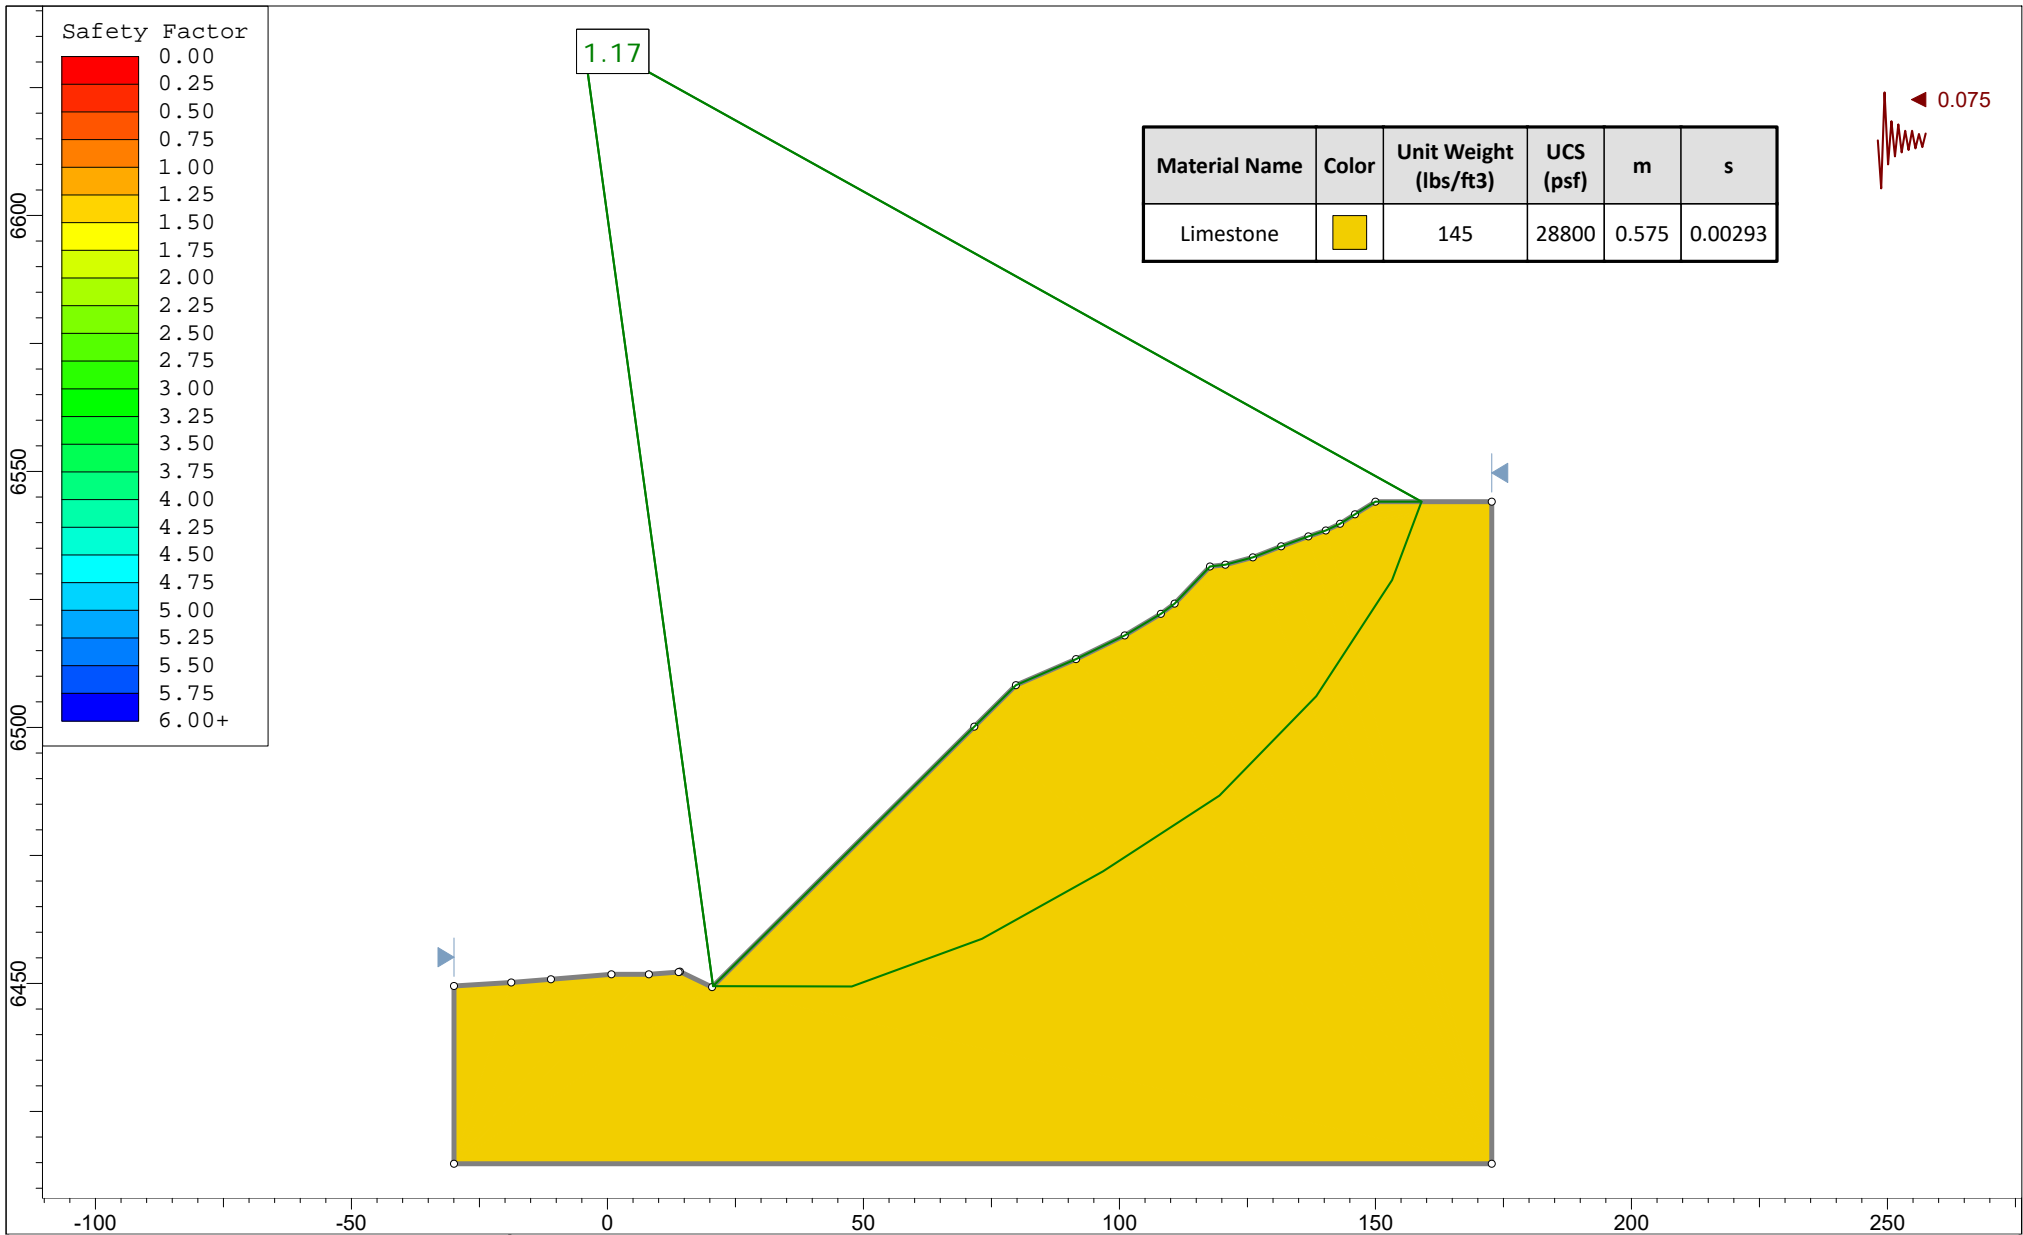
Project			
	Wells Truck Climbing Lane EA# 73793			
	Analysis Description			
	Pseudo Static Analysis of Cut Slope 1: Station "PEC" 648+00 to "PEC" 654+00			
Drawn By	S. Jensen	Scale	1:450	Company
				NDOT
Date	7/11/2018, 3:34:38 PM		File Name	CutSlope1_PseudoStaticAnalysis.slim
