NDOT Research Report

Report No. 342-18-803 TO 1

**DATA COLLECTION AND ANALYSIS OF
CROSSING STRUCTURES ALONG WEST I80
AND USA PARKWAY IN NEVADA**

August 2019

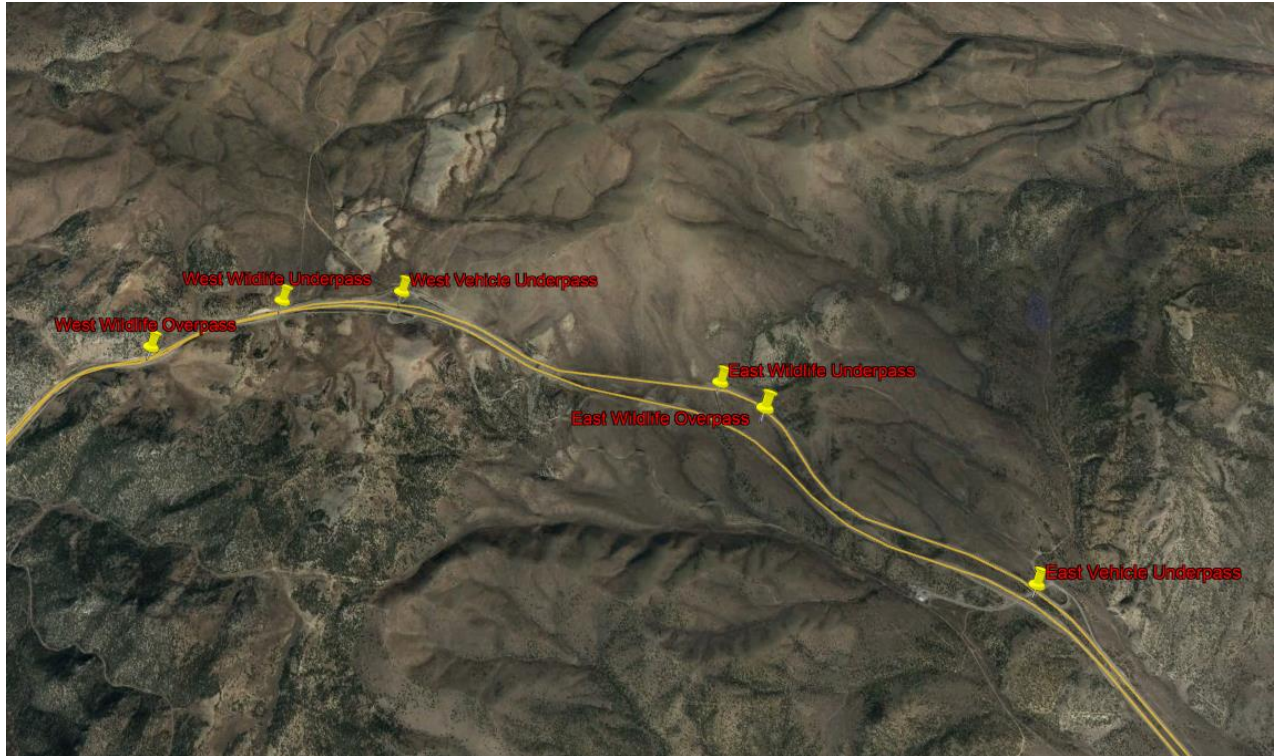
Figure 1-3 I80 crossing structures in the Pequop Mountains

The Nevada Department of Transportation (NDOT) collaborates with the Nevada Department of Wildlife (NDOW) to improve highway safety and wildlife ecology in Nevada, especially in areas where wildlife-vehicle crashes are concentrated. NDOT constructs wildlife fencing and wildlife crossing structures to reduce WVCs. One focal area in Nevada is between Wells and Wendover along I80 in Elko County. Crash data of 2015-2016 shows that Elko has the highest frequency of wildlife-vehicle crashes in Nevada counties, as shown in Figure 1-1. Figure 1-2 shows the highest number of wildlife bodies that were found and removed by NDOT District engineers in Elko. The Pequop Mountains area is problematic with many deer crossing I80 while high-density wild horses live in the USA Parkway area and horses crossing the highway very often. NDOT built two 10' x 10' wildlife underpasses, two vehicle-underpasses and two wildlife-overpasses along I80 in the Pequop Mountains as located in Figure 1-3. And there are two wildlife underpasses in along the USA Parkway as located in Figure 1-4.

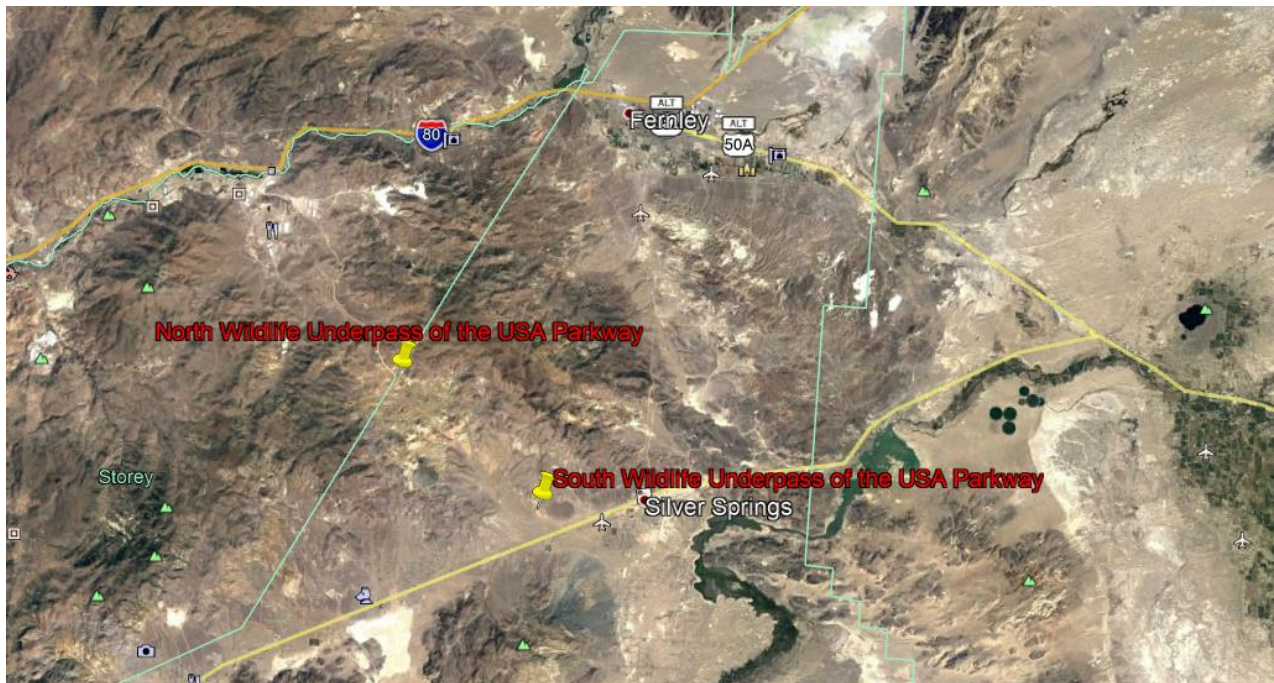
Figure 1-4 USA Parkway crossing structures¹

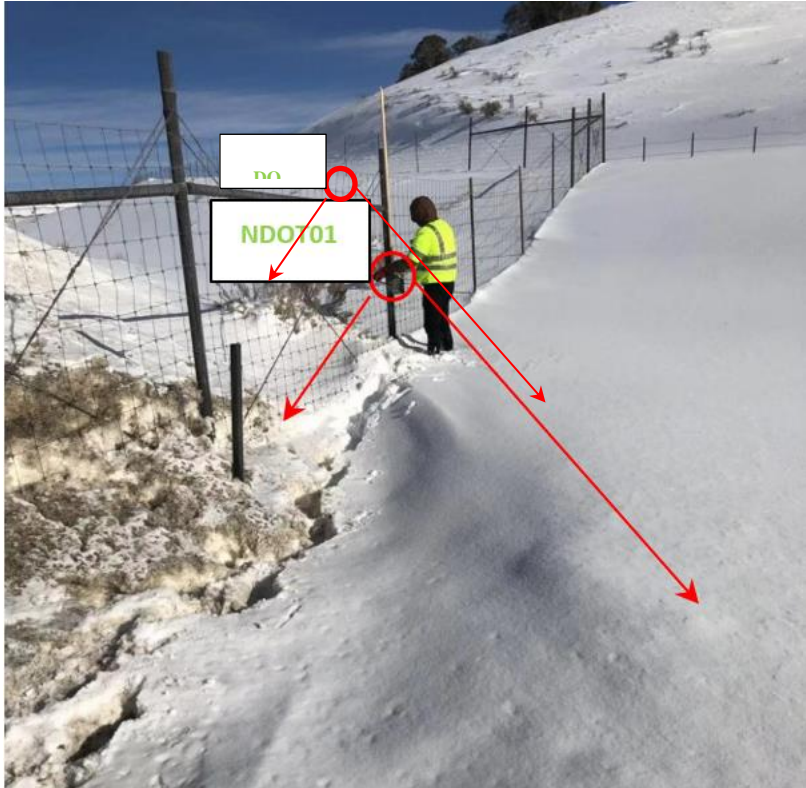
Figure 2-4 Camera location and direction at the south entrance of the west wildlife underpass in the Pequop Mountain (2019 spring)

A 10'x10' wildlife underpass in the Pequop Mountains is to the west of the vehicle underpass at the I80 milepost EL 95.25 (latitude 41.077589° and longitude -114.579315°) as shown in Figure 2-1. The camera labeled as NDOT01 was installed at the north entrance in 2018 fall and moved to the south entrance in 2019 spring. The location and angle of the camera NDOT01 in 2018 fall are shown in Figure 2-1 and Figure 2-2; its location and angle in 2019 spring are demonstrated in Figure 2-3 and Figure 2-4.

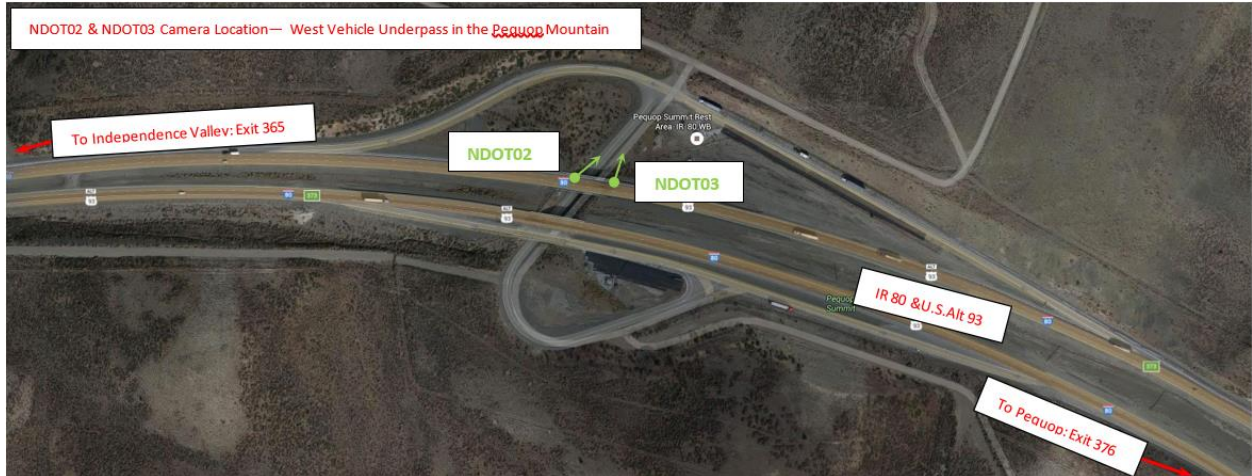
Figure 2-5 Camera layout at the west vehicle underpass in the Pequop Mountain (2018 fall)

entrance in 2019 spring. The locations and angles of the cameras NDOT02 and NDOT03 are shown in Figure 2-5 for 2018 fall, and the two cameras' locations and angles are shown in Figure 2-5 and Figure 2-6 for 2019 spring.; its location and angle in 2019 spring are demonstrated in Figure 2-7 and Figure 2-8.

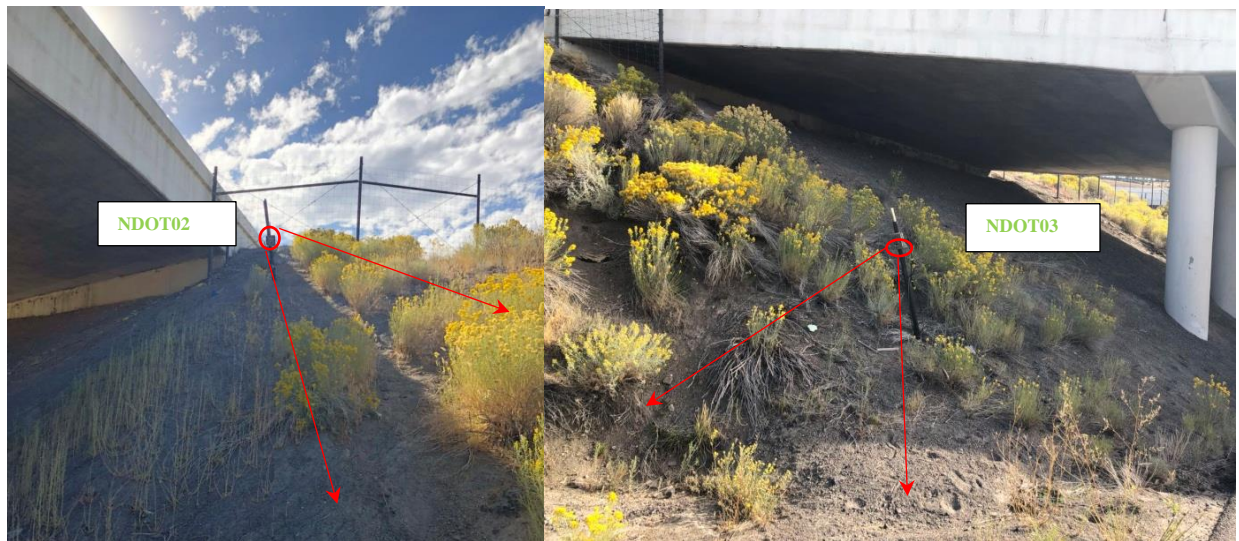
Figure 2-6 Locations and directions of two cameras at the west vehicle underpass in the Pequop Mountain (2019 spring)

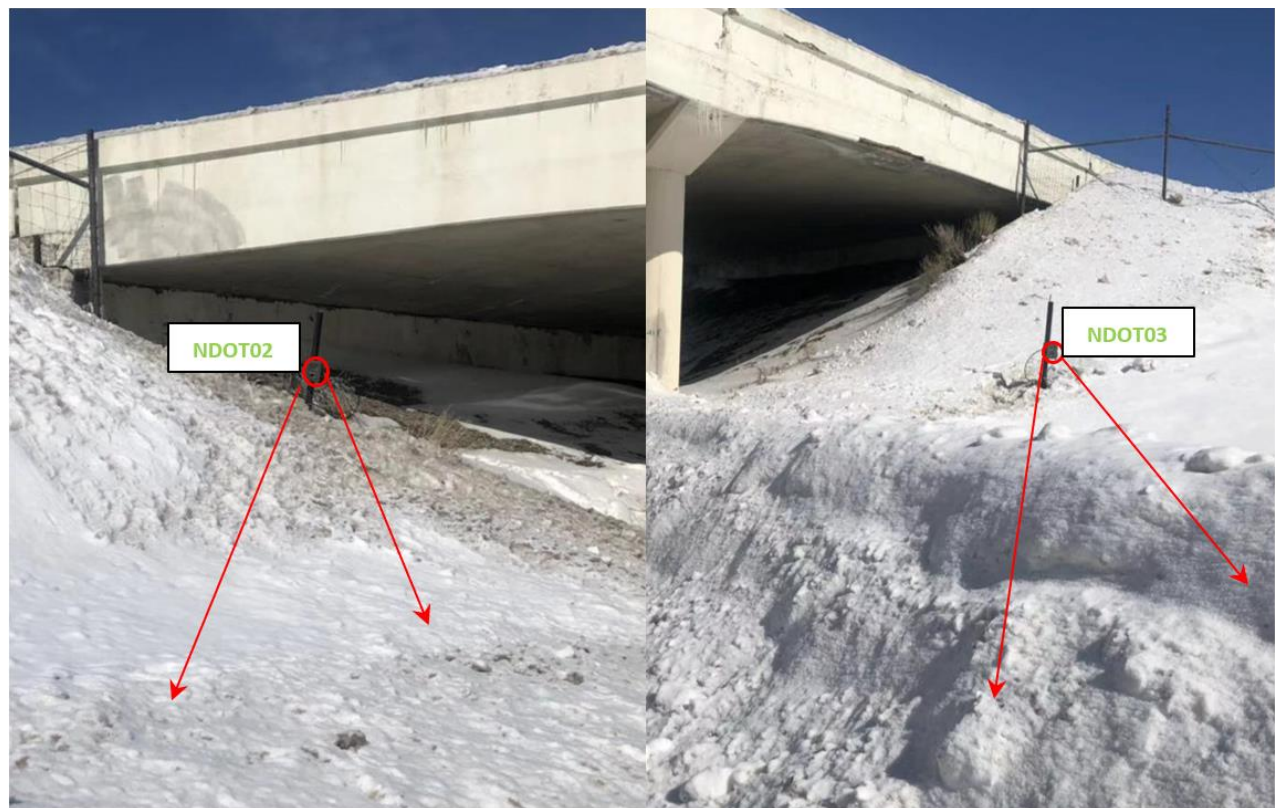
Figure 2-8 Locations and directions of two cameras at the west vehicle underpass in the Pequop Mountain (2019 spring)

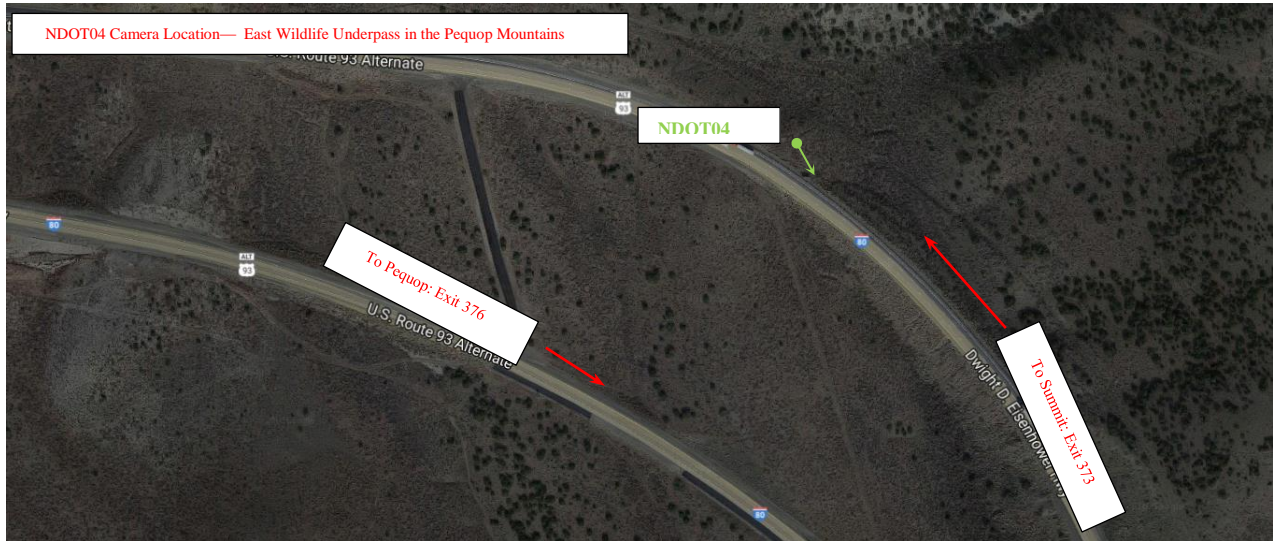
Figure 2-9 Camera layout at the east wildlife underpass in the Pequop Mountains (2018 fall)

installed on a fence pole at the north entrance in 2018 fall, Figure 2-9 and Figure 2-10, and moved to the south entrance in 2019 spring, Figure 2-11 and Figure 2-12.

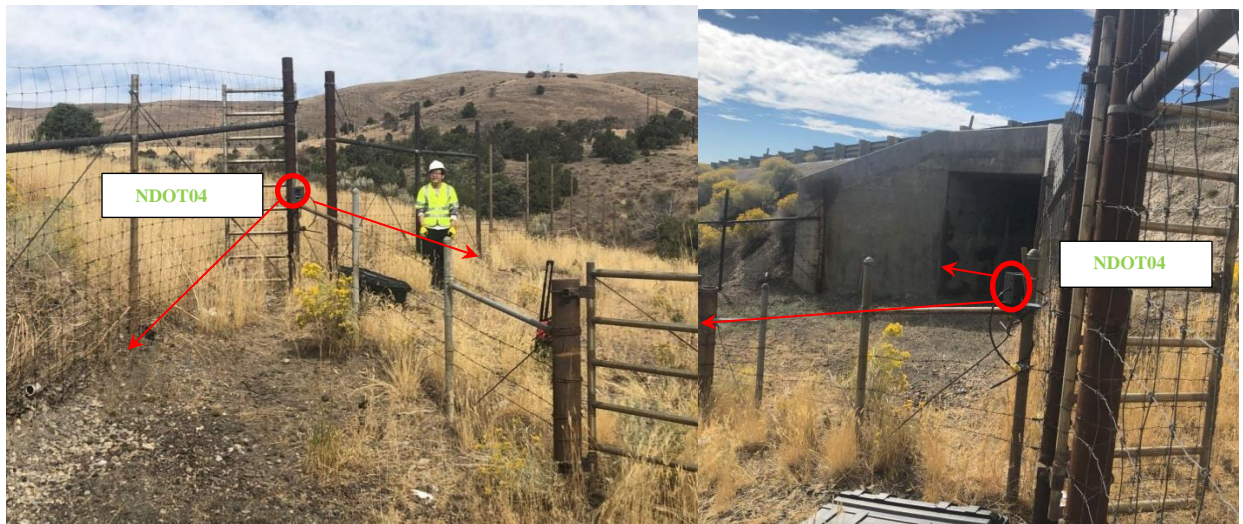
Figure 2-10 Locations and angles of the camera at the east wildlife underpass in the Pequop Mountains (2018 fall)

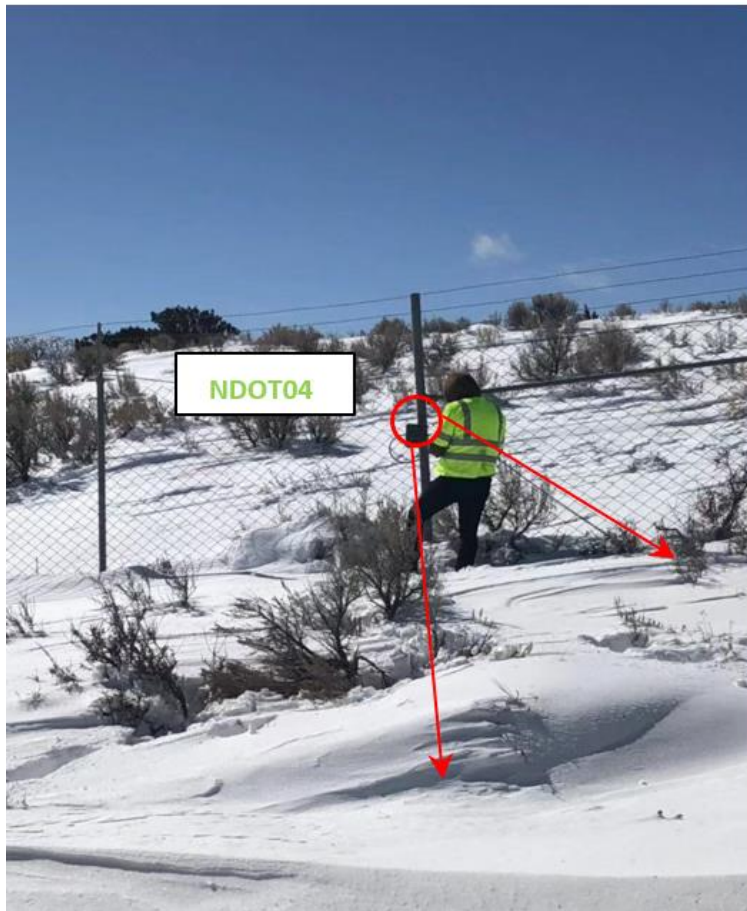
Figure 2-12 Locations and angles of the camera at the east wildlife underpass in the Pequop Mountains (2019 spring)

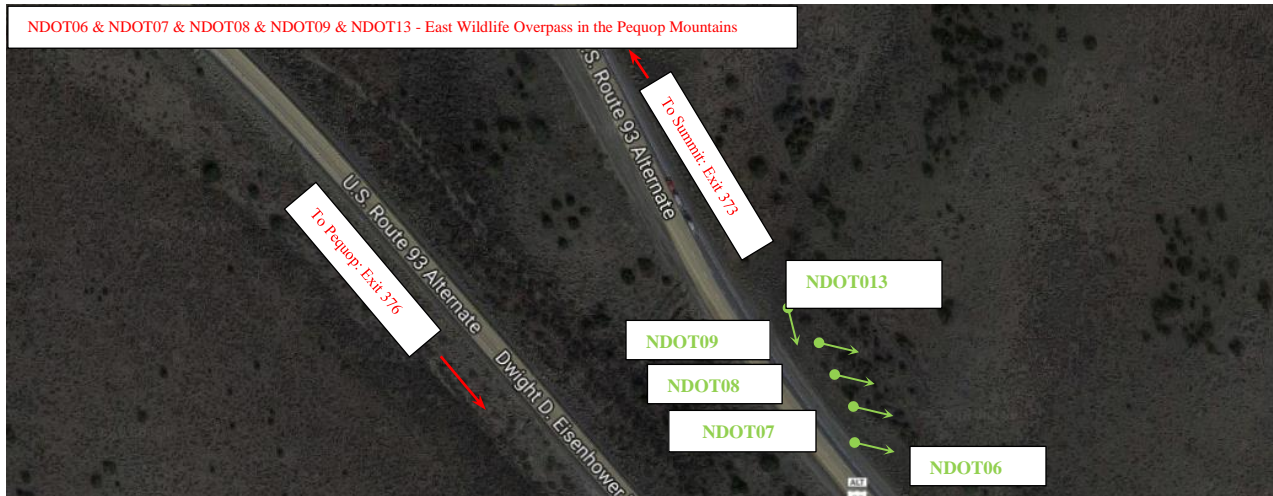
Figure 2-13 Cameras layout at the East Wildlife Overpass in the Pequop Mountains (2018 fall)

Cameras of NDOT06 & NDOT07 & NDOT08 & NDOT09 & NDOT13 were installed at the north entrance of the new overpass in 2018 fall, Figure 2-13, and moved to the south entrance in 2019 spring, Figure 2-14. Due to the wide width of the overpass, five cameras were installed to maximize the coverage. All of them were placed on the fence poles. The camera layout was shown in Figure 2-

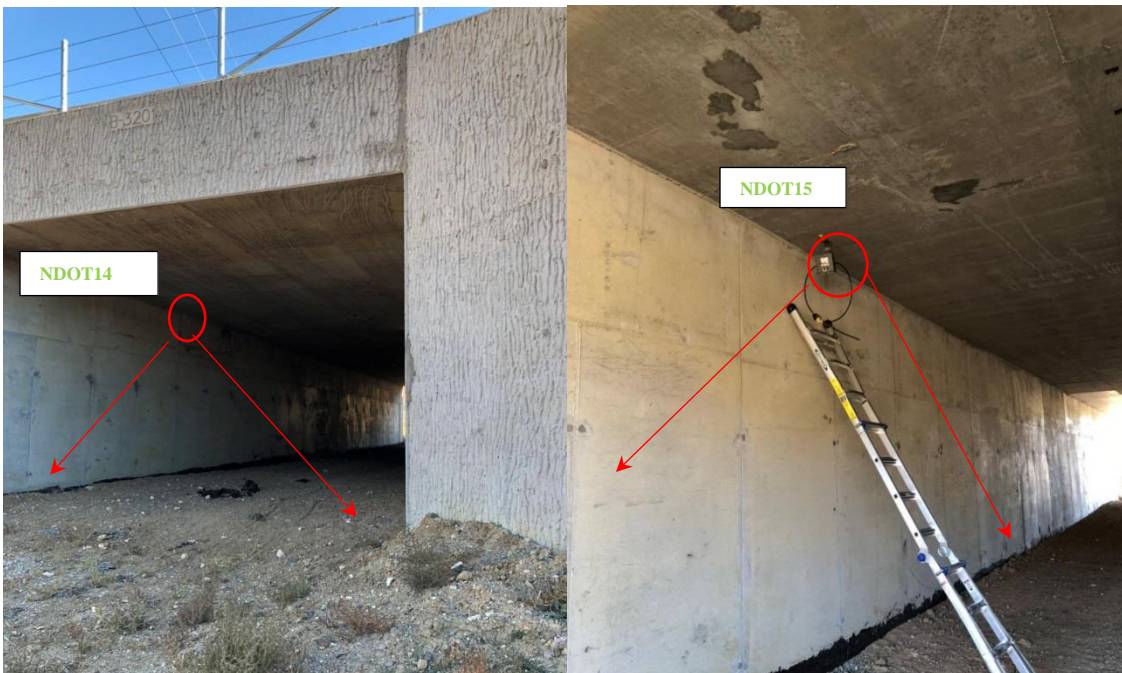
Figure 2-6 Locations and directions of the cameras at the north Wildlife Underpass on USA Parkway

Camera brackets were installed by NDOT District II before 10/12/2018. Locations of NDOT14 & NDOT15 were demonstrated in Figure 2-6.

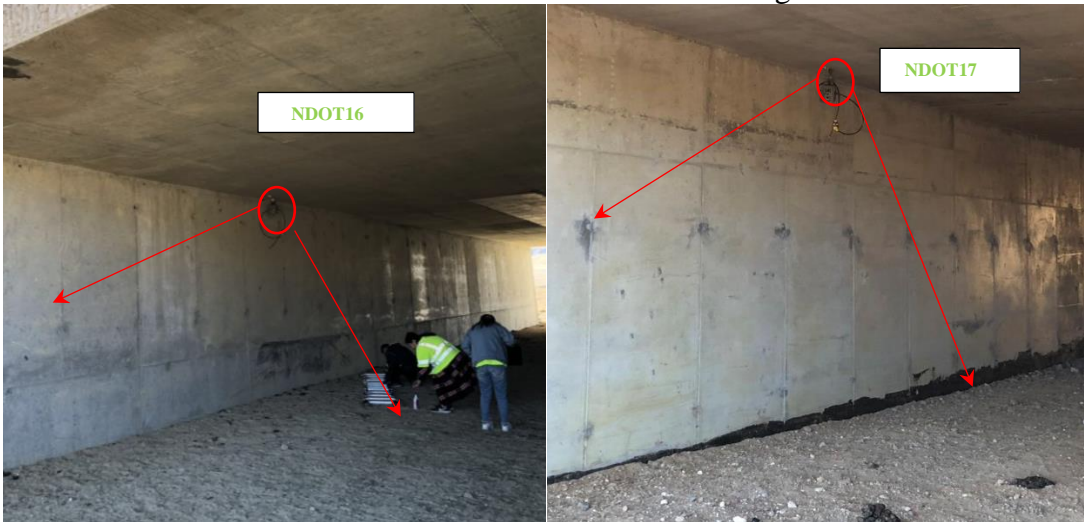
Figure 2-8 Locations and directions of the cameras at the East Wildlife Underpass in the USA Parkway

Cameras of NDOT16 & NDOT17 were demonstrated in Figure 2-8.

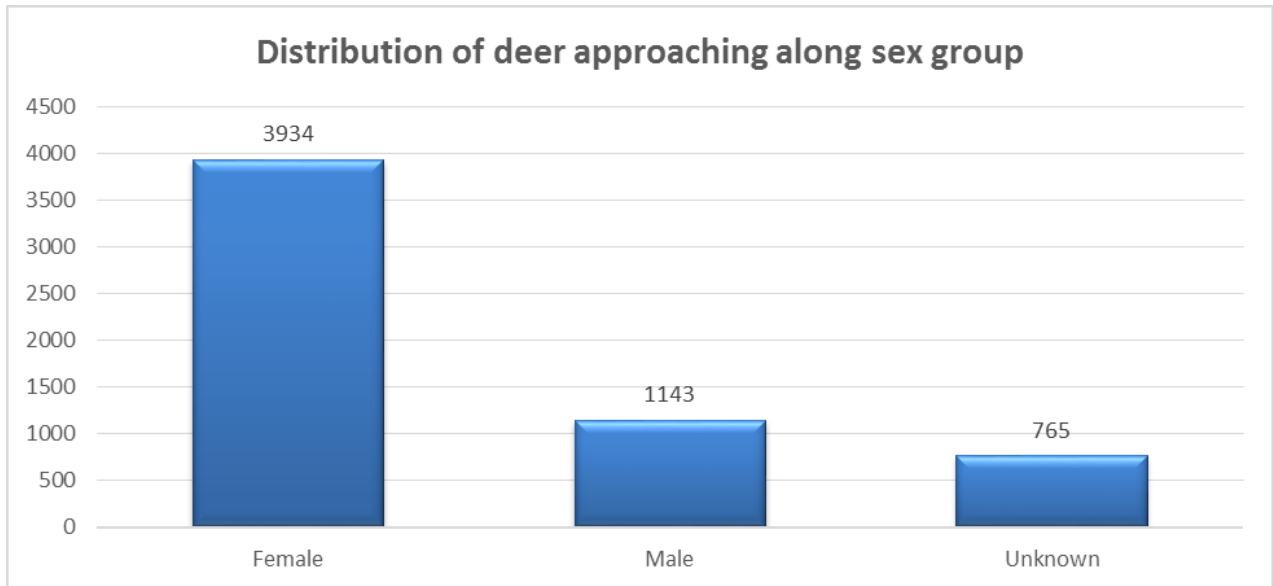
Distribution of male and female deer is in Figure 4-14. There are more female than the male deer using the crossing structures.

Figure 4-14 Distribution of deer approaching along with sex group

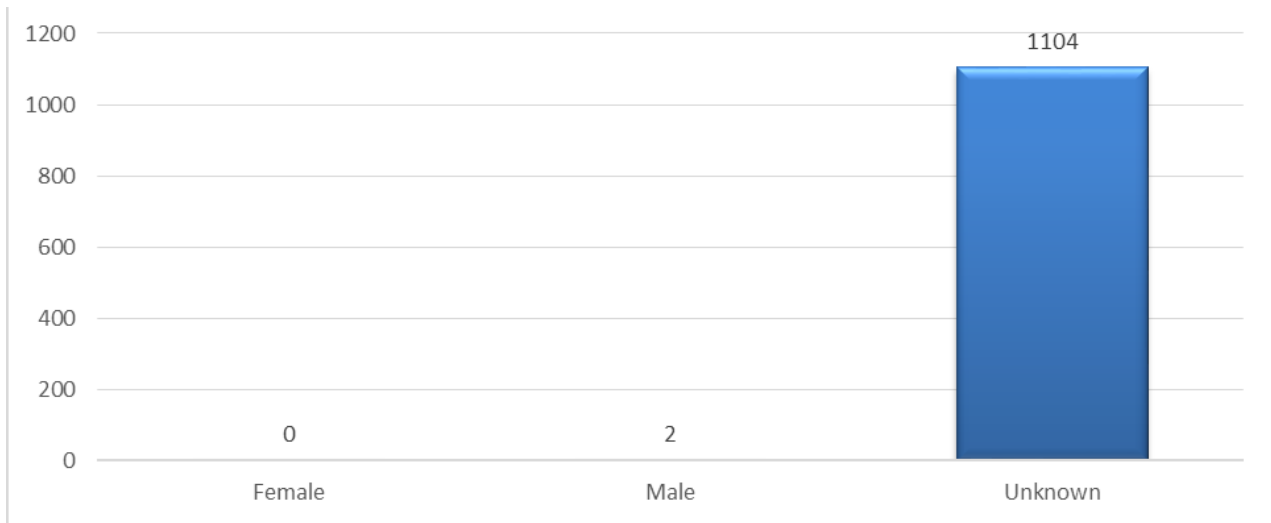
Distribution of male and female wild horses is in Figure 4-26. Most of their gender could not be identified.

Figure 4-26 Distribution of wild horses approaching along with sex group

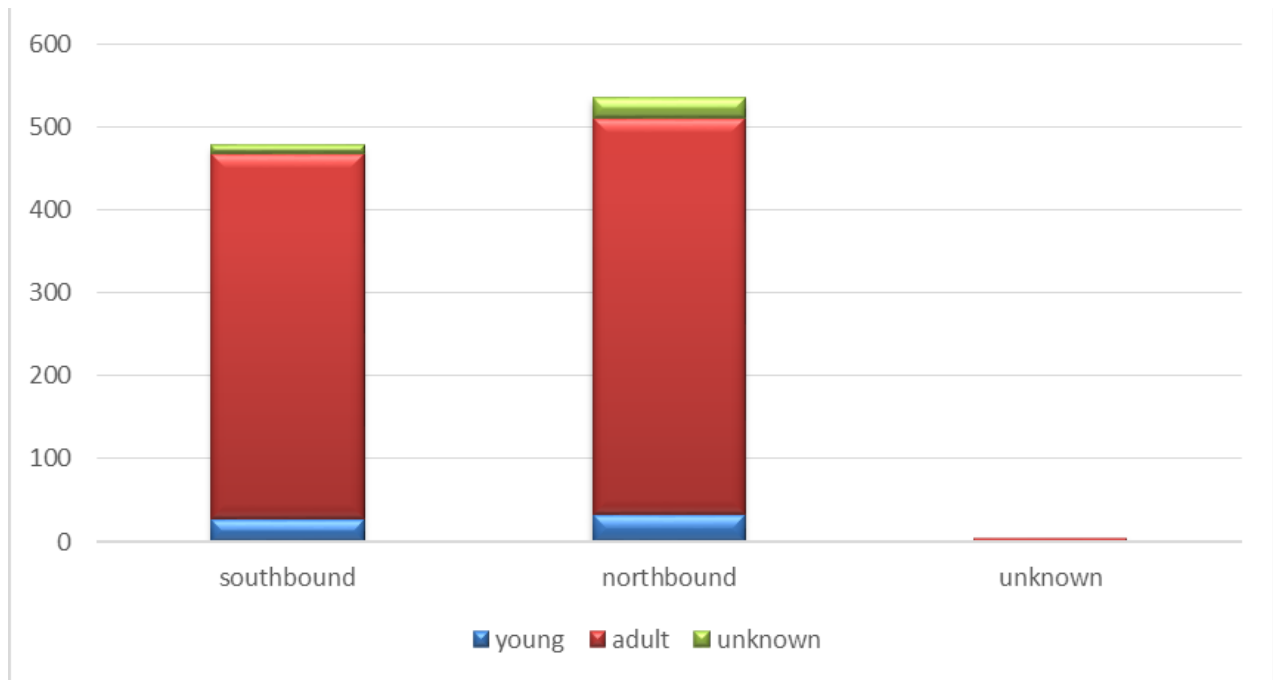
Figure 4-84 Wild horses approaching by age

A total of 231 group picture collected from 10/12/2018 to 05/12/2019 including **113** horse groups, 22 cow groups, 24 bird groups, 47 coyote groups and 17 groups with human and vehicle. A total of 50 southbound wild horses groups with 478 individuals and 54 northbound wild horses groups with 524 individuals were observed at the South Wildlife Underpass in the Pequop Mountains, and there are also 9 groups of wild horses left without identified direction. The numbers of wild horses approaching, crossing, and retracting are in Table 4-10. The total number of southbound and northbound wild horses approaching this wildlife underpass is shown in Figure 4-79. Comparison of deer approaching and retractions is in Figure 4-80. Wild horses approached this underpass more often in 2018 fall, and most of them crossed his structure. The total number of wild horses approached every day is steady. And the number of southbound and northbound are usually same one which means the same groups wild horses use this structure twice every day. The total number distribution of wild horses approaching this structure by month is shown in Figure 4-81. The total number distribution of wild horses approaching by time is in Figure 4-82. Figure 4-83 presents the total number distribution of wild horses approaching at different temperatures. It shows that the number of wild horses approached in October and November is basically the same while after that, the number of wild horses approached is gradually decreasing. Wild horse's favorite approaching time is from 7 am to 2 pm in the afternoon. The most suitable temperature is 35°F to 56 °F. There were more adult wild horses than young deer based on Figure 4-84, and the gender of the horse is difficult to identify.

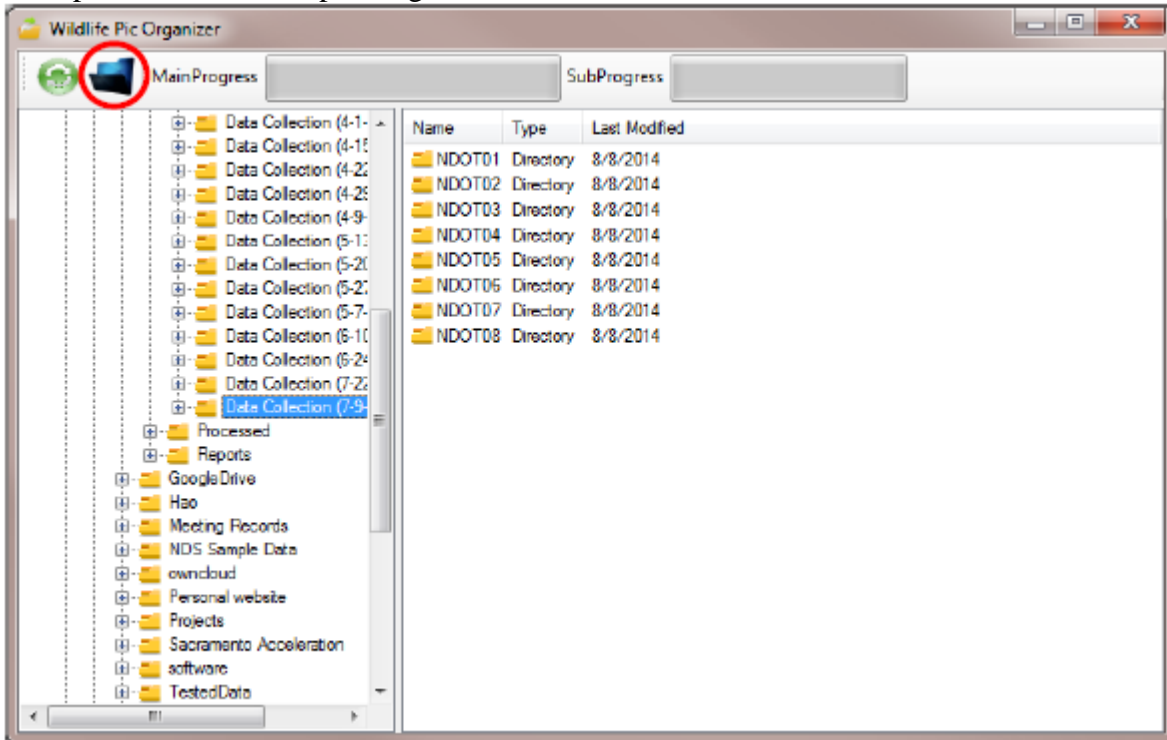
Figure 0-7 Selecting the parent folder of the camera folders and clicking the upper-left button for picture grouping

picture's capture-time (YearMonthDay_HourMinuteSecond) and the last picture's capture-time (YearMonthDay_HourMinuteSecond) with hyphens. For example, if the first picture of a sub-folder was captured at 18:01:04 on 07/08/2014 and the last picture was captured at 18:01:15 on the same day, the sub-folder's name is "20140708_180104-20140708_180115". All pictures are then copied into the corresponding folders based on the time metadata.
