NDOT Research Report

Report No: RDT04-049

Development and Implementation of a Scour Monitoring Program for Selected Bridges Crossing the Truckee River

December 2004

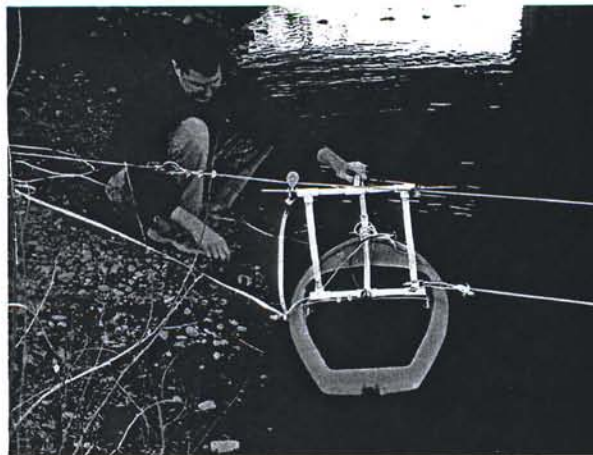
Figure 3.1 Kneeboard with portable sonar device

After several trials of different measuring techniques and board configurations, streambed elevations were effectively obtained with this device. The board is manually pulled across the channel on a guide cable attached to fence posts installed on either side of the river. The sonar cable should be lengthened to facilitate measurements when the channel section is wider than 100 feet. As the river rises, the guide cable may be raised on the posts to maintain the proper height for the kneeboard. Additional fence posts may be necessary if the river reaches an elevation 2 to 3 feet higher than present.

The device was tested at five bridge sites (i.e., Lockwood, East McCarran, Highway 395/Interstate 580, Kietzke, and Kunezli). The device should provide adequate streambed data to evaluate contraction scour conditions as well as provide some information on local pier scour. Preliminary cross sectional data obtained are included in Appendix A.

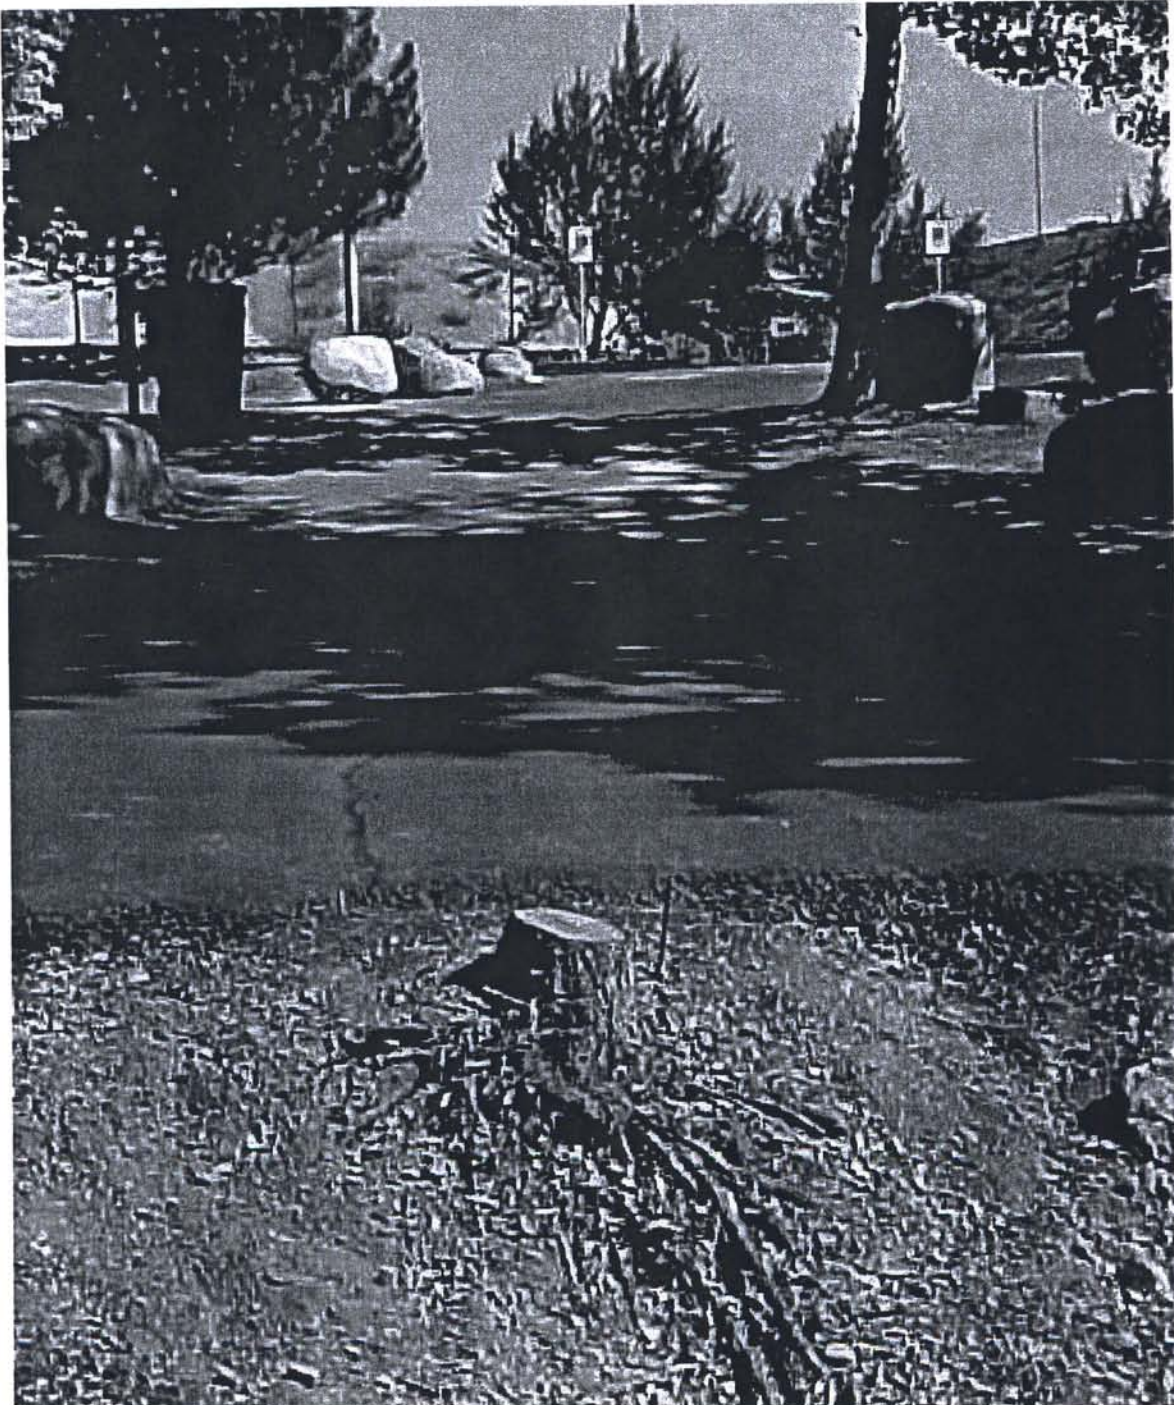
Kietzke Bridge, north bank looking north at possible equipment access. (parking lot for fishermans park)

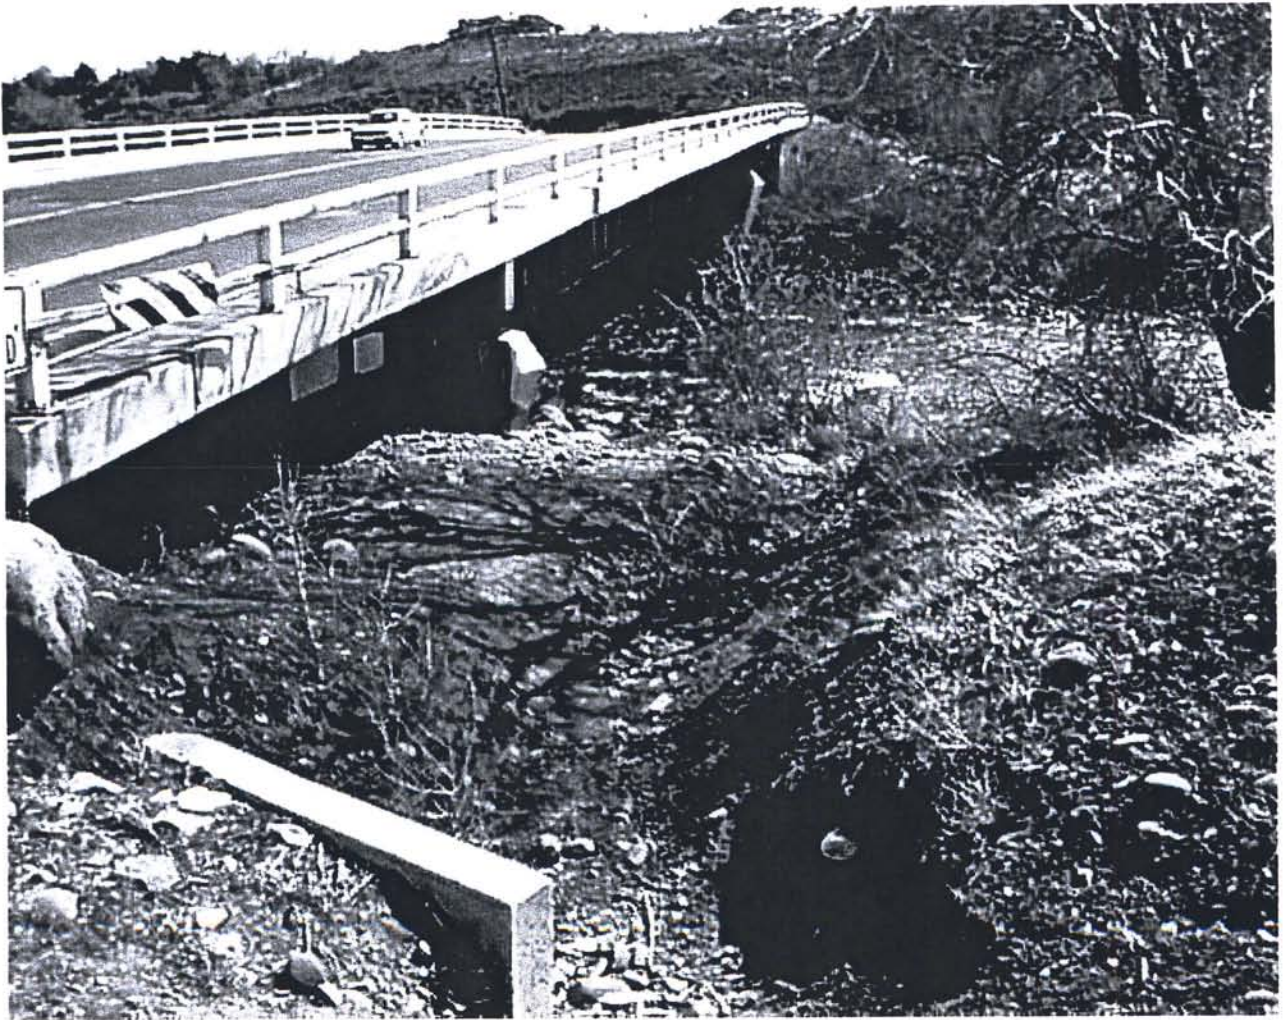
Mayberry Bridge – NW Corner (looking south)

1. Access to the northwest bank from the sewer access road off of Mayberry Drive appears to be feasible. Some earthwork would be required to grade an access to the riverbank, but appears to be minimal.
2. Some vegetation would be disturbed at the riverbank.
3. Digging a 12-foot deep hole appears to be feasible, casting the soil to a clear spot under the bridge for bagging or characterization onsite. Need to determine how and where the size distribution would be characterized (e.g., onsite or in laboratory). NDOT geotechnical engineers should be consulted.
4. ROW – Need to review ownership and easements and obtain permission for access and operations.
5. Environmental – Need site review by NDOT Environmental Services Division. Dewatering should not be necessary and encroachment into the surface water can likely be avoided.
6. Renting clean equipment may be necessary.

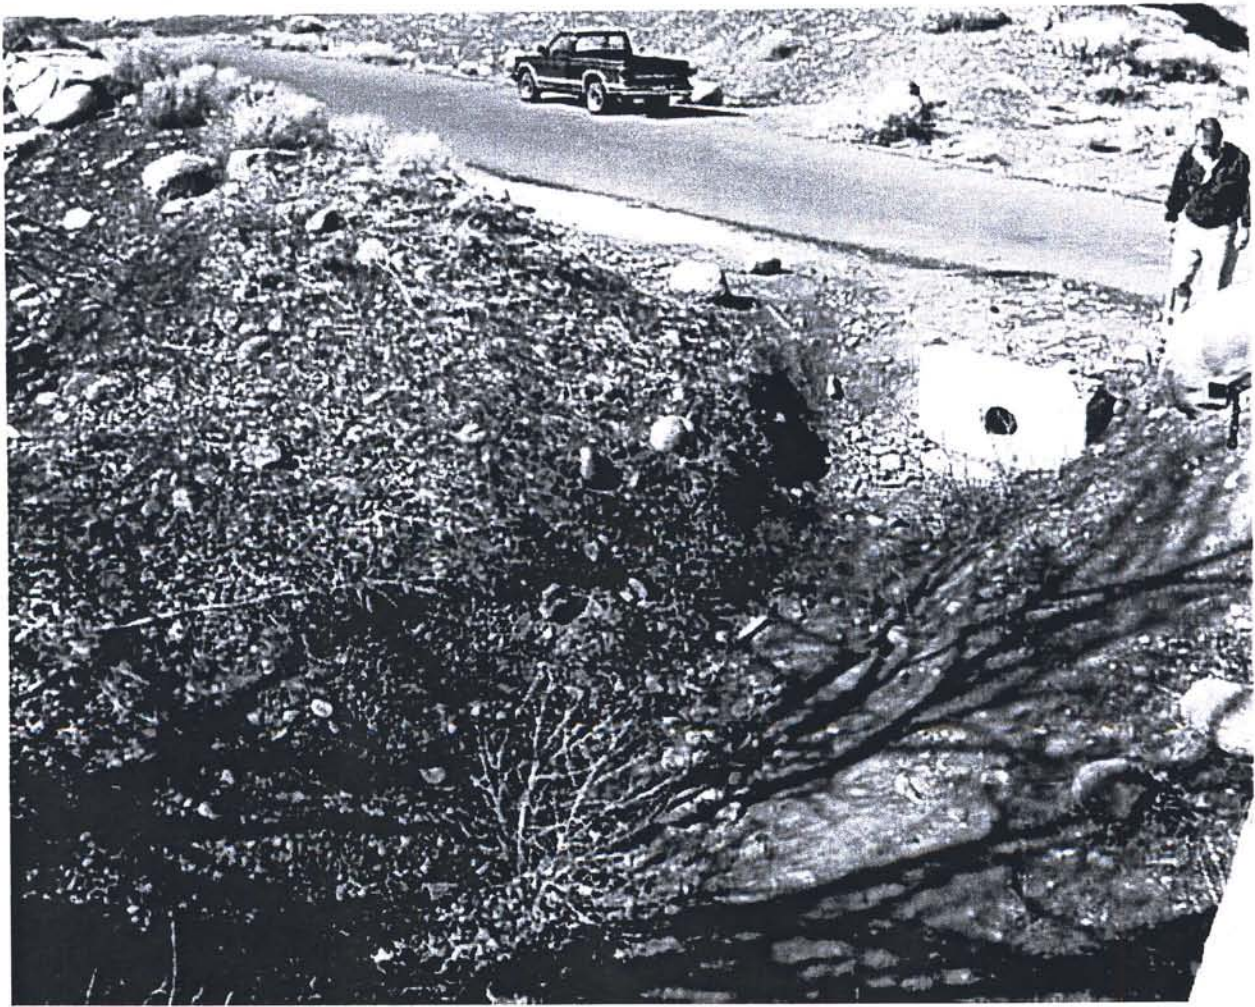
Mayberry Bridge - NW Corner (looking north)
