NV-RDT-06-008

Experimental Study on Installing Tilted Signs to Prevent Snow Accretion on Sign Surfaces

Final Research Report

October 2006

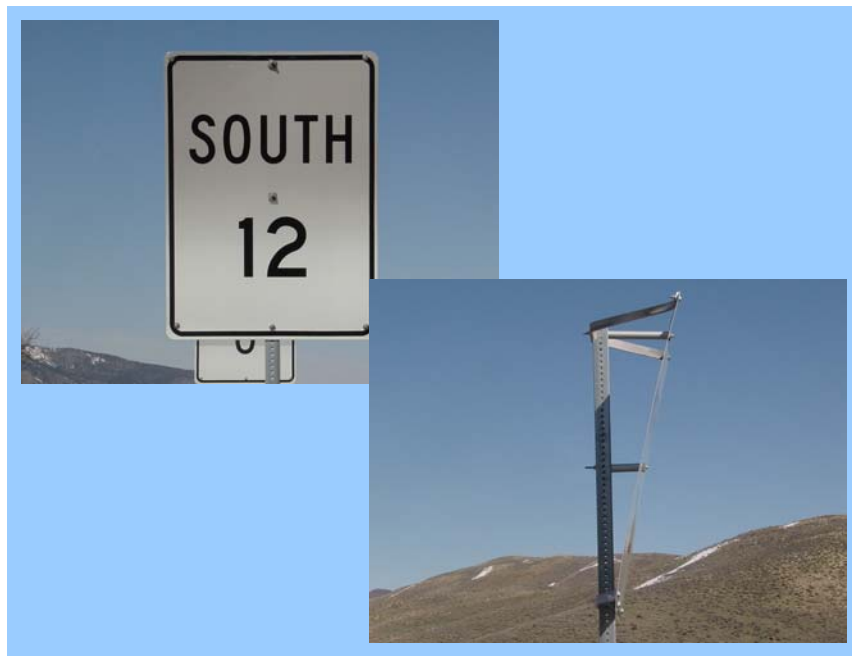
Figure 2-3. Illustration of Vertically Tilted Sign Installation

Figure 2-3 illustrated one the signs showing the sign face and a side view. Of particular note is the side view illustrating the mounting bracket at the top of the sign, which District II Maintenance personnel needed to fabricate in order to provide a rigid sign mounting system. There was some concern about the structural stability of the signs with the larger angles of tilt. In response to a request the Bridge Division provided a qualitative review and was not concerned with the structural stability. The fabrication process became more difficult as the angle of tilt increased, especially for the angles of 9 and 12-degrees. However, smaller signs would not be as difficult.

While the signs with the largest angle of tilt produced the least snow, there is concern for the structure stability of the signs with the larger tilts. Additionally, there was difficulty with the fabrication of the top mounting brackets for the signs with the larger tilts. For practical reasons, a tilt of 6° appears to be the most reasonable for larger signs.

The tilt is to be at the top of the sign and angled toward the driver. For a 6-degree vertical tilt, a 1.25" offset for 12" of height is needed. For a 12-degree vertical tilt, a 2.5" offset for 12" of height is needed. Metal bracing, made of typical z-bar available in NDOT sign shops, is to be used to tilt the signs. The photograph below illustrates how the tilt is provided. If the Department uses a substantial number of tilted signs it may be more economical to have the tilting brackets manufactured. Also, in some instances it may be possible to slant the sign post rather than use brackets.

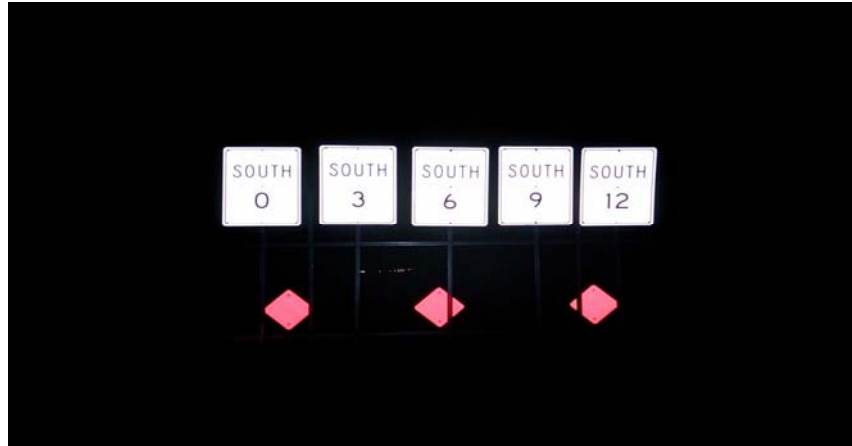
Figure 3-1. Nighttime View with Vehicle Headlights On

Note: The red diamonds indicate the end of frontage road

There was another concern that differences in the observed brightness of the signs with different angles of tilt may affect the perceived snow accretion during nighttime storms. Signs that seemed brighter may appear to have less snow accretion than seemingly dimmer signs when, in fact, they had more snow accretion. To explore this concern the nighttime retroreflectivity issue including the effect of the tilt, one set of signs (the South set) was relocated to the northern end of the east side frontage road in June of 2005. This location was approximately $\frac{1}{4}$ mile to the north of the initial installations and the signs were placed side by side for each comparison. The South sign set was the best choice because the retroreflectivity readings had the least variation among the five signs; consequently, any perceived differences in brightness would result from the angle of tilt. Three research technical panel members visited this set of signs and could not detect any difference in the apparent brightness among the five signs. A digital photograph is included, Figure 3-1, that illustrates the lack of apparent differences. Clearly, the tilt angle did not affect the apparent brightness of the sign faces.

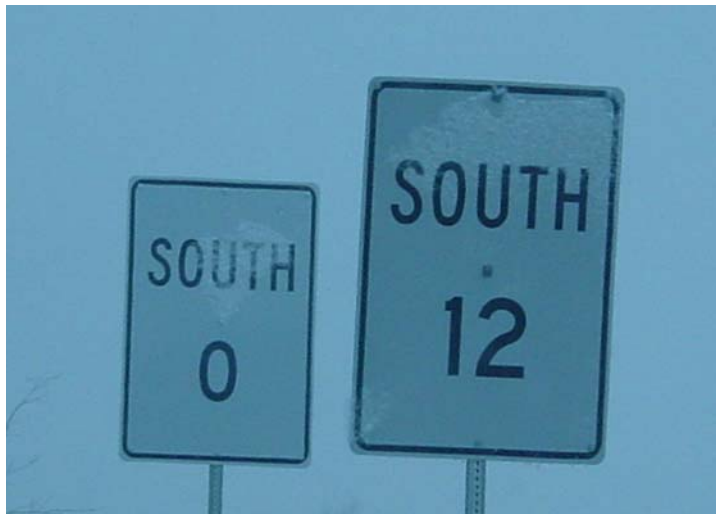
Figure 3-2. Illustrates Very Little Difference in Snow Accretion and Tilt
(Storm date 12-29 & 30-2004)

Digital photographs were obtained for each of the eight storms and typical photographs are shown herein. Figure 3-2 provides an example of the situation where there is very little difference in the snow accretion as a function of tilt. However, most of the photographs revealed a clear pattern and the set of photographs in Figure 3-3 is representative of the majority of the photographs. The reader should note the date of the storms when the photographs were taken is shown immediately after the figure title. Figure 3-4 illustrated that during a heavy storm, part of the sign message of a conventional sign, 0° tilt, cannot be read, while the sign with the 12° tilt can be read. Figure 3-5 shows that the snow accretion on some signs developed inconsistent patterns.

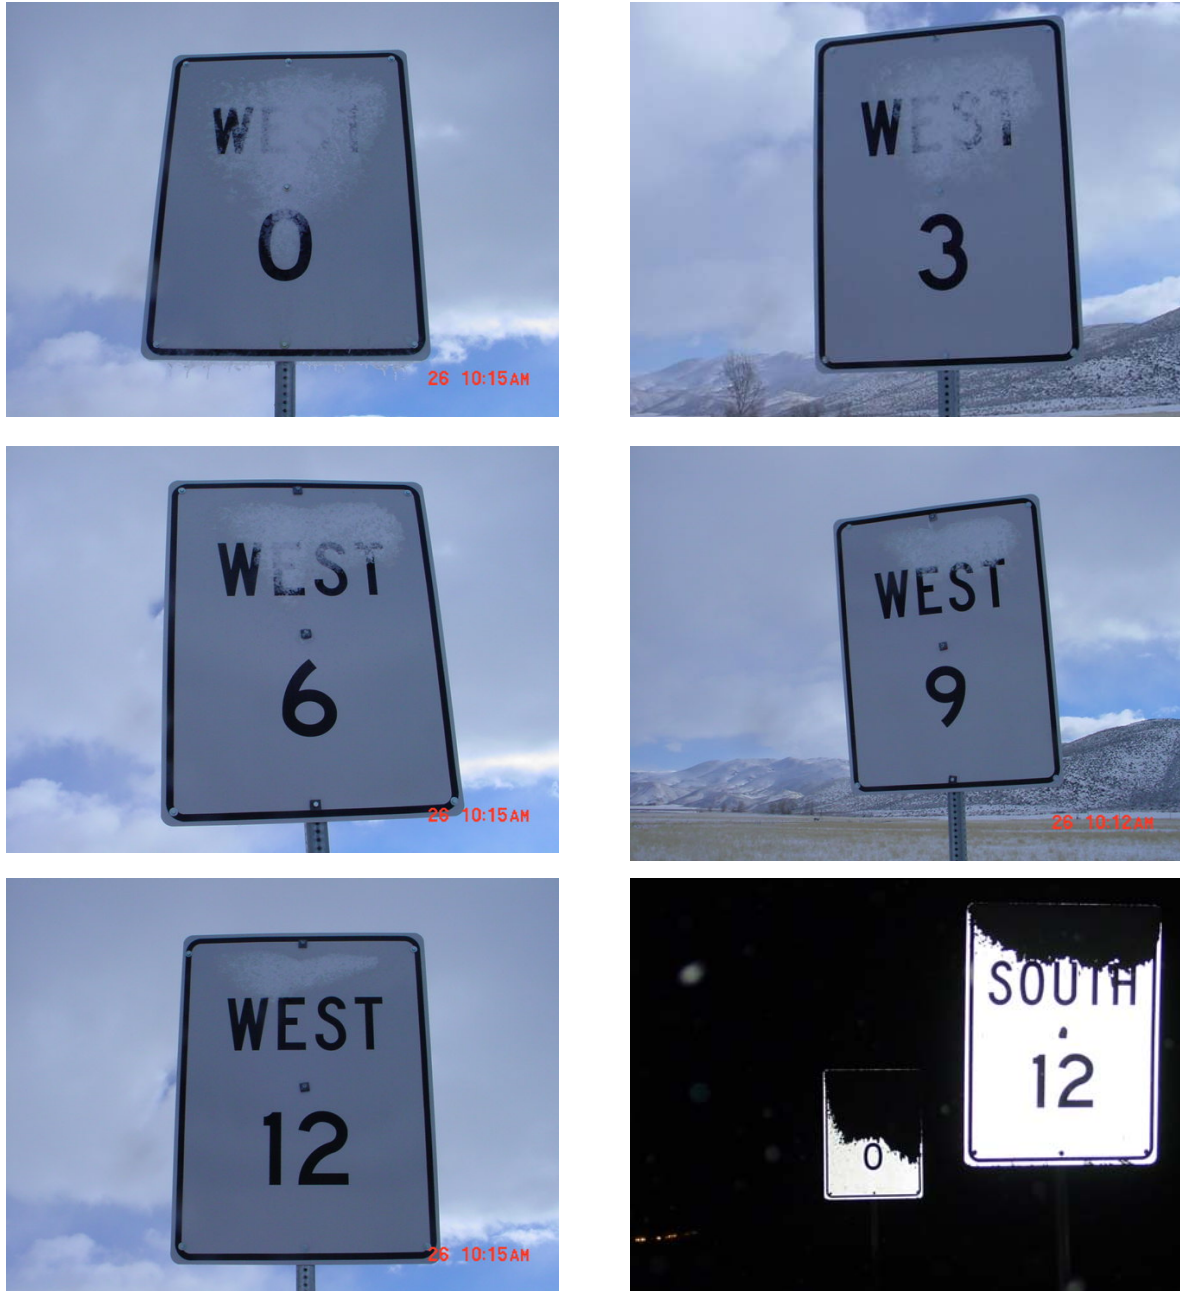
Figure 3-3. Illustrates the Snow Accretion as Function of Sign Tilt
(Storm date 2-26-2004)

(Storm Date January 2004)

From an examination of the photographs, a clear pattern was observed. The degree of snow accretion decreased as the angle of tilt increased from 0° to 12°. However, there were examples when there was little or no advantage in tilting the signs depending on wind direction or heavy snow fall.

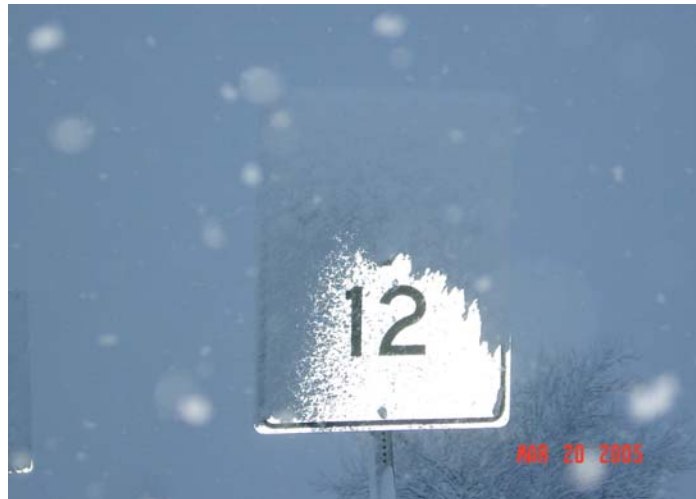
Figure 3-6. In Some Storms Even the Message of 12° Tilted Sign Cannot Be Intirely Read
(Storm date 3-20-2005)

Although the trend was that the sign face with 12° angle of tilt accumulates the least amount of snow, Figure 3-6 illustrates that even the message of these sign could not always be read. However, the pattern was clear, there was generally less snow accretion as the angle of tilt increased.
