NDOT Research Report

Report No: RDT 91-026

**EVALUATION of 1988 CHIP
SEAL TEST SECTIONS on
US 50 BETWEEN FALLON
and SILVER SPRINGS,
NEVADA**

September 2001

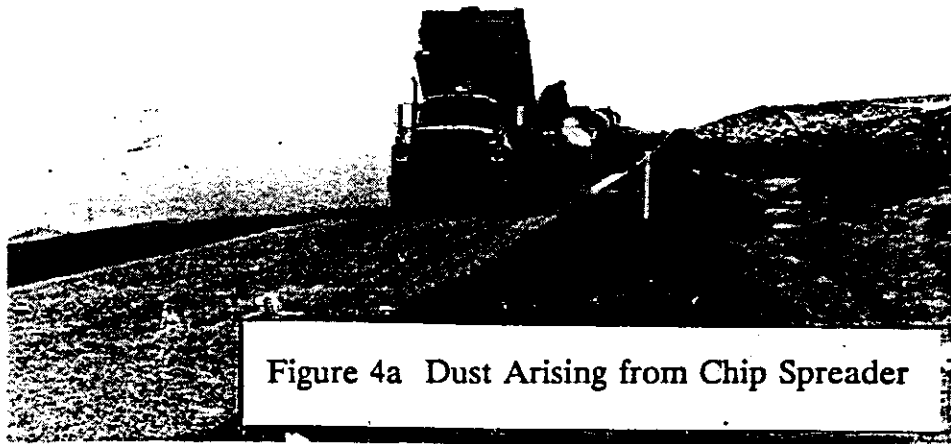
Figure 4a Dust Arising from Chip Spreader

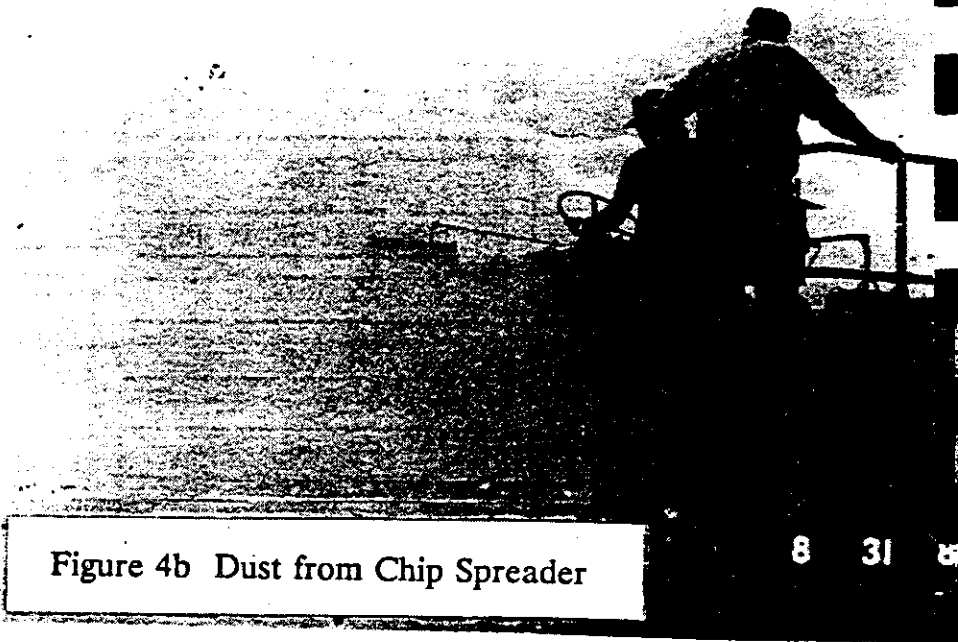
Figure 4b Dust from Chip Spreader

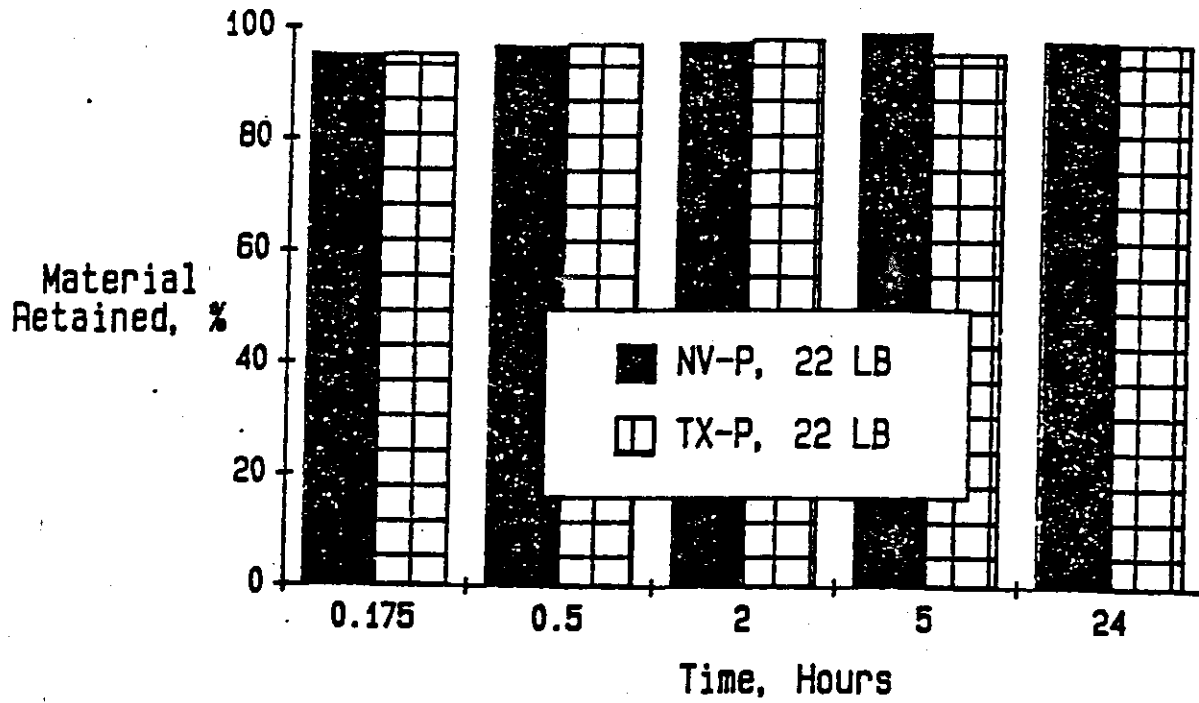
Figure 23 Comparison of EVA PM 2000, and Viscolastic AC with NVP, 22 LB Aggregate and TXP, 22 LB Aggregate

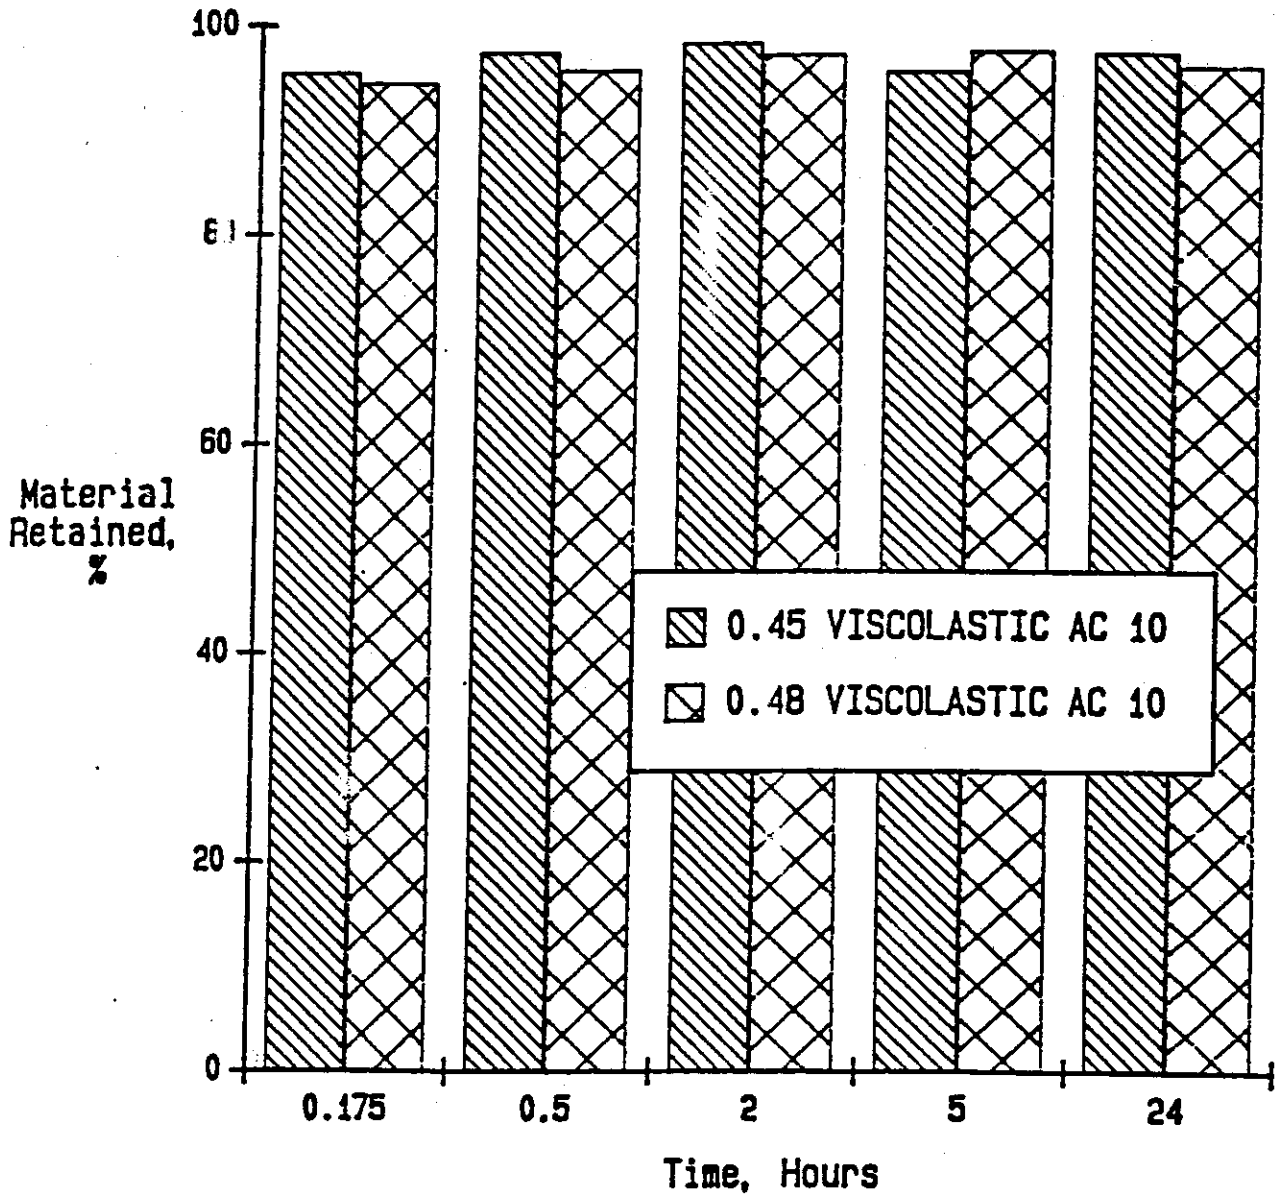
Figure 25: Comparison of 0.45 Viscolastic AC 10 and 0.48 Viscolastic AC 10 using TX-P, 22 LB Aggregate

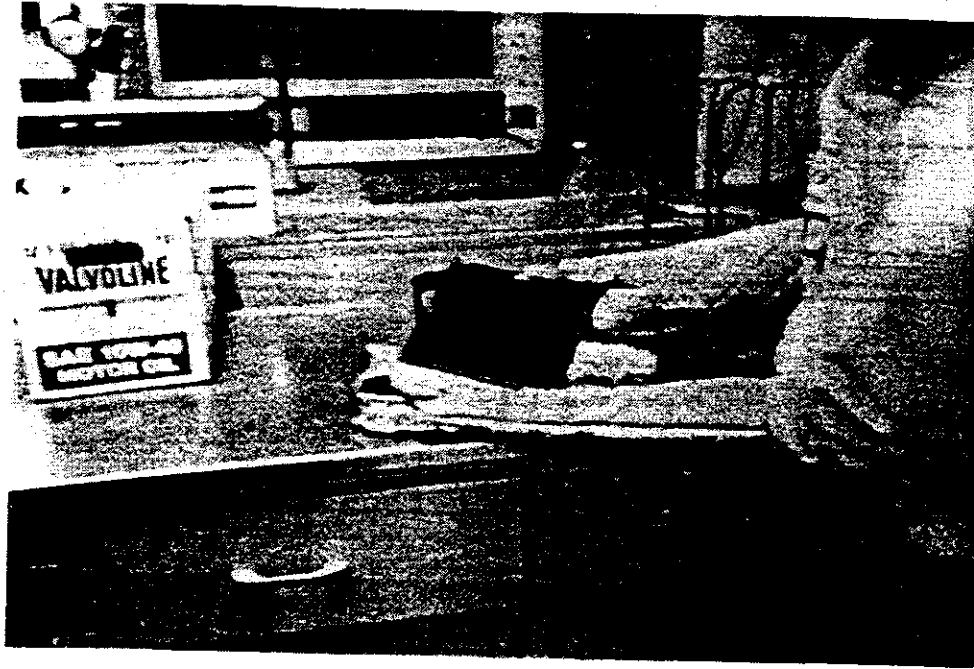
Figure 4: Preparation of Sample
