BATHYMETRIC RECONNAISSANCE OF MARLETTE AND SPOONER LAKES, WASHOE COUNTY AND CARSON CITY, NEVADA

By
F. Eugene Rush, Bruce R. Scott,
Patrick A. Glancy, Terrance L. Katzer
and Edwin P. Ament
1972

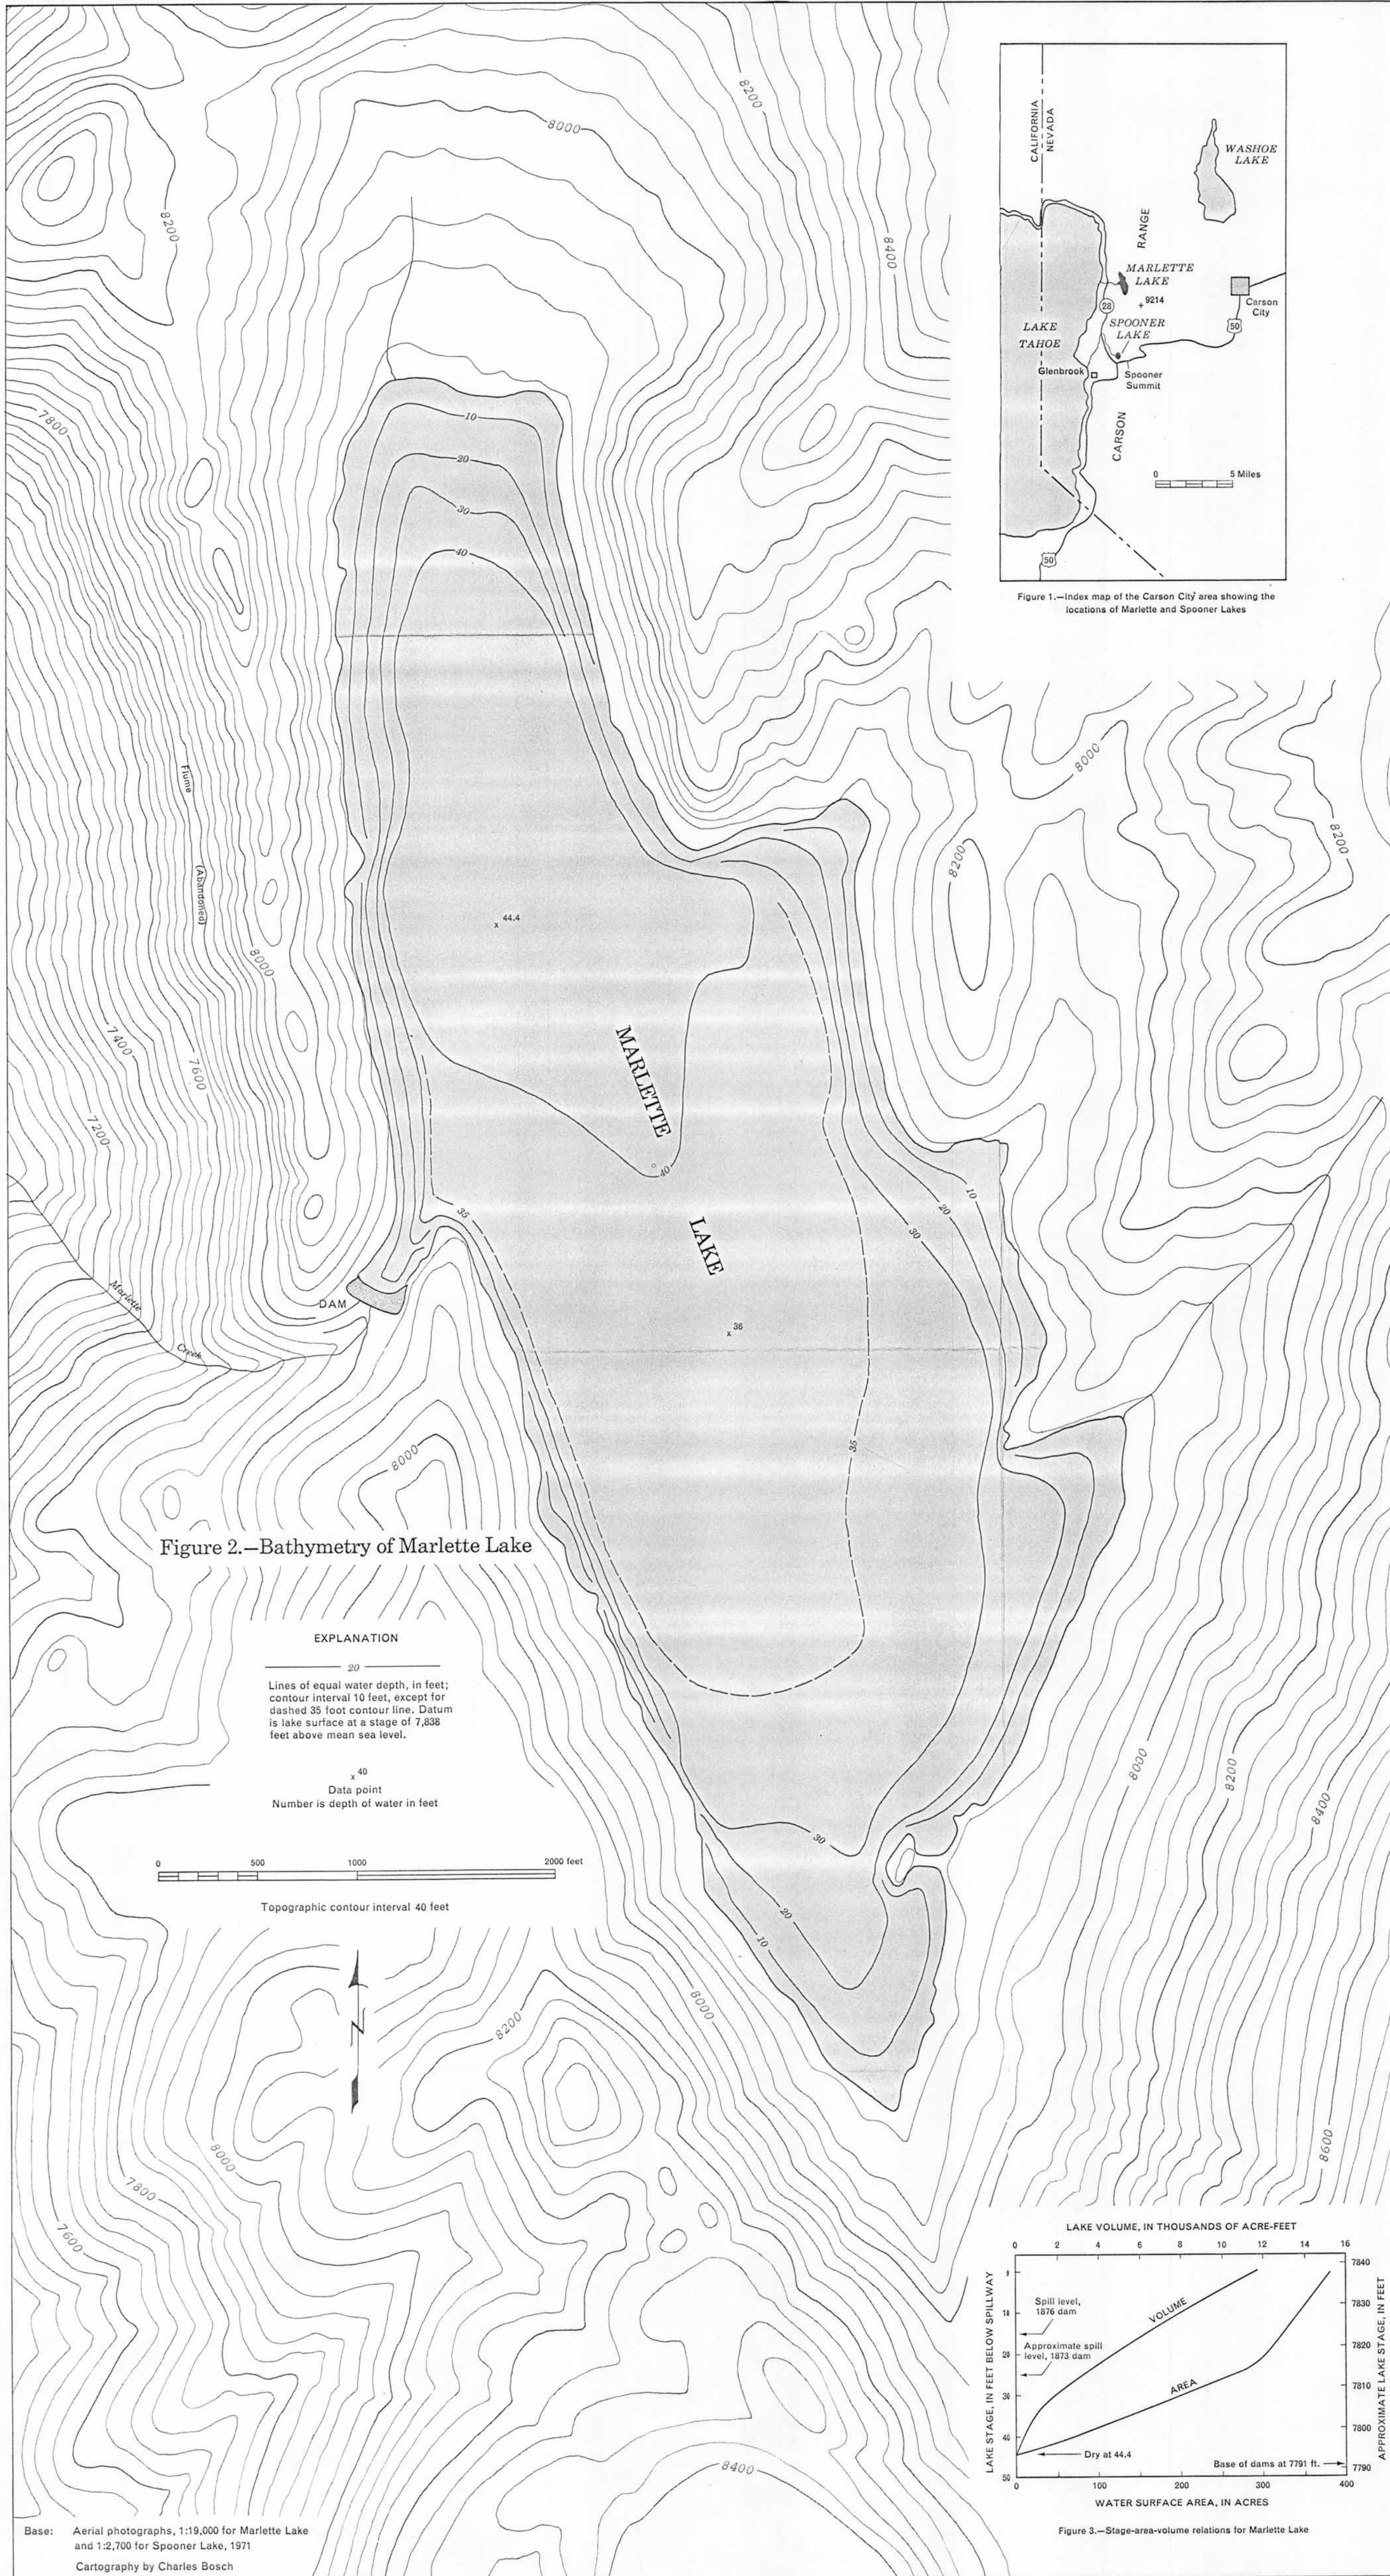
Figure 2.—Bathymetry of Marlette Lake

— 20
Lines of equal water depth, in feet; contour interval 10 feet, except for dashed 35 foot contour line. Datum is lake surface at a stage of 7,838 feet above mean sea level.

x 40
Data point
Number is depth of water in feet

Base: Aerial photographs, 1:19,000 for Marlette Lake and 1:2,700 for Spooner Lake, 1971
Cartography by Charles Bosch

A continuously recording, electronic fathometer was used to measure the depths of Marlette and Spooner Lakes, making a total of 19 traverses on Marlette Lake and 17 on Spooner Lake. The results of the survey are summarized in figures 2, 3, 4, and 5. The dimensions of Marlette Lake at high-water lines with 1873, 1876, and the 1959 dams are summarized in the following tabulation:

The bottom of Marlette Lake, or that area below a depth of 35 feet, generally can be characterized as a very gently sloping plane. The plane, dipping to the northwest, may have been formed as a horizontal playalike surface that has been tilted by faulting along the western margin of the lake. The short time since faulting has limited the modification of the surface by sedimentation or erosion.
