# Exploring Alternative Strategies for the Rehabilitation of Low-Volume Roads in Nevada

Final Management Report

January 2008

Nevada Department of Transportation  
Carson City, Nevada

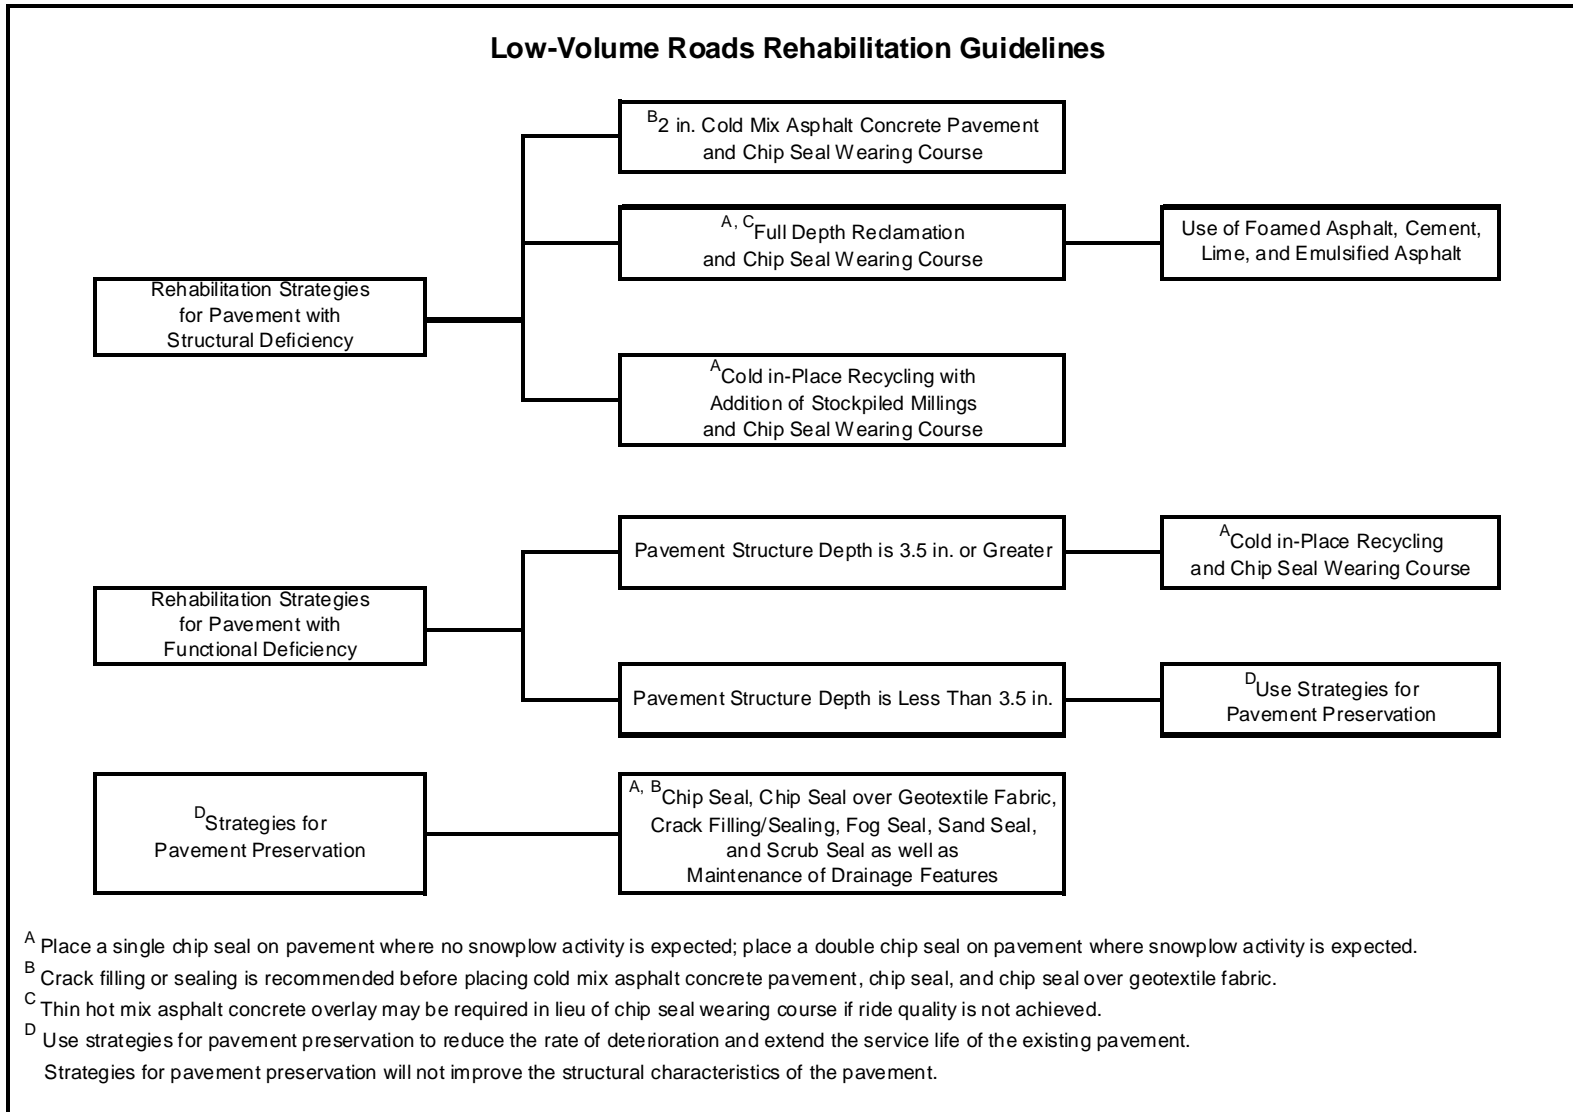
**FIGURE E.1 Proposed low-volume roads rehabilitation guidelines.**

- 1) Adopt the proposed low-volume roads rehabilitation guidelines in Figure E.1. These guidelines were developed for both structural and functional pavement deficiencies. The guidelines are the outcome of group consensus between engineers and managers to advance low-volume roads rehabilitation techniques to better serve state needs using recognized construction practices. The guidelines will provide systematic and cost-effective alternatives for pavement managers when tasked with choosing among numerous rehabilitation options.

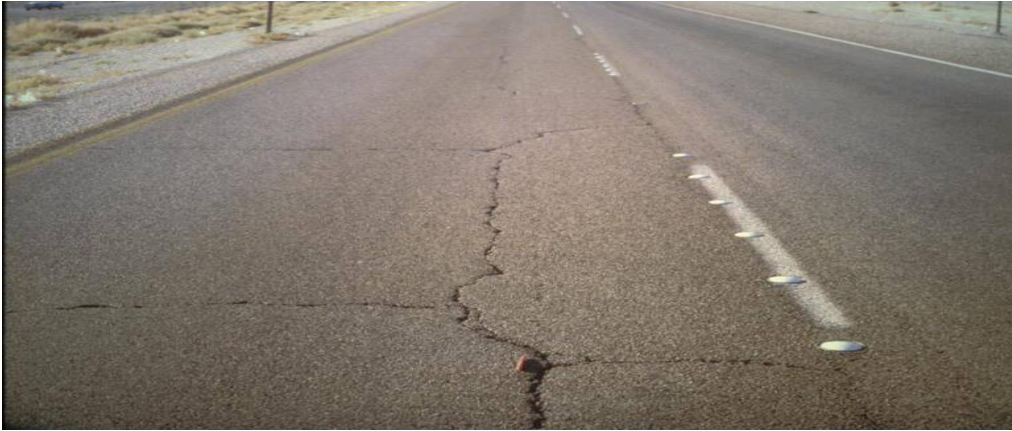
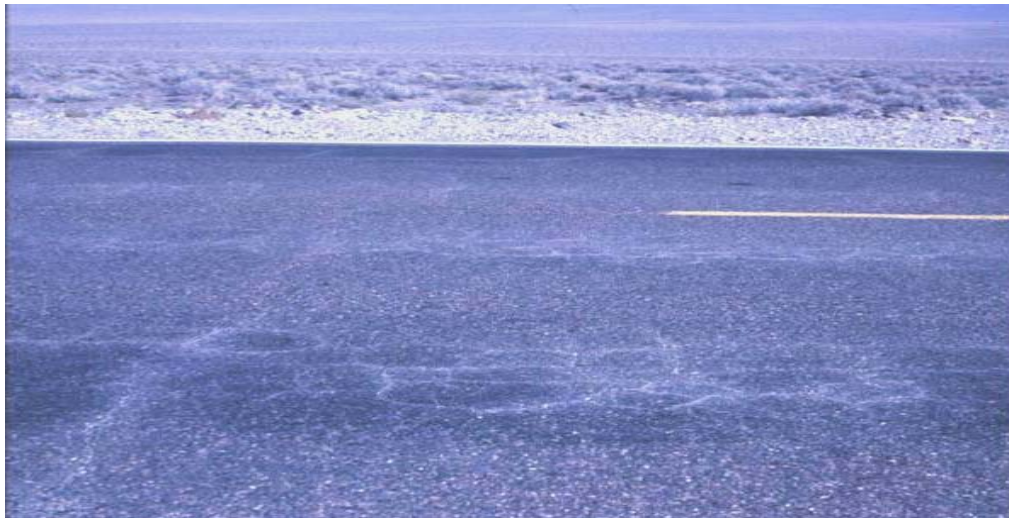
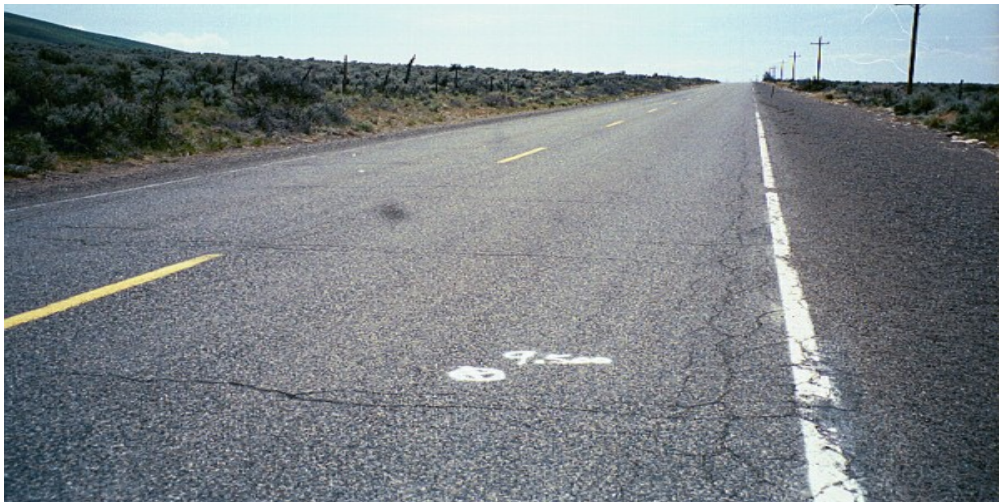
**FIGURE 1.2a Common low-volume road distresses.**

Five low-volume roads located throughout the state were chosen as demonstration test sections. The roads were age hardened, brittle, and contained distresses such as block, nonwheel path longitudinal, transverse, and fatigue cracking. Raveling was noticeable in some areas. Figure 1.2a shows examples of common distresses evident on these roads.

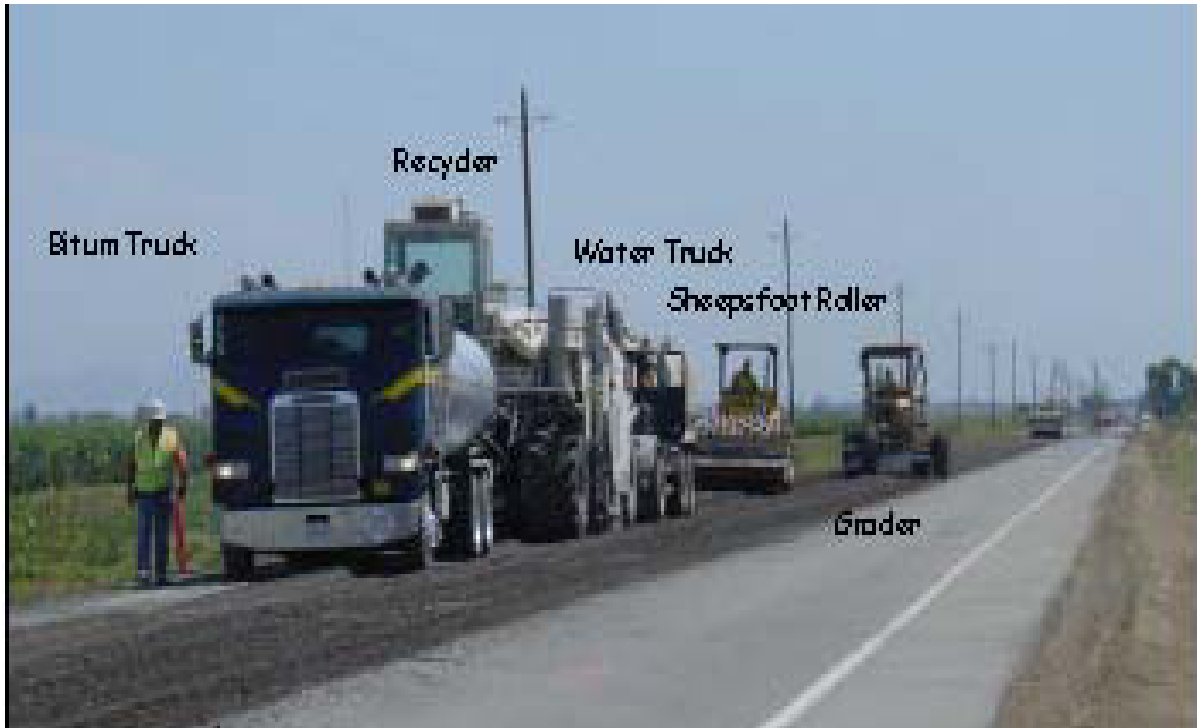
**FIGURE 2.6b Example of typical foamed asphalt equipment (3).**

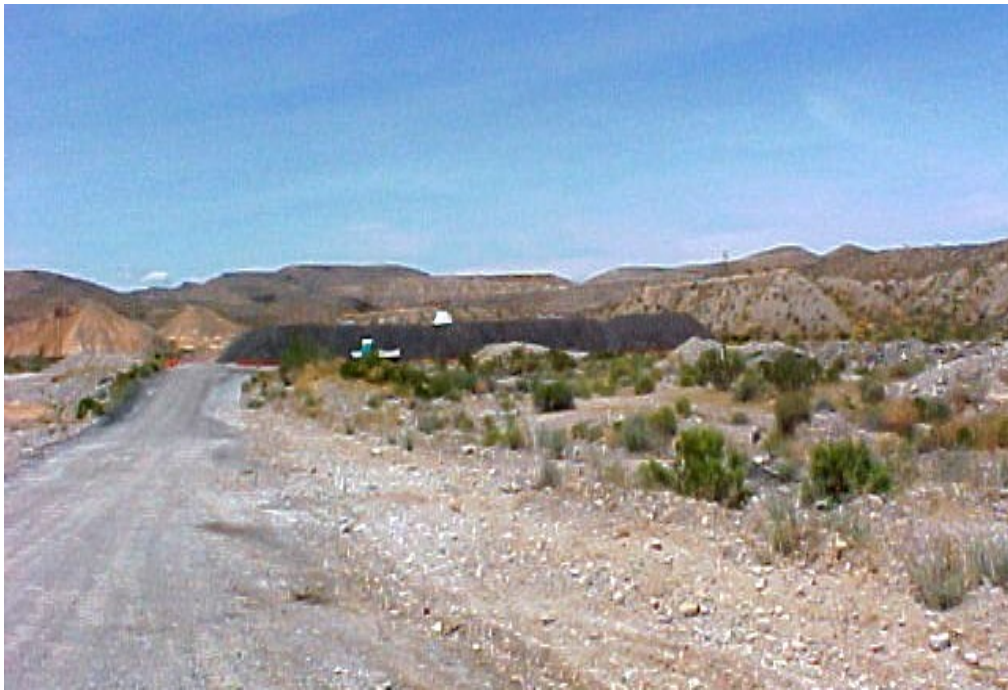
**FIGURE 4.2a Stockpiled millings.**

The CIR rehabilitation strategy was used with stockpiled millings to construct an improved pavement structure on SR168 (Figure 4.2a). Pre-construction core data revealed that the pavement structure was marginal for CIR operations and the use of recycled millings and chip seal wearing course was recommended. Millings that were leftover from a local interstate project were placed in a windrow in front of the recycle train. The roadway was milled 1 in. to provide for an adequate bond between the existing and new pavement structure. The freshly milled material and windrowed millings from stockpile were recycled using the train and a paver was used to place the 3 in. pavement structure (Figure 4.2b). This project was NDOT's first attempt at using a CIR operation with stockpiled millings for creating an improved pavement structure. Preliminary results are encouraging and this strategy will be used on future projects where logistics are feasible for incorporating stockpiled millings into CIR operations on low-volume roads.

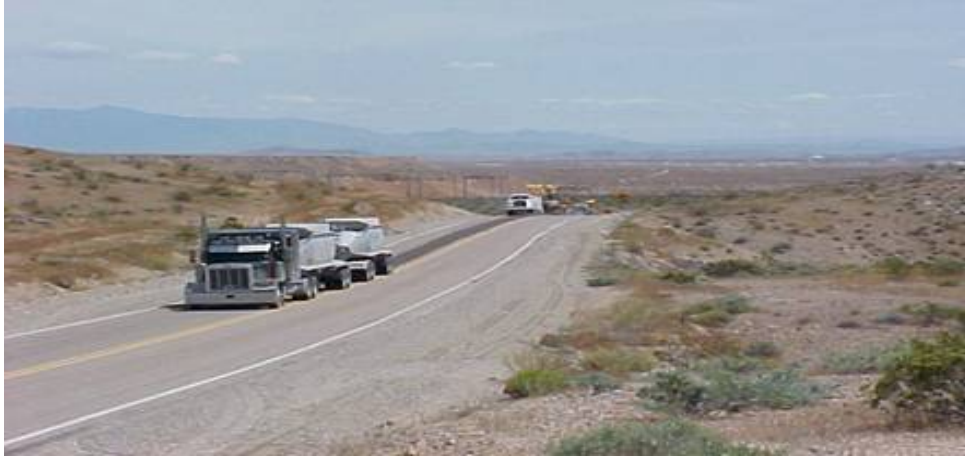
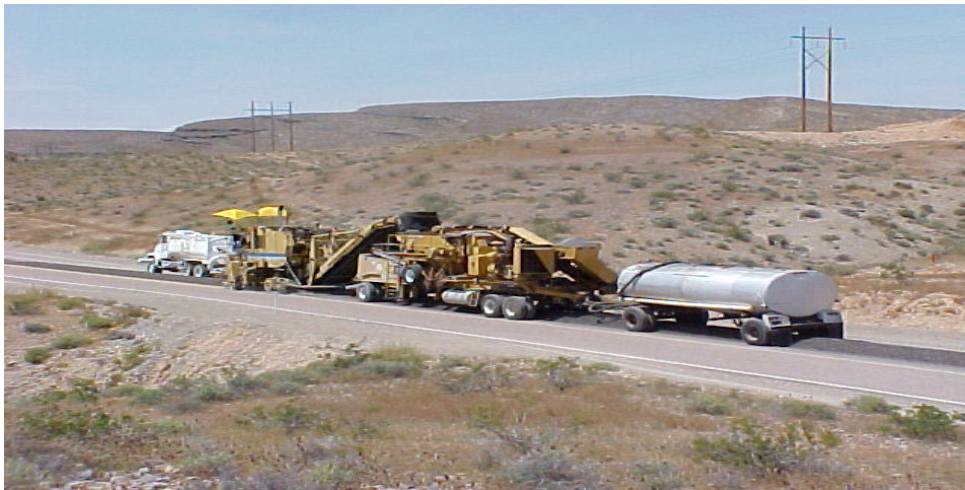
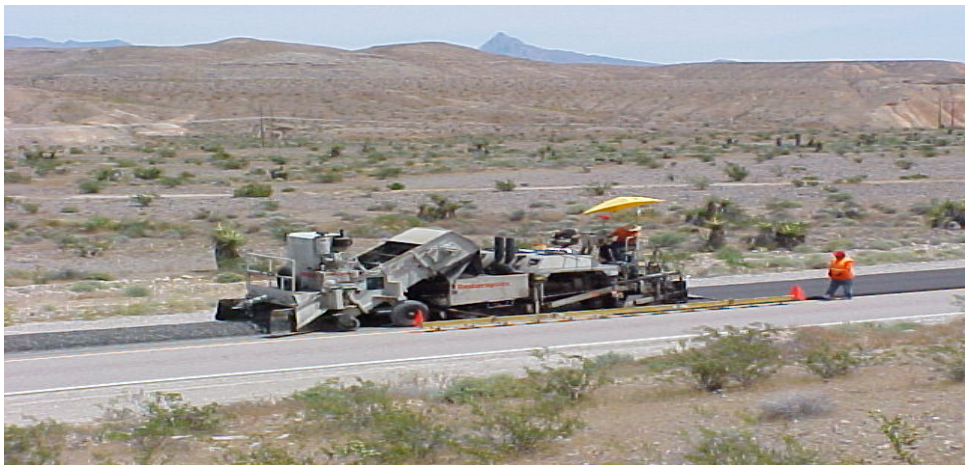
**FIGURE 4.2b CIR using stockpiled millings (a) millings hauled for windrow, (b) CIR train mills 1 in. and recycles material with millings in windrow, and (c) paver places 3 in. recycled pavement structure.**

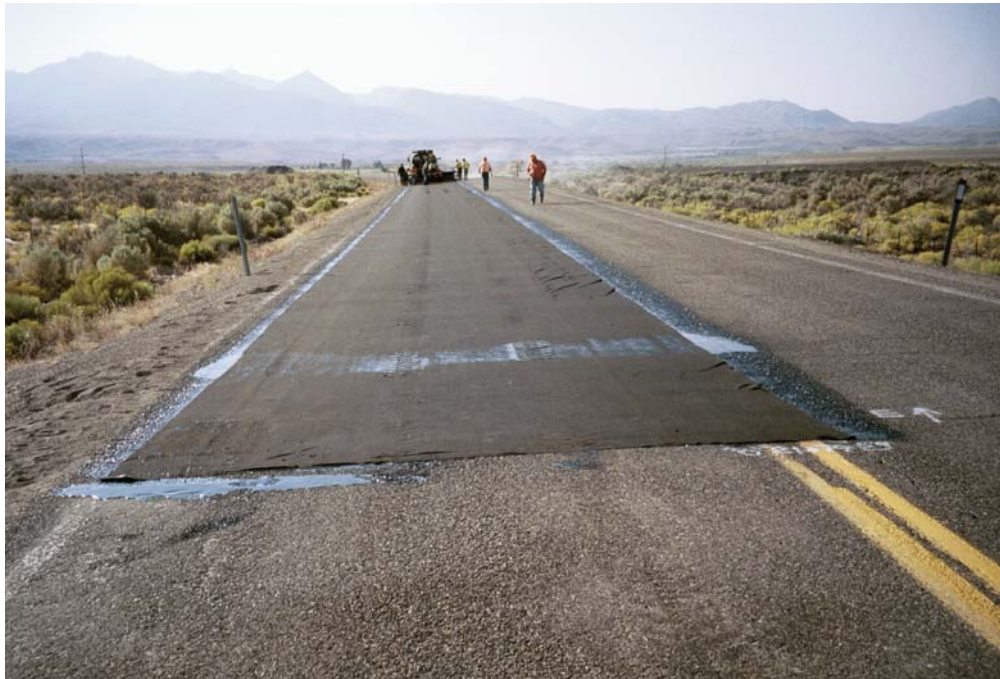
**FIGURE 5.1a Nonwoven polypropylene geotextile fabric seated in tack coat.**

A chip seal can be used in combination with other products such as nonwoven polypropylene geotextile fabric. The fabric is seated in a tack coat and a single or double chip seal is placed on top of the fabric. The fabric acts as a waterproof interlayer that prevents water from penetrating into the pavement structure and also acts as a crack retardant. This strategy was placed on SR230 for a side-by-side comparison with a double chip seal surface treatment without fabric. Figures 5.1a and 5.1b show a nonwoven polypropylene geotextile fabric seated in the tack coat and maintenance personnel placing a chip seal over the fabric.

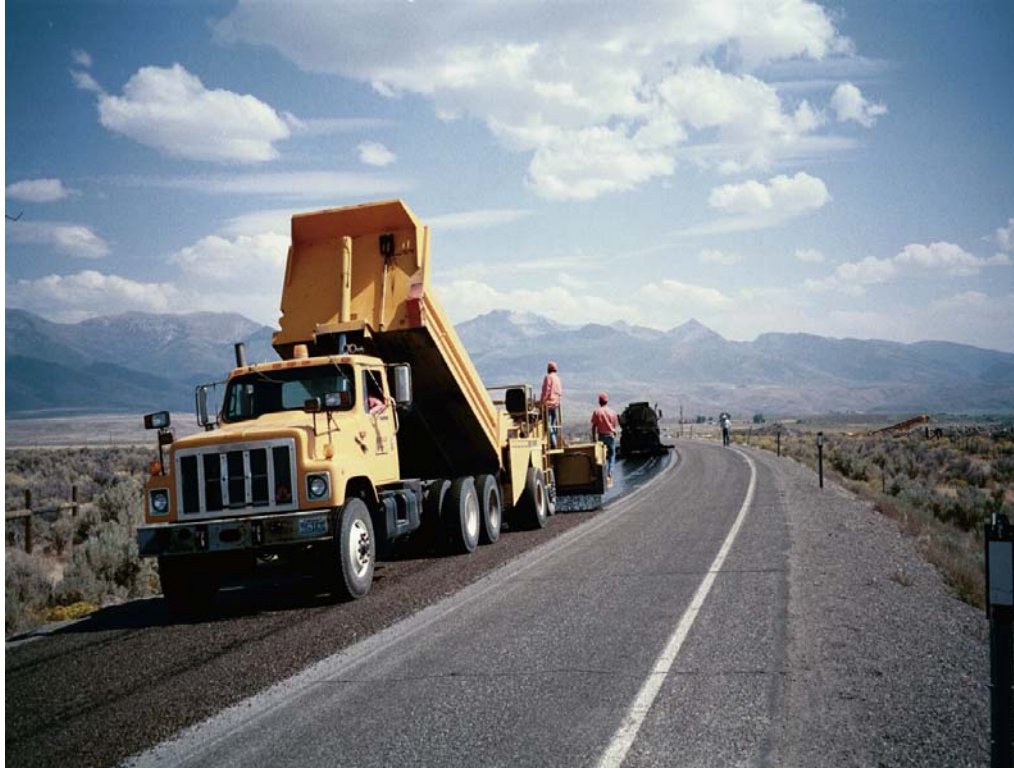
**FIGURE 5.1b Maintenance personnel place chip seal.**

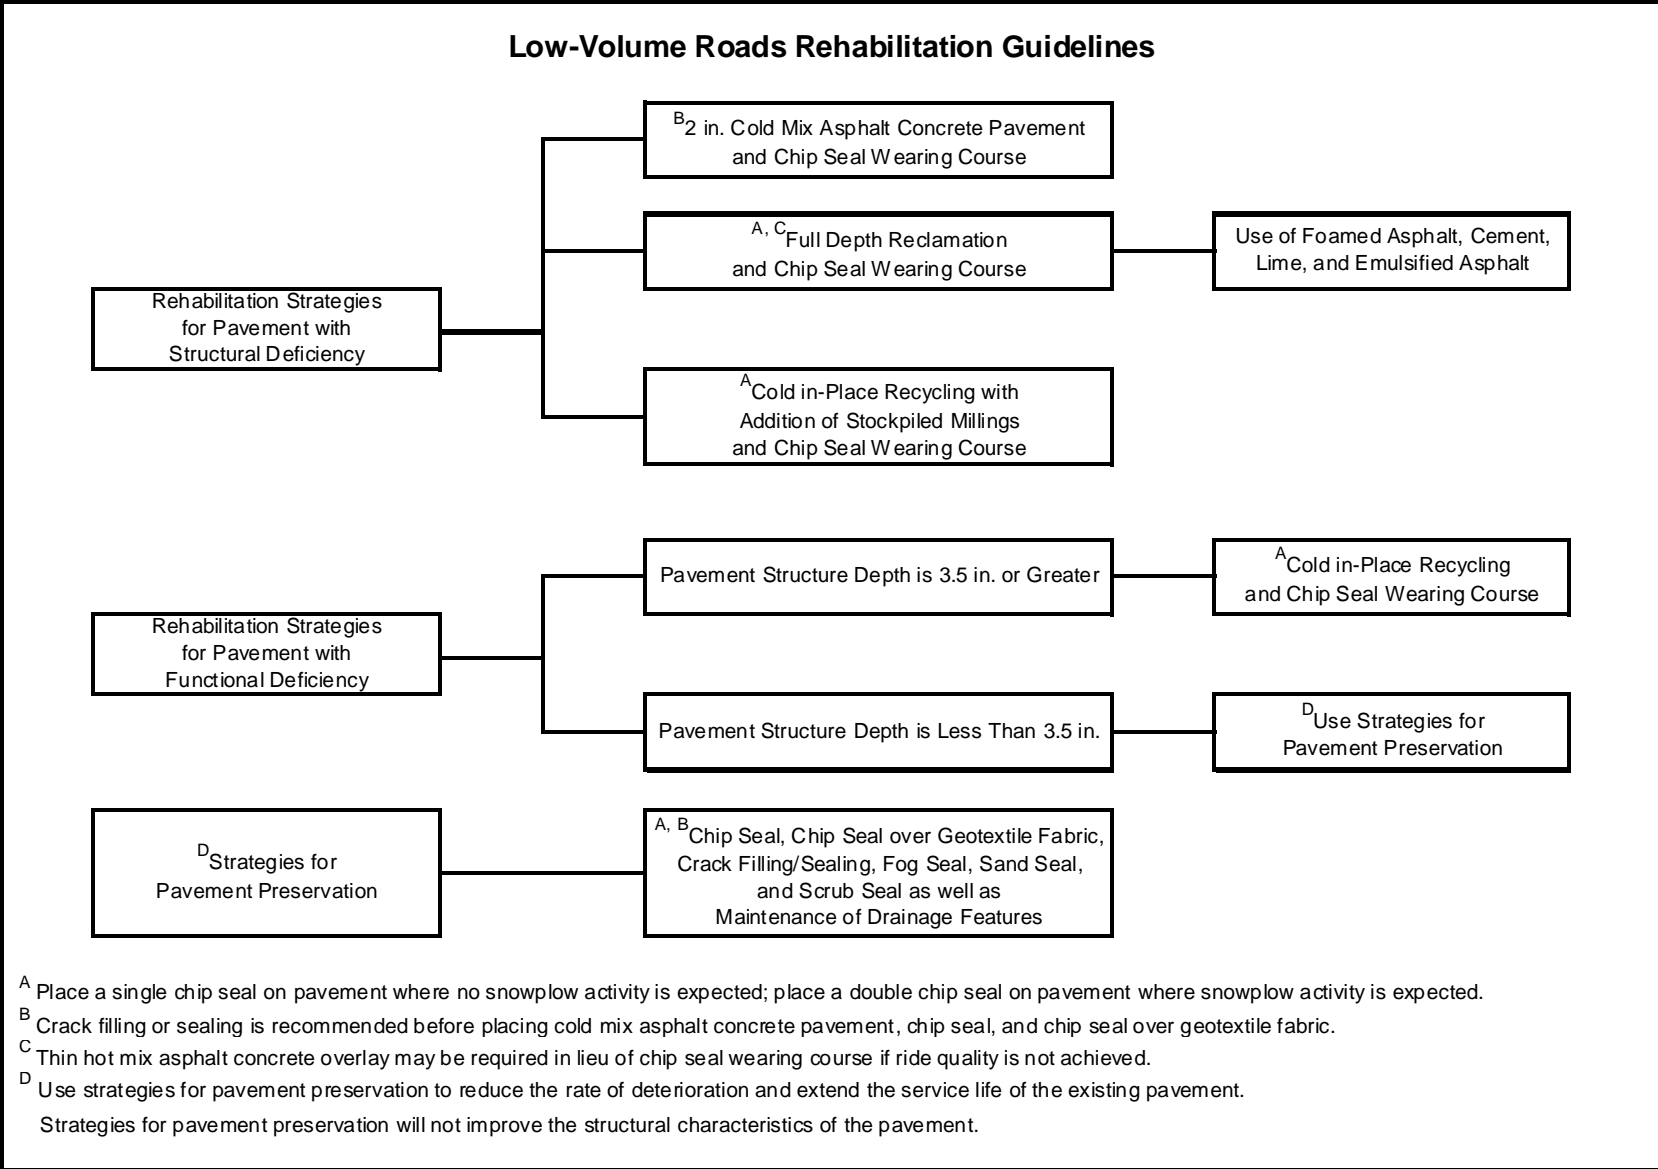
**FIGURE 7.3 Proposed low-volume roads rehabilitation guidelines.**

Pavement preservation includes the timely application of surface treatments to extend the service life of the pavement structure. The treatments do not include new and reconstructed pavements or treatments that increase the structural capacity of the pavement structure. Items to consider when choosing an appropriate surface treatment include durability, service life expectancy, material availability, weather limitations, context compatibility, and availability of skilled labor. Surface characteristics, construction impacts, safety, and long-term life-cycle cost should also be examined.

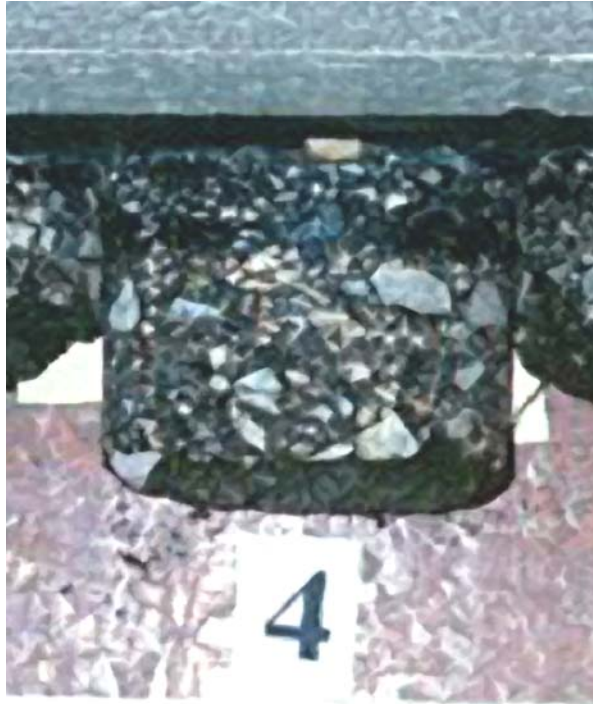
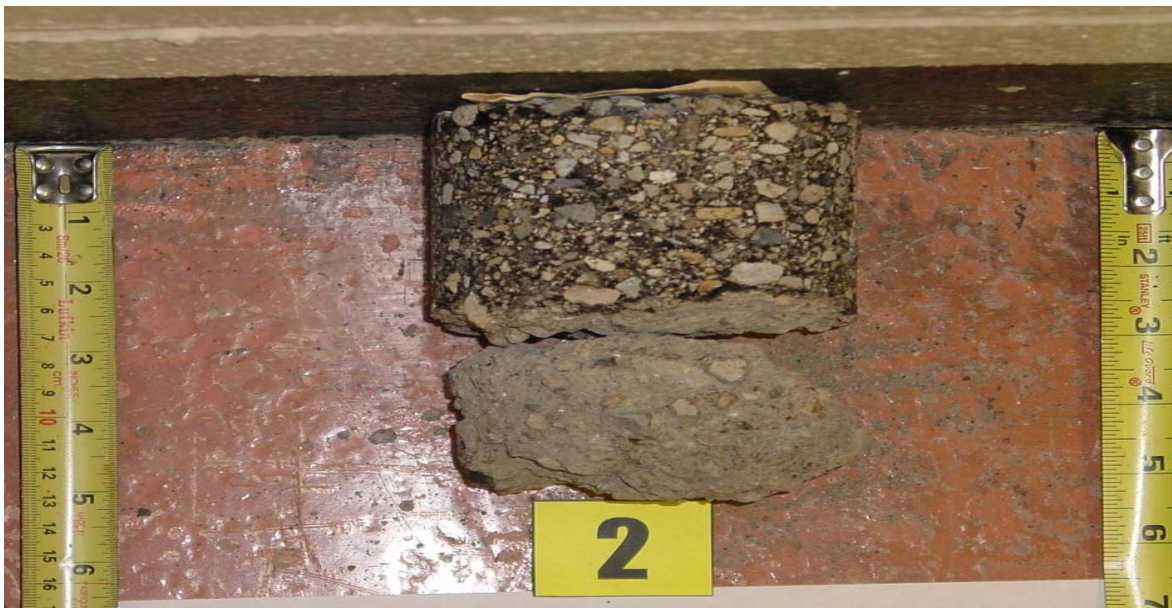
Before Construction: Medium Stripping  
Pavement Condition: High Severity Transverse Cracking

3 Years after Construction: Broke at 2.25 in.  
Pavement Condition: Low Severity Transverse Cracking

**FIGURE A.1 SR230: Full depth reclamation with CMS-2S and lime, 1.5 in. hot mix asphalt concrete overlay, and single chip seal.**

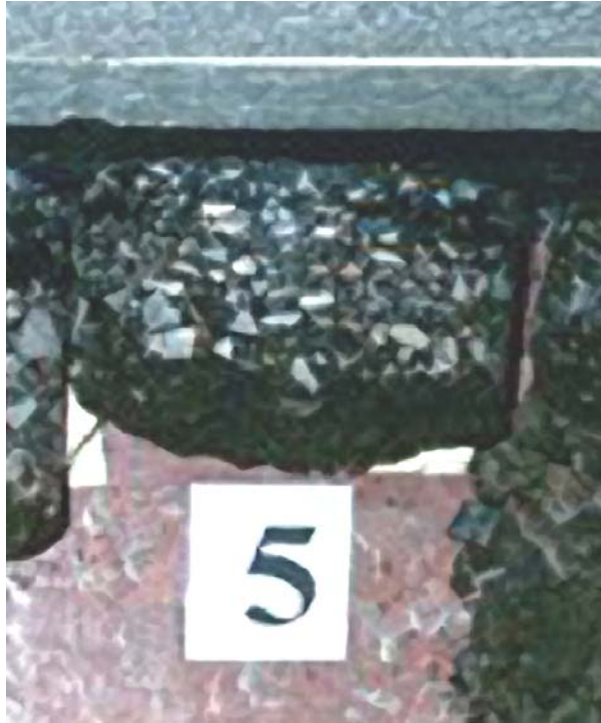
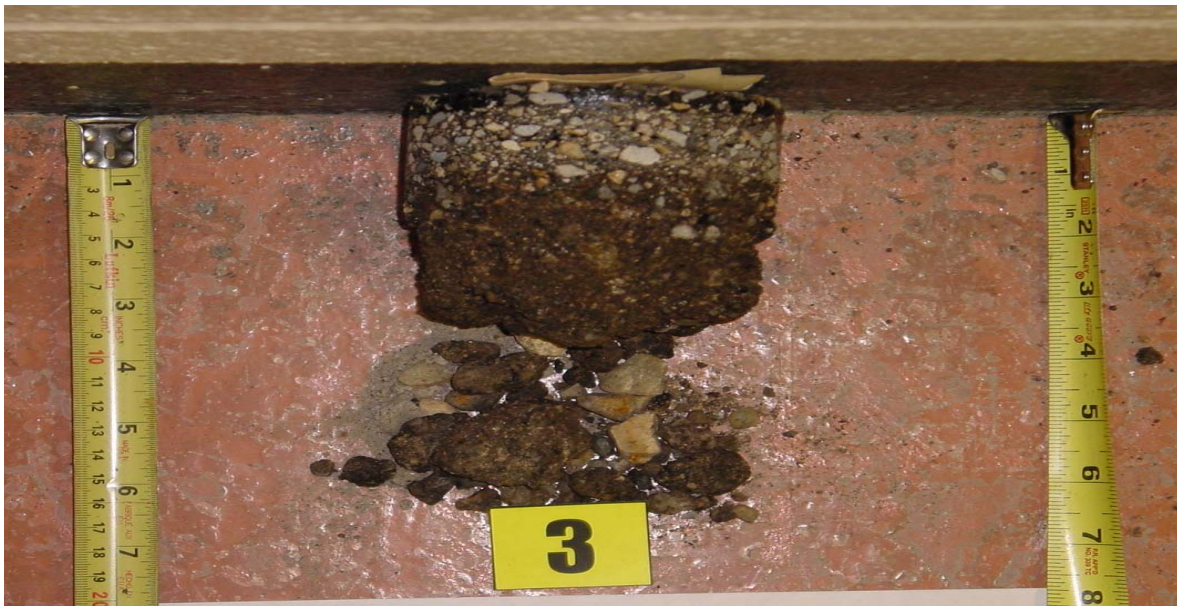
Before Construction: Stripped and Fell Apart  
Pavement Condition: Transverse and Fatigue Cracking

3 Years after Construction: Stripped and Fell Apart  
Pavement Condition: Good Condition

**FIGURE A.2 SR230: 3 in. full depth reclamation with proprietary liquid stabilizer, 1.5 in. hot mix asphalt concrete overlay, and single chip seal.**

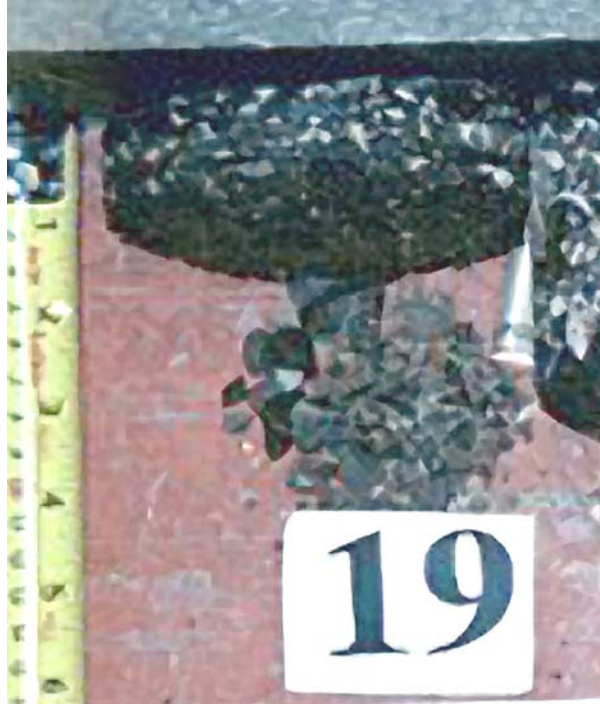
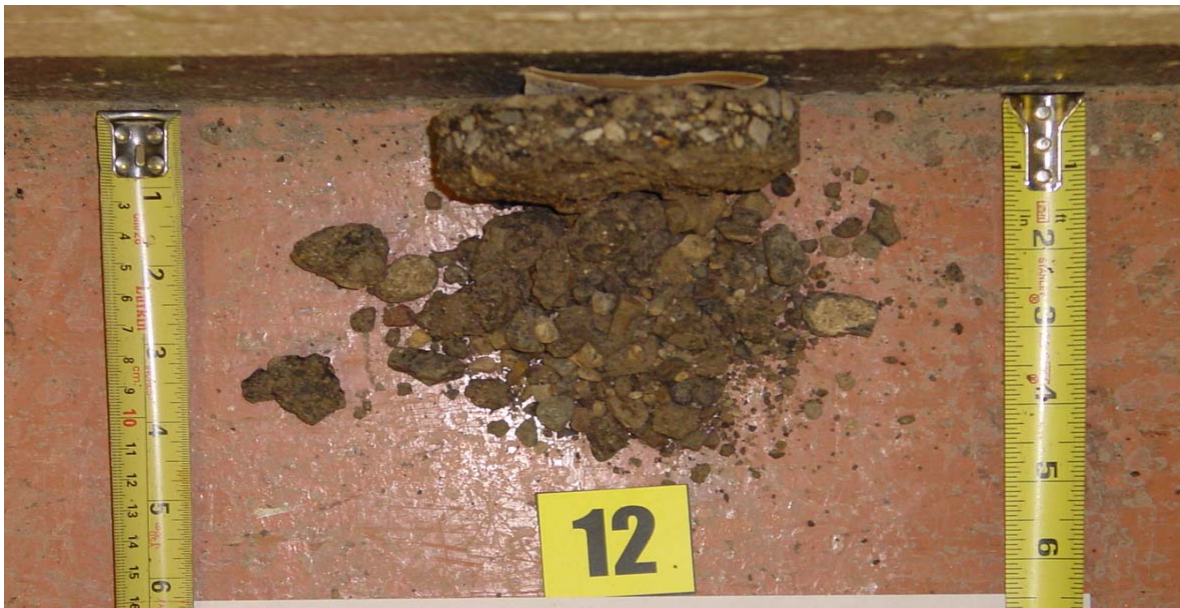
Before Construction: Stripped and Fell Apart  
Pavement Condition: Transverse and Fatigue Cracking

3 Years after Construction: Stripped and Fell Apart  
Pavement Condition: Good Condition

**FIGURE A.3 SR230: 6 in. full depth reclamation with proprietary liquid stabilizer, 1.5 in. hot mix asphalt concrete overlay, and single chip seal.**

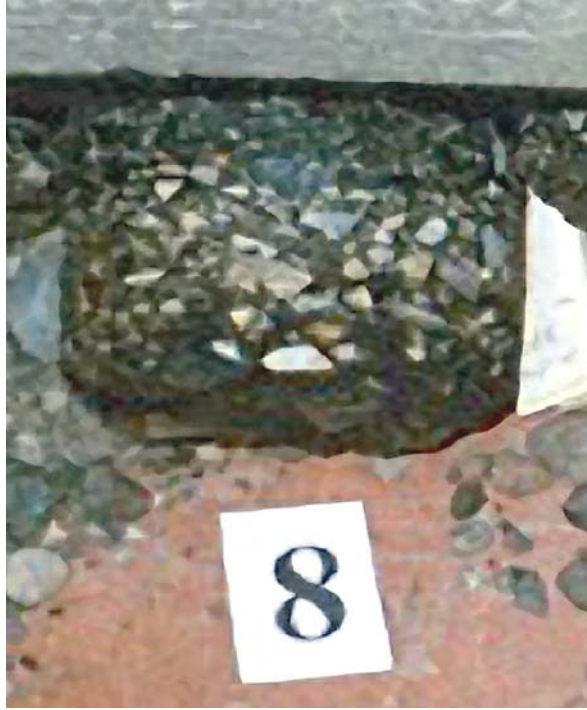
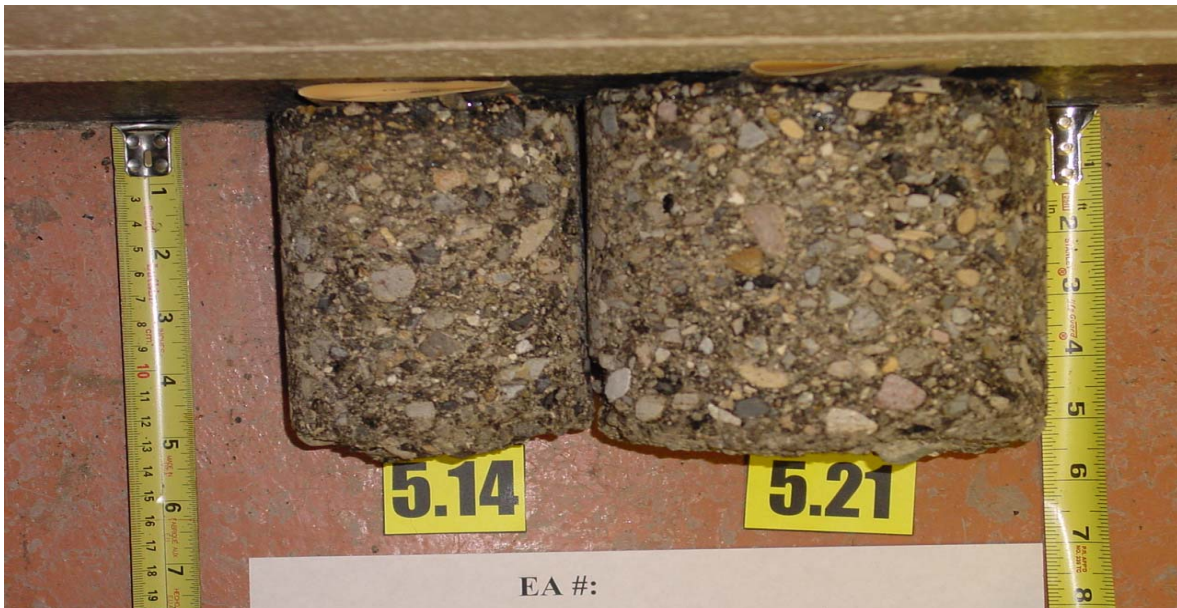
Before Construction: Medium Stripping  
Pavement Condition: High Severity Transverse Cracking

3 Years after Construction: Light Stripping  
Pavement Condition: Low Severity Transverse Cracking

**FIGURE A.4 SR230: Full depth reclamation with foamed asphalt and single chip seal (eastbound).**

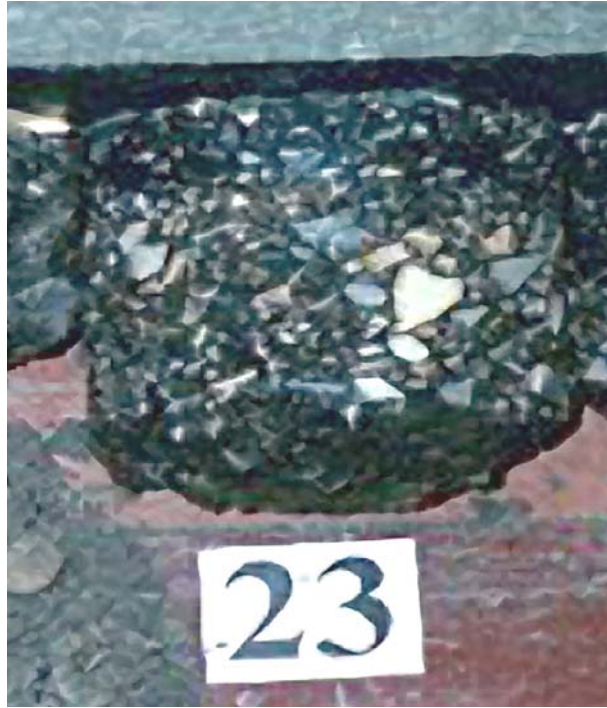
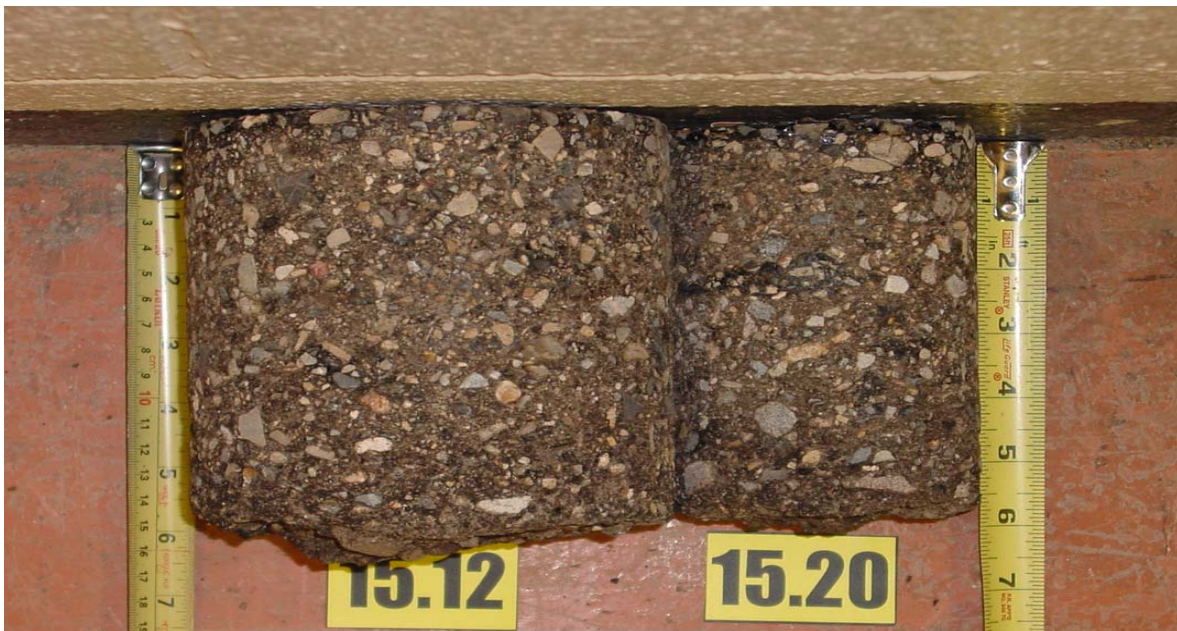
Before Construction: Heavy Stripping  
Pavement Condition: High Severity Transverse Cracking

3 Years after Construction: Light to Medium Stripping  
Pavement Condition: Low Severity Transverse Cracking

**FIGURE A.5 SR230: Full depth reclamation with foamed asphalt and single chip seal (westbound).**

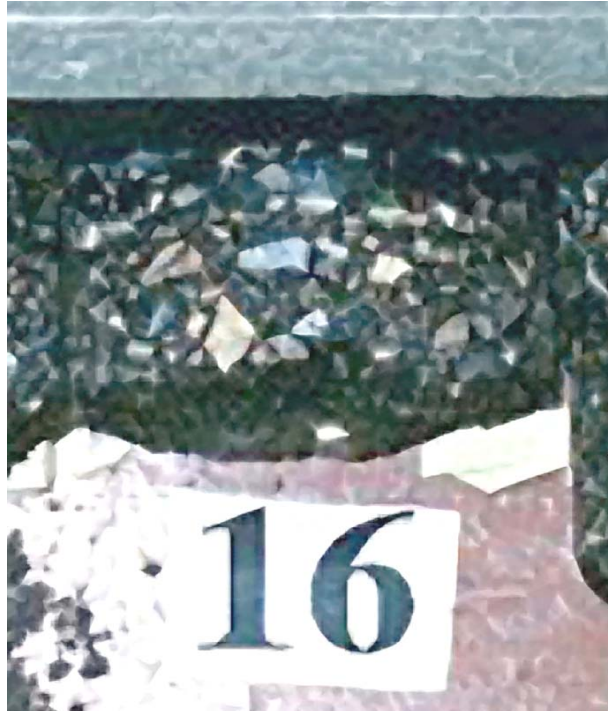
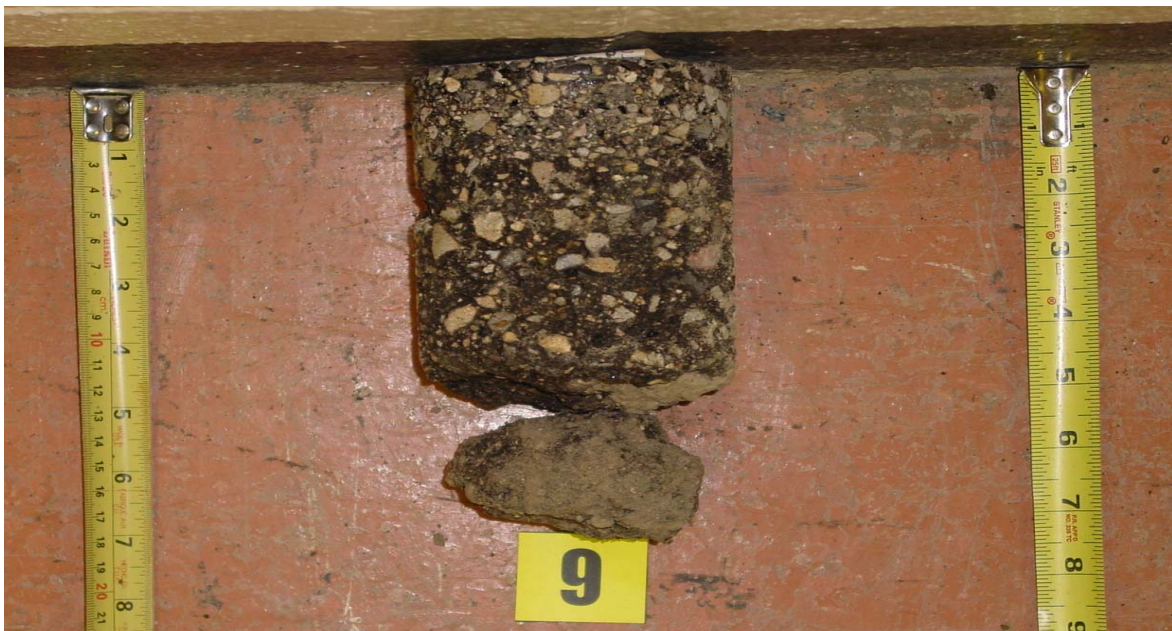
Before Construction: Medium Stripping  
Pavement Condition: High Severity Transverse Cracking

3 Years after Construction: Stripped and Fell Apart  
Pavement Condition: Good Condition

**FIGURE A.6 SR230: Full depth reclamation with proprietary emulsion, 1.5 in. hot mix asphalt concrete overlay, and single chip seal.**

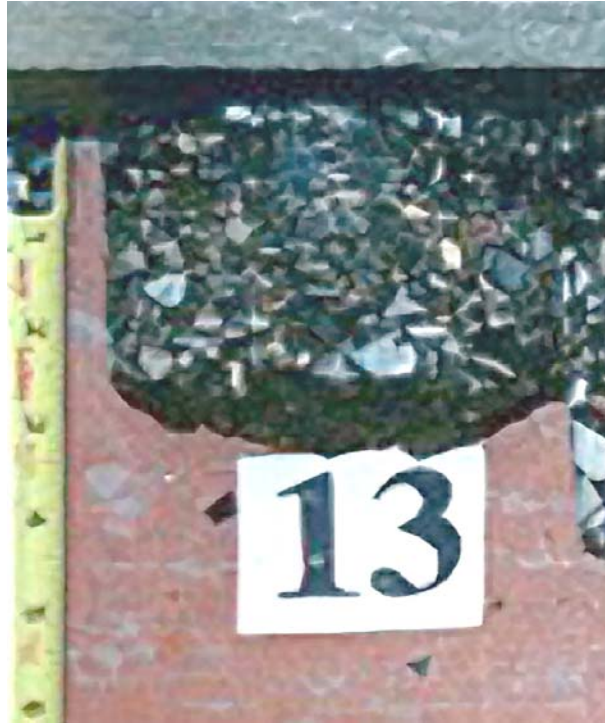
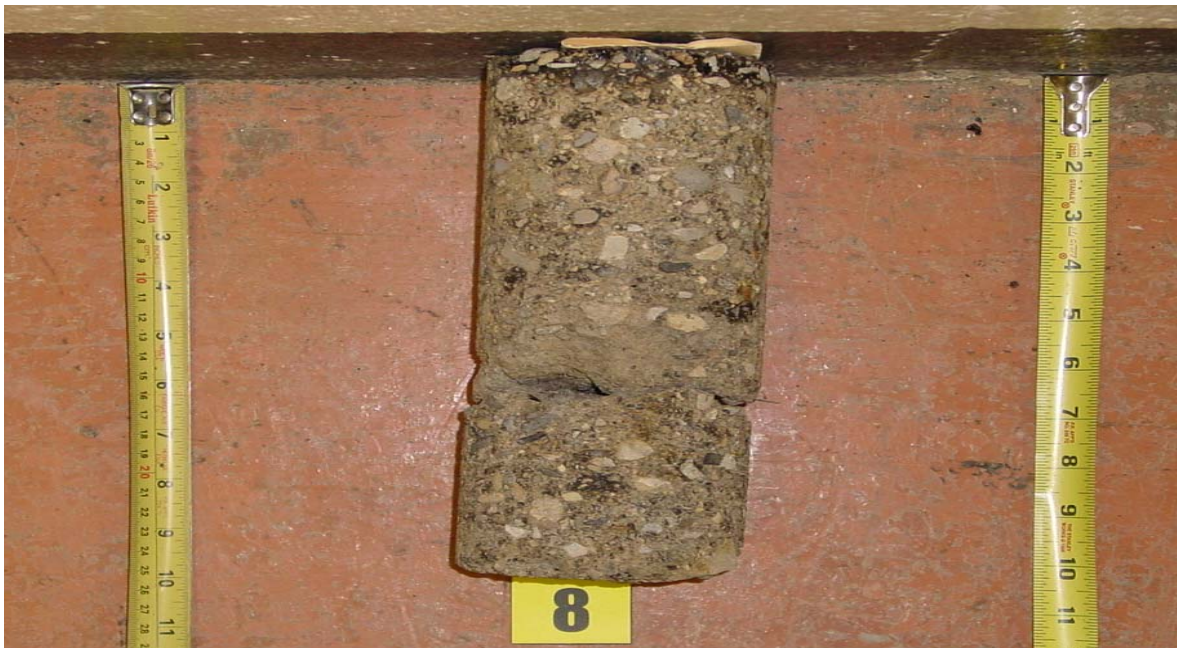
Before Construction: Medium Stripping  
Pavement Condition: High Severity Transverse Cracking

3 Years after Construction: Broke from 6.0 in. to 7.3 in.  
Pavement Condition: Low Severity Transverse Cracking

**FIGURE A.7 SR230: Full depth reclamation with 3.0% cement and double chip seal.**

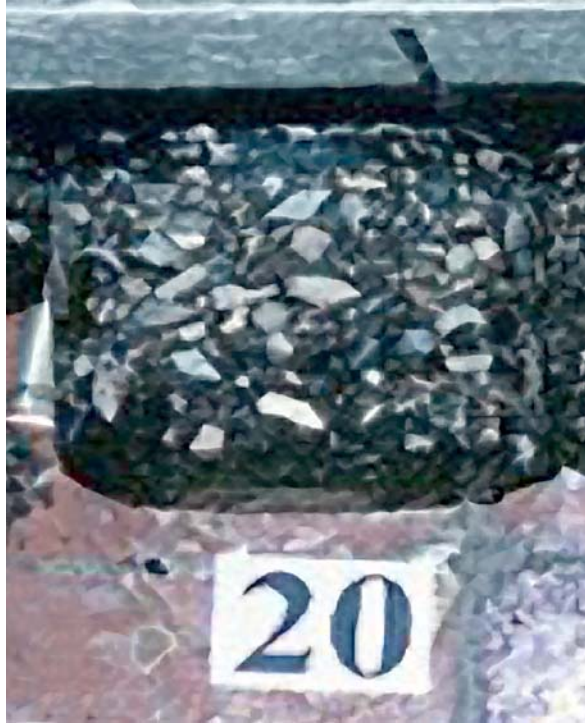
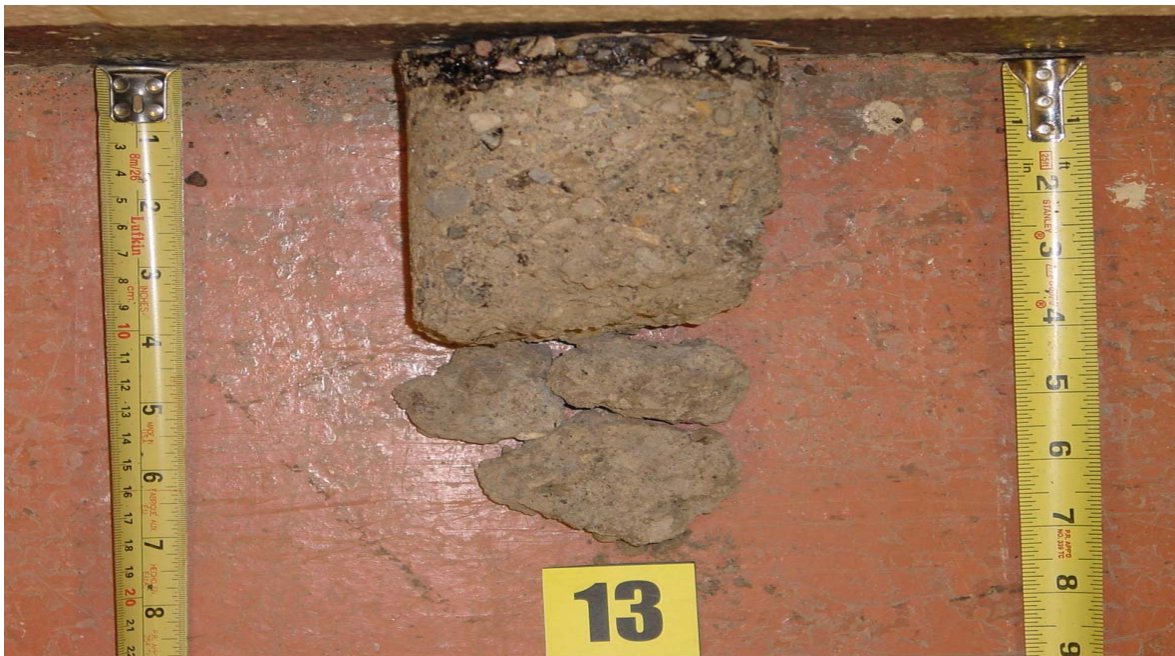
Before Construction: Medium Stripping  
Pavement Condition: Fatigue Cracking

3 Years after Construction: Broke and Fell Apart  
Pavement Condition: Good Condition

**FIGURE A.8 SR230: Full depth reclamation with 4.5% cement and double chip seal.**

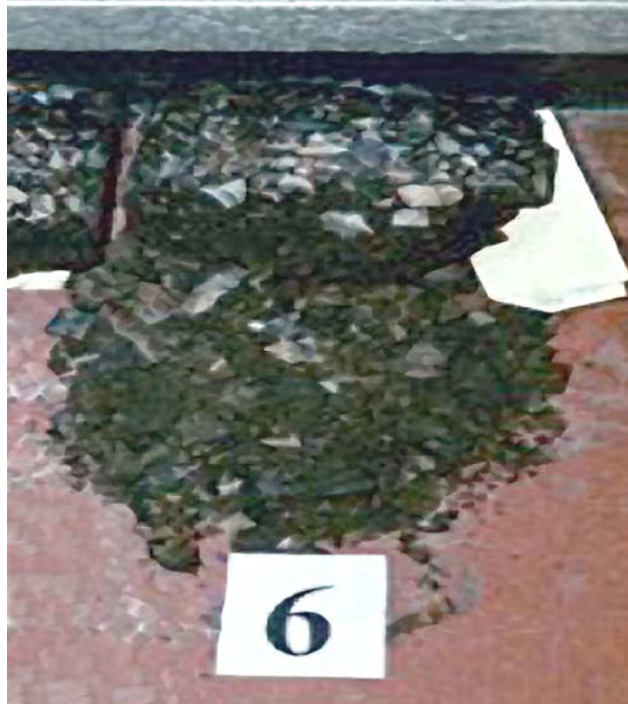
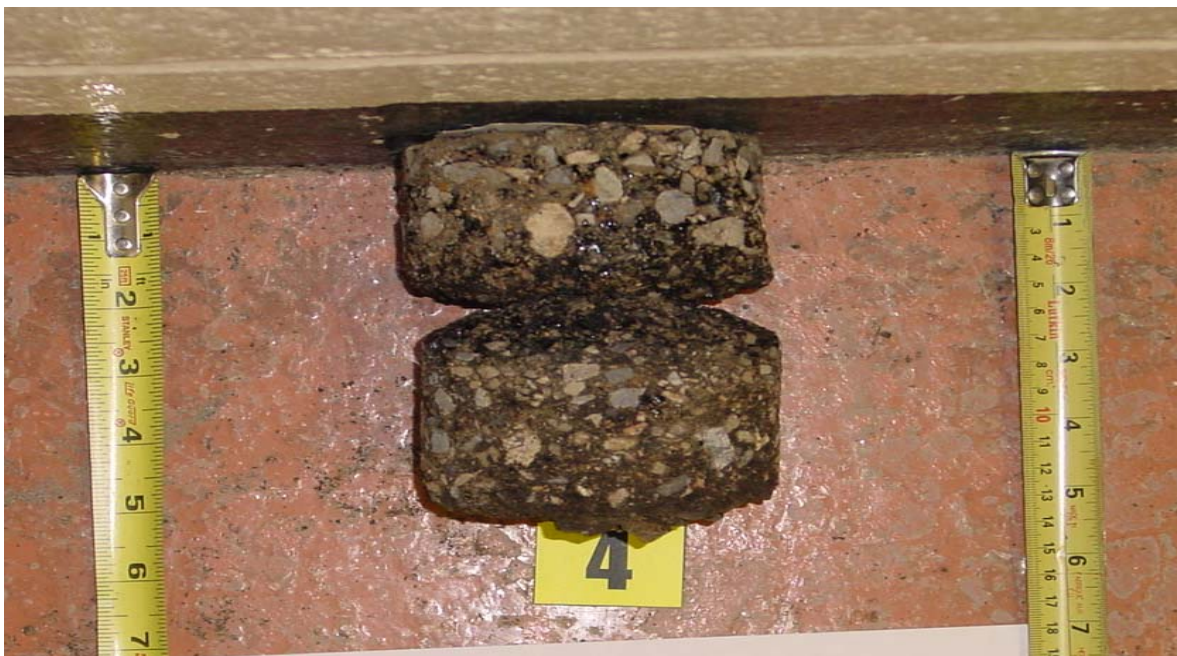
Before Construction: Heavy Stripping and Fell Apart  
Pavement Condition: Fatigue Cracking

3 Years after Construction: Delaminated at 2.3 in. with Medium to Heavy Stripping  
Pavement Condition: Good Condition

**FIGURE A.9 SR230: 2 in. cold mix asphalt concrete with CMS-2S and single chip seal (eastbound).**

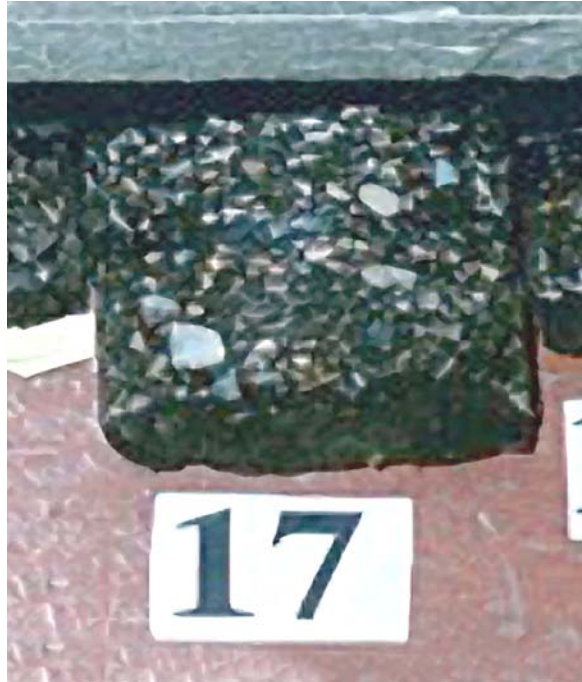
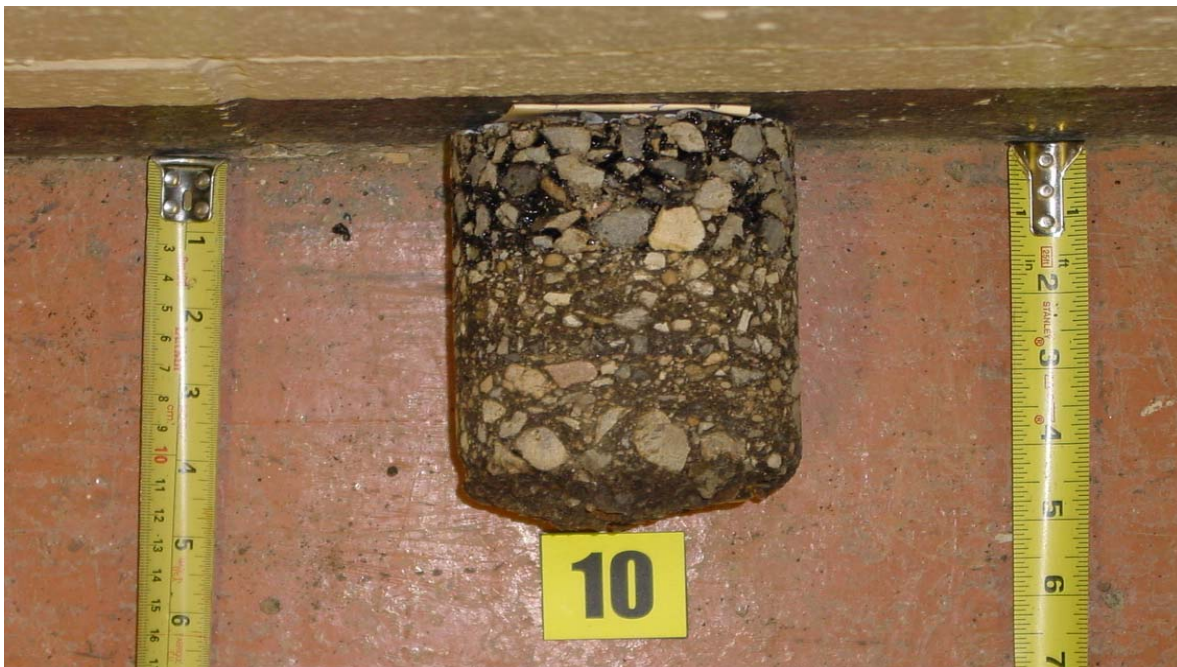
Before Construction: Light Stripping  
Pavement Condition: High Severity Transverse Cracking

3 Years after Construction: Light to Medium Stripping  
Pavement Condition: Good Condition

**FIGURE A.10 SR230: 2 in. cold mix asphalt concrete with CMS-2S and single chip seal (westbound).**
