# Exploring Alternative Strategies for the Rehabilitation of Low-Volume Roads in Nevada

Final Management Report

January 2008

Nevada Department of Transportation  
Carson City, Nevada

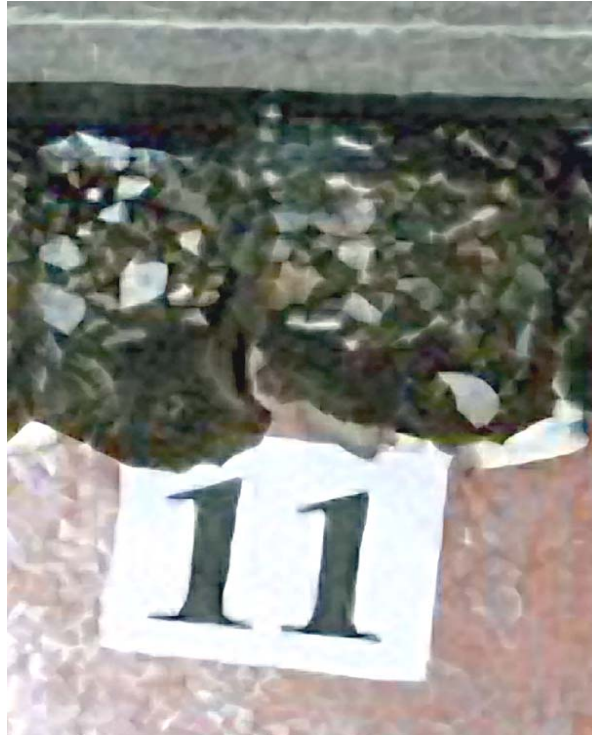
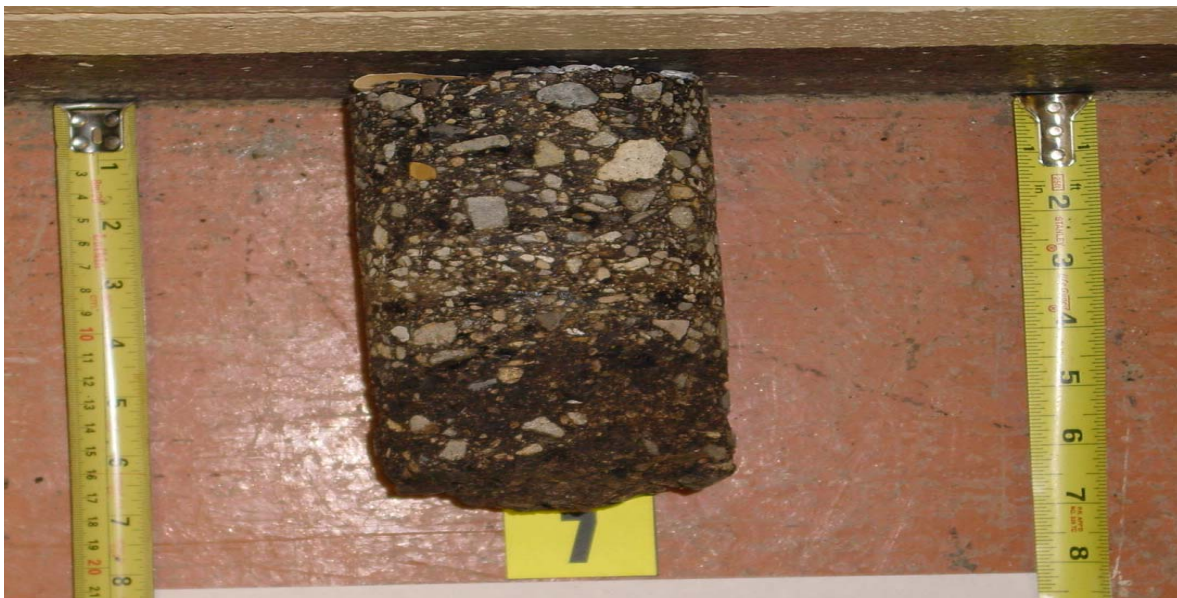
Before Construction: Heavy Stripping and Fell Apart  
Pavement Condition: Transverse and Fatigue Cracking

3 Years after Construction: Light to Medium Stripping  
Pavement Condition: Good Condition

**FIGURE A.11 SR230: 2 in. cold mix asphalt concrete with HFMS-2S and single chip seal.**

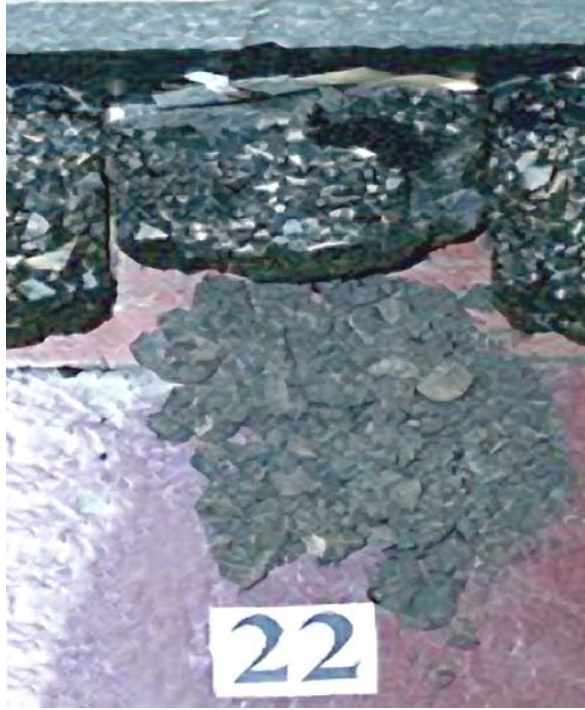
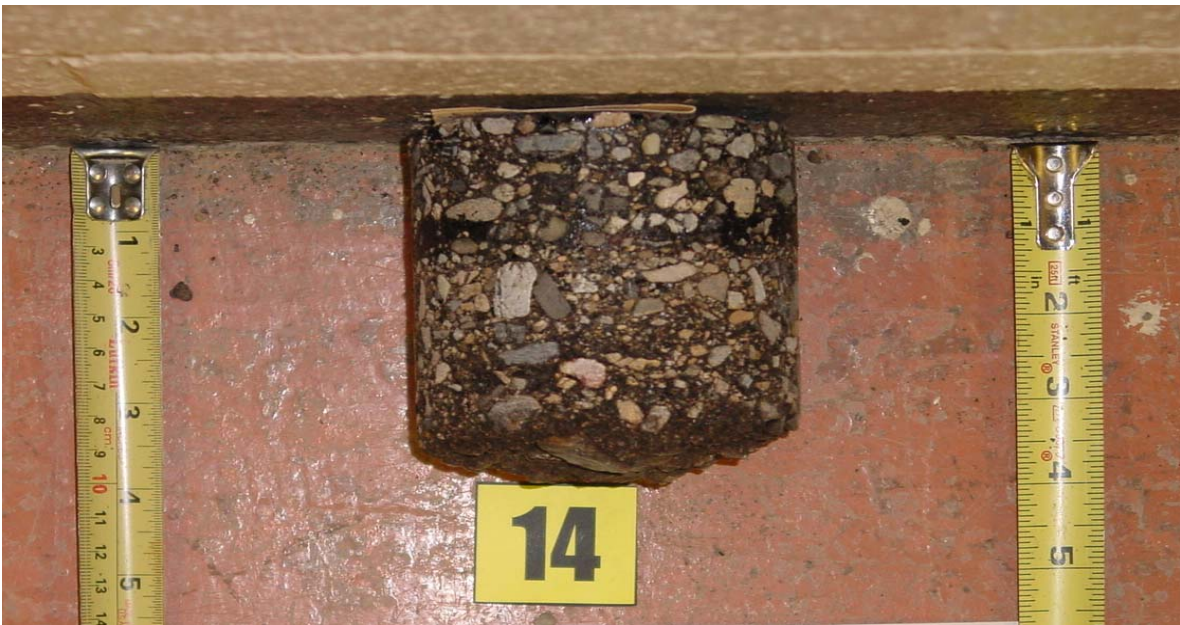
Before Construction: Heavy Stripping and Fell Apart  
Pavement Condition: High Severity Transverse Cracking

3 Years after Construction: Light to Medium Stripping  
Pavement Condition: Good Condition

**FIGURE A.12 SR230: 2 in. cold mix asphalt concrete with MC-800 and single chip seal.**

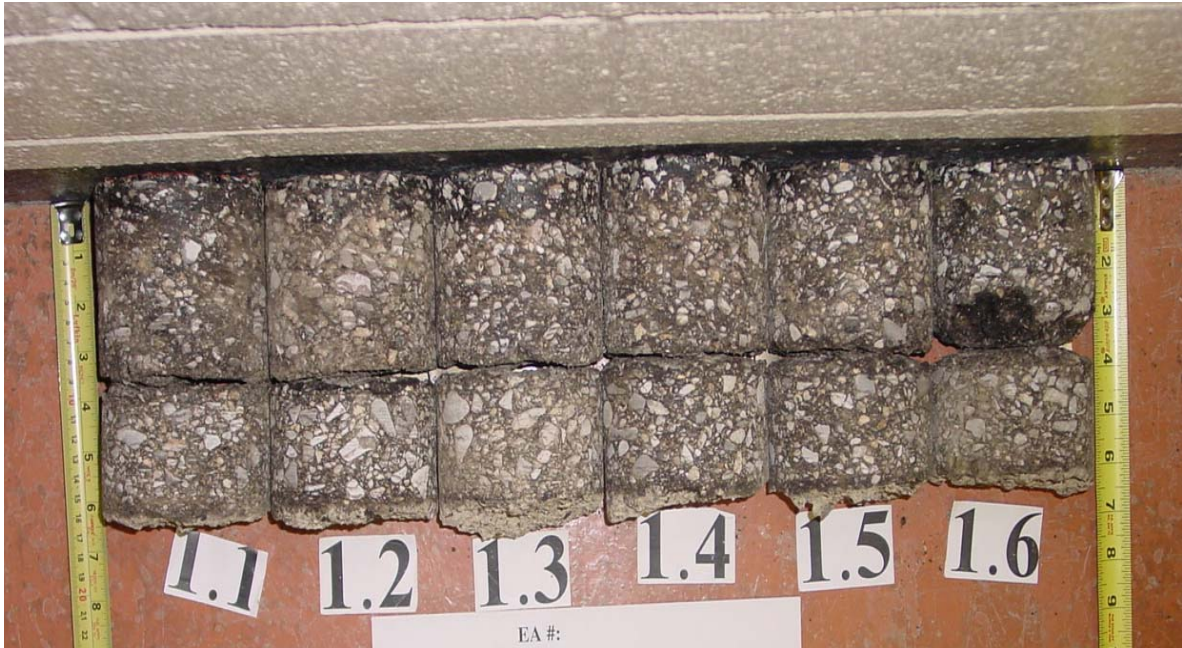
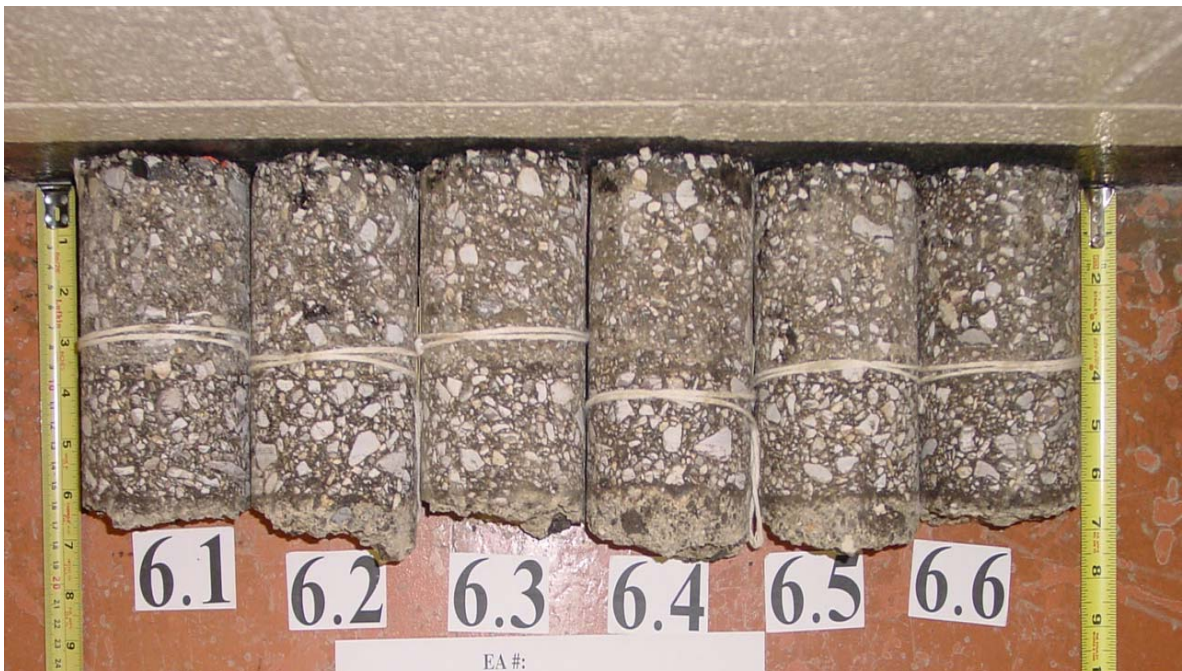
(a) 2 Years after Construction: Delaminated at 3.6 in. with Light to Medium Stripping  
Pavement Condition: Good Condition

(b) 2 Years after Construction: Cores in Good Condition  
Pavement Condition: Good Condition

**FIGURE A.13 US006: 3 in. cold in-place recycling with (a) solvent free emulsified asphalt, no lime, and double chip seal and (b) CMS-2S, lime, and double chip seal.**

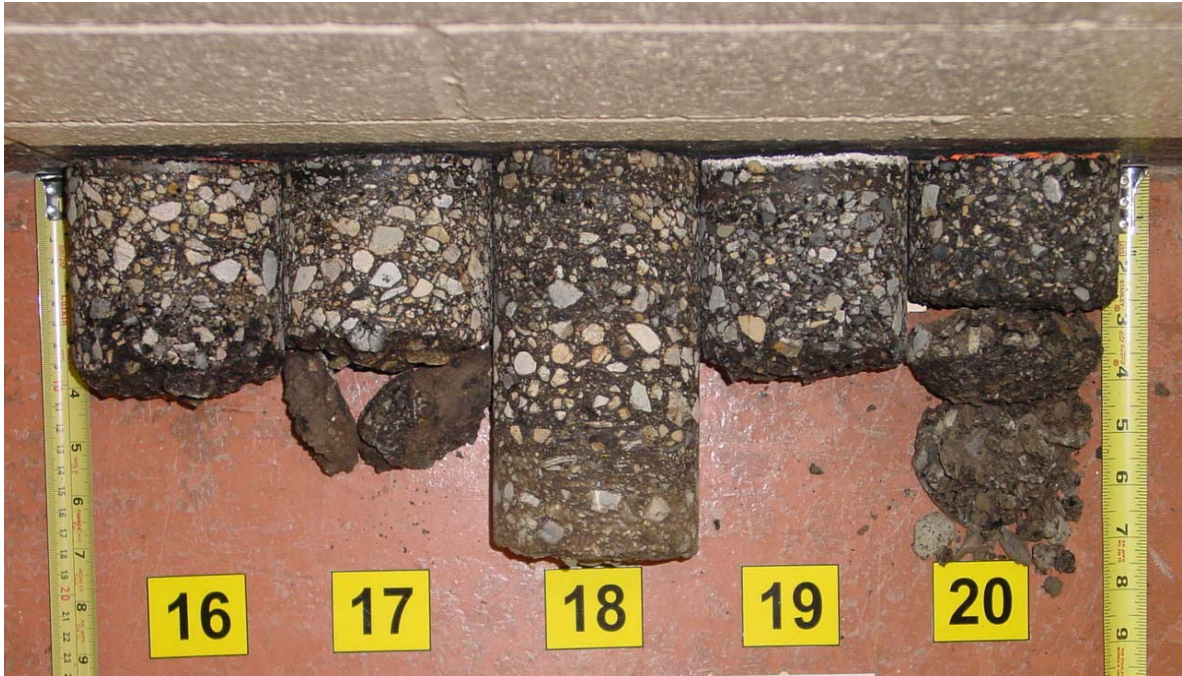
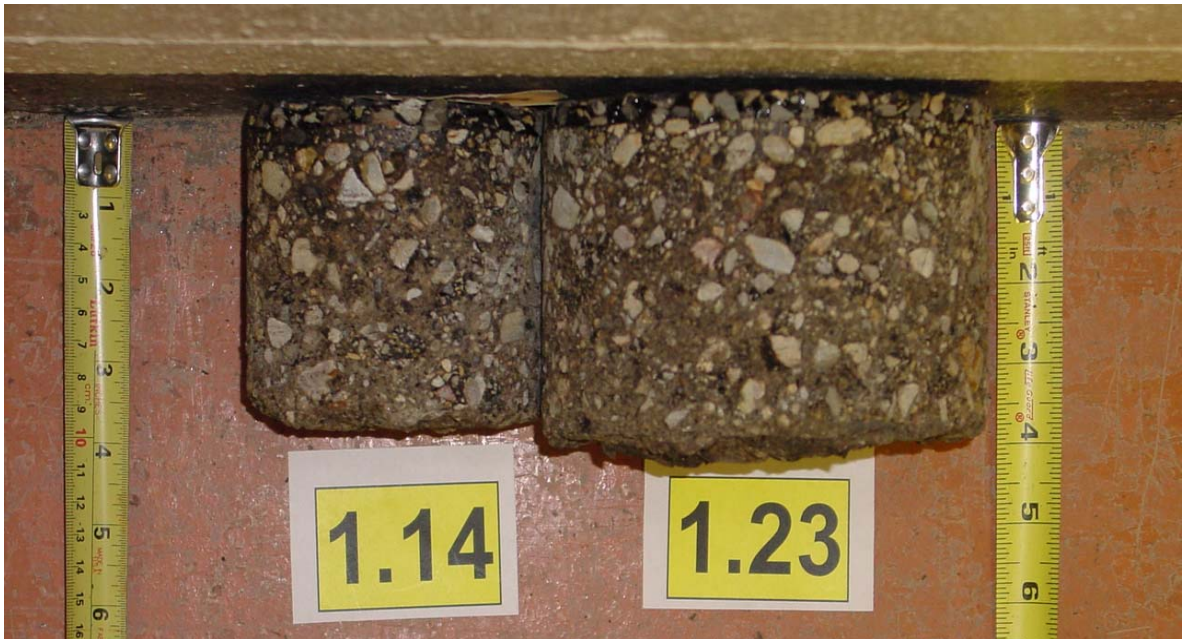
Before Construction: Light to Heavy Stripping, Delaminated, and Fell Apart  
Pavement Condition: Transverse and Nonwheel Path Cracking

1 Year after Construction: Light Stripping  
Pavement Condition: Good Condition

**FIGURE A.14 SR226: 3 in. cold in-place recycling with CMS-2S, lime, and double chip seal.**

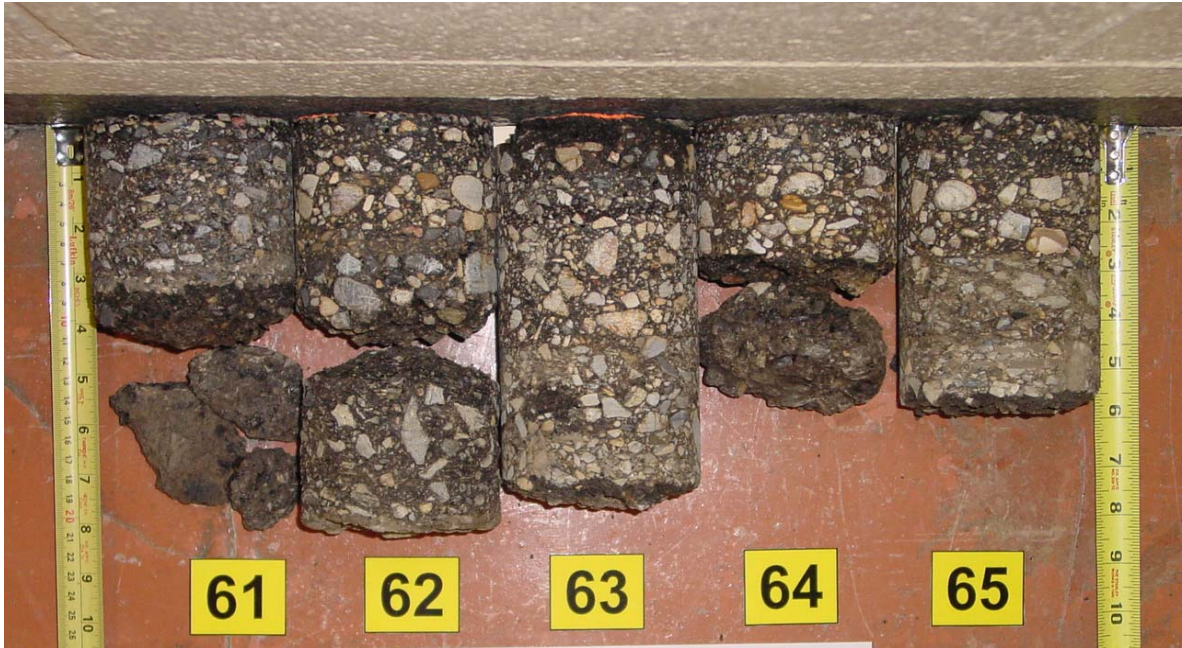
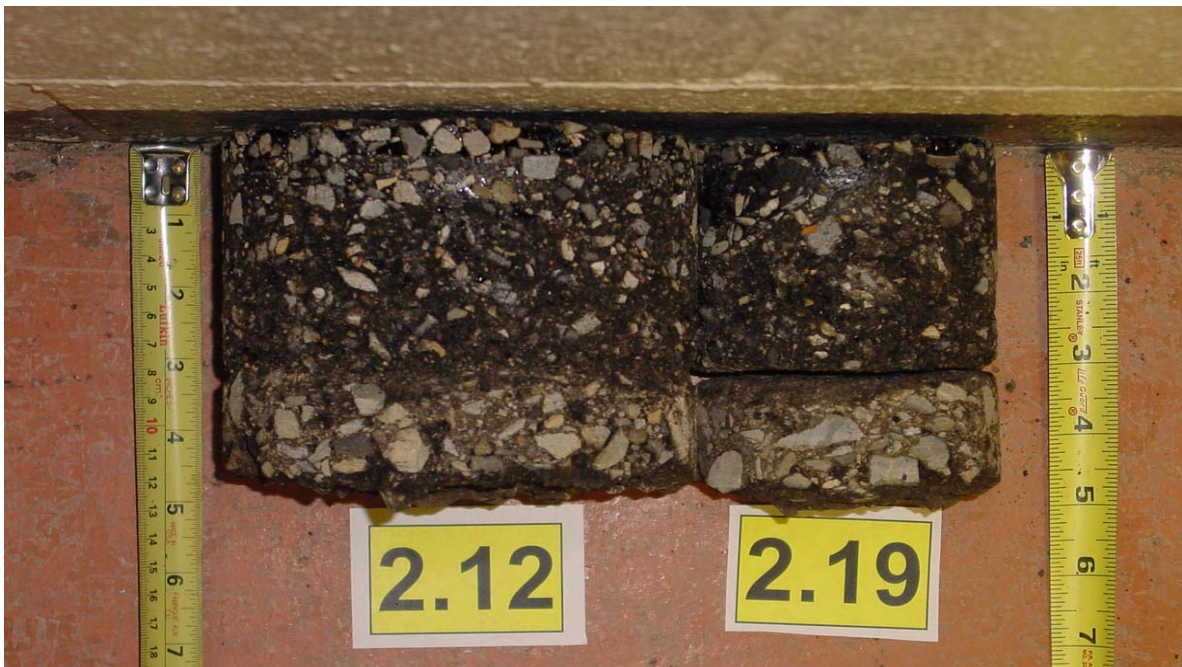
Before Construction: Light to Heavy Stripping and Fell Apart  
 Pavement Condition: Transverse and Nonwheel Path Cracking

1 Year after Construction: Light to Medium Stripping and Delaminated at 3.0 in.  
 Pavement Condition: Good Condition

**FIGURE A.15 SR226: 3 in. cold in-place recycling with solvent free emulsified asphalt, no lime, and double chip seal.**

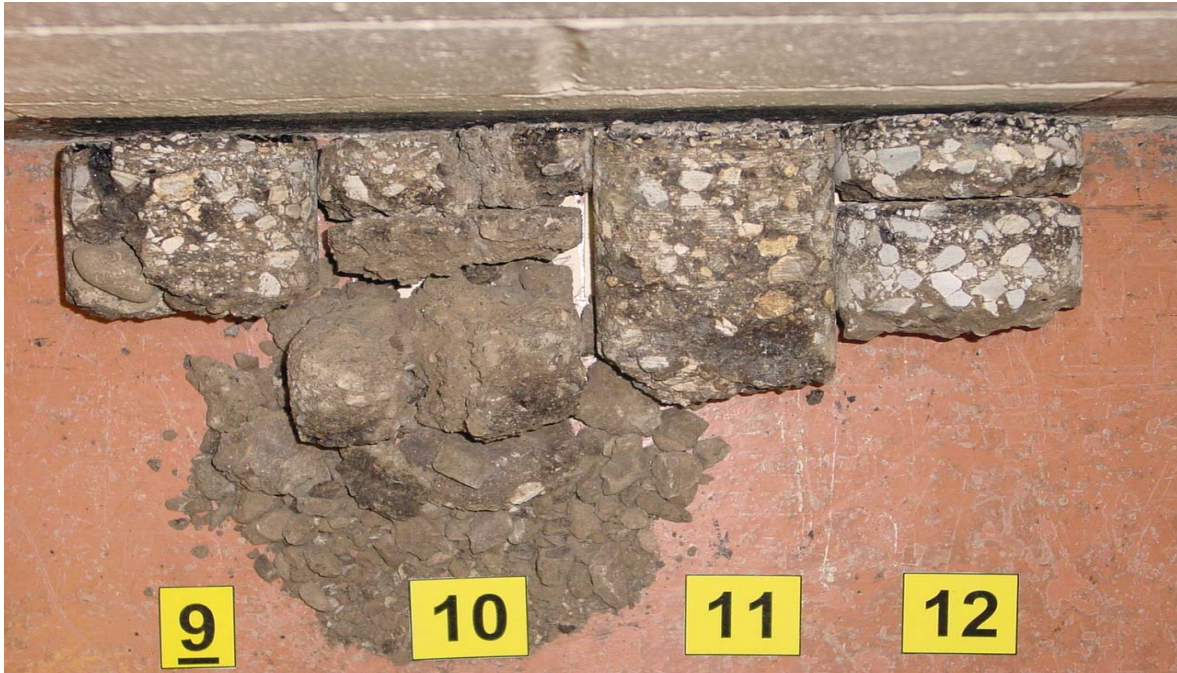
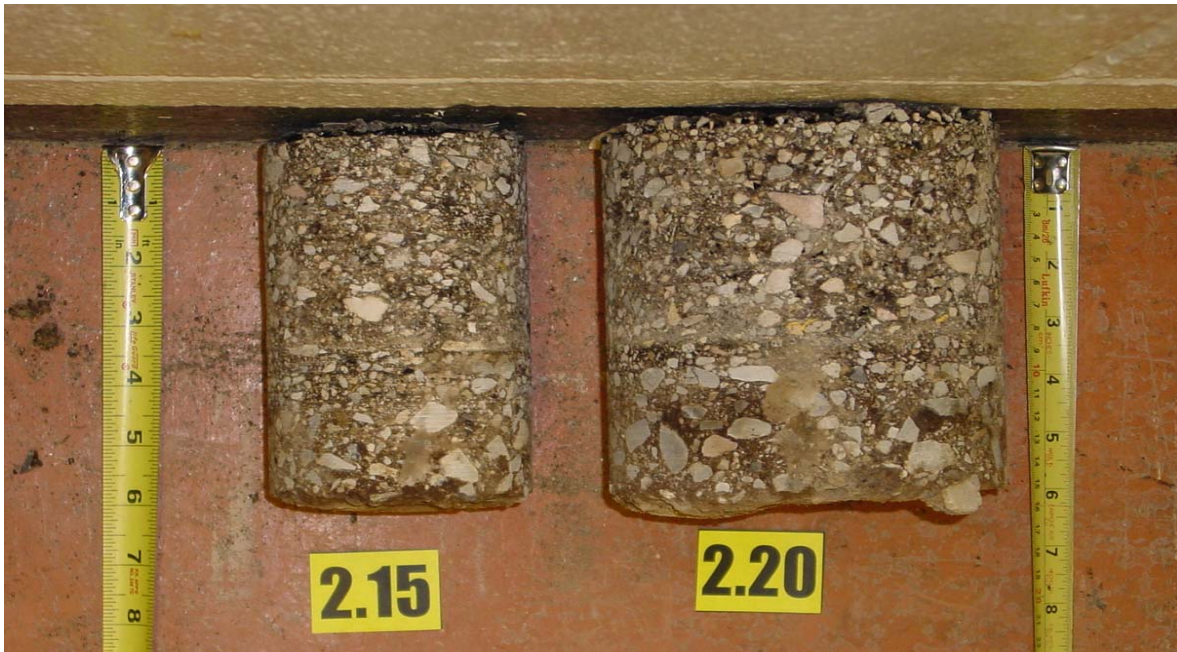
Before Construction: Light to Heavy Stripping, Delaminated, and Fell Apart  
Pavement Condition: Transverse and Block Cracking

2 Months after Construction: Cores in Good Condition  
Pavement Condition: Good Condition

**Figure A.16 SR168: 3 in. cold in-place recycling with stockpiled millings and CMS-2S, lime, and single chip seal.**

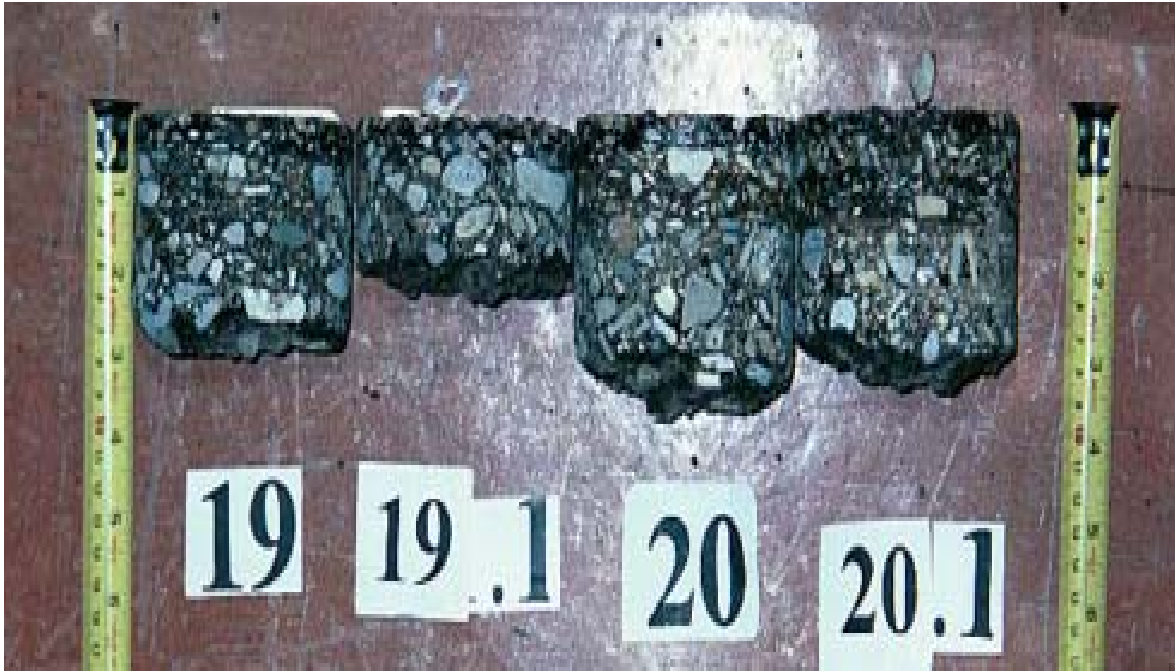
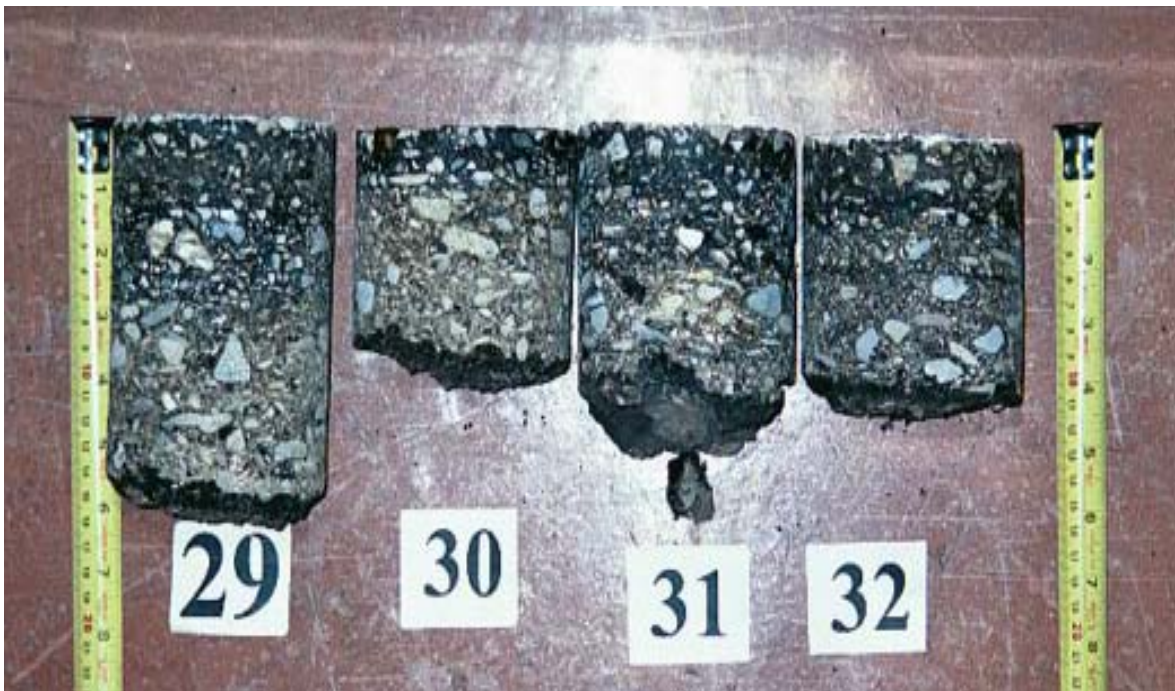
Before Construction: Light Stripping  
Pavement Condition: Transverse and Fatigue Cracking

Before Construction: Light Stripping  
Pavement Condition: Transverse Cracking

**FIGURE A.17 SR892: Before construction.**

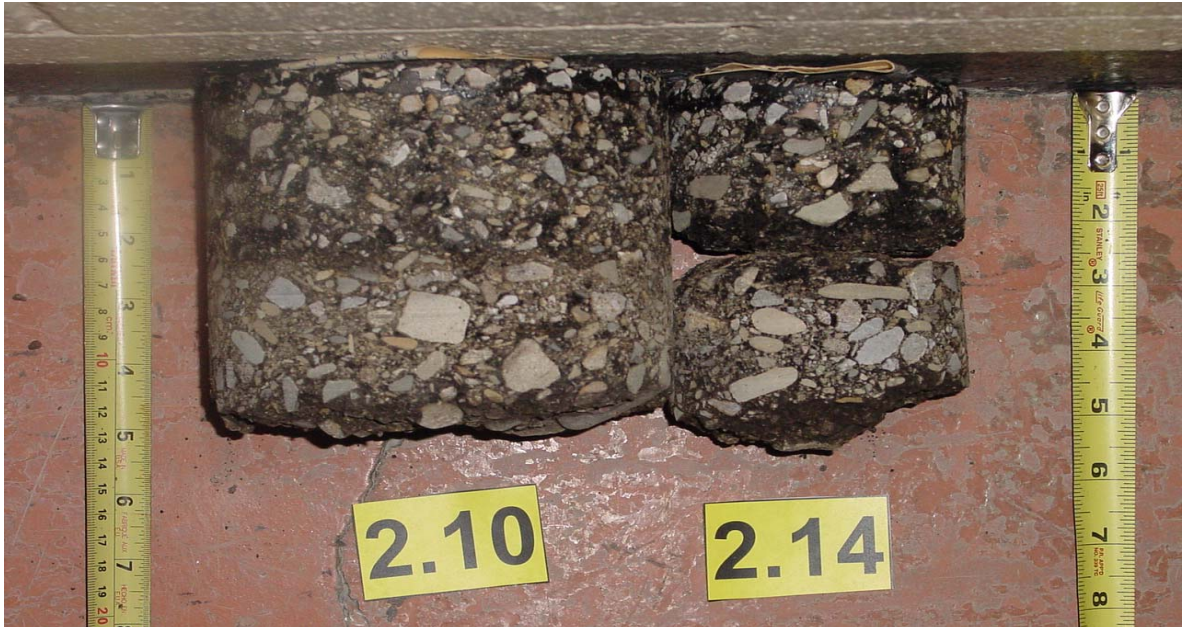
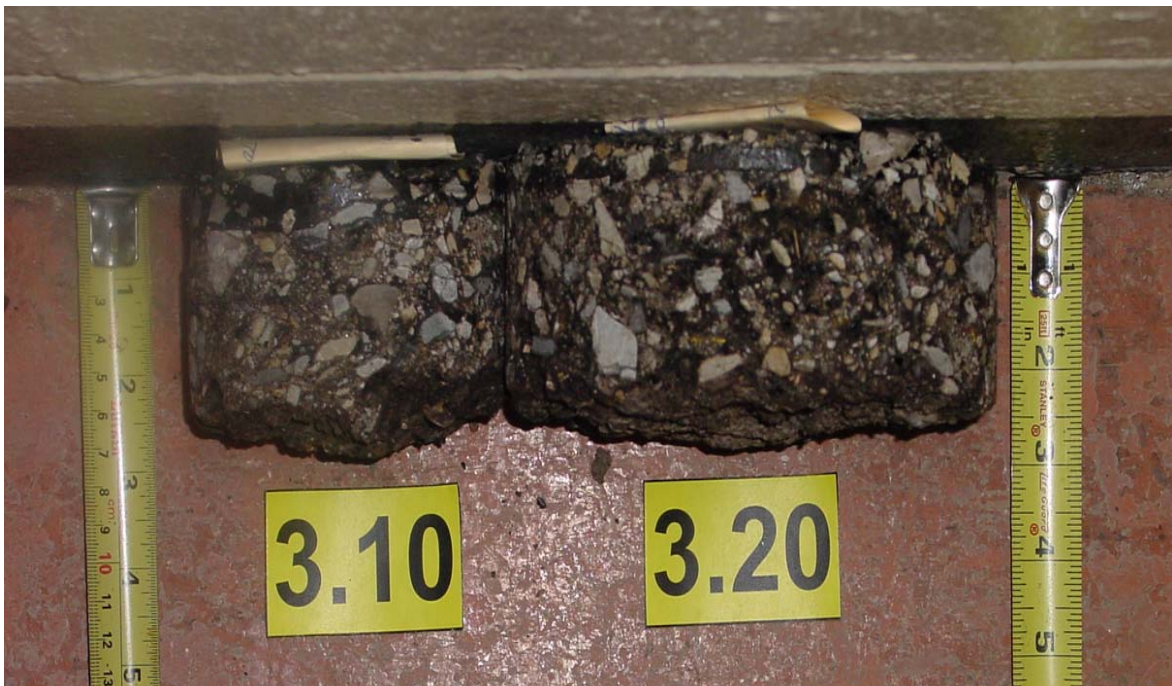
(a) 4 Months after Construction: Light to Medium Stripping and Delaminated  
Pavement Condition: Good Condition

(b) 4 Months after Construction: Light Stripping  
Pavement Condition: Good Condition

**FIGURE A.18 SR892: 2 in. cold in-place recycling with (a) polymer modified emulsified asphalt, no lime, and double chip seal and (b) solvent free emulsified asphalt, no lime, and double chip seal.**
