INVESTIGATION OF CORROSION OF MSE WALLS IN NEVADA

Final Report to:
NEVADA DEPARTMENT OF TRANSPORTATION
1263 South Stewart Street
Carson City, Nevada 89712

Research Report No. 2010-01
September 2010

UNIVERSITY OF NEVADA, RENO

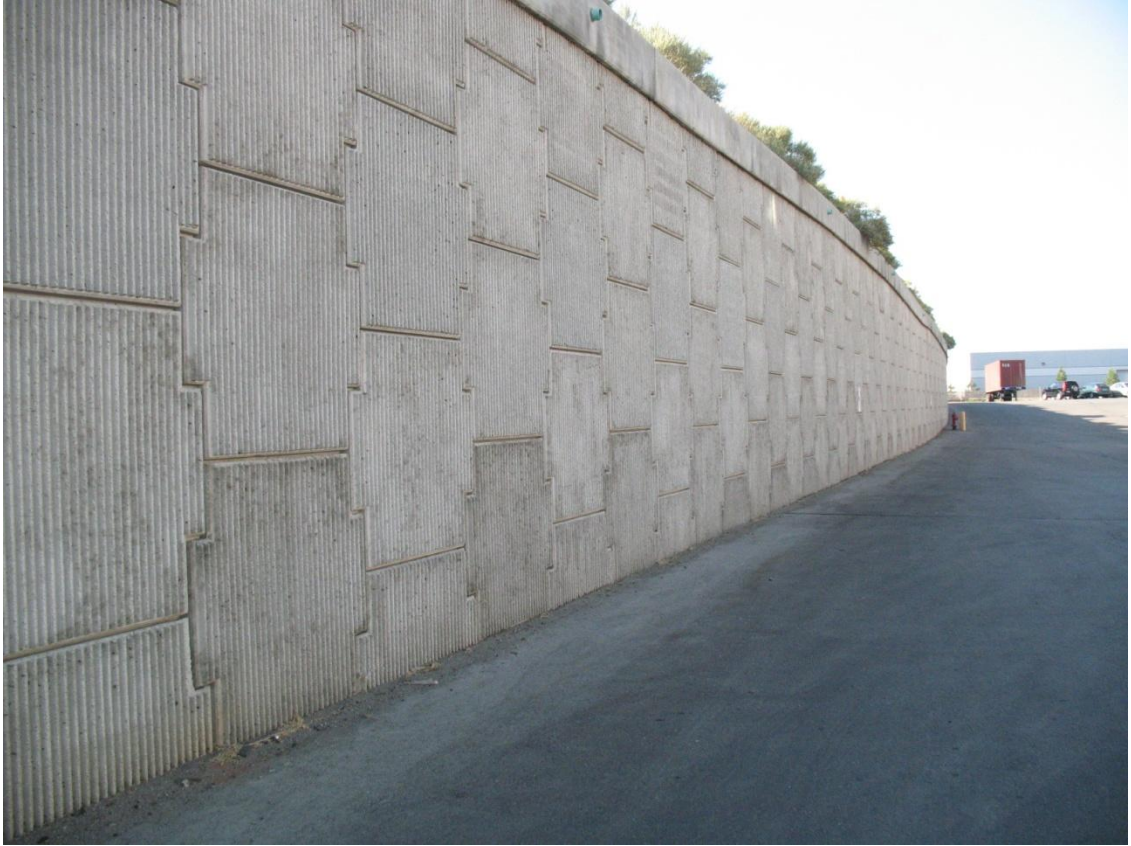
Figure 1. MSE Wall Located at South McCarran and I-80 (Contract #2957)

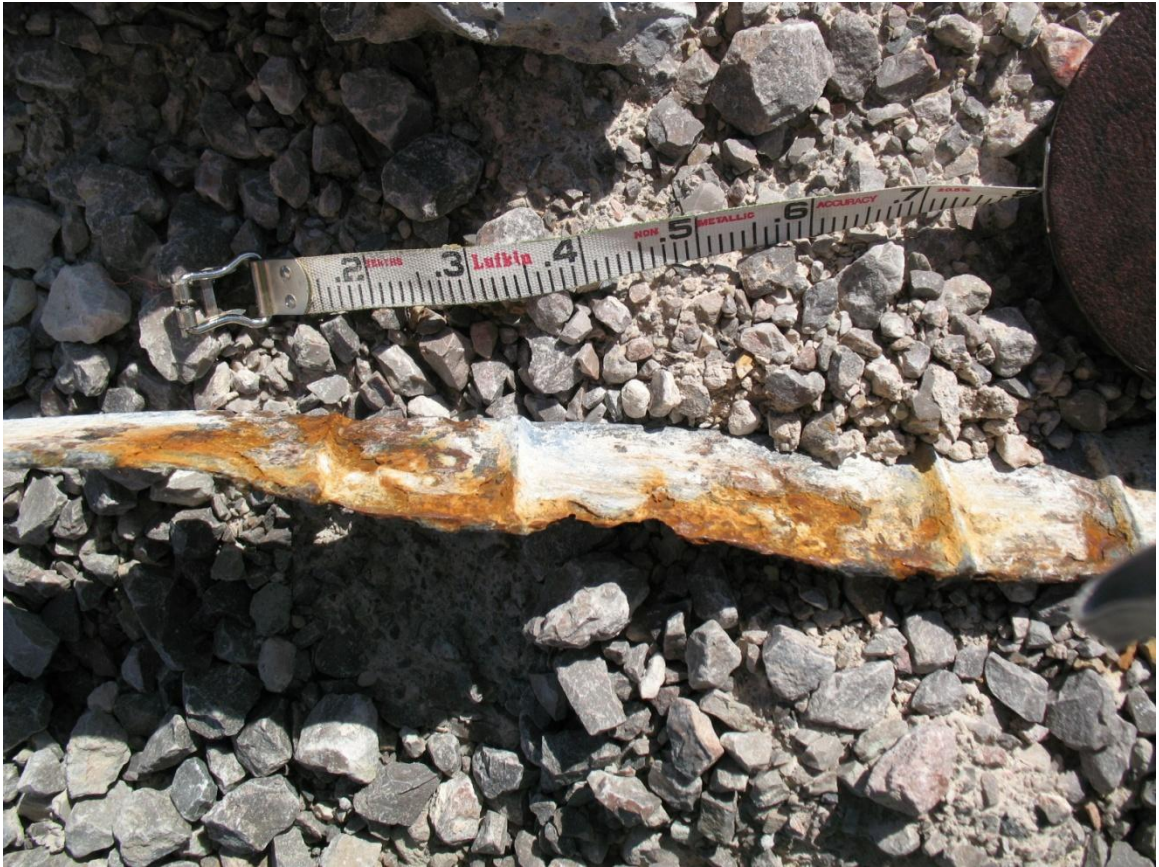
Figure 47. Cheyenne MSE Wall Corrosion Investigation - Highly Corroded Reinforcing Strip

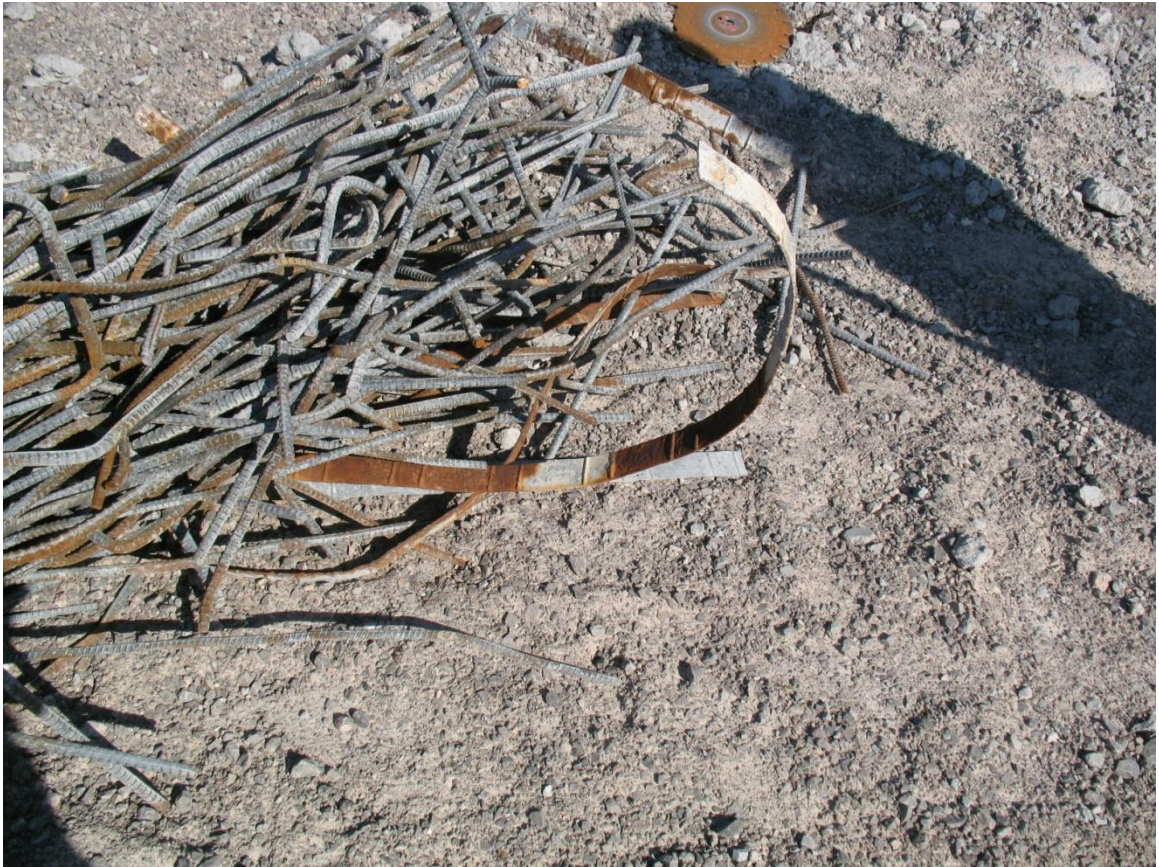
Figure 48. Cheyenne MSE Wall Corrosion Investigation - Reinforcing Strips in Pile of Debris

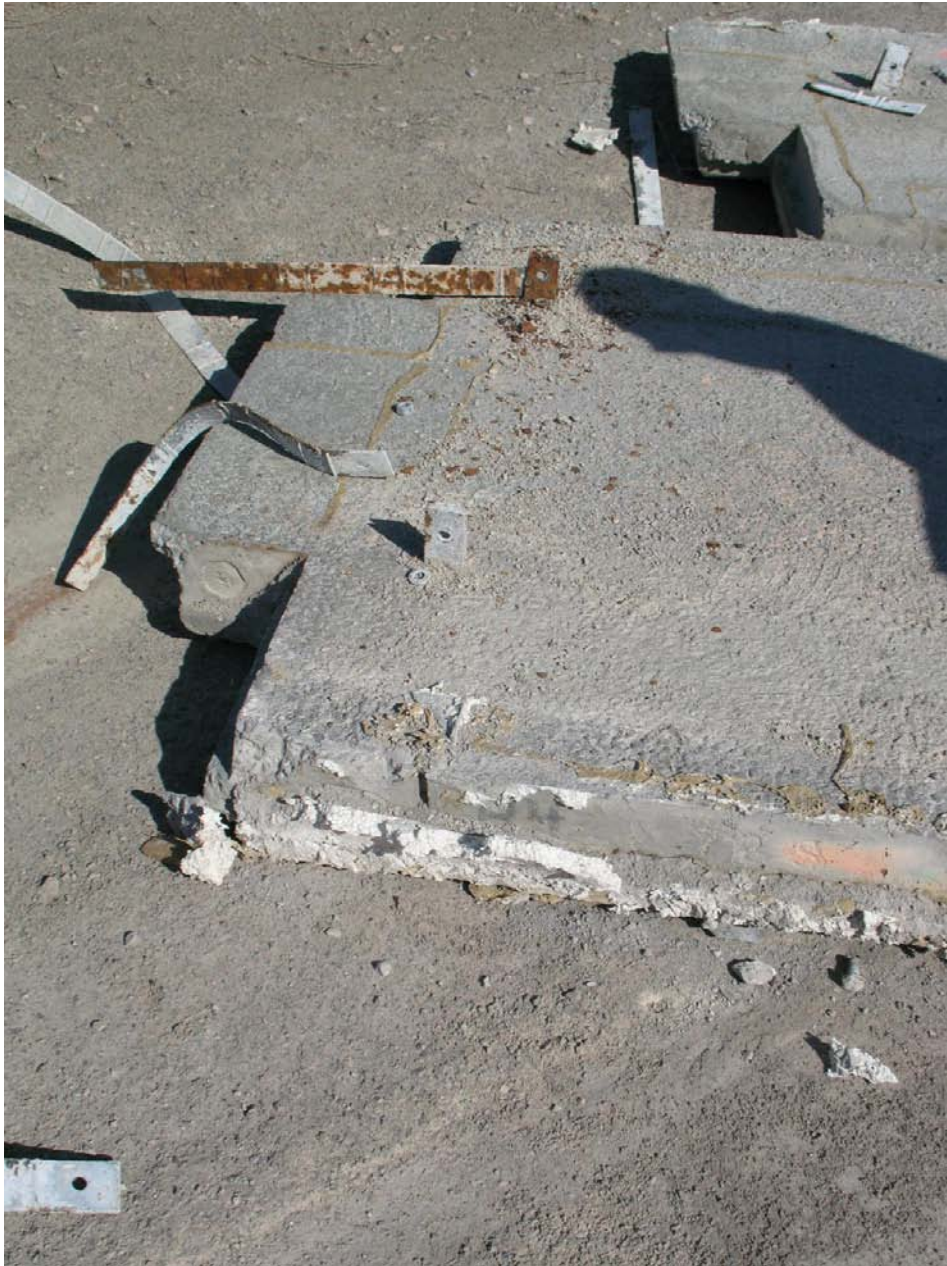
Figure 49. Cheyenne MSE Wall Corrosion Investigation - Styrofoam at Top End of Panel

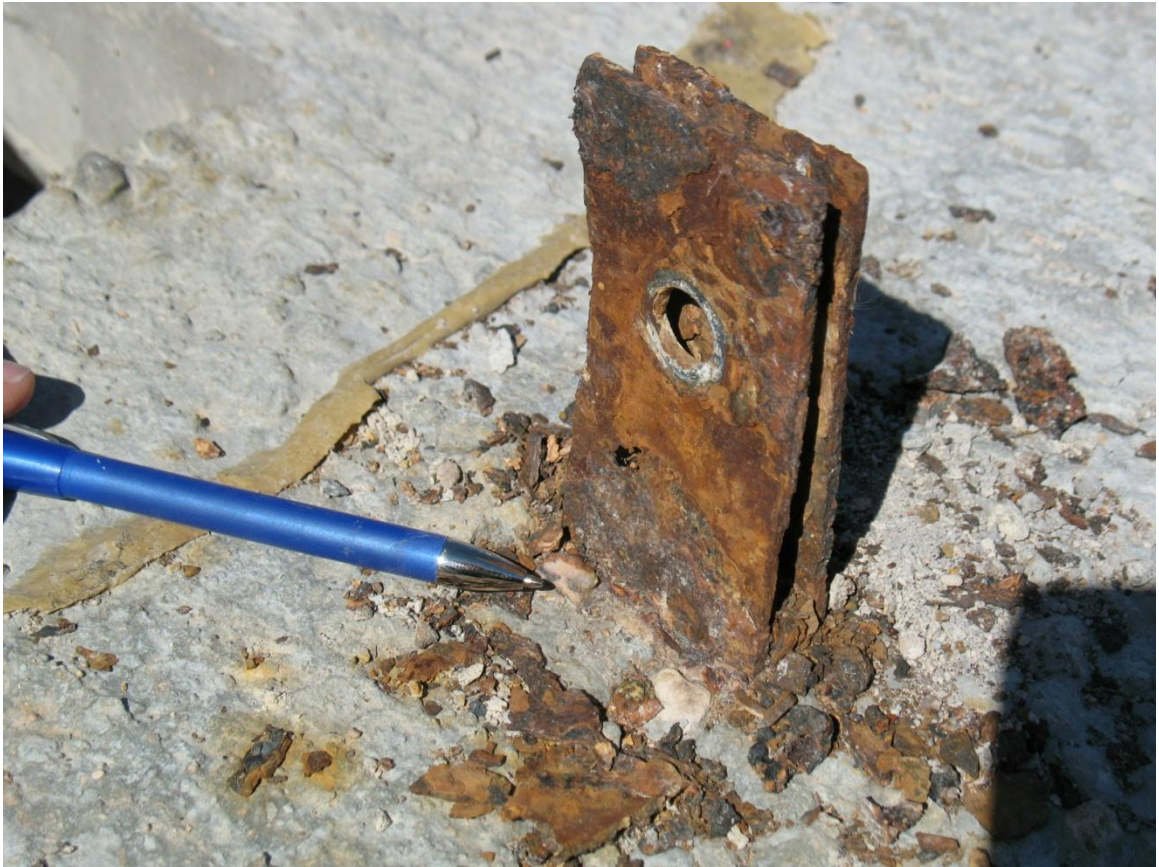
Figure 50. Cheyenne MSE Wall Corrosion Investigation - Corroded Steel Facing Connection
