**NDOT Research Report**

**Report No. 173-06-803**

**The Tire Noise Performance of Nevada  
Highway Pavements: On-Board Sound  
Intensity (OBSI) Measurements**

**June 2008**

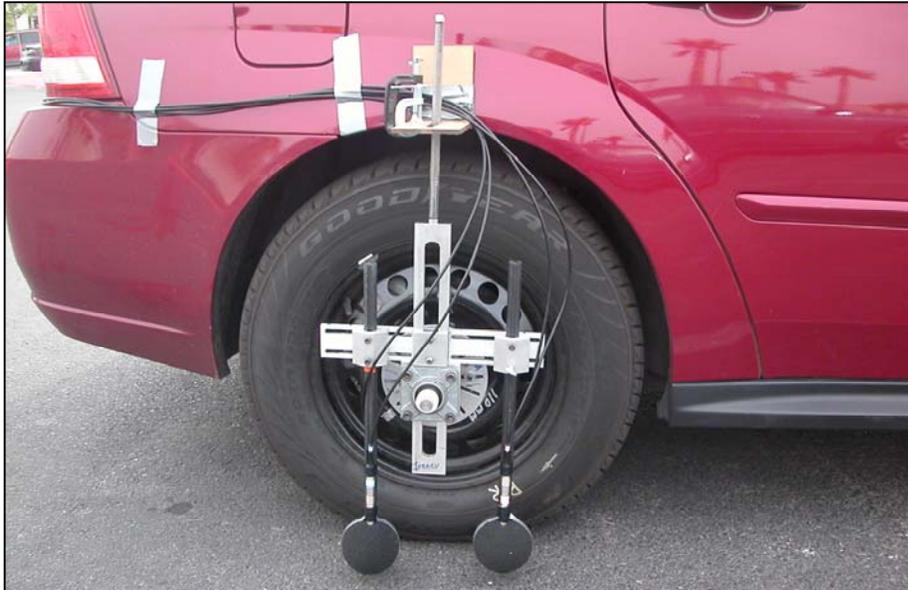
On-vehicle OBSI testing was conducted using a dual-probe sound-intensity fixture and associated microphones, attached to and supported by the test vehicle in free space as indicated in Figure 1, to allow for measurement positions that are very close to the leading or trailing edge of the tire contact patch. The dual-probe sound-intensity fixture allows the leading and trailing edge positions to be measured simultaneously. Each probe consisted of two ½” G.R.A.S phased matched condenser microphones, installed on ½” G.R.A.S 26AK microphone preamplifiers, attached to a plastic probe holder at a spacing of 0.63 inches (16mm) in a side-by-side configuration, and fitted with a spherical windscreen. The probe was positioned 3 inches (75mm) from the pavement surface and 4 inches (100mm) from the face of the tire, at locations opposite the leading and trailing contact patch of the tire, and oriented so that the sensitive axis was positioned toward the tire. Data from the leading and trailing edge positions are acquired separately for the same section of pavement and then averaged together during post-analysis. Use of the dual-probe sound-intensity fixture allows the leading and trailing edge positions to be

**Figure 1: OBSI Equipment Installed on the Malibu Test Vehicle**

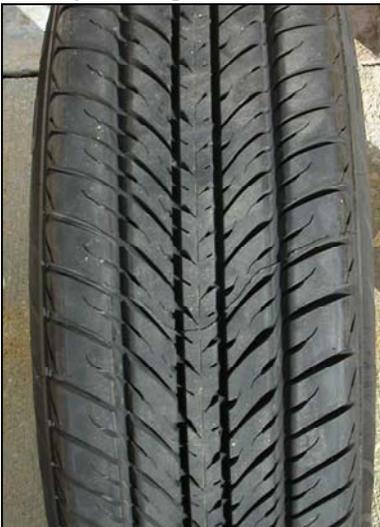
**Figure 2: Photograph of Aquatred 3 Test Tire**

people and the OBSI instrumentation. A photograph of the test tire is shown in Figure 2. For all of the test sites except Site 14, testing was conducted in the right through travel lane at a test speed of 60 mph (97 km/h) and a 'cold' tire inflation pressure of 30 psi. Due to lower speed limits and traffic flow speeds at Site 14, testing was conducted at a speed of 45 mph (72 km/h).

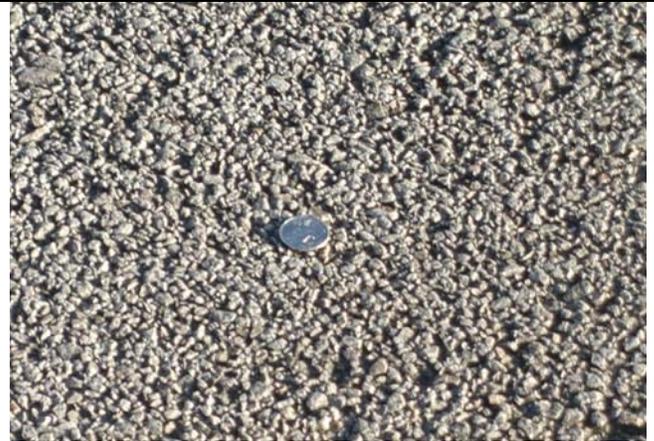
Site 10, Jan. 2008  
Open Graded Friction Course (OGFC)

The 1/3 octave band spectra for Sites 4, 10, and 12a are typical of porous pavements, which generally have reduced levels in the 1600 to 2500 Hz bands. This is indicated in Figure 6, which plots these pavements against a Rubberized Asphalt Concrete pavement measured along Shasta 299 near Redding, California. Although decreased mid-frequency levels occurred for all three test sites, the overall A-weighted levels were not all in the lower range of OBSI levels, indicating that porosity alone does not necessarily result in a quiet pavement surface. Low frequencies, which are typically controlled by pavement roughness, varied or large aggregate size, and positive pavement texture, dominate the overall noise levels for these pavements. As mentioned earlier, Site 10 was the loudest of the OGFC pavements. Observation of the pavement at Site 10 (see Figure A-1) shows this to be a notably rough pavement with positive pavement texture.

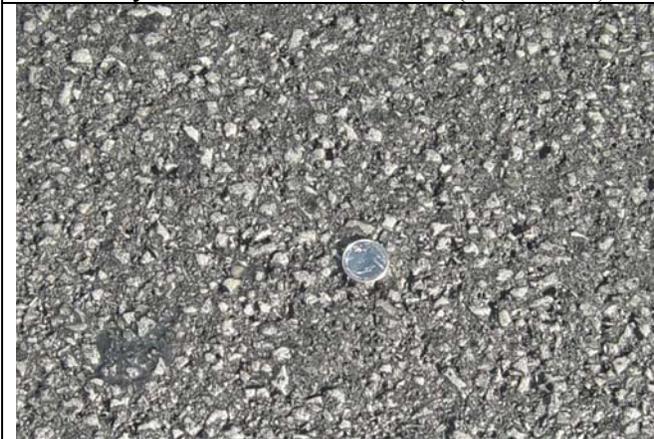
Site 11, Jan. 2008  
Open Graded Friction Course (OGFC)

pavements against a DGAC pavement section measured at LA-138 in California. The rubberized pavements shown in Figure 7 indicate similar spectral characteristics. During field measurements, Sites 11 and 12b were both visually identified as OGFC; however, the pavements appeared to be compacted in the wheel path, which could explain the spectral shape similarities to DGAC pavement.

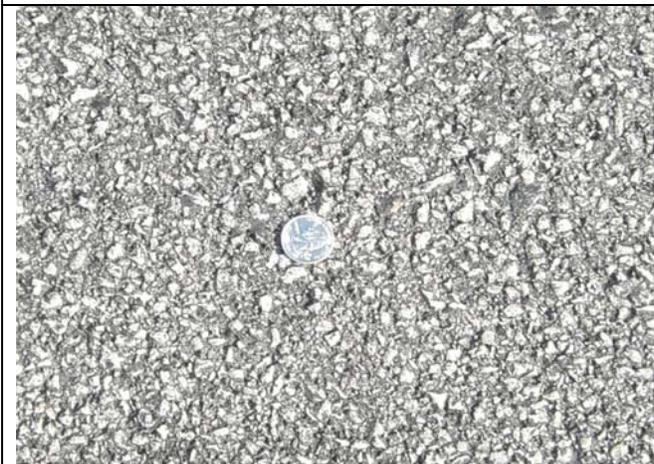
Site 12b, Jan. 2008  
Open Graded Friction Course (OGFC)
