NDOT Research Report

Report No. 531-13-803

**Comparing the Direct Costs and Infrastructure
Implications of Anti-Icing Strategies**

November 2015

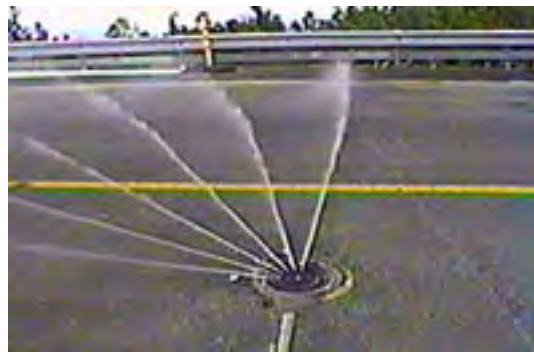
Figure 2- 1 FAST system in action.

apply the anti-icing chemical just prior to the frosting or icing event. FAST is a technological solution designed to provide quick, effective service delivery to such high-risk locations prone to icy conditions and/or with high traffic volumes, while reducing the amount of labor and materials needed through timely prevention of ice formation to the pavement or bonding or packing of snow. Indirect benefits from FAST may include reduced corrosion and environmental impacts and reduced traveler delay and stress. A conceptual study indicated that eliminating even one accident a year would provide a benefit-cost ratio greater than 1 for two automated FAST systems installed on bridges for the Minnesota Department of Transportation (Mn/DOT) (Keranen, 1998). Another study indicated a benefit/cost ratio of 2.36 for a proposed FAST installation on a section of I-90 in Washington State, assuming a 60 percent reduction in snow and ice-related accidents (Stowe, 2001). Figure 2- 1 shows the FAST system in action.

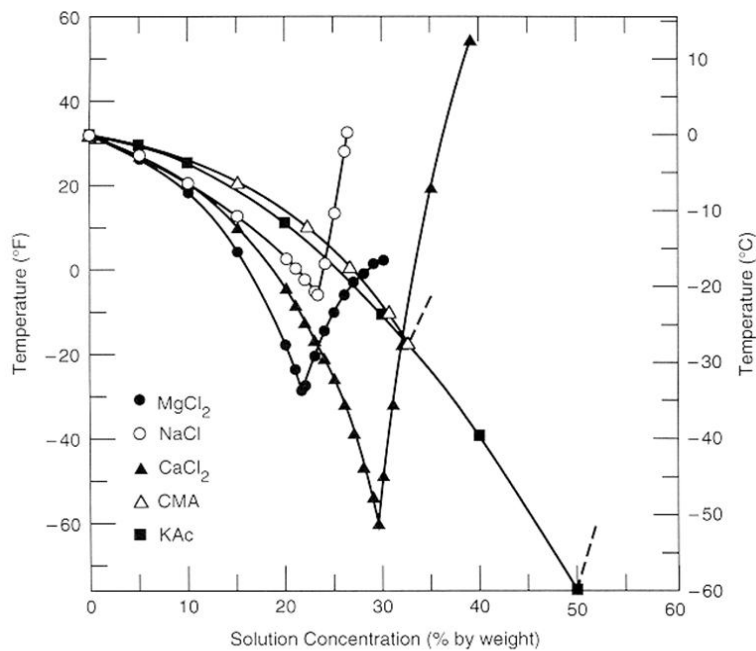
Figure 2- 2 Freezing Point of Common Road Chemicals (Rubin, 2010)

point theory values, the study found that 60% less salt concentration is sufficient for anti-icing operations (Klein-Paste and Wåhlin, 2013). This discrepancy is attributed to role of chemicals to weaken the ice bond with the pavement such that the ice formed on the pavement after anti-icing operations is weak enough to break with the mechanical load caused by traffic. CaCl_2 and MgCl_2 that exhibit better ice-melting performance than salt brine at cold temperatures are used by many DOTs as brine solutions for anti-icing or to pre-wet rock salt (Baroga, 2005). However, CaCl_2 and MgCl_2 are more costly than NaCl , and can be more difficult to handle. At low relative humidity, their residue on roads can attract more moisture than NaCl , which can lead to dangerous, slippery conditions under certain circumstances (Perchanok *et al.*, 1991; Center for Watershed Protection, 2003; Wasstrom, 2007).

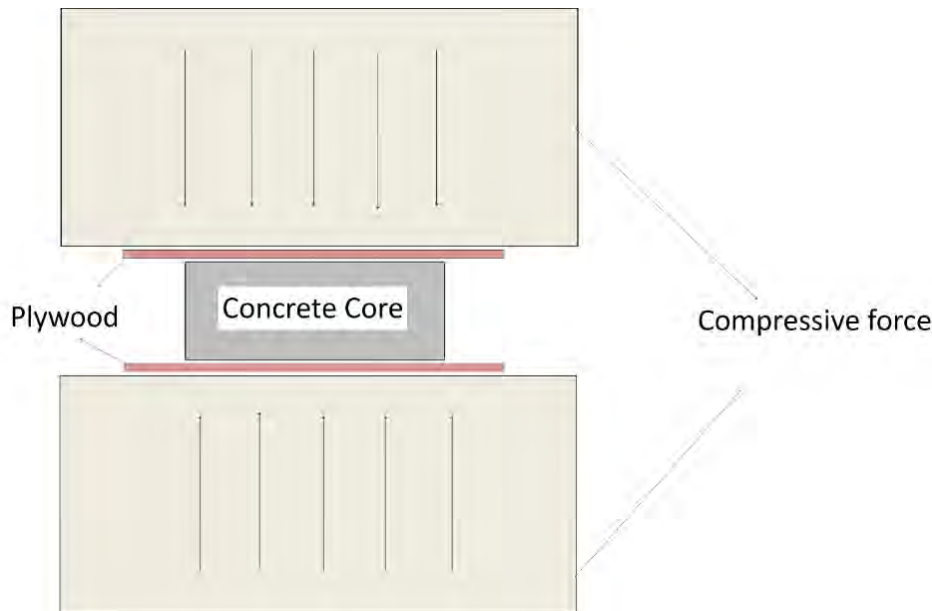
Figure 4- 1 The setup of the splitting tensile strength test

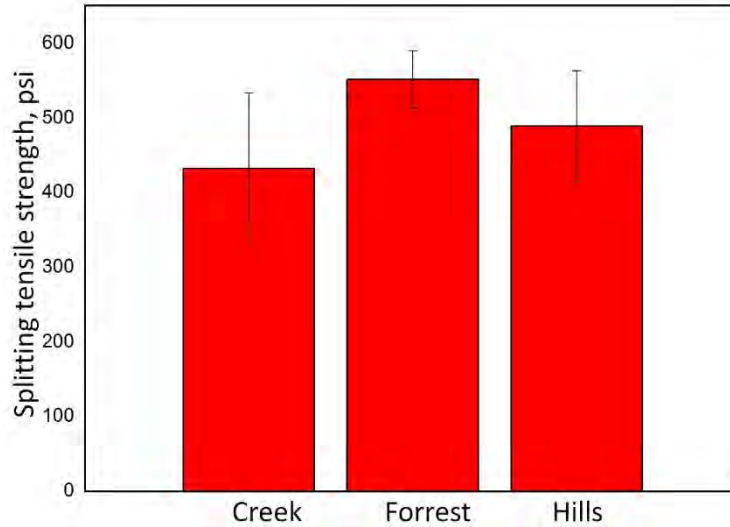
The results of the splitting tensile strength tests are shown in Figure 4-3.. The samples cored from Creek site exhibit the lowest splitting tensile strength, while the Forest samples show the highest, with average values of 433 ± 71 psi and 552 ± 37 psi, respectively. The samples cored from Hills show an average value of 489 ± 58 psi.

Figure 4- 3 Splitting tensile strengths of cored concrete samples from the bridge decks of Creek, Forest, and Hills.

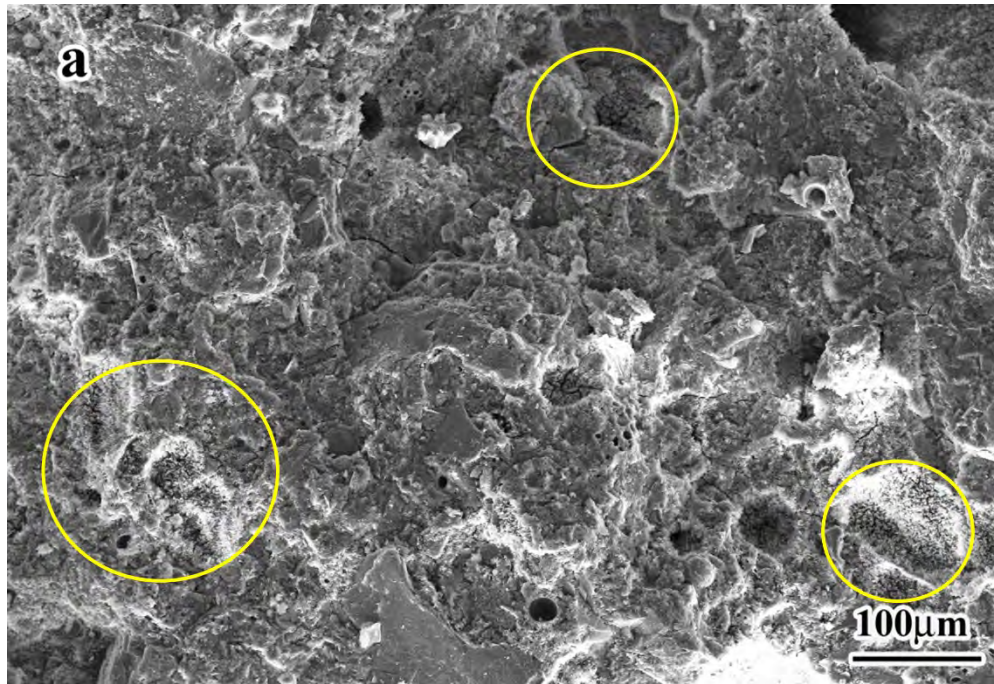
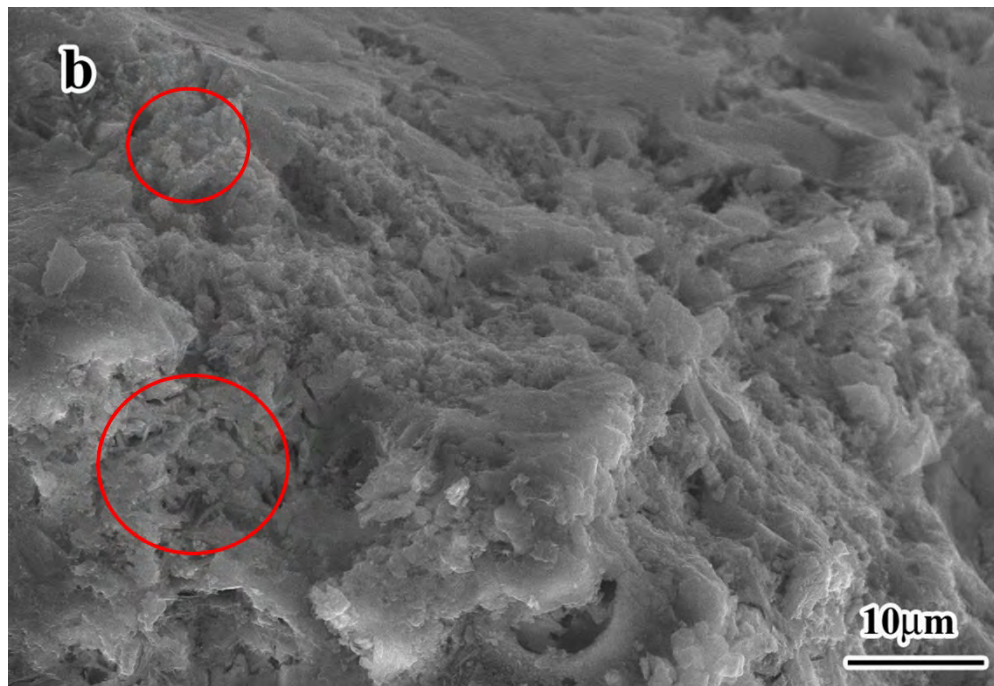
Like all solid materials, the overall performance of concrete is largely determined by its microstructures. Therefore, the microstructure of the concrete samples was analyzed to elucidate the mechanisms behind the degradation in performance. In this section, scanning electron microscopy (SEM) was used to analyze the microstructure of the samples cored from three sites. The goal of the SEM analysis was to demonstrate the morphology of the cement paste at the interface between two aggregates.

Figure 4- 4 SEM fracture surface morphologies of the samples cored from the Creek site with a) low and b) high magnification.

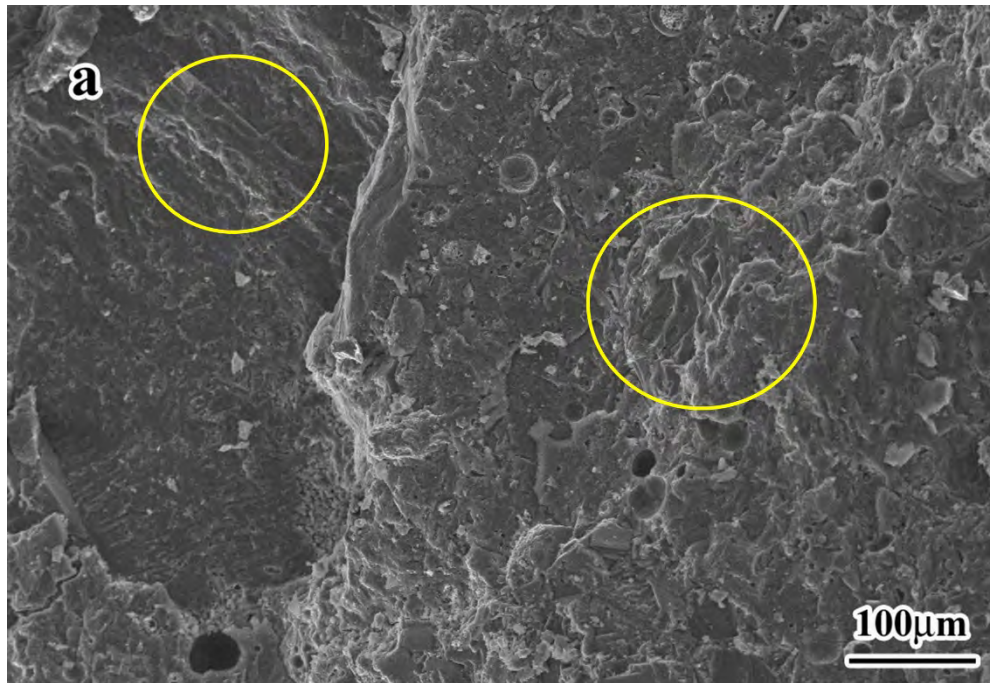
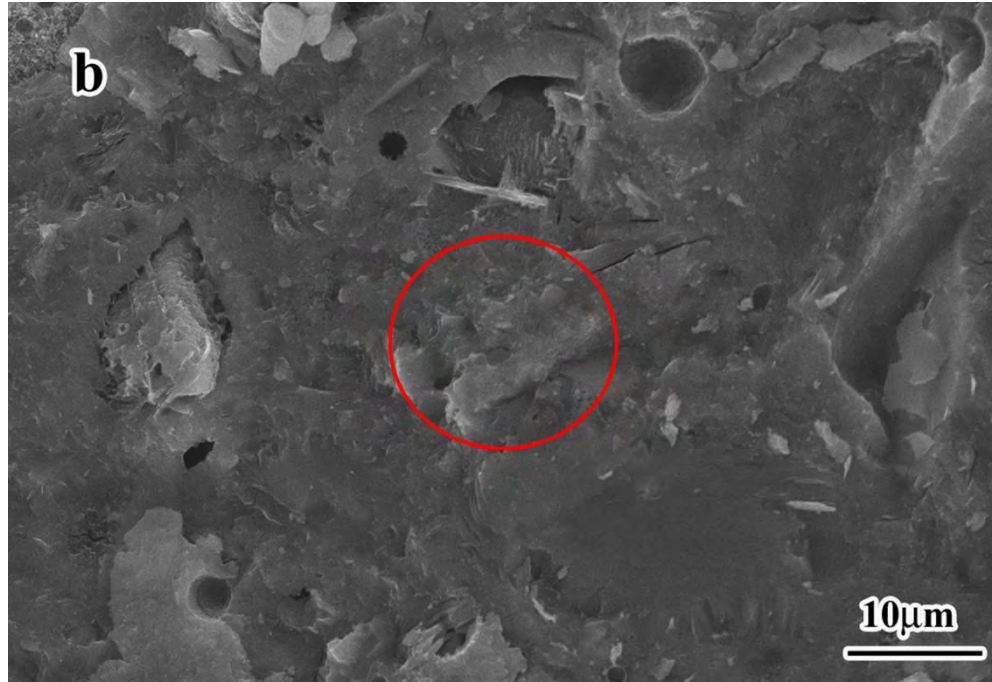
Figure 4- 5 a) and b) show the low and high magnification SEM fracture surface morphologies of the samples cored from the Forest site, respectively. As can be seen in the low magnification image Figure 4- 5a, the quantity of the pores in the cement paste of the Forest sample is less than that from the samples of the Creek site. In the high magnification image (Figure 4- 5b), in comparison with the Creek sample, some layered structure C-S-H phases can be observed, and the surfaces of the pores are smoother than those from the Creek site. Similar to the Creek samples, some sticky precipitate phases can also be observed, and crystal particles embedded in the sticky phase can be detected as well (as shown in the red circle in the high magnification image).

Figure 4- 5 SEM fracture surface morphologies of the samples cored from the Forest site with a) low and b) high magnification.

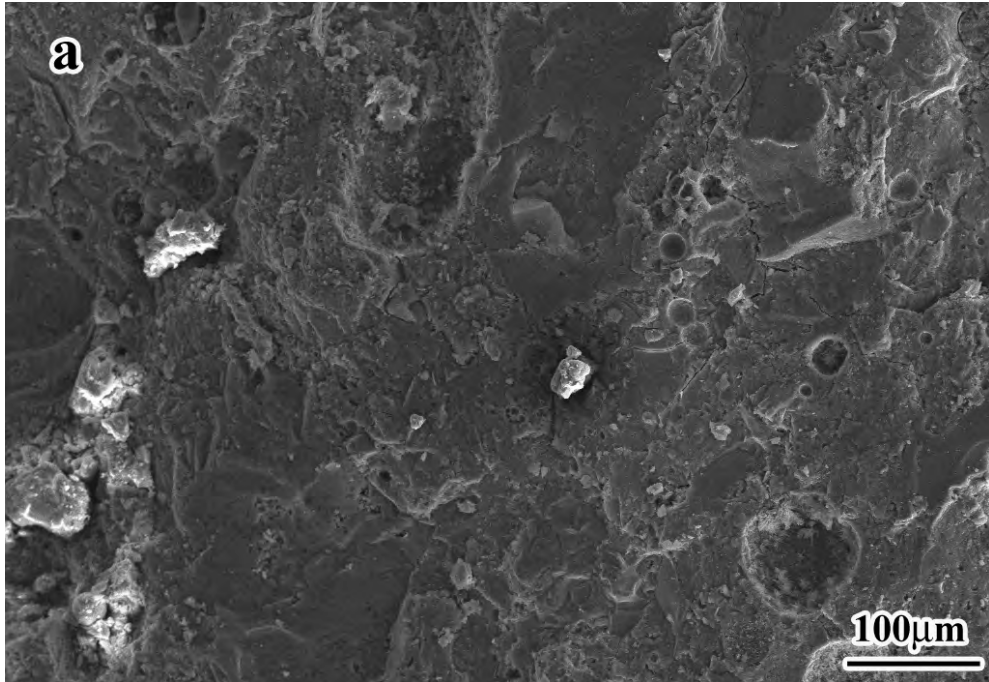
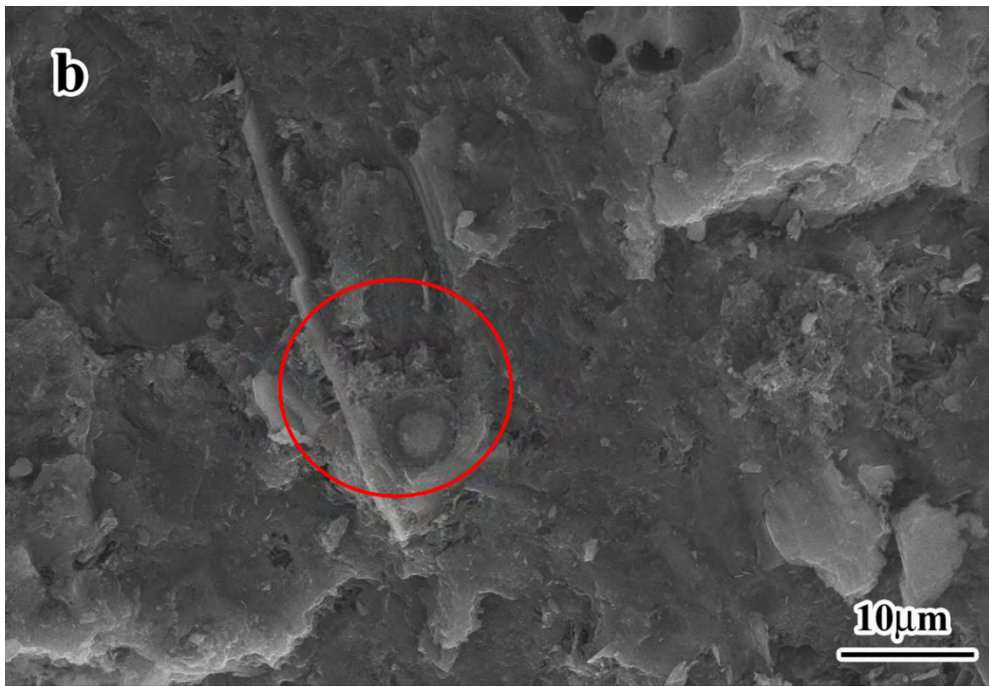
Figure 4- 6a) and b) show the low and high magnification SEM fracture surface morphologies of the samples cored from the Hills site, respectively. In the low magnification image (Figure 4- 6a), the surface shows relatively low pore content, and the layered C-S-H phase can be observed. In the high magnification image, however, some needle shaped precipitates, which are embedded in the sticky phases (shown as the red circle in Figure 4- 6b), can be observed, although the content is relatively low. As demonstrated in Figure 4- 6b, the diameters of the needle shaped precipitates are about 100 nm, and the surfaces of some needles are smooth while others are not.

Figure 4- 6 SEM fracture surface morphologies of the samples cored from the Hills site with a) low and b) high magnification.

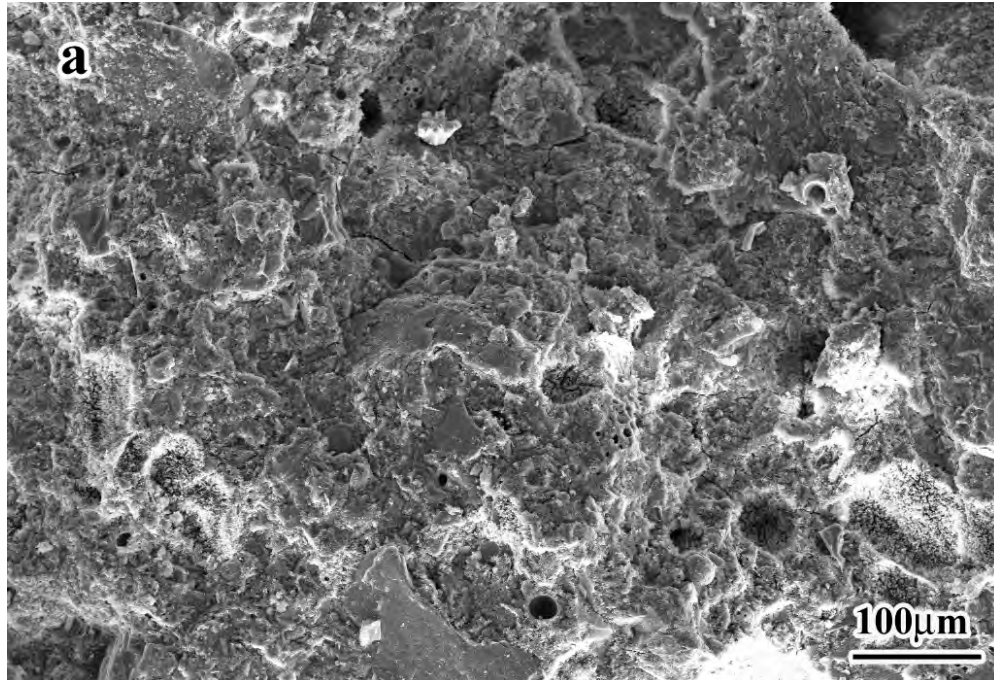
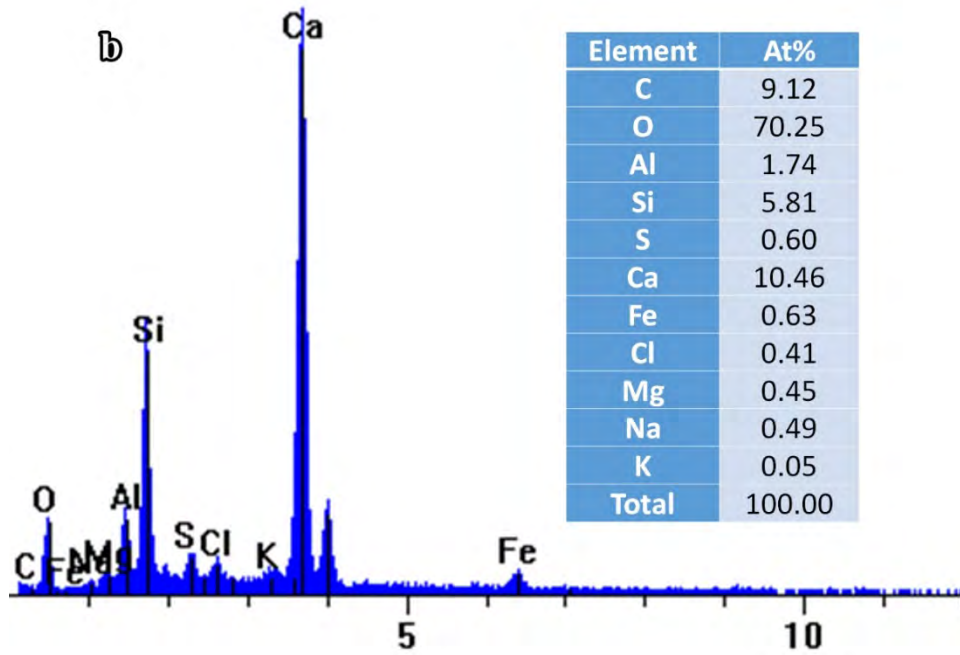
Figure 4- 7 SEM/EDS of the fracture surface of the samples cored from the Creek site with a) SEM image and b) corresponding EDS results.

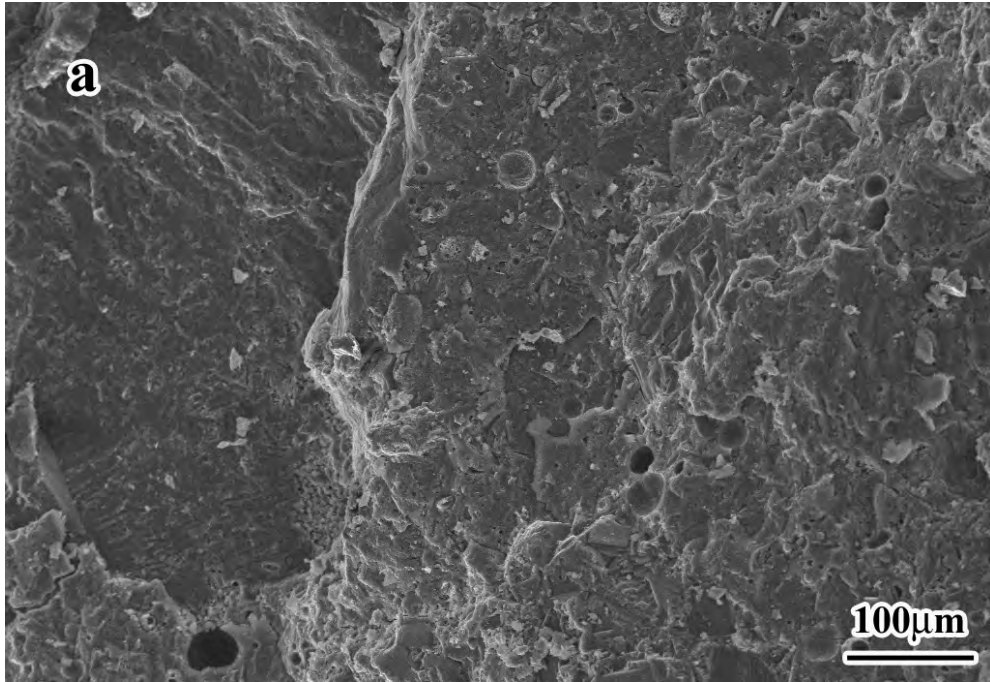
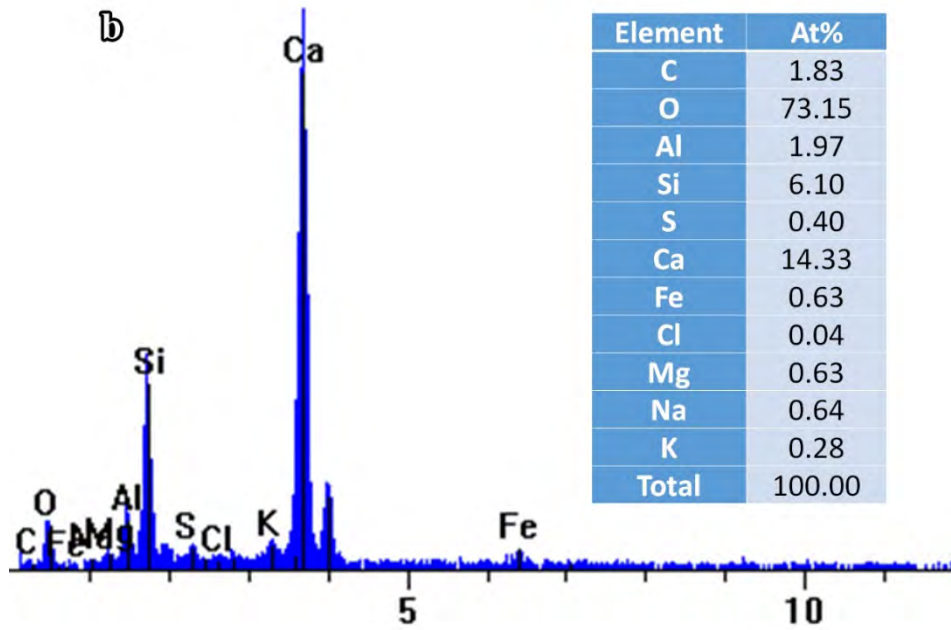
Figure 4- 8 SEM/EDS of the fracture surface of the samples cored from the Forest site with a) SEM image and b) corresponding EDS results.

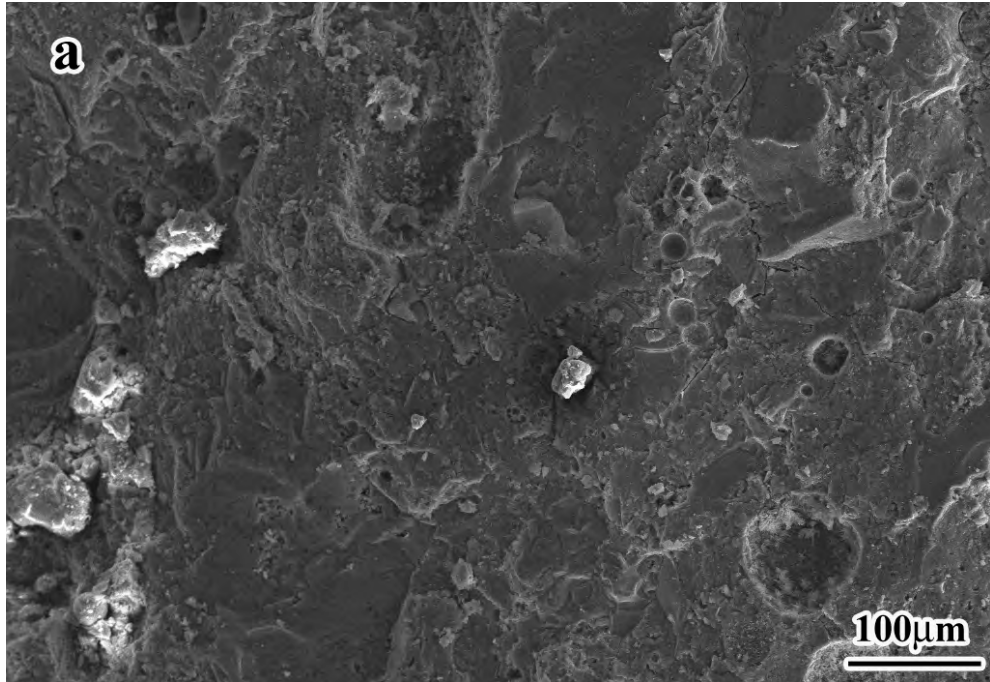
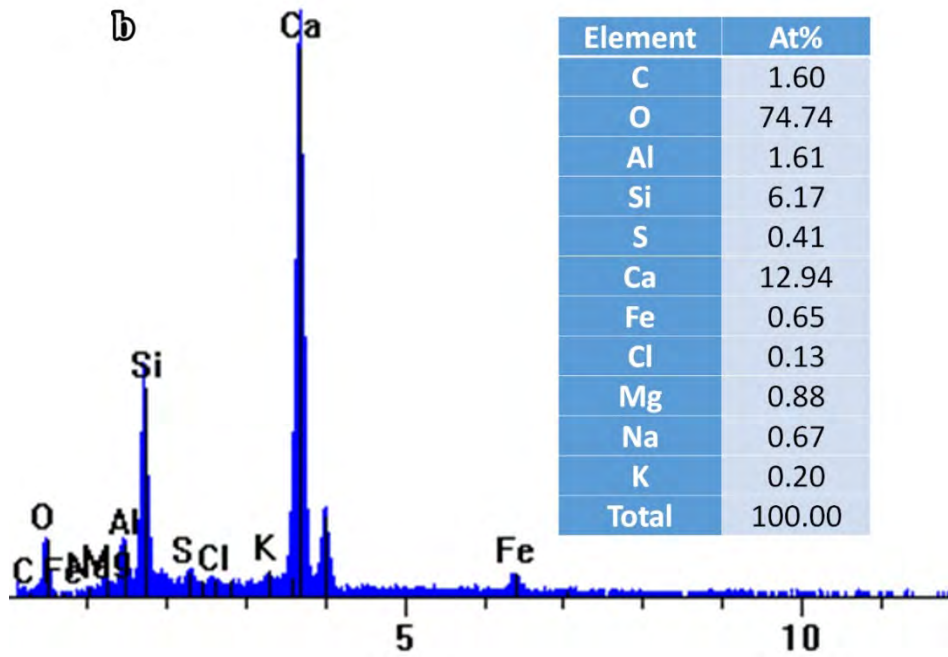
Figure 4- 9 SEM/EDS of the fracture surface of the samples cored from the Hills site with a) SEM image and b) corresponding EDS results.

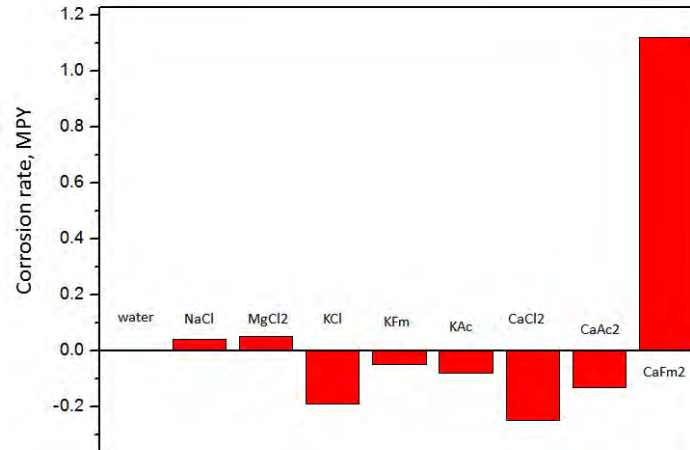
Figure 5- 1 The corrosion rates of stainless steel with exposure to various deicers.

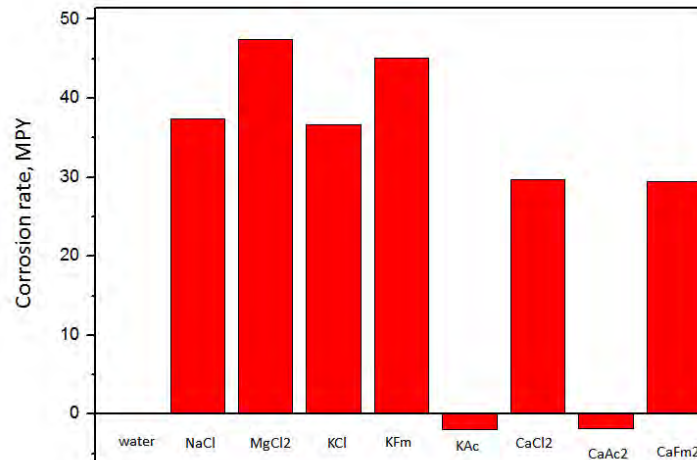
Figure 5- 2 The corrosion rates of plain steel with exposure to various deicers.

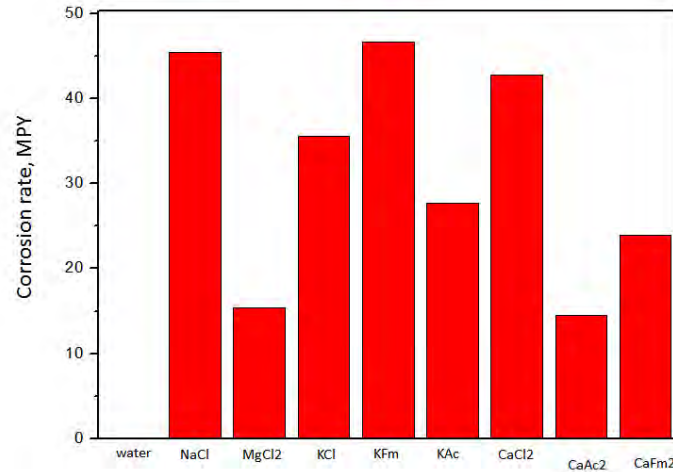
Figure 5- 3 shows the corrosion rates of galvanized steel with exposure to various deicers. As can be seen in this table, the corrosion rates of the galvanized steel with exposure to various deicers are all relatively high, ranging from 15 to 47 MPY.

Figure 5- 3 The corrosion rates of galvanized steel with exposure to various deicers.

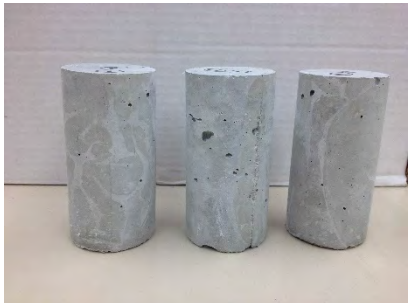
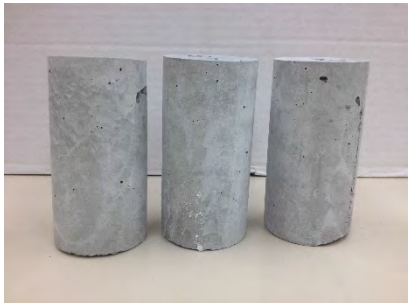
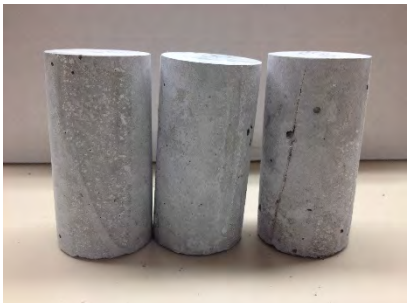
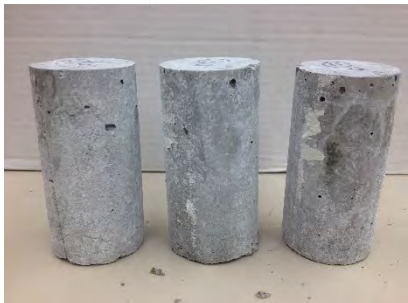
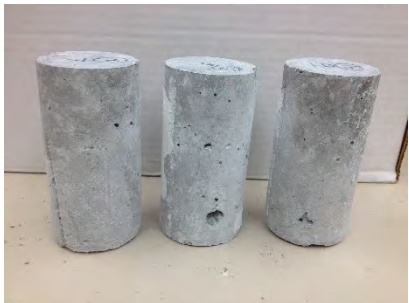
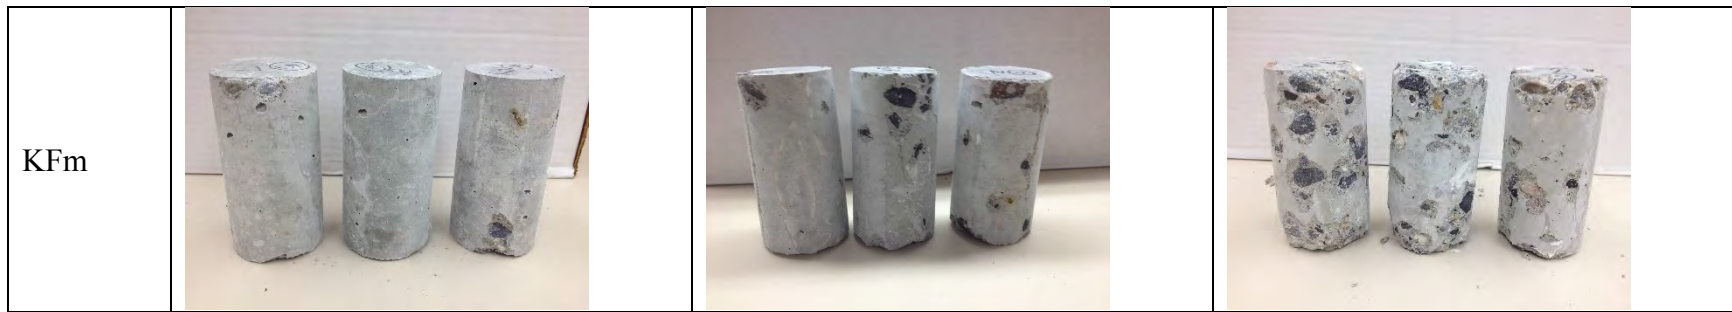
Figure 5- 4 The external morphologies of laboratory-fabricated concrete cylinders exposed to various deicer solutions after 3, 7, and 15 F/T and W/D cycles.

Figure 5- 4 illustrates the damage caused to laboratory-fabricated concrete cylinders exposed to the eight types of deicer solutions with concentration of 3 wt.% after 3, 7, and 15 F/T cycles, respectively. As can be seen in this figure, all concrete samples exposed to alkali based deicer solutions (KCl, NaCl, KAc, and KFm) exhibit severe surface distress after 7 F/T cycles, while the samples exposed to alkali earth based deicer solutions (CaCl₂, MgCl₂, CaAc₂ and CaFm₂) show little surface distress.

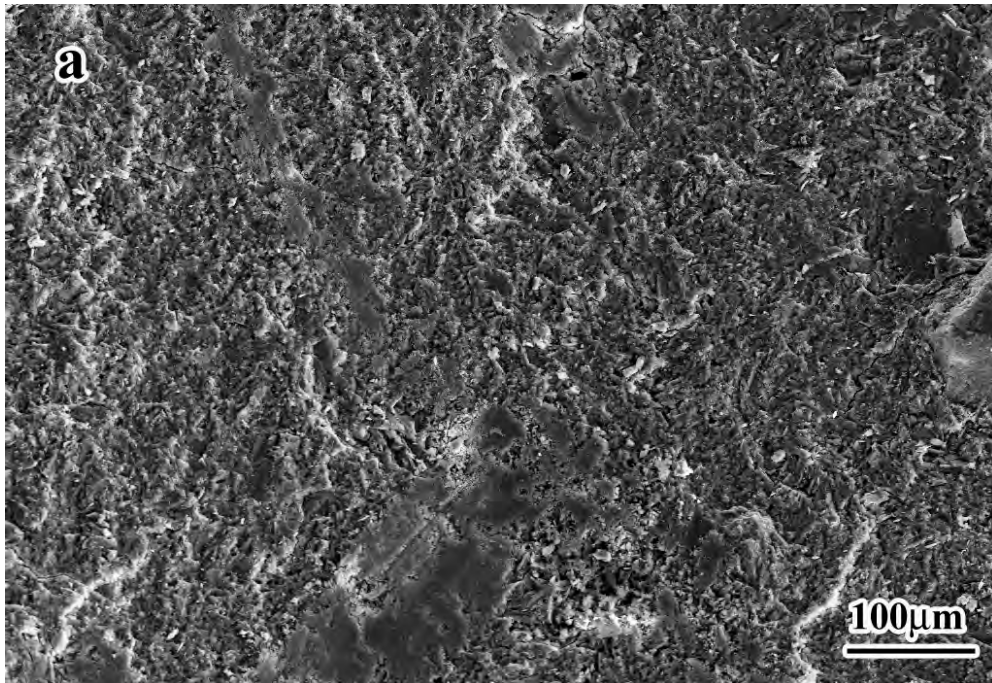
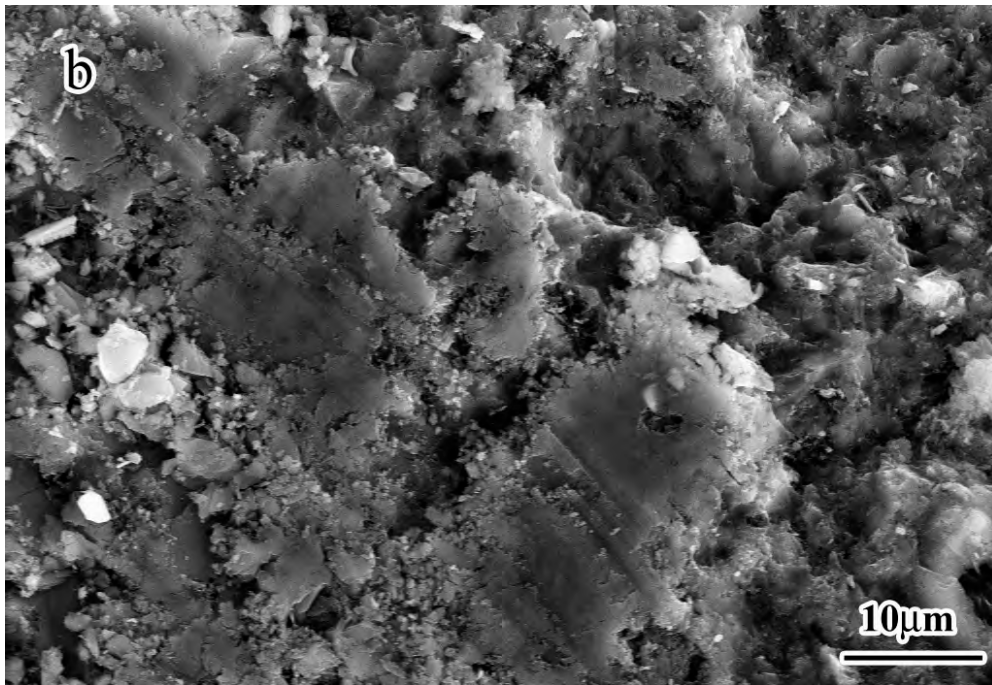
Figure 5- 8 SEM images of the concrete samples after 15 F/T and W/D cycles in water with a) low and b) high magnification.

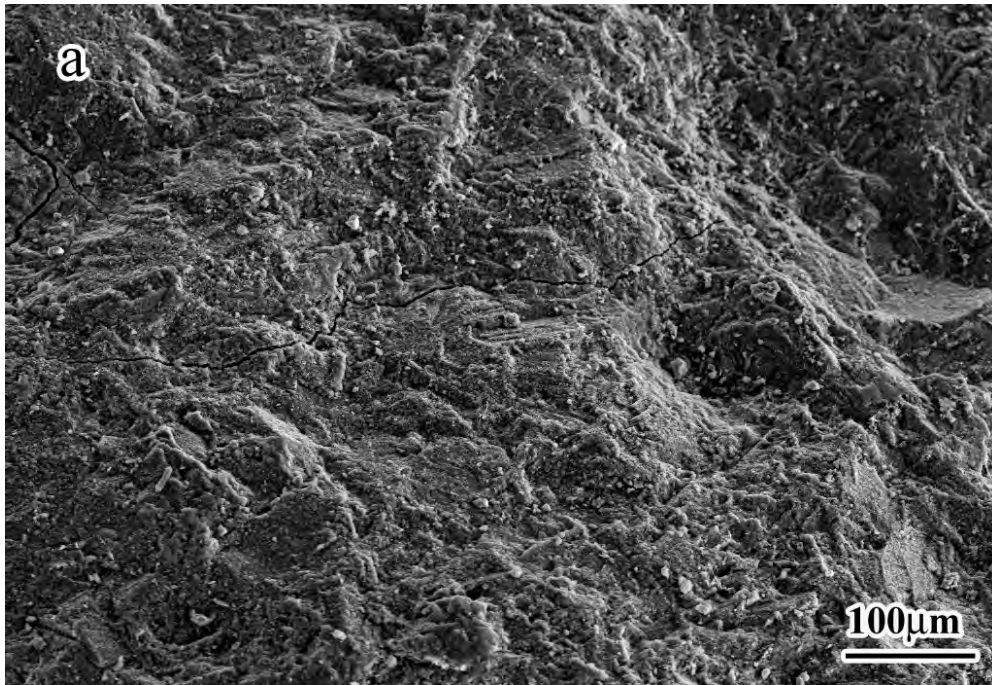
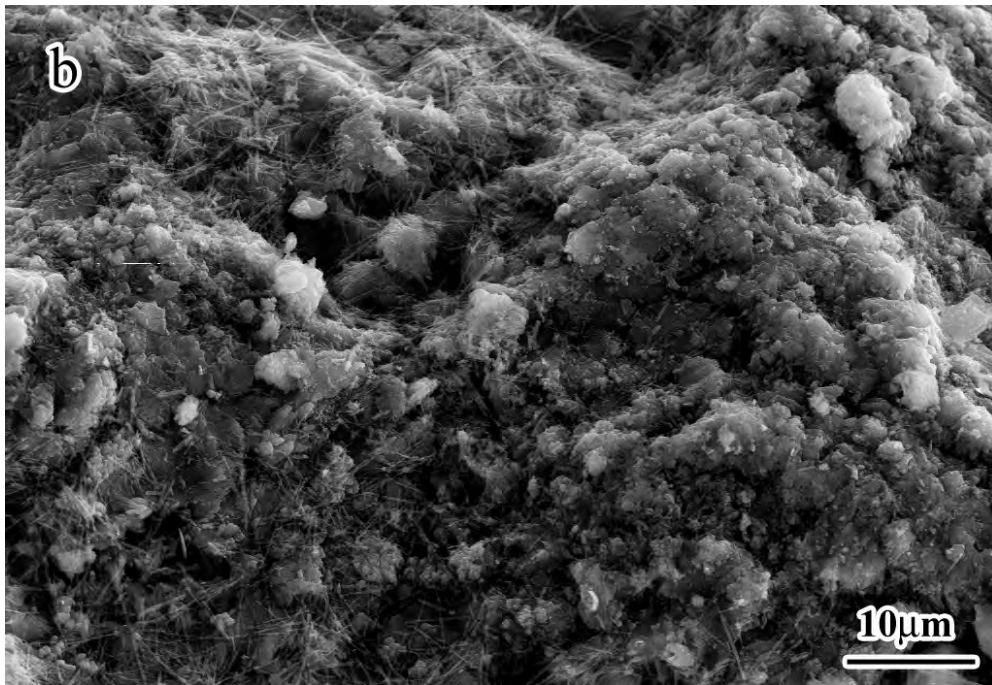
Figure 5- 9 shows the low and high magnification SEM images of the concrete samples after 15 F/T and W/D cycles in NaCl. Unlike the microstructure of the samples in water, the fracture surface of the NaCl sample is not flat and shows many needle shaped precipitates that are nanometers in diameter. These nano sized needle shape precipitates are randomly distributed in the hydration products without any orientations.

Figure 5- 9 SEM images of the concrete samples after 15 F/T and W/D cycles in NaCl solution with a) low and b) high magnification.

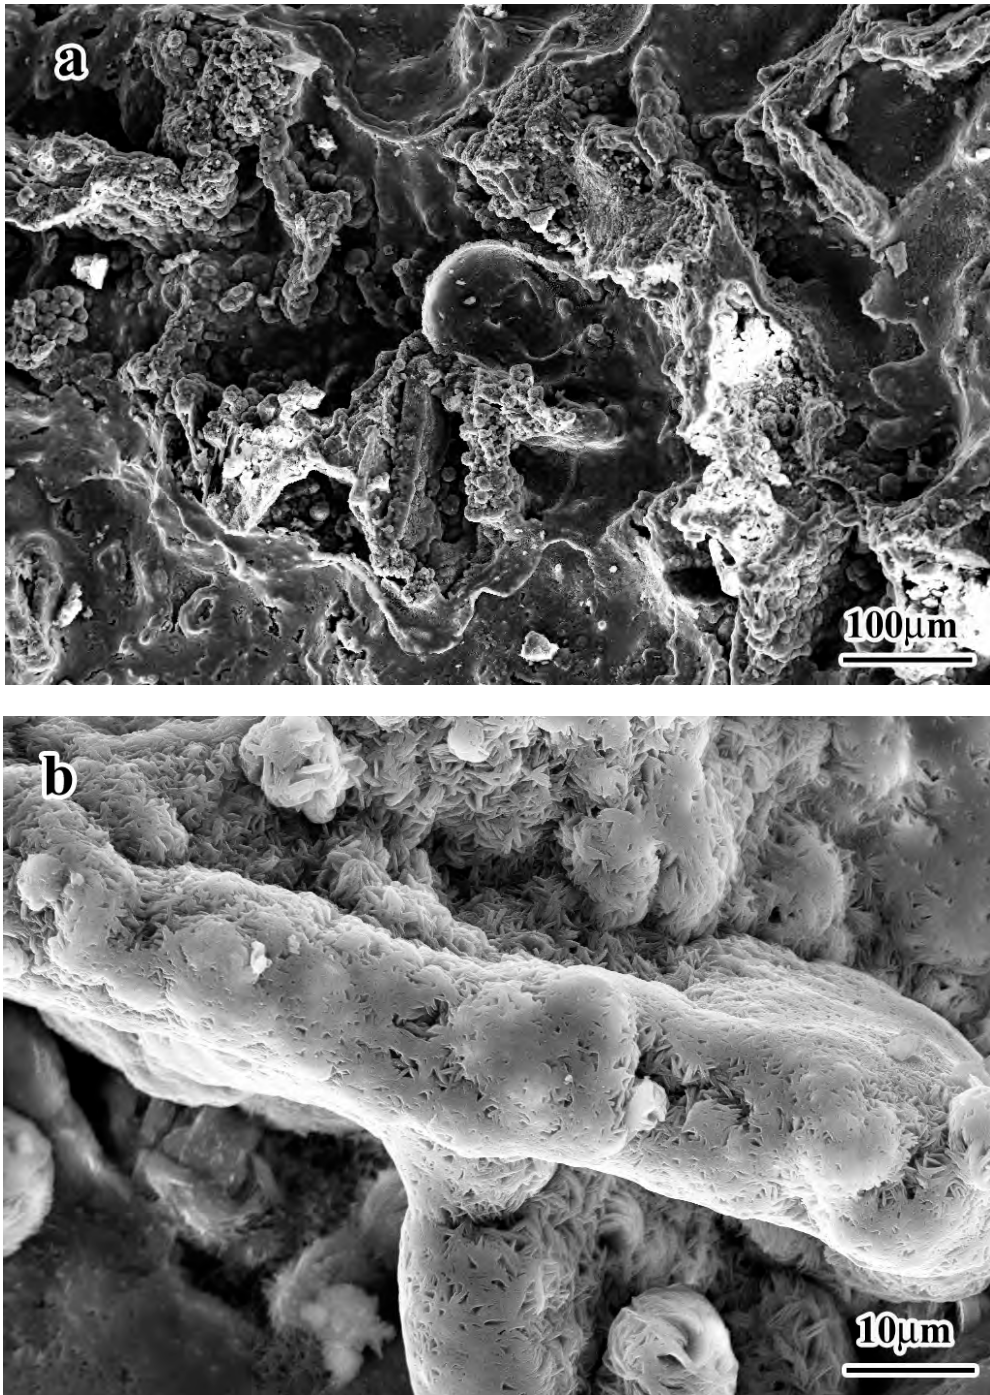
As demonstrated in Figure 5- 10 and Figure 5- 11, the concrete samples exposed to $MgCl_2$ solution are composed of different microstructures than those exposed to water and $NaCl$. One typical microstructure observed in the $MgCl_2$ exposed samples is the large quantity of plate-like precipitates, which are randomly distributed in the cement paste matrix, shown as Figure 5- 10 a). As shown in the high magnification image Figure 5- 10 b), the precipitates are mostly composed of plate-like crystals without specific orientations. Another typical microstructure, demonstrated in Figure 5- 11, is the highly porous microstructure and absence of high density cement hydrates. It can be seen from the high magnification image that the microstructure of the high density C-S-H phase was no longer a dense lamellar structure but a penetrable porous structure. This deleterious microstructure corresponds very well with the low splitting tensile strength of the samples.

Figure 5- 10 The SEM images of the concrete samples after 15 F/T and W/D cycles in MgCl₂ solution with a) low and b) high magnification.

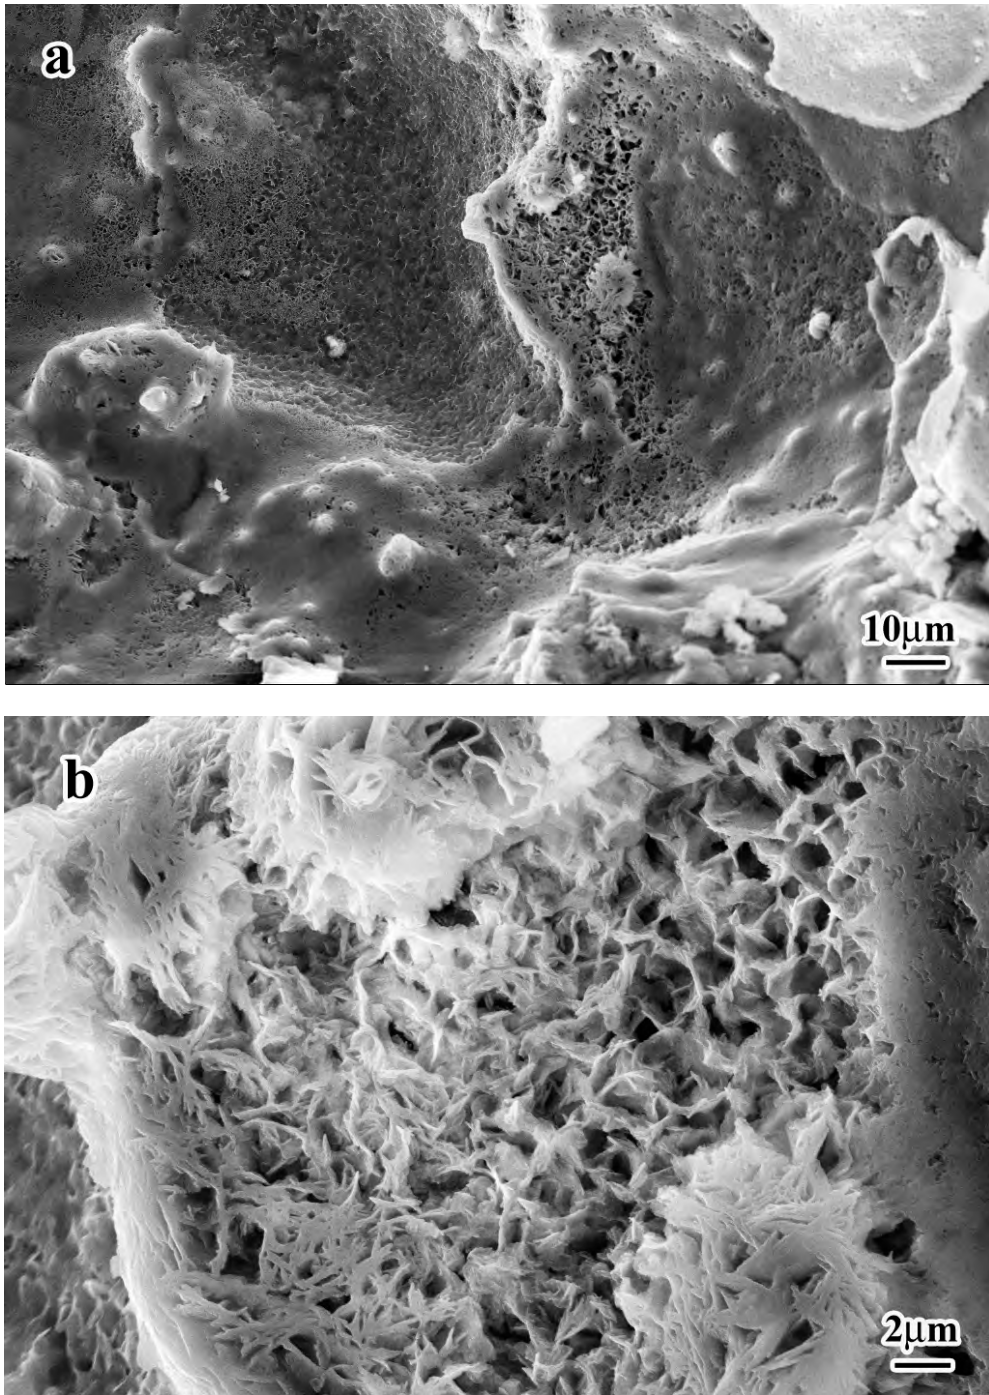
Figure 5- 11 The SEM images of the concrete samples after 15 F/T and W/D cycles in MgCl₂ solution with a) low and b) high magnification.

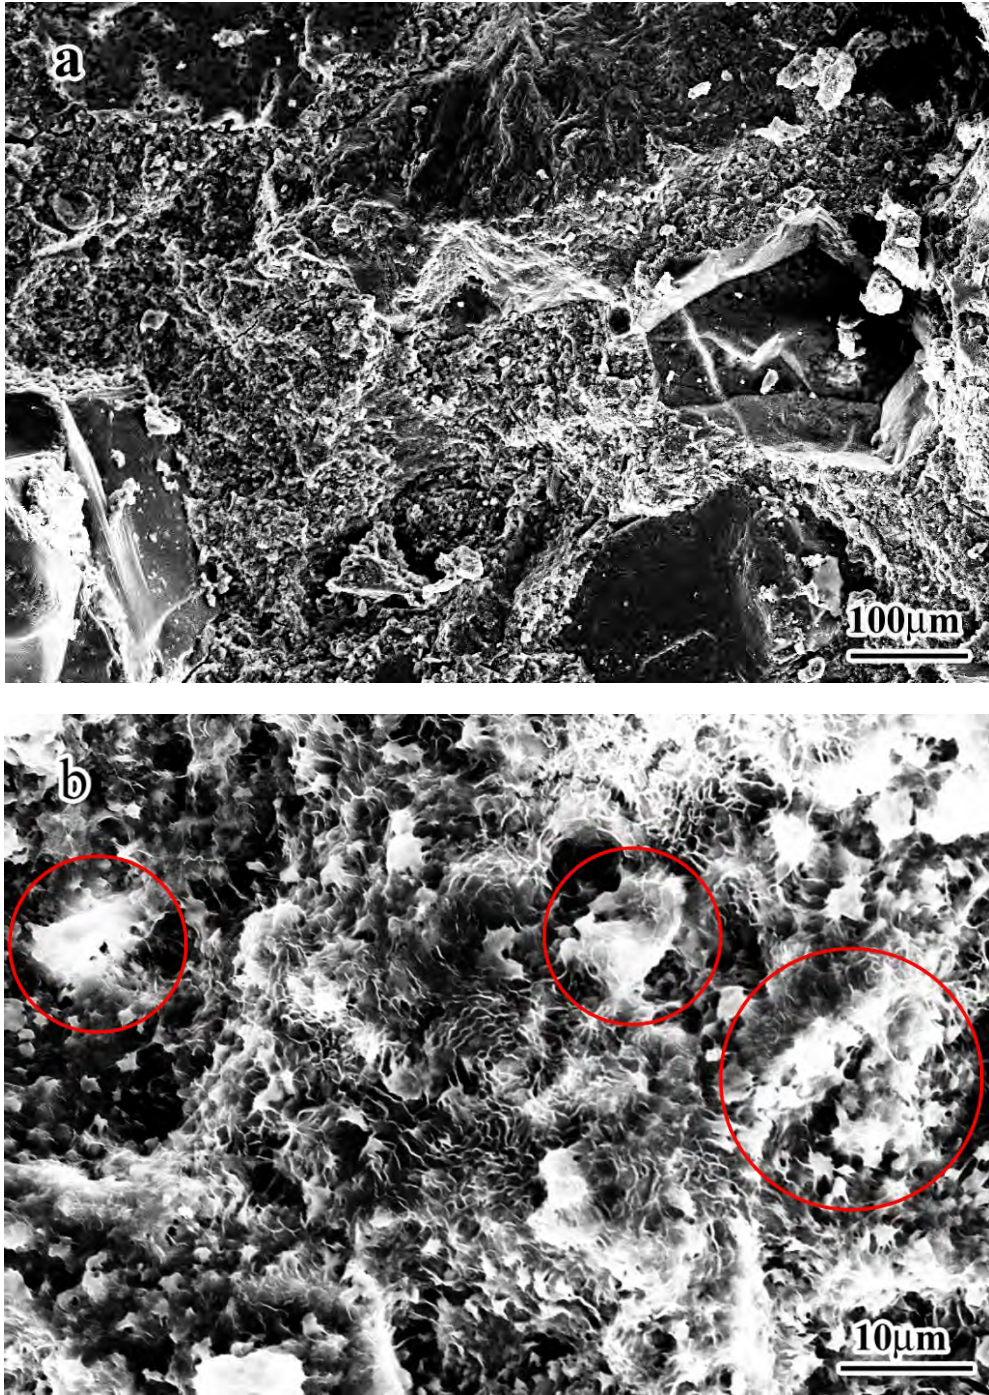
Figure 5- 12 The SEM images of the concrete samples after 15 F/T and W/D cycles in KFm solution with a) low and b) high magnification.

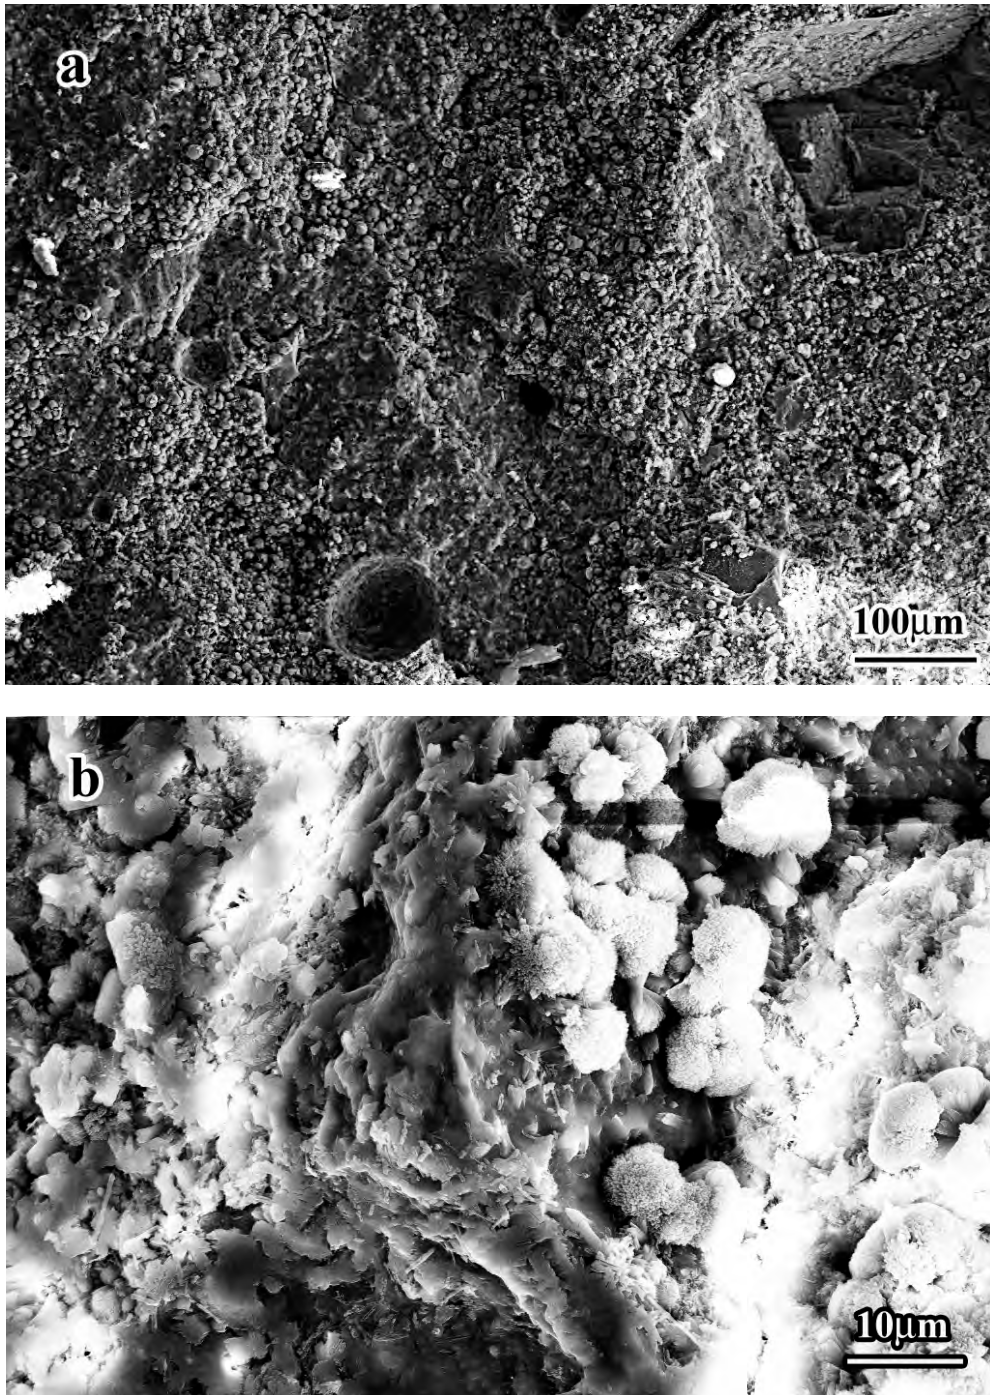
Figure 5- 13 The SEM images of the concrete samples after 15 F/T and W/D cycles in KAc solution with a) low and b) high magnification.
