NDOT Research Report

Report No. 531-13-803

**Comparing the Direct Costs and Infrastructure
Implications of Anti-Icing Strategies**

November 2015

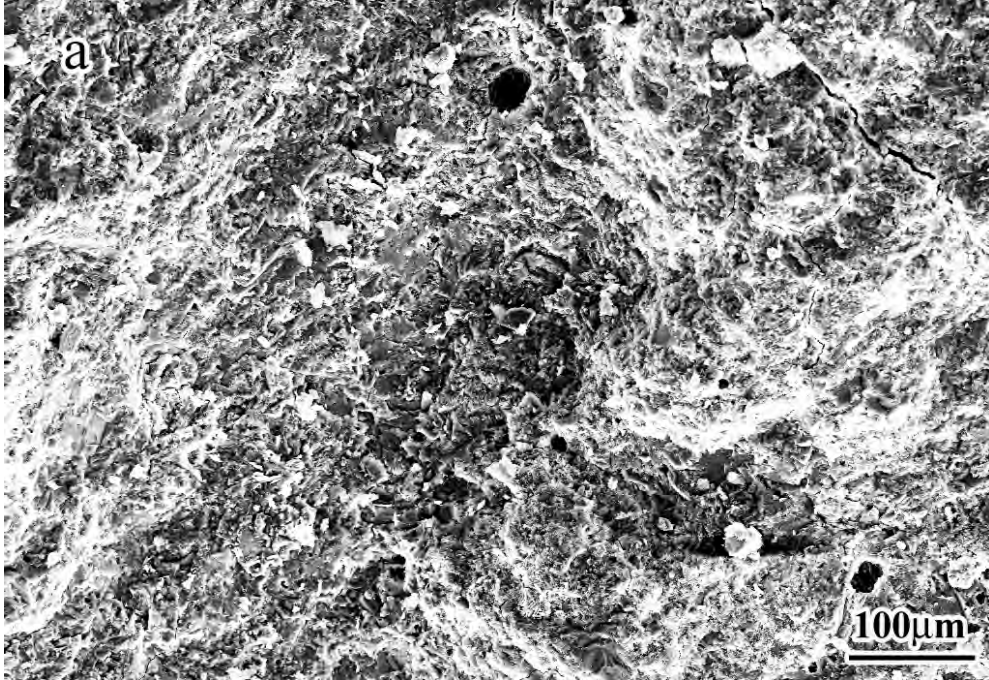
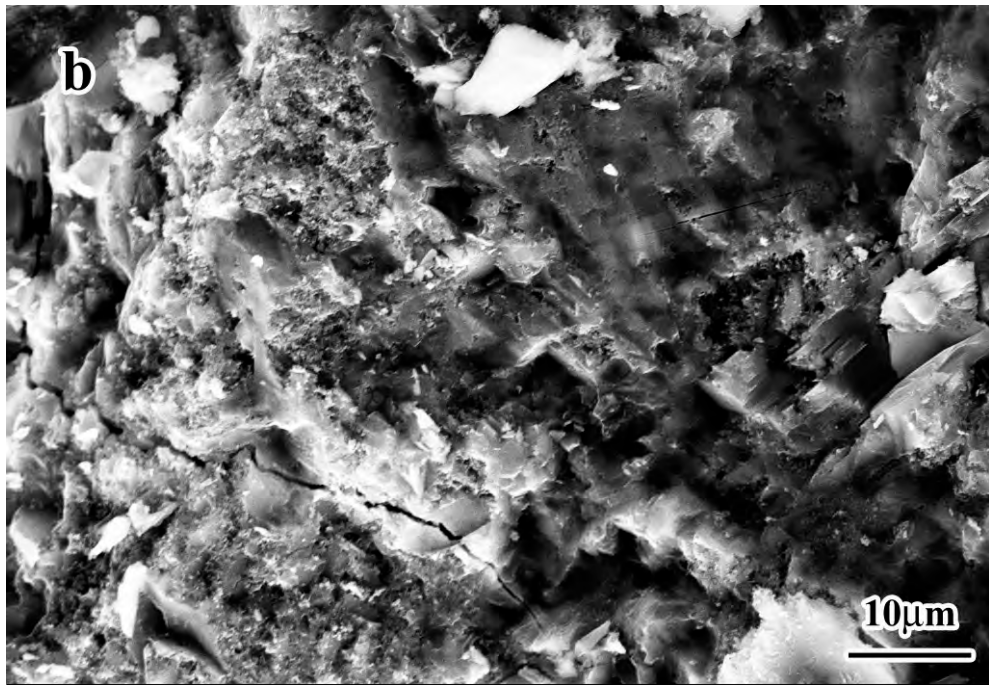
Figure 5- 14 The SEM images of the concrete samples after 15 F/T and W/D cycles in CaCl₂ solution.

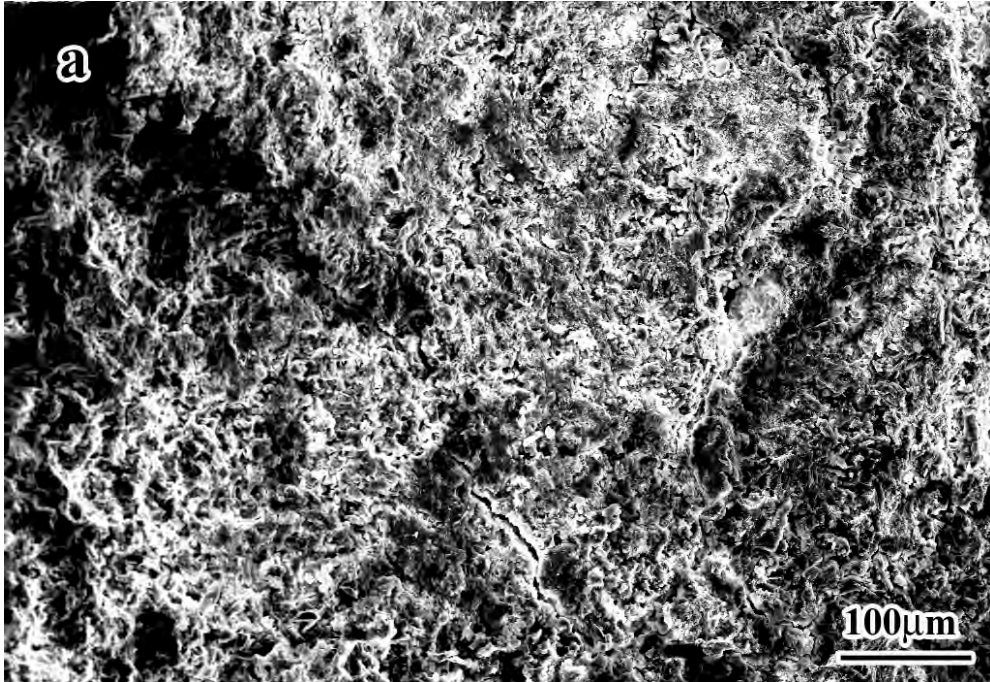
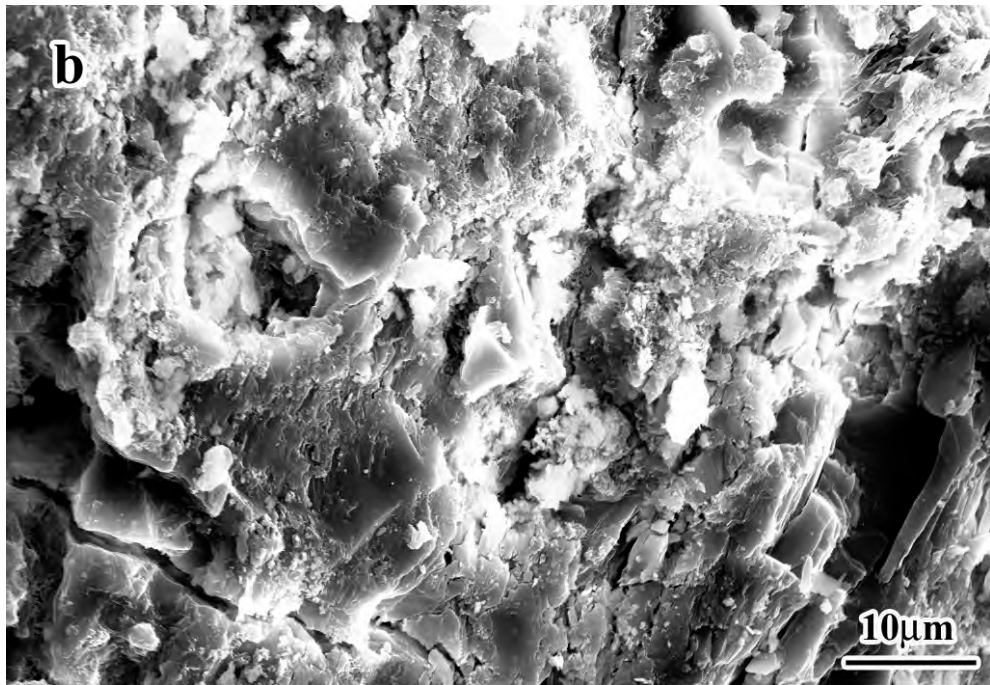
Figure 5- 15 The SEM images of the concrete samples after 15 F/T and W/D cycles in CaAc2 solution with a) low and b) high magnification.

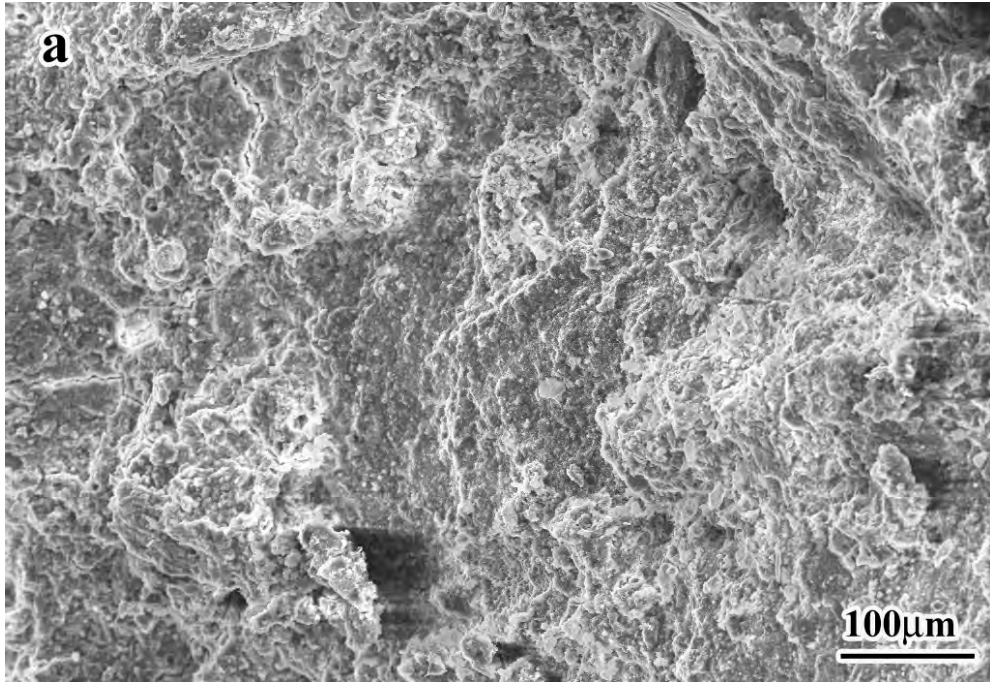
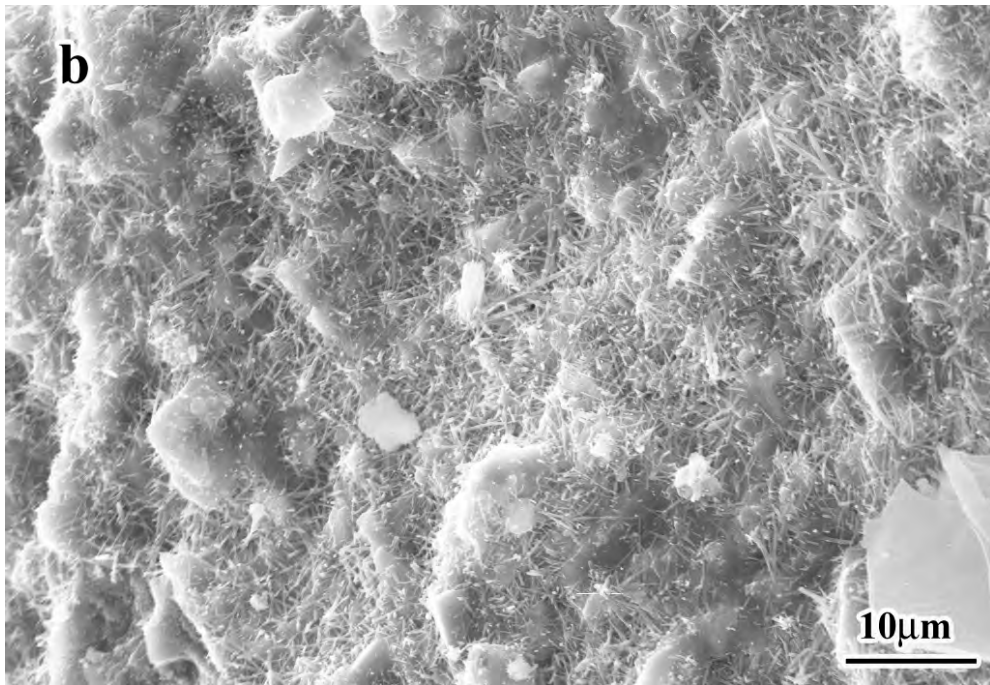
Similar to the microstructure of the sample exposed to NaCl solution, the fracture surface of the sample exposed to $CaFm_2$ shows a bumpy morphology (Figure 5-16). Many small sized precipitates are embedded in the binder phase. As demonstrated in the high magnification image (Figure 5-16 b), many needle shaped precipitates with diameters of nanometers can be clearly observed. These nano sized needle shape precipitates are randomly distributed in the hydration products without any orientations.

Figure 5- 16 The SEM images of the concrete samples after 15 F/T and W/D cycles in CaFm2 solution with a) low and b) high magnification.

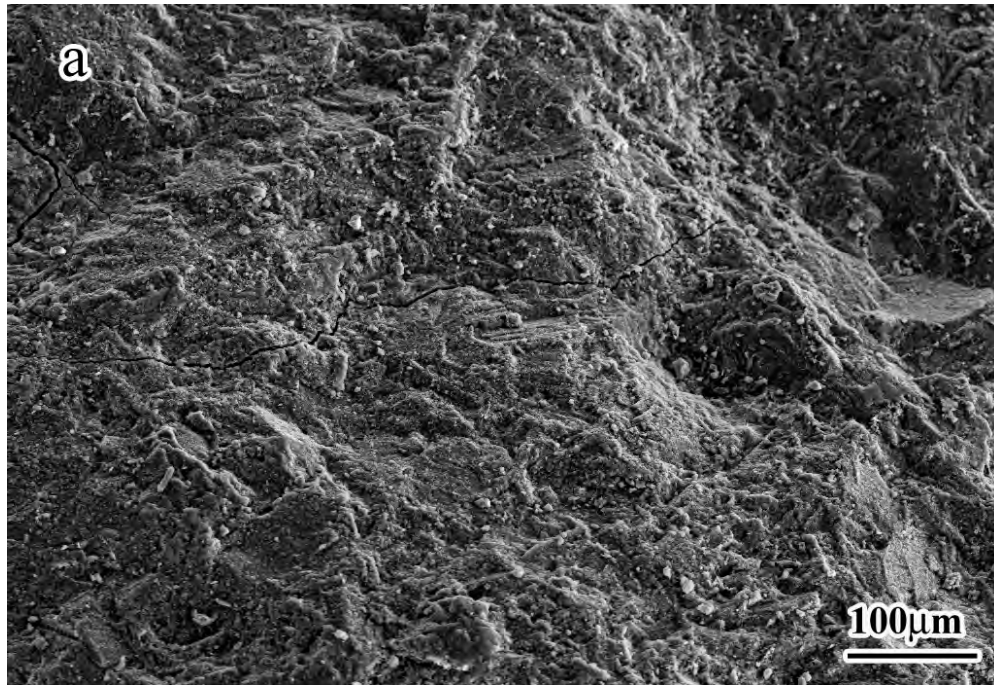
Figure 5- 18 The SEM/EDS result of the concrete samples after 15 F/T and W/D cycles in NaCl with a) SEM image and b) corresponding EDS element distribution results.

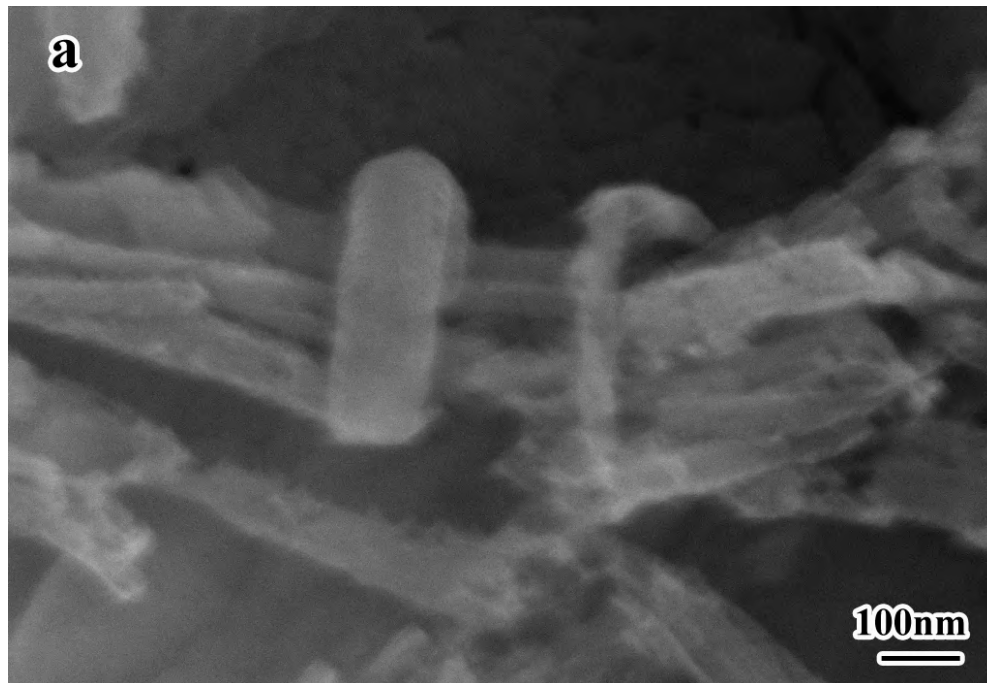
Figure 5- 19 The SEM/EDS result of the concrete samples after 15 F/T and W/D cycles in NaCl with a) high magnification SEM image and b) corresponding EDS element distribution results. *NOTE: The SEM image is a little bit out of focus due to the device limitation on magnification.*

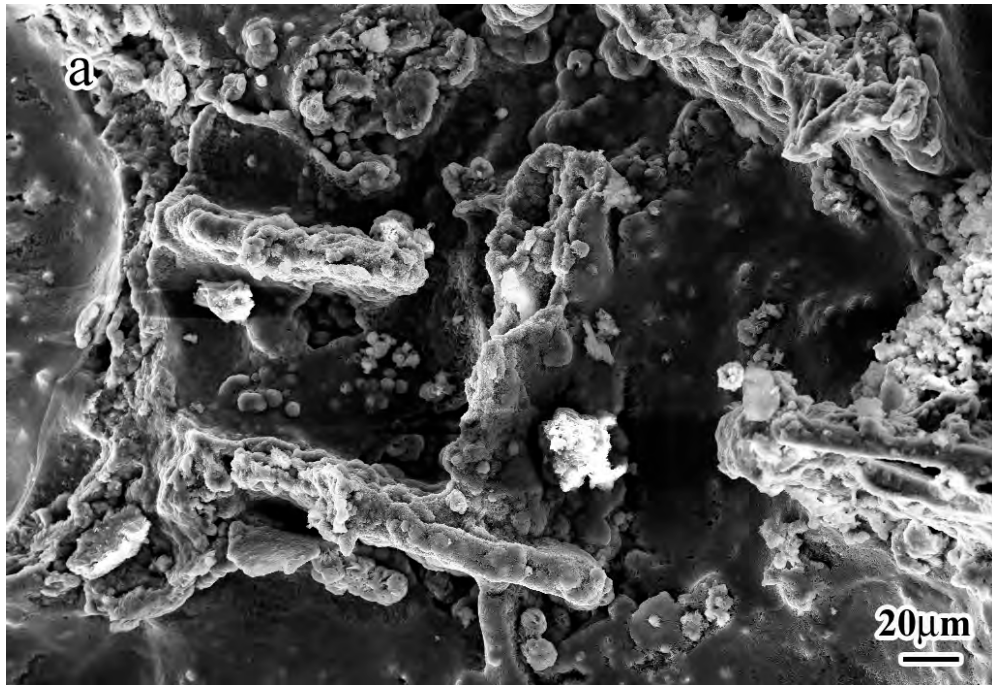
Figure 5- 20 The SEM/EDS result of the concrete samples after 15 F/T and W/D cycles in MgCl₂ with a) SEM image and b) corresponding EDS element distribution results.

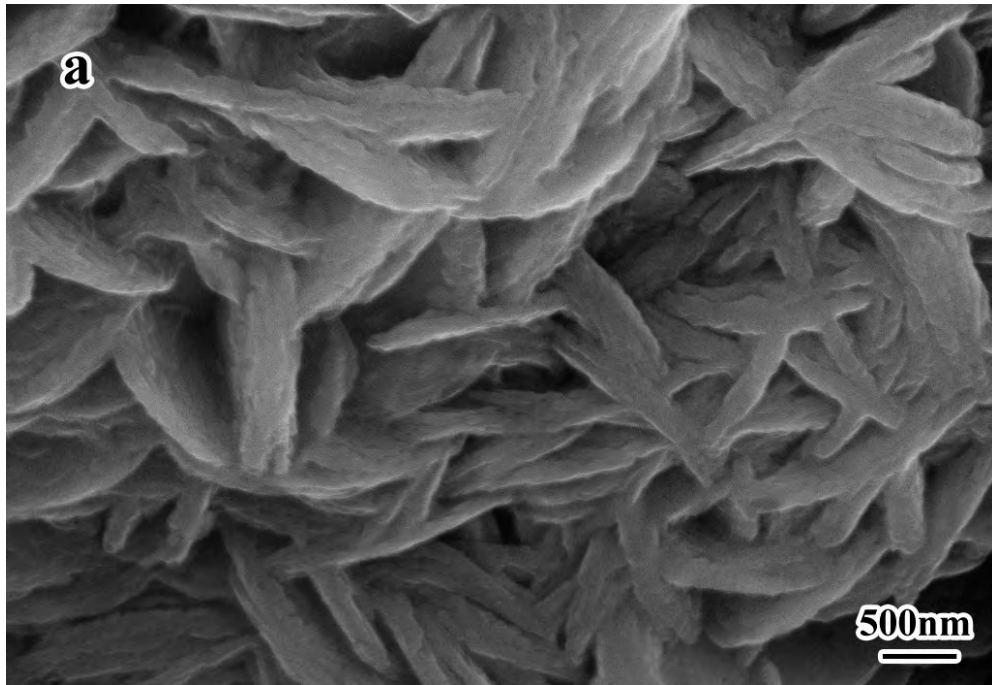
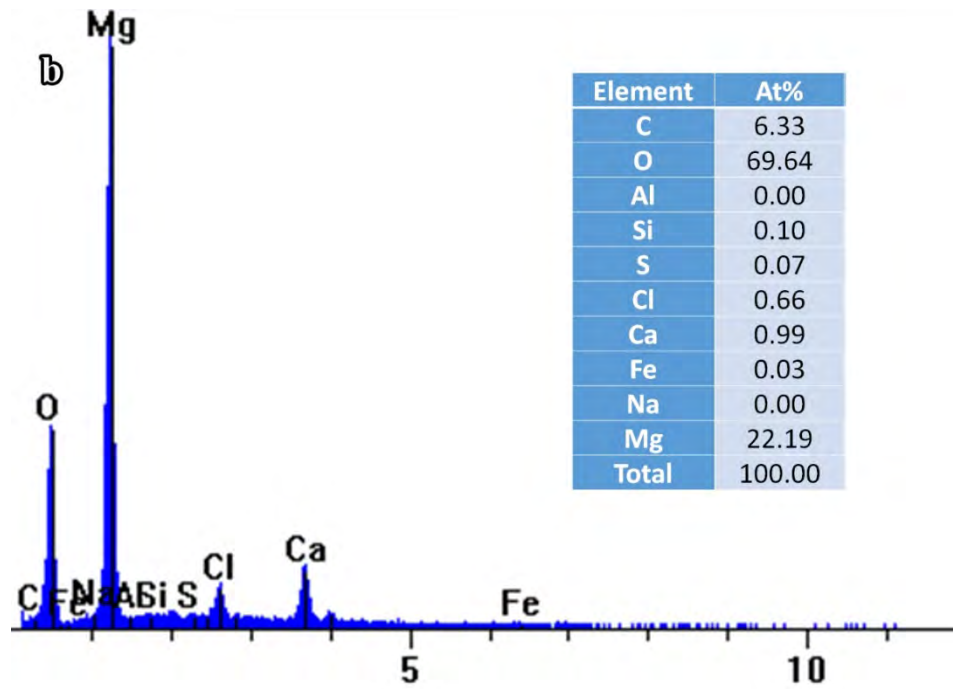
Figure 5- 21 The SEM/EDS result of the concrete samples after 15 F/T and W/D cycles in $MgCl_2$ with a) high magnification SEM image and b) corresponding EDS element distribution results.

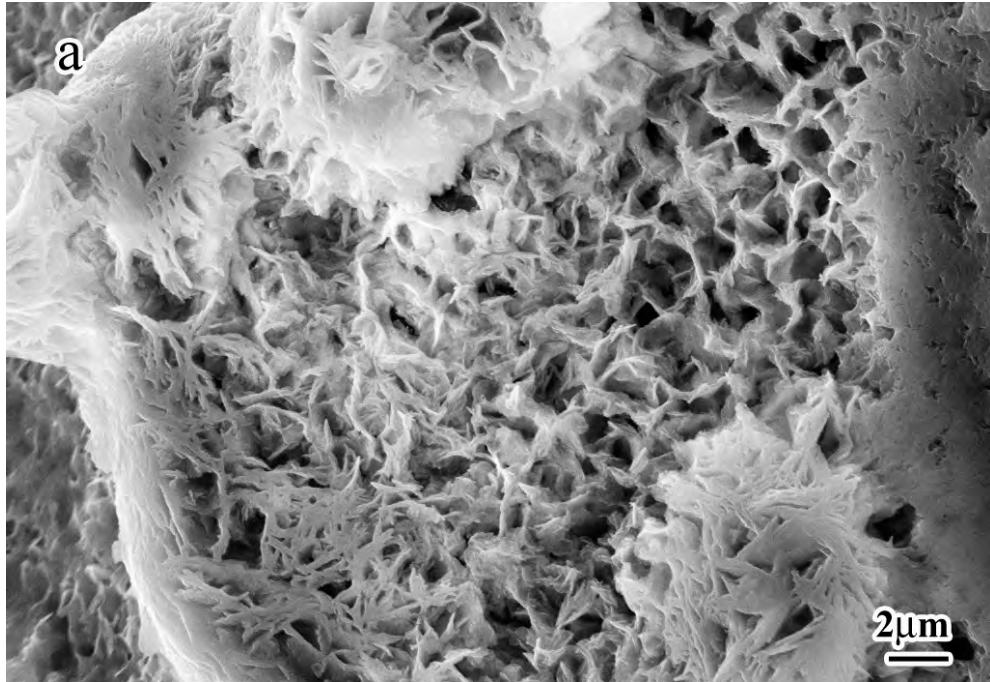
Figure 5- 22 The SEM/EDS result of the concrete samples after 15 F/T and W/D cycles in MgCl₂ with a) SEM image and b) corresponding EDS element distribution results.

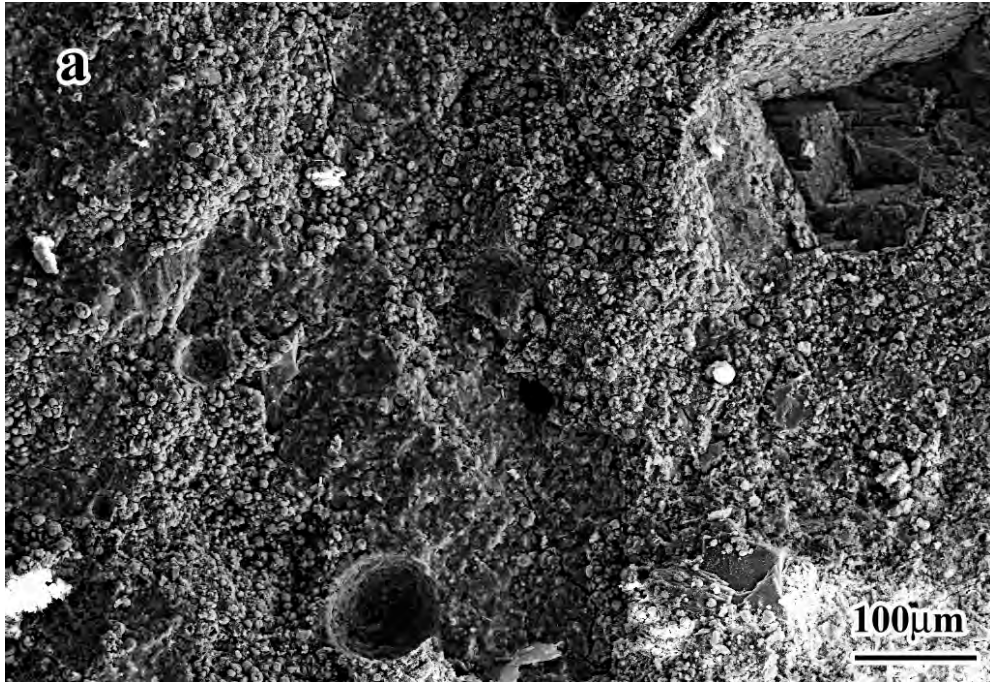
Figure 5- 23 The SEM/EDS result of the concrete samples after 15 F/T and W/D cycles in KAc with a) SEM image and b) corresponding EDS element distribution results.

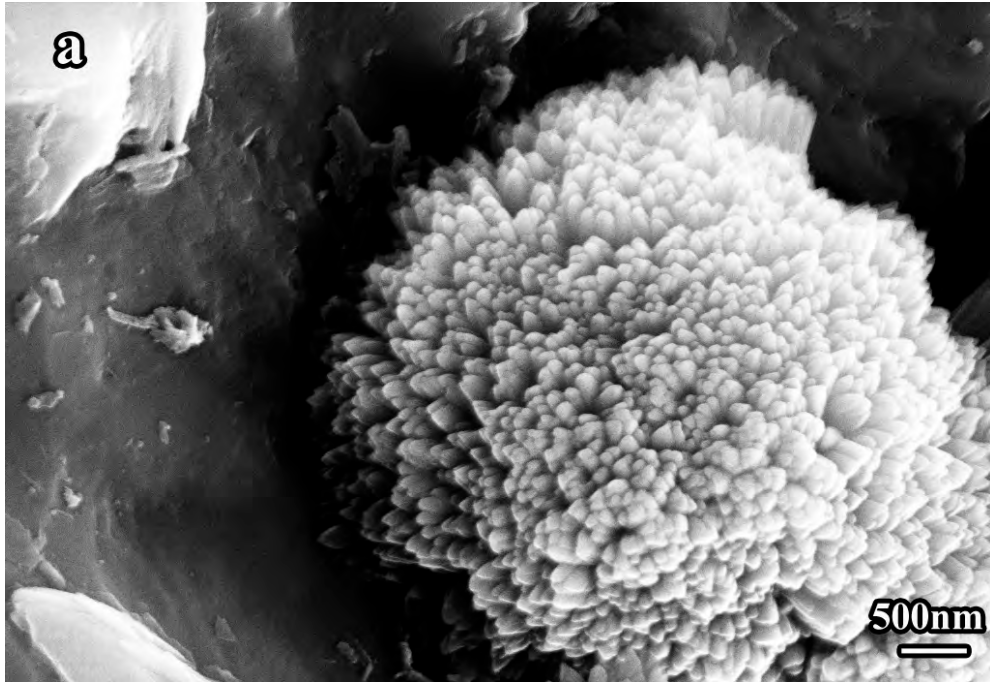
Figure 5- 24 The SEM/EDS result of the concrete samples after 15 F/T and W/D cycles in KAc with a) high magnification SEM image and b) corresponding EDS element distribution results.

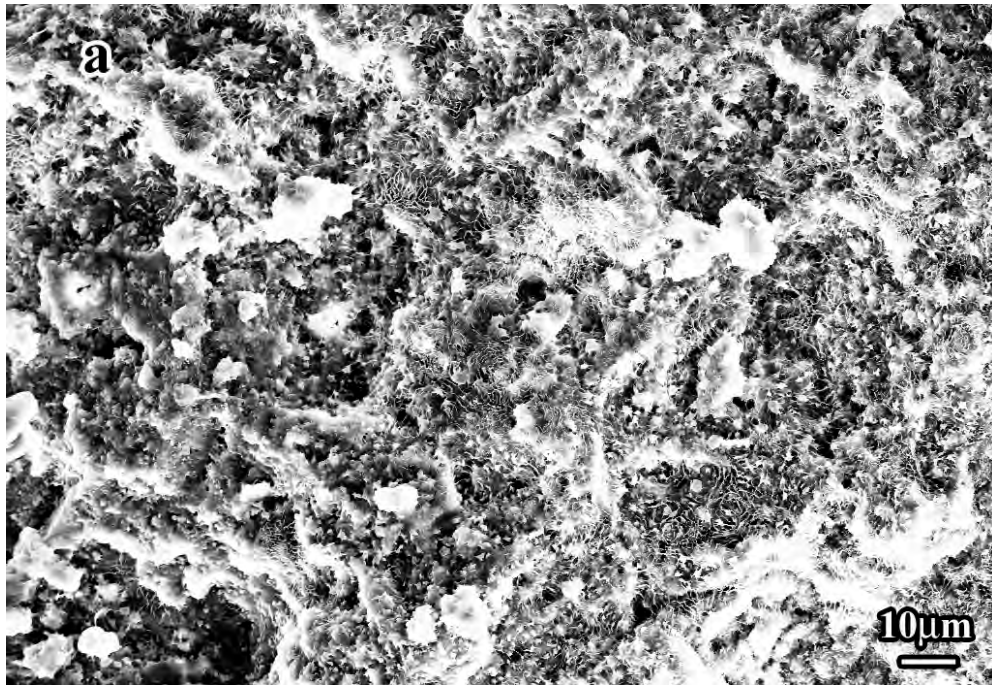
Figure 5- 25 The SEM/EDS result of the concrete samples after 15 F/T and W/D cycles in Kfm with a) SEM image and b) corresponding EDS element distribution results.

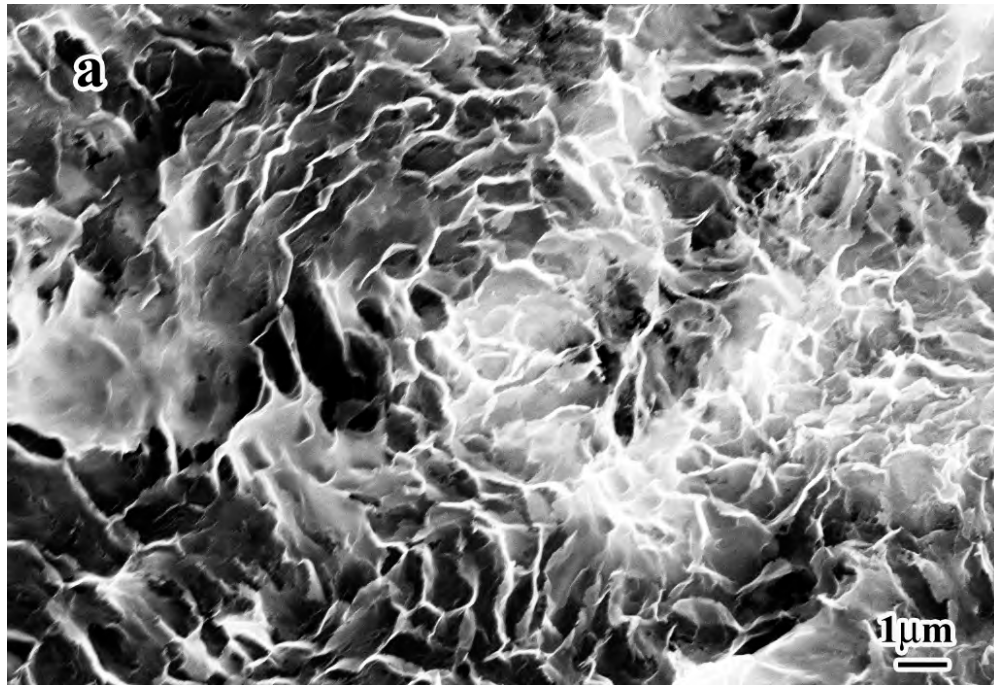
Figure 5- 26 The SEM/EDS result of the concrete samples after 15 F/T and W/D cycles in Kfm with a) high magnification SEM image and b) corresponding EDS element distribution results.

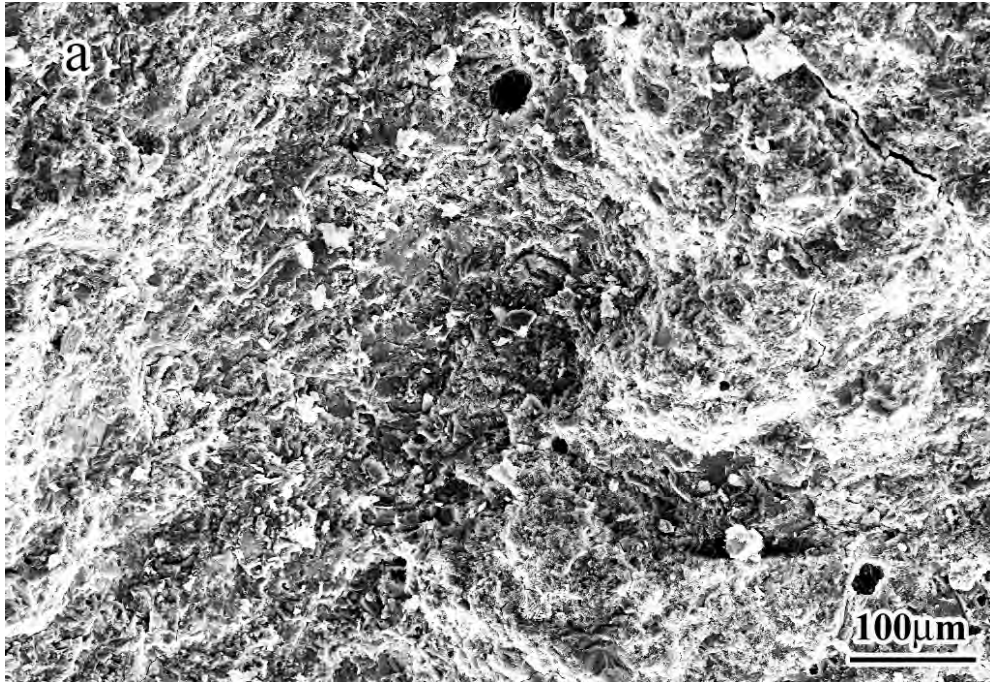
Figure 5- 27 The SEM/EDS result of the concrete samples after 15 F/T and W/D cycles in CaCl_2 with a) SEM image and b) corresponding EDS element distribution results.

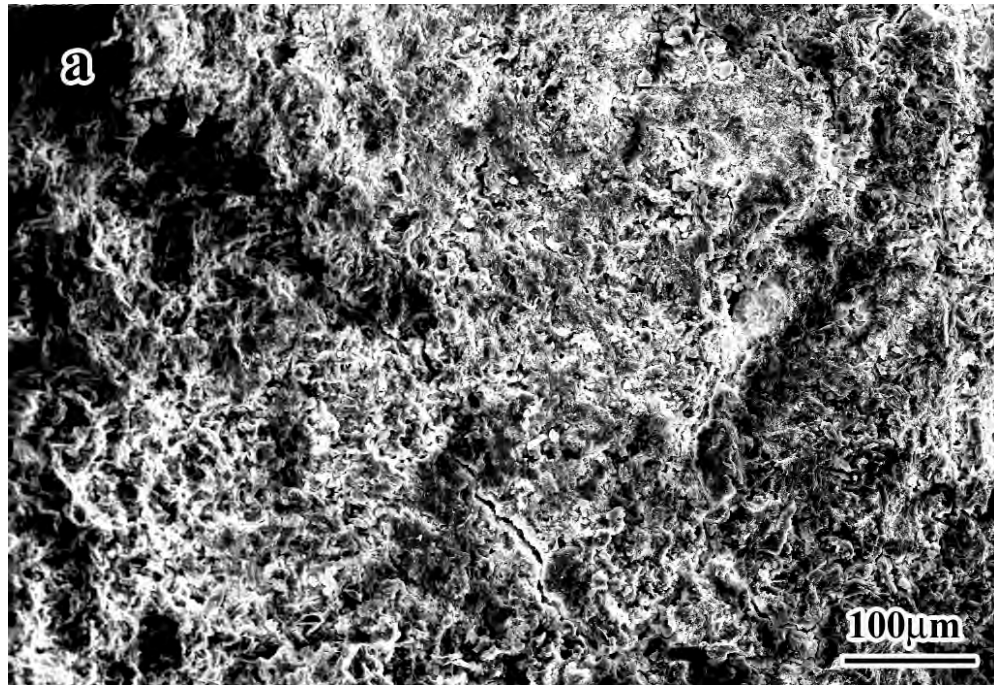
Figure 5- 28 The SEM/EDS result of the concrete samples after 15 F/T and W/D cycles in CaAc₂ with a) SEM image and b) corresponding EDS element distribution results.

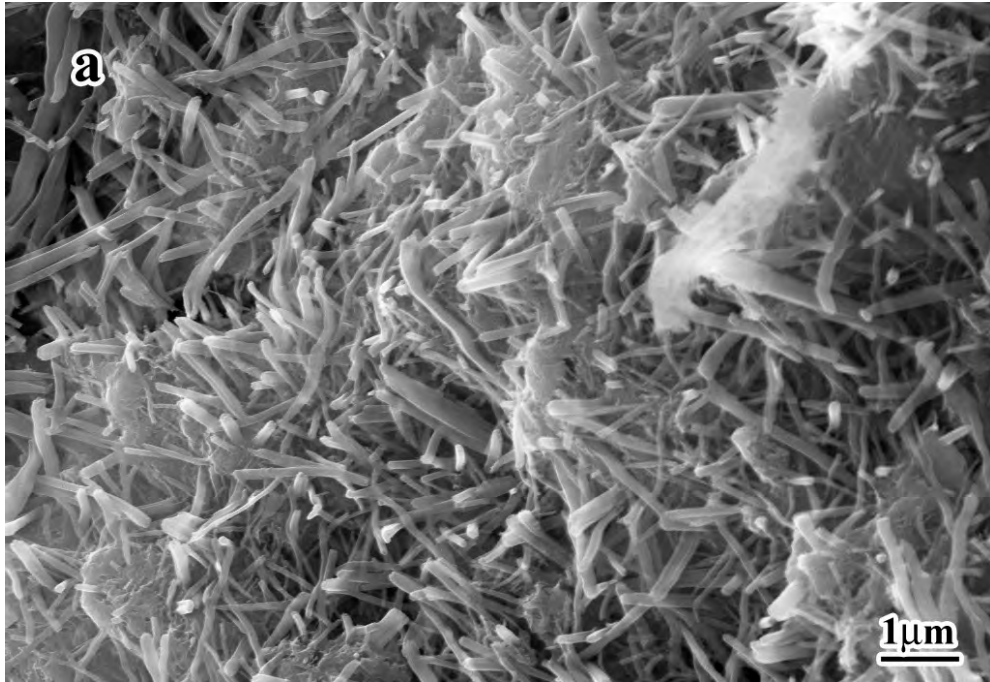
Figure 5- 29, demonstrate that the nano-sized needle shaped precipitates are composed mainly from Ca and Si. The reaction mechanism is worthy of further systematic investigation.

Figure 5- 29 The SEM/EDS result of the concrete samples after 15 F/T and W/D cycles in CaFm_2 with a) high magnification SEM image and b) corresponding EDS element distribution results.

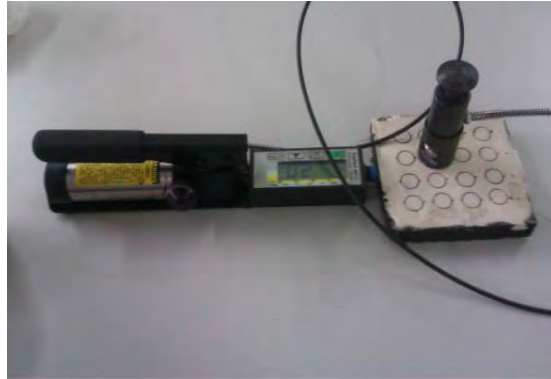
After the polymer coatings were cured on asphalt concrete for 2 days, the head of the testing device was bonded with the coating using a two components glue. Two hours later, the asphalt concrete was frozen or heated at set temperature for another two hours, followed by the bond strength testing.

Figure 6- 6 Bond strength tests

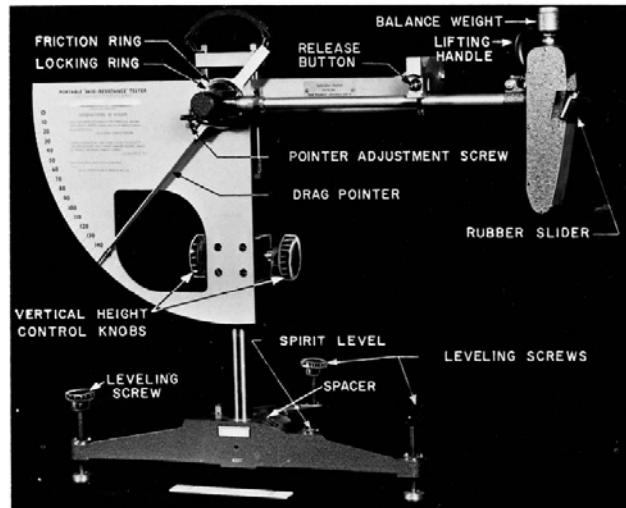
The surface friction tests of anti-skid coatings were conducted in accordance with ASTM E303 Standard Test Method for Measuring Surface Frictional Properties Using the British Pendulum Tester. Before the tests, specimens with polymer coatings were kept in an open-air environment for 24 h to keep all test coatings in equivalent curing conditions. The apparatus is shown in Figure 6- 7.

Figure 6- 7 British Pendulum Tester.

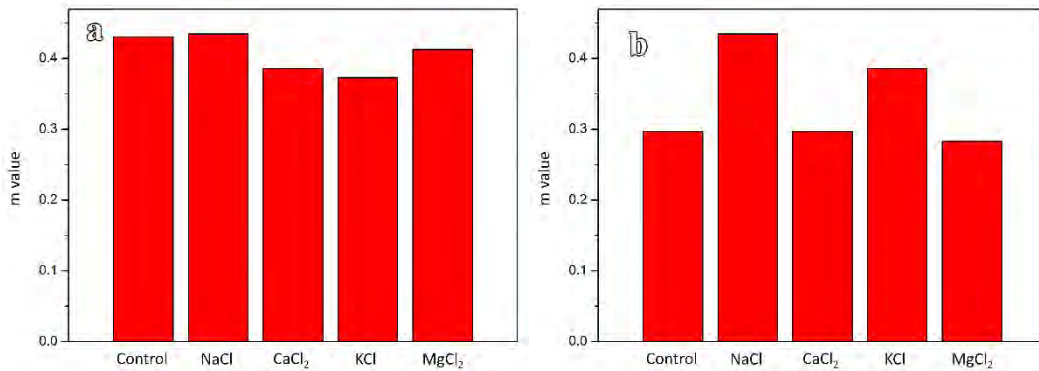
Figure 6- 9 m-values of PG 68-22 grade asphalt exposed to chloride based deicers at a) -12 °C and b) -18 °C

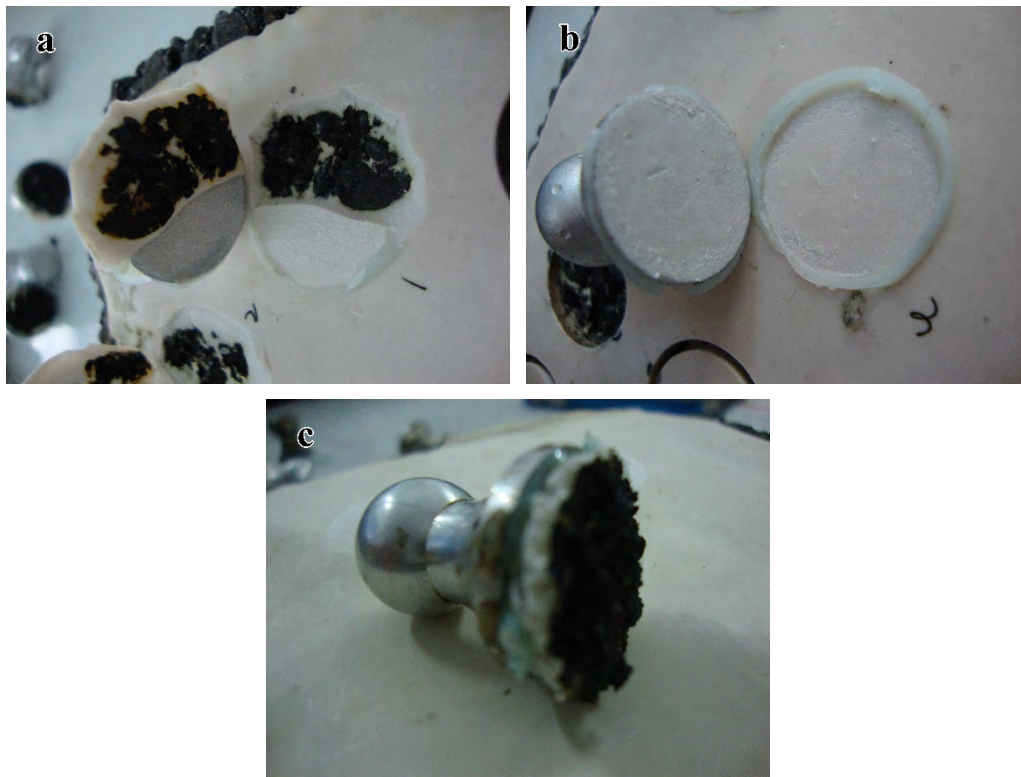
Of note, three types of failure mechanisms of the coating can be found in all samples tested below $-18\text{ }^{\circ}\text{C}$. At room temperature, however, most of the failures occurred on the polymers, as shown in Figure 6- 10 b). At high temperatures ($>45\text{ }^{\circ}\text{C}$), the failure of acrylic polymer coatings was not observed, and all failures occurred on asphalt materials, shown as Figure 6- 10 c).

Figure 6- 10 External failure images of the acrylic polymer coating on asphalt concrete, a) failure of both polymer and asphalt, b) failure of polymer, and c) failure of asphalt.

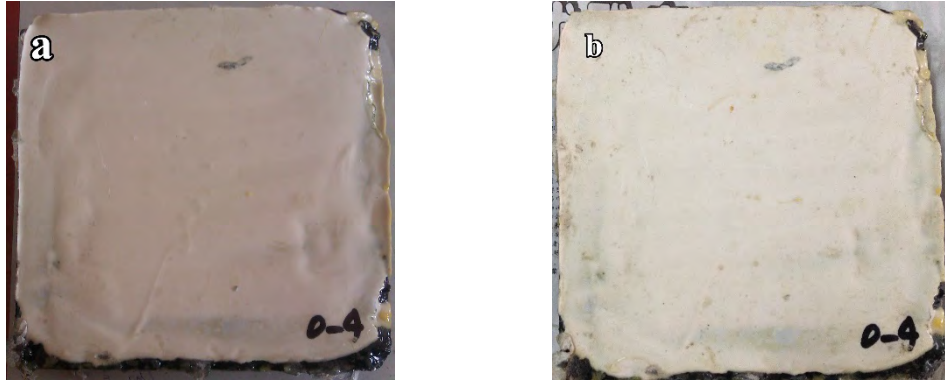
Figure 6- 11 External image of acrylic polymer coating a) before and b) after F/T cycles in water.

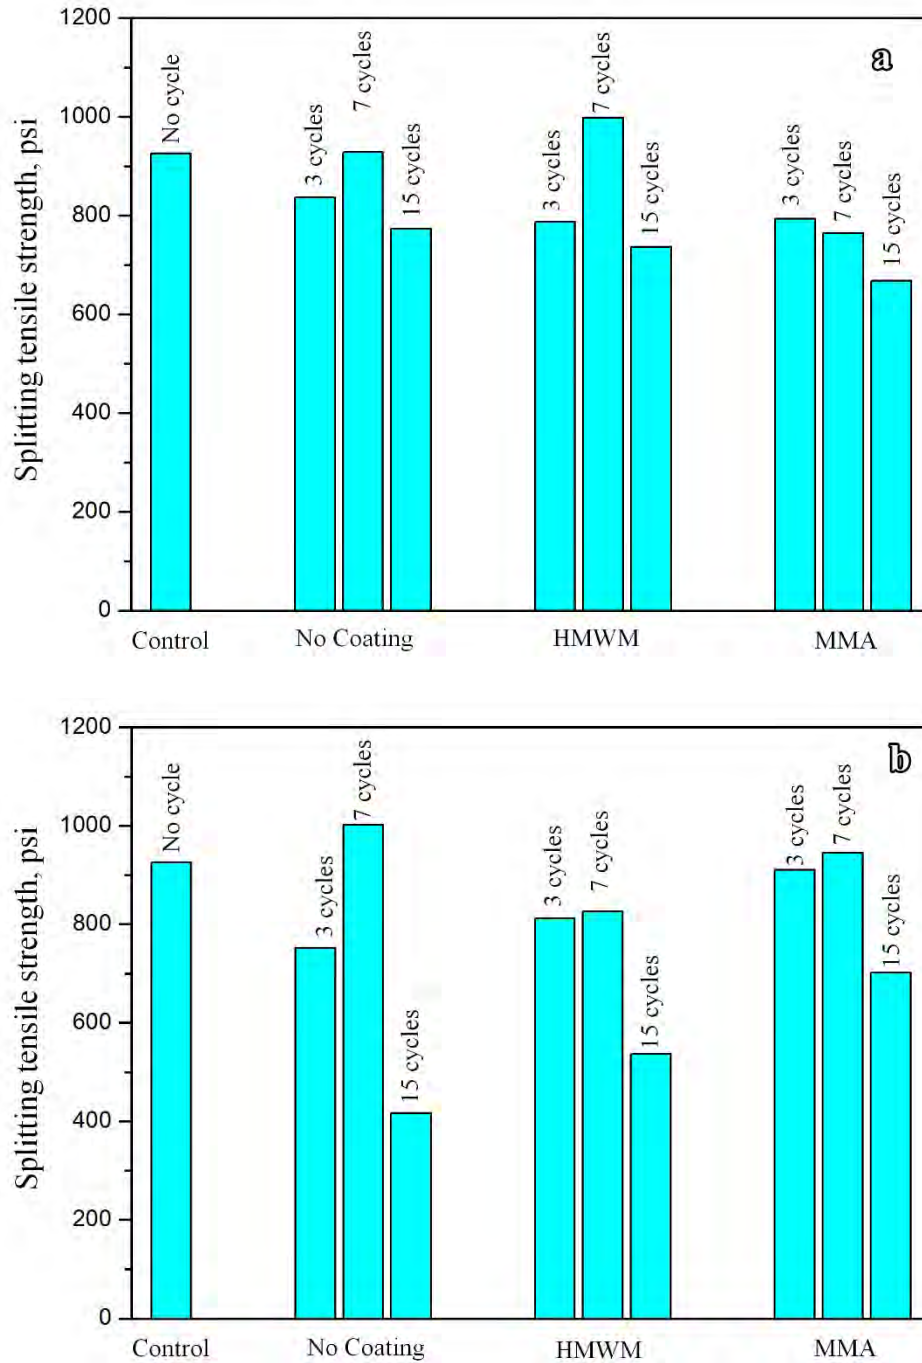
Figure 6- 15 Splitting tensile strength of concrete samples with various coatings with exposure to a) NaCl and b) MgCl₂ solution.

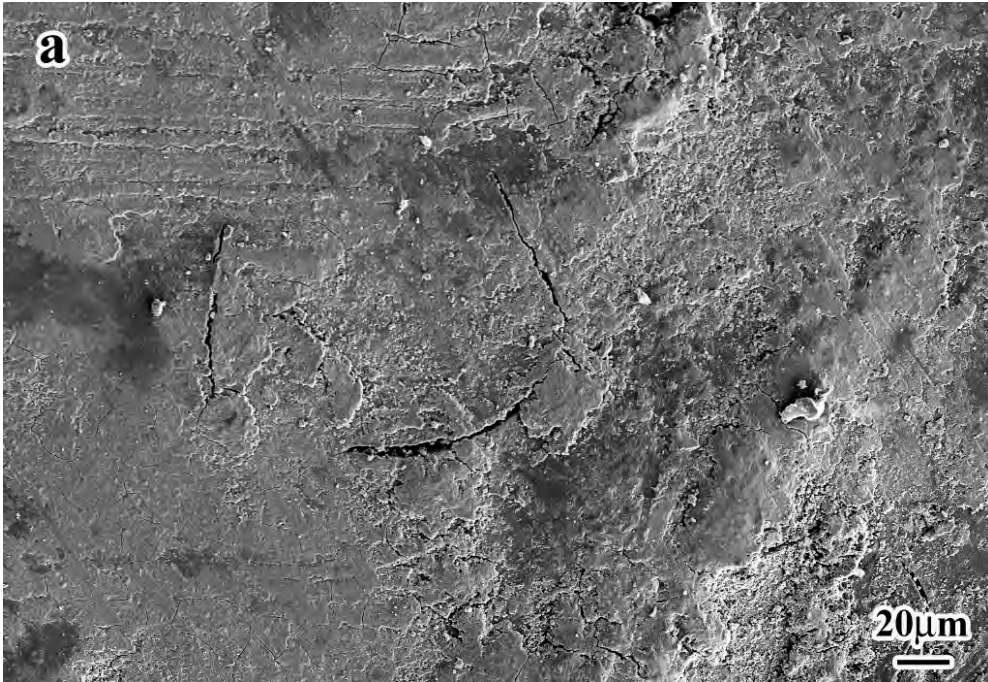
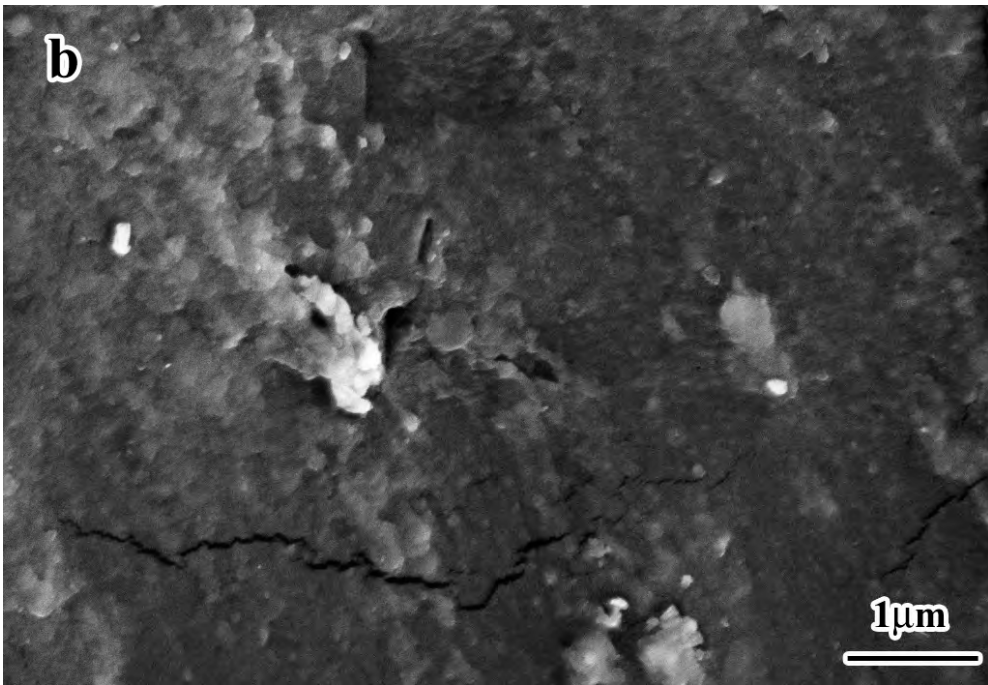
Figure 6- 16 SEM microstructure images of the HMWM coatings after 15 F/T cycles with exposure to MgCl₂ solution a) low magnification, b) high magnification.

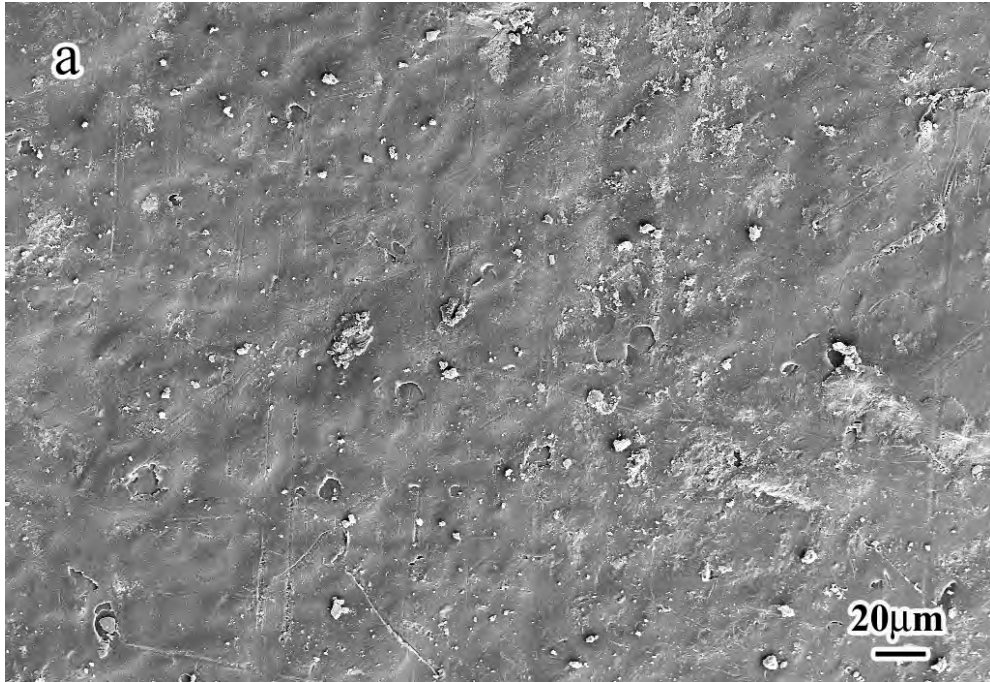
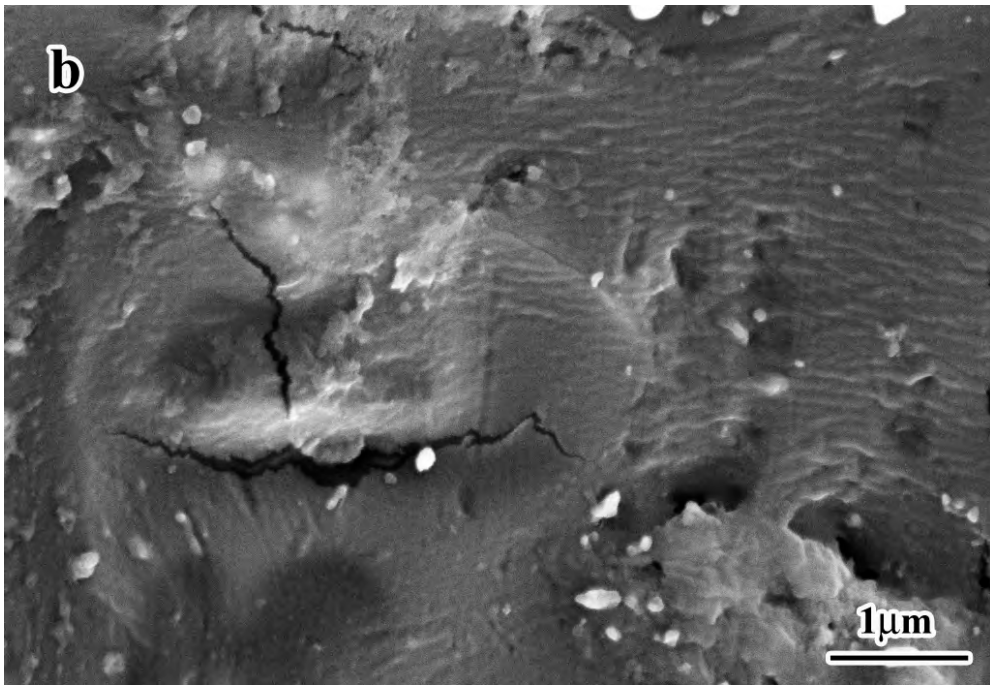
Figure 6- 17 SEM microstructure images of the MMA coatings after 15 F/T cycles with exposure to MgCl₂ solution a) low magnification, b) high magnification.

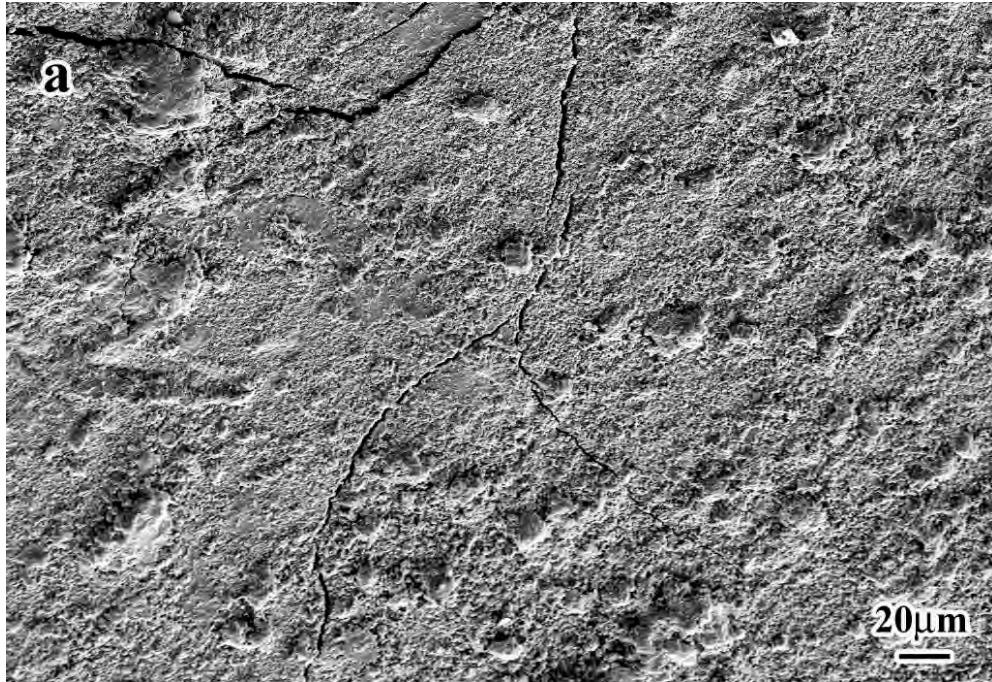
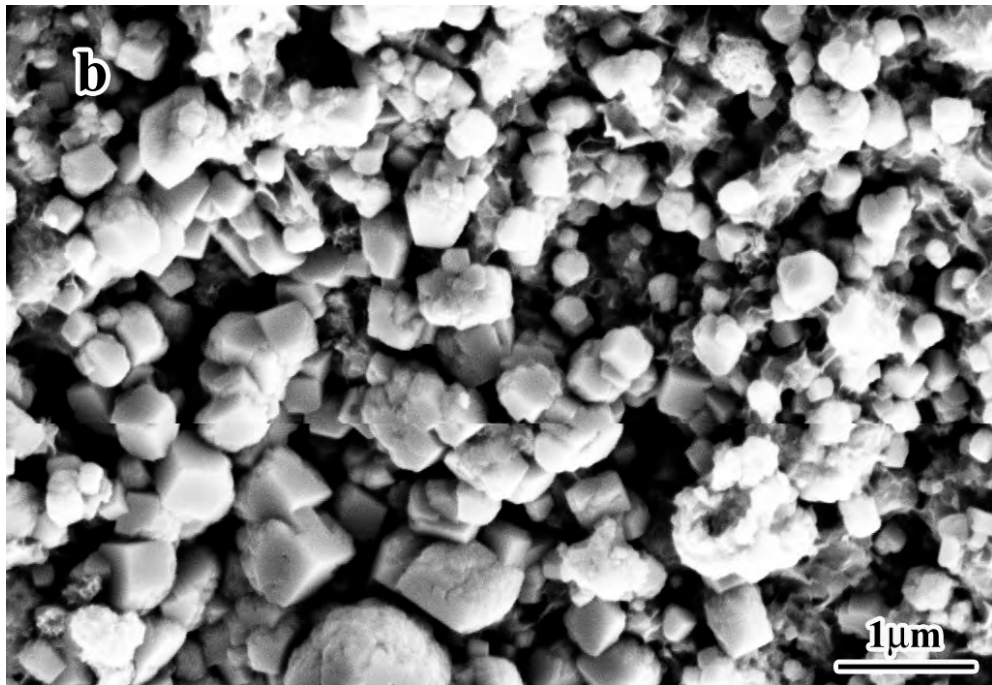
Figure 6- 18 SEM microstructure images of the HMWM coatings after 15 F/T cycles with exposure to NaCl solution a) low magnification, b) high magnification.

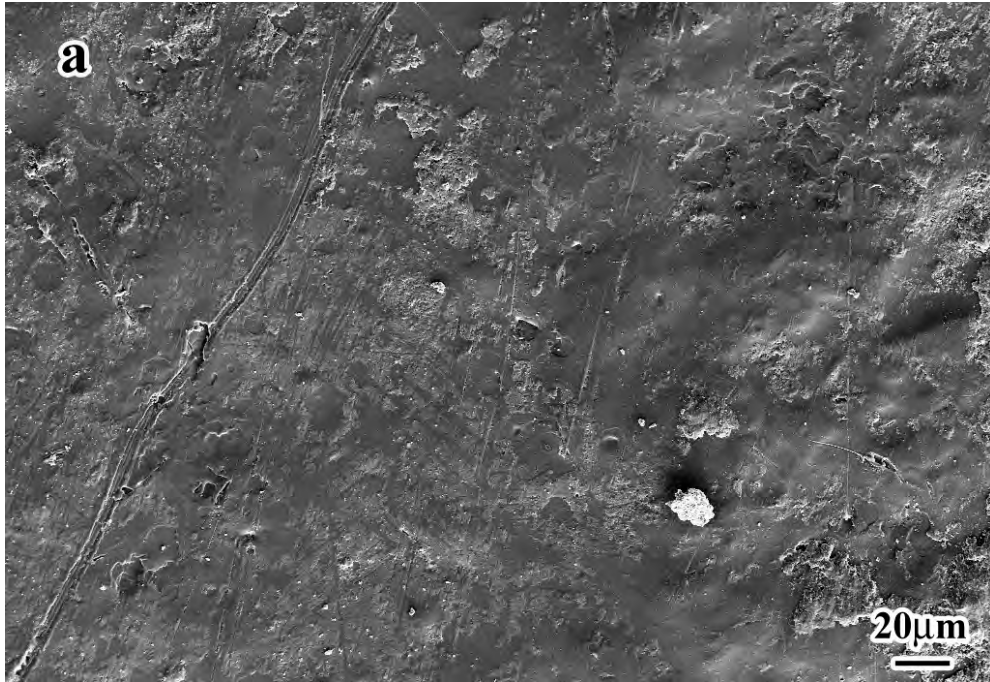
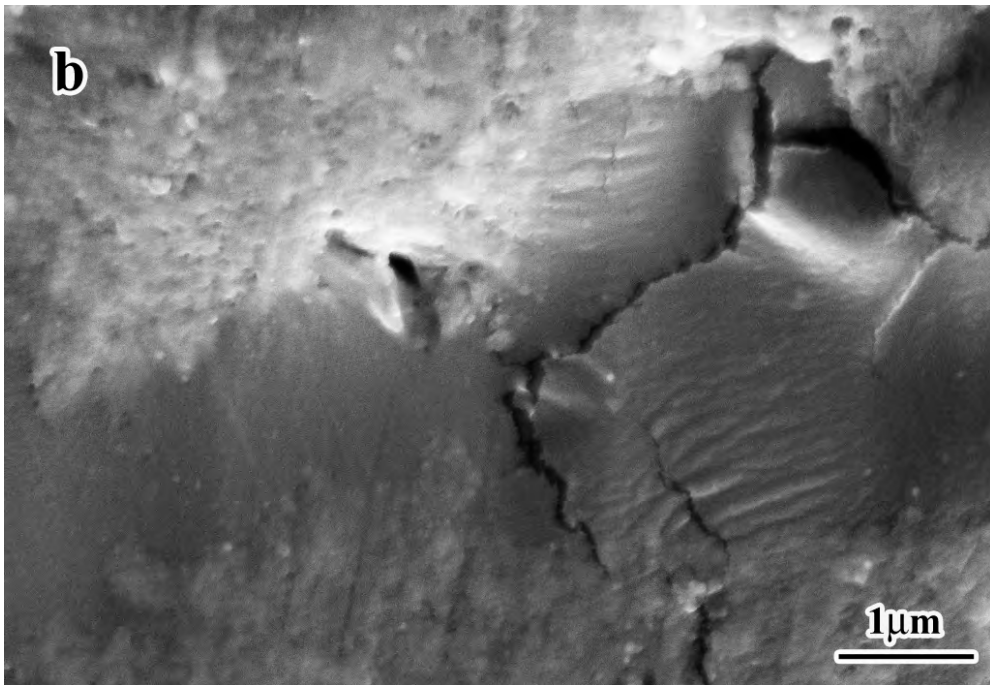
Figure 6- 19 SEM microstructure images of the MMA coatings after 15 F/T cycles with exposure to NaCl solution a) low magnification, b) high magnification.
