**NDOT Research Report**

Report No. 530-14-803

# Phase I: Minimization of Cracking in New Concrete Bridge Decks

May 2016

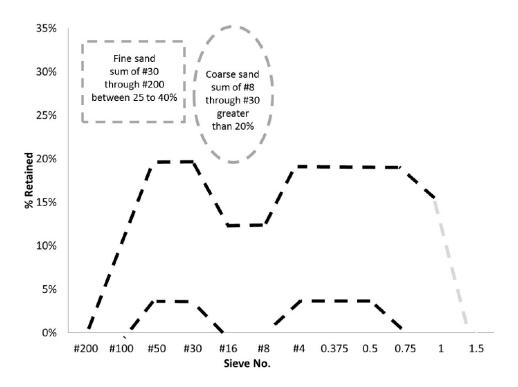
Figure 2-1. Recommended grading limits for bridge deck concrete that is pumped (Cook et al. 2015).

The Oklahoma Department of Transportation (OKDOT) commissioned a study to evaluate the use of optimized graded concrete to improve the workability of concrete that is to be pumped, such as is done commonly for bridge decks (Cook et al. 2015). Considerable laboratory work was done to support this effort, using a concrete pump in the laboratory to investigate flowability characteristics of various concrete mixtures. It was determined that if the aggregate is properly graded, a pumpable concrete mixture can be created for bridge applications having a total cementitious materials content of 564 lbs and a minimum slump of 4 inches. This study provided a proposed special provision for consideration by OKDOT, in which a modified "tarantula" curve (shown in figure 1) provides the recommend grading limits.

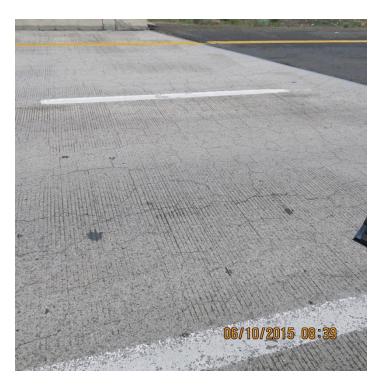
Figure 3-2. Bridge H-2298 bridge deck. Note high density random cracking throughout.

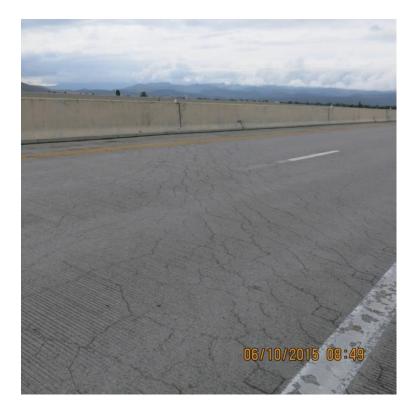
Figure 3-3. Bridge I-2296 bridge deck. Note the high density random cracking throughout, with some cracking oriented above underlying skewed pier.

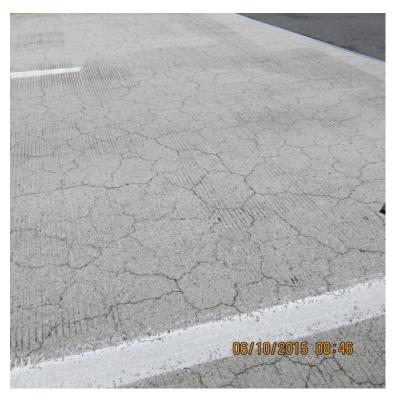
Figure 3-4. Bridge H-2297 bridge deck. Note high density random cracking throughout.

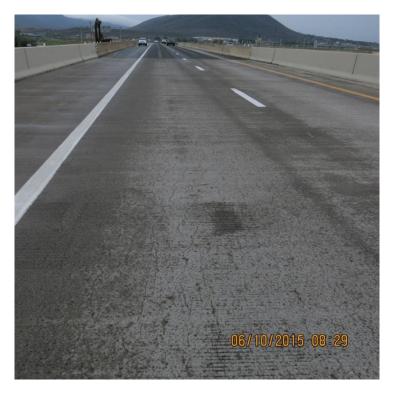
Figure 3-5 is a photo of the bridge deck taken in June 2015 (after 9 years in service). Considerable random cracking is evident, likely due to restraint of shrinkage. This deck has subsequently been treated with a multi-lift overlay to effectively seal the cracks.

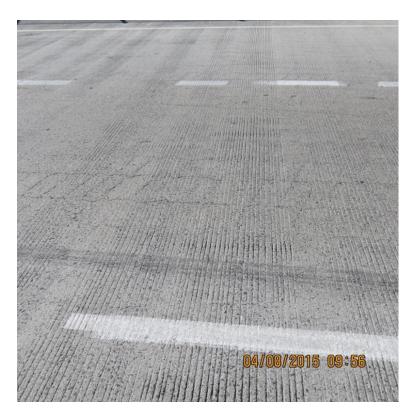
Figure 3-6. Bridge H-2288 bridge deck with readily visible cracking throughout.

A photo of the bridge deck of the Bridge H-2288 bridge deck taken in April 2015 (7 years following construction) is shown in Figure 3-6. Moderate cracking is visible, some in a pattern of unknown origin, although restraint is a likely contributor.

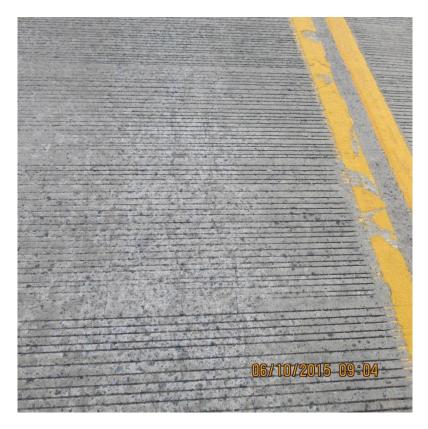
Figure 3-7. Bridge H-2287 bridge deck with faint cracking visible.

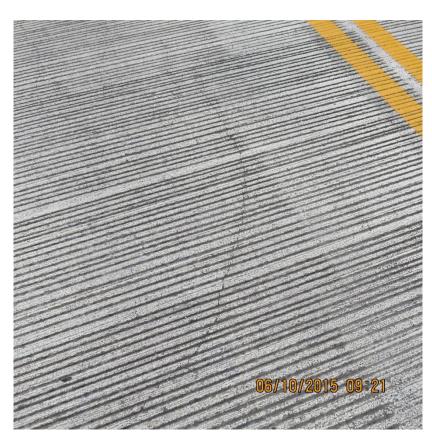
Figure 3-8. Bridge deck of bridge H-2285 with some visible cracking.

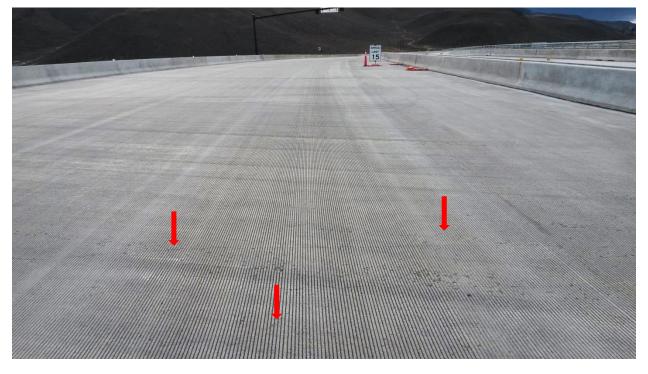
Figure 3-10. View looking south on eastern deck of SE Connector with visible cracking that is difficult to see.

A visual assessment was conducted on the two bridges crossing the Truckee River as part of the SE Connector, extending Sparks Avenue to the south of Greg Street. The two bridges are side by side, but separate. The bridge lying to the east is currently carrying construction traffic whereas the one to the west has been un-trafficked since construction, nearly two years ago. Visual inspection of the two SE Connector bridges reveals very similar conditions. Fine random cracking is readily visible on both decks. Figure 3-10 shows a view looking down the deck where the cracks are barely visible, but the close up in Figure 3-11 clearly reveals the presence of cracking. At times the cracking appears to be oriented with what is likely transverse steel, but at other times it is random in nature. Similar cracking is visible on the western deck, as seen in the close up in Figure 3-12.

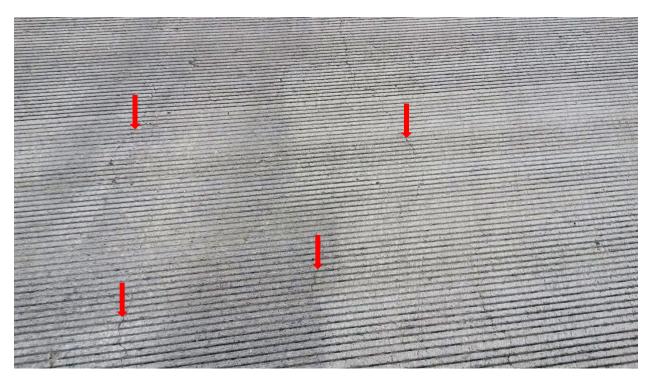
Figure 3-11. Close up of eastern deck of SE Connector with visible cracking.

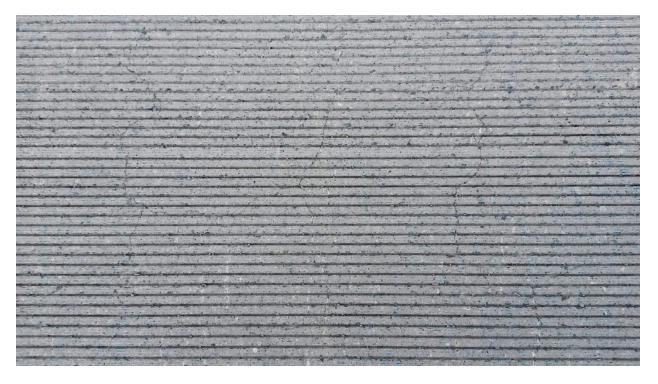
Figure 3-12. Close-up of cracking on eastern deck showing fine cracks.

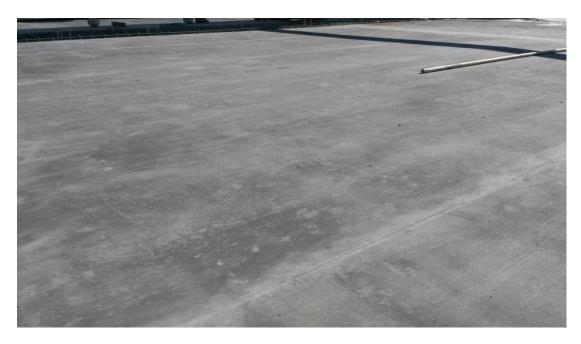
Figure 3-13. Overview of main deck of Virginia Street Bridge with no observed cracking.

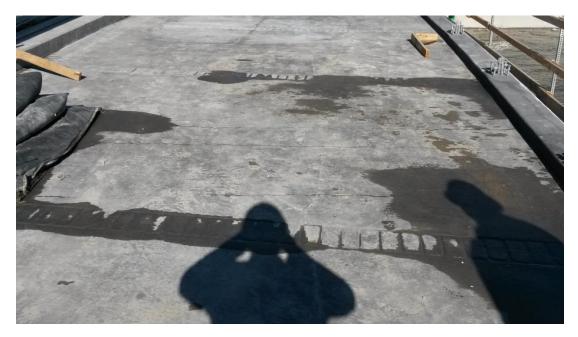
Figure 3-14. Two cracks observed on the eastern sidewalk of the Virginia Street Bridge.

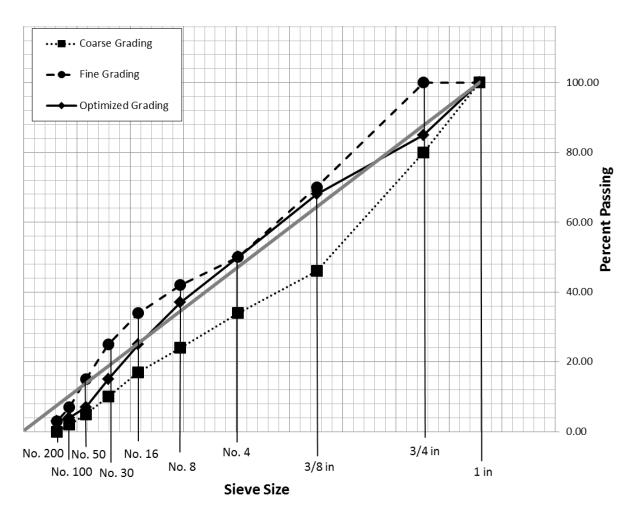
Figure 5-1. Range of acceptable aggregate gradings within NDOT specifications plotted on a 0.45 power chart.

The 0.45 power chart examines aggregate grading by plotting the percent retained against sieve size, raised to the 0.45 power. A common tool used in understanding asphalt gradations, in the 0.45 power curve a dense, optimized grading aligns closely with a straight line drawn from the maximum aggregate size through the origin. This is shown in figure 1 as the solid gray line. Greatly deviating above this line indicates a fine aggregate grading where greatly deviating below the line indicates a coarse aggregate grading. Figure 5-1 illustrates three possible aggregate gradings that are all acceptable under the Nevada DOT specifications: a fine grading, a coarse grading, and an optimized grading. It can be seen that both of the extreme gradations deviate from the central, target line, despite all falling within NDOT gradation specifications. A gradation that does not cross the maximum density line will not have sufficient space for the cementitious materials and would not be proposed.

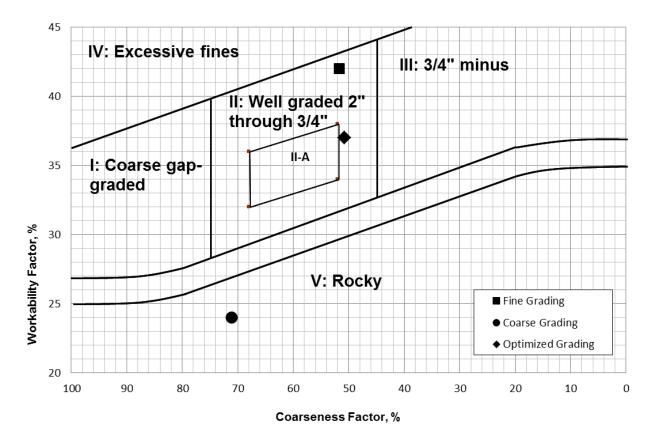
Figure 5-2. Coarseness factor-workability factor chart showing NDOT Gradations.

The coarseness factor-workability factor chart plots the coarseness factor against the workability factor for a given gradation. The coarseness factor (CF) is the percent of the combined aggregate that is retained on the No. 8 sieve that is also retained on the 3/8 inch sieve whereas the workability factor (WF) is the percent of the combined aggregate that passes the No. 8 sieve. The CF and WF are plotted to see where the grading lies within the five zones of the coarseness factor-workability factor chart as presented in Figure 5-2. Zone II is considered the dense, optimal grading zone, and is thought to be most desirable for paving grade mixtures. Further optimization can be found in sub-zone II-A. It is seen in Figure 5-2 that the NDOT fine and optimized gradings fall within the desirable Zone II, with the optimized grading being very close to the sub-zone II-A. The NDOT coarse grading falls within Zone V: Rocky.

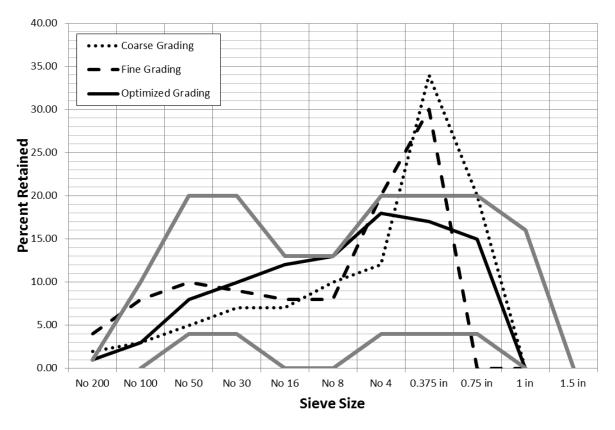
Figure 5-3. Modified percent passing chart based on Cook et al. 2015.

Recently, efforts focused on proper grading of concrete aggregates for use in bridge decks has resulted in the development of the modified-combined grading percent retained chart, also known as the Tarantula Curve (Cook et al. 2015). An optimal grading should fall within the bands in order to achieve multiple mixture parameters related to workability, pumpability, finishability, and strength. It can be seen in Figure 5-3 that both the fine and the coarse gradings exceed the recommended boundaries outlined in the chart; however, the optimized gradation falls within the prescribed boundaries.

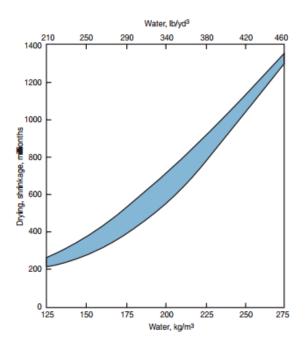
Figure 5-4. Effect of water content on drying shrinkage of concrete (Kostmatka and Wilson 2011).

It is known that the total water content in a concrete mixture directly affects the drying shrinkage potential of concrete. This relationship is represented in Figure 5-4 (Kostmatka 2002), which shows a distinctly linear relationship between ultimate drying shrinkage and total water content.

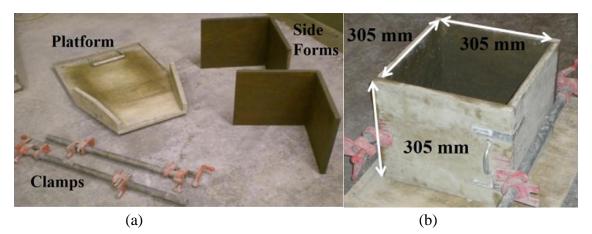
Figure 5-5. Box Test components (a) and assembled box (b) (Cook et al., 2014).

The Box Test is very simplistic in concept. It consists of a platform, two right-angled side forms, and two clamps that form a "box" having a 1 ft<sup>3</sup> volume as shown in Figure 5-5. Concrete is uniformly placed into the box to a depth of 9.5 inches and an internal electric vibrator (set at 12,500 vpm) is lowered into the center of the box for three seconds and then raised out of the box over a period of three seconds.

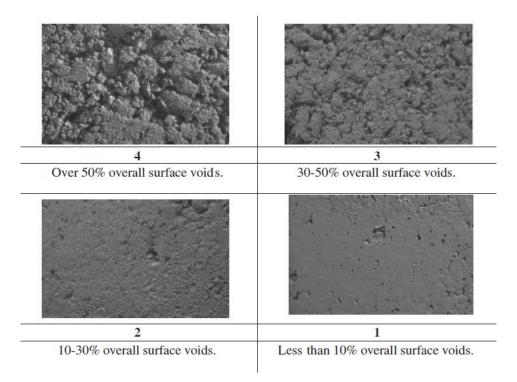
Immediately after vibration, the clamps are detached and the side forms removed exposing the vertical edges of the concrete. A qualitative assessment of the degree of consolidation is then made for each vertical side using rankings based on the percent overall surface voids as shown

in Figure 5-6. Edge slumping is also measured using a straight edge placed at a corner and measuring the length of the highest extruding point.
