NDOT Research Report

Report No: RDT04-049

# Development and Implementation of a Scour Monitoring Program for Selected Bridges Crossing the Truckee River

**December 2004**

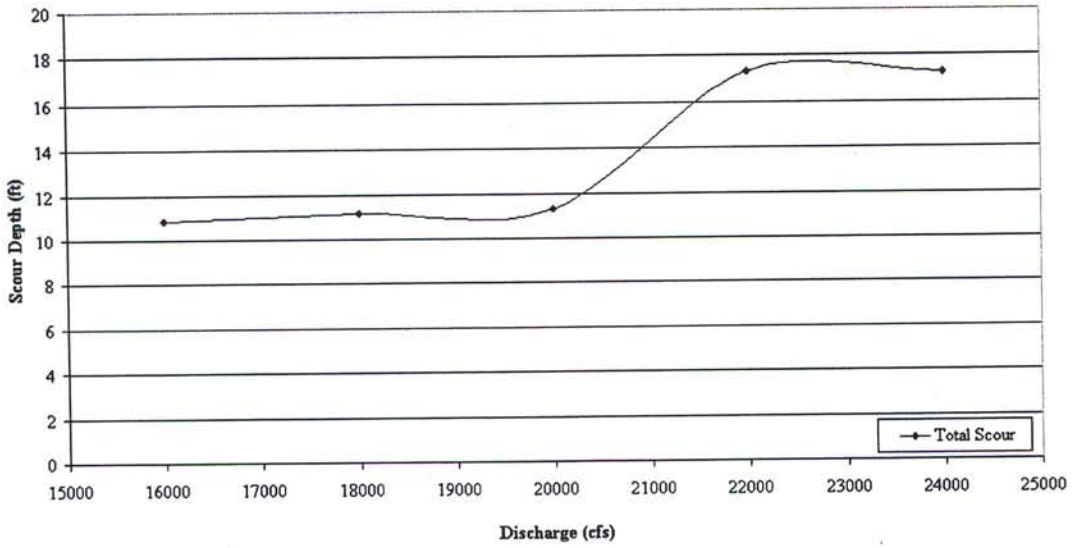
**Figure 2.2. Variation of total scour depth with discharge for Bridge B-578N**

As shown in Figure 2.2 for B-578N, the predicted scour depth abruptly increases after the flow exceeds 20,000 cfs. Below a flow of 20,000 cfs, only pier scour was considered. As soon as the scour depth reaches the top of the foundation, foundation scour increases the overall scour depth.

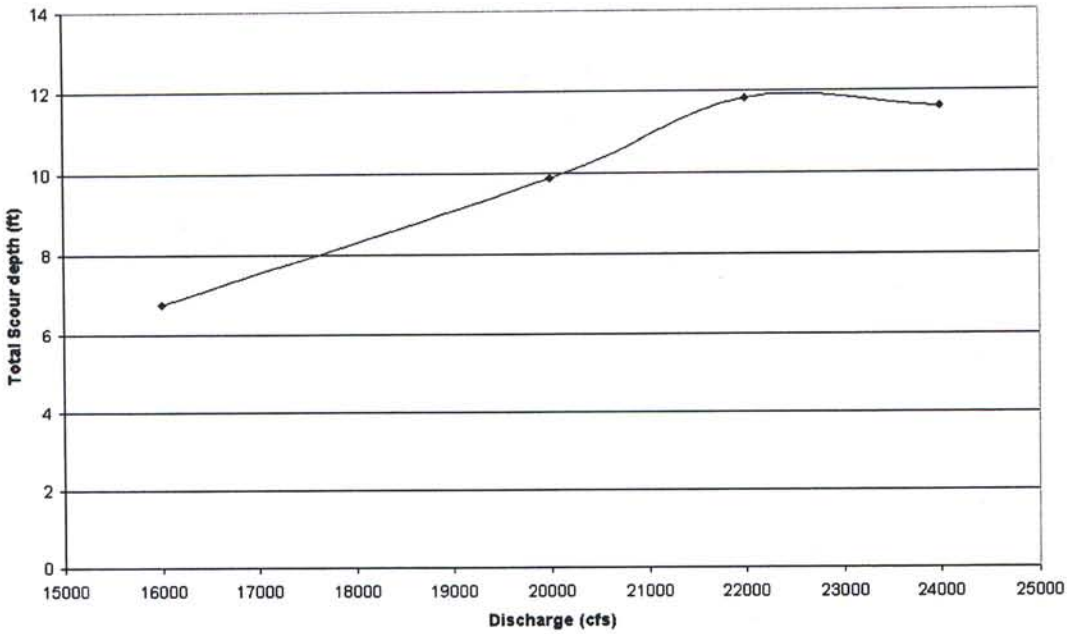
**Figure 2.3. Variation of total scour depth with discharge for Bridge B-1487**

As shown in Figure 2.3 for B-1487, the scour depth increases linearly as discharge increases from 16,000 cfs to 22,000 cfs. At a flow of 24,000 cfs, the scour depth decreased by 0.2 ft since the flow begins overtopping the bridge section. Under actual conditions, scour is likely to be increase as flow increases. It is recommended that B-1487 should be analyzed further for pressure flow conditions.

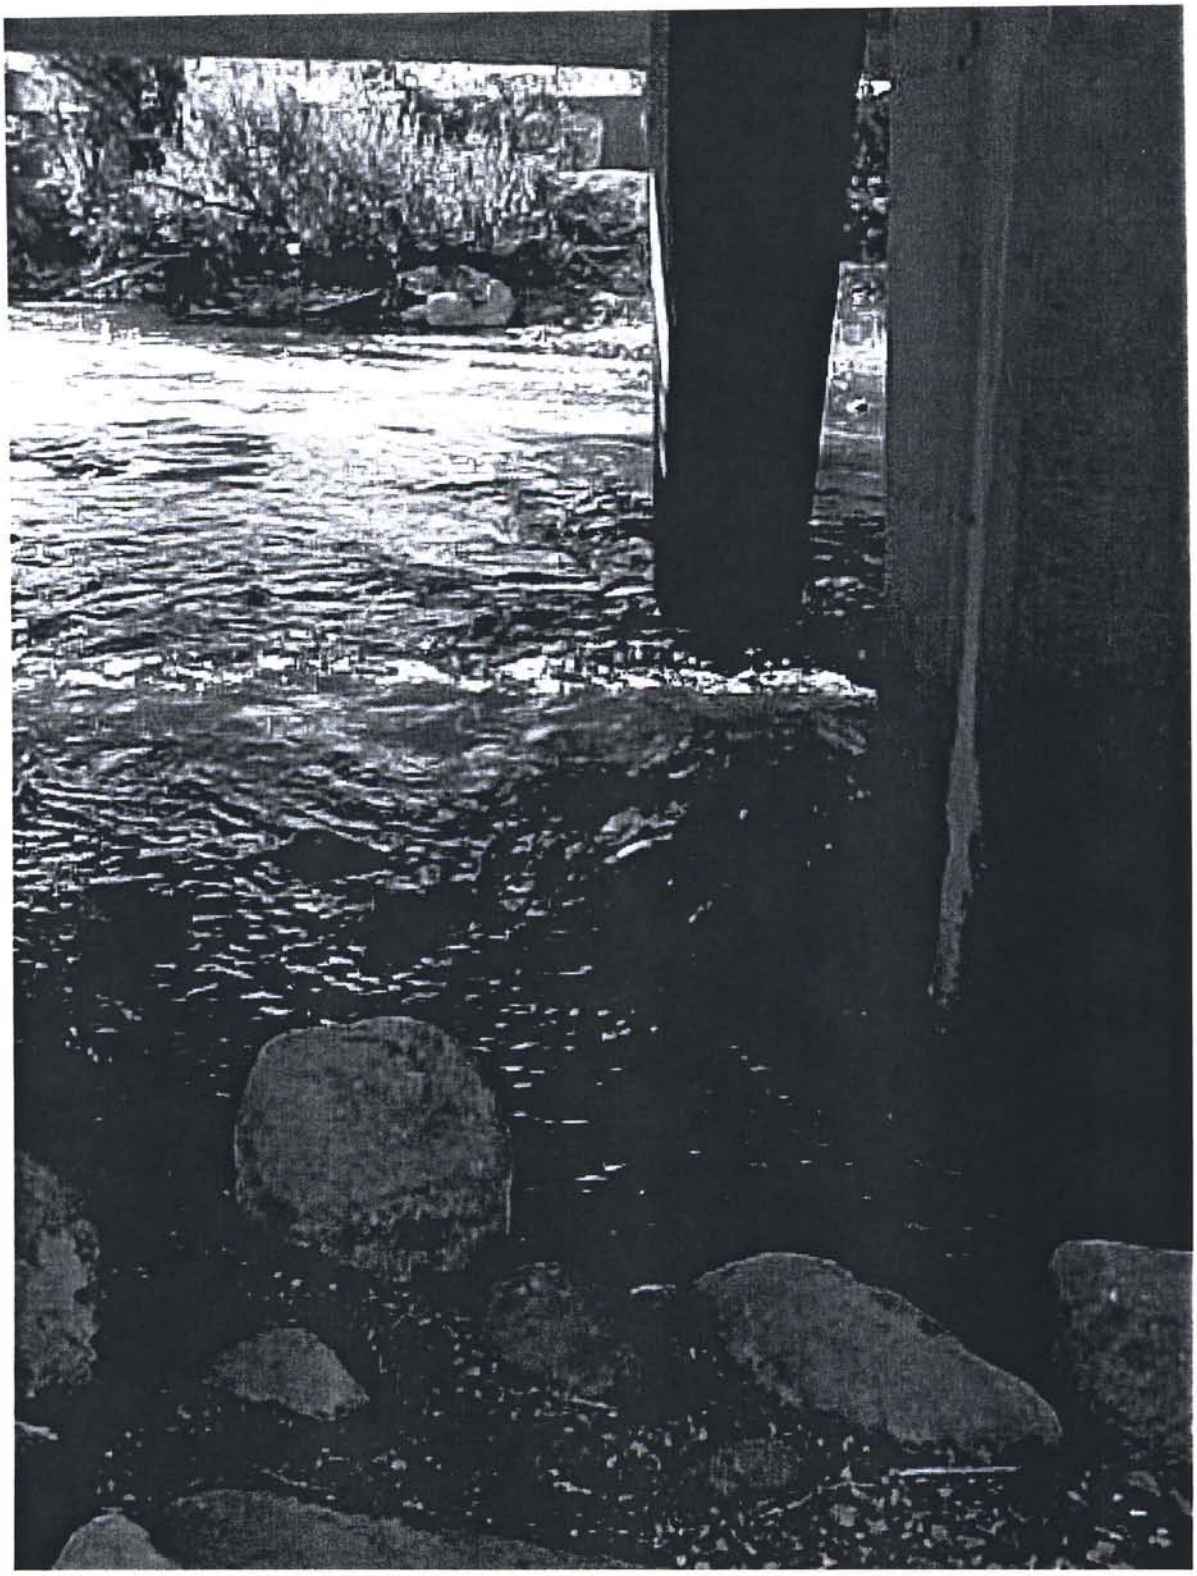
**Kietzke Bridge, north bank looking north at possible equipment access. (parking lot for fishermans park)**

**Kietzke bridge north bank looking across and downstream at piers for upstream bridge.**

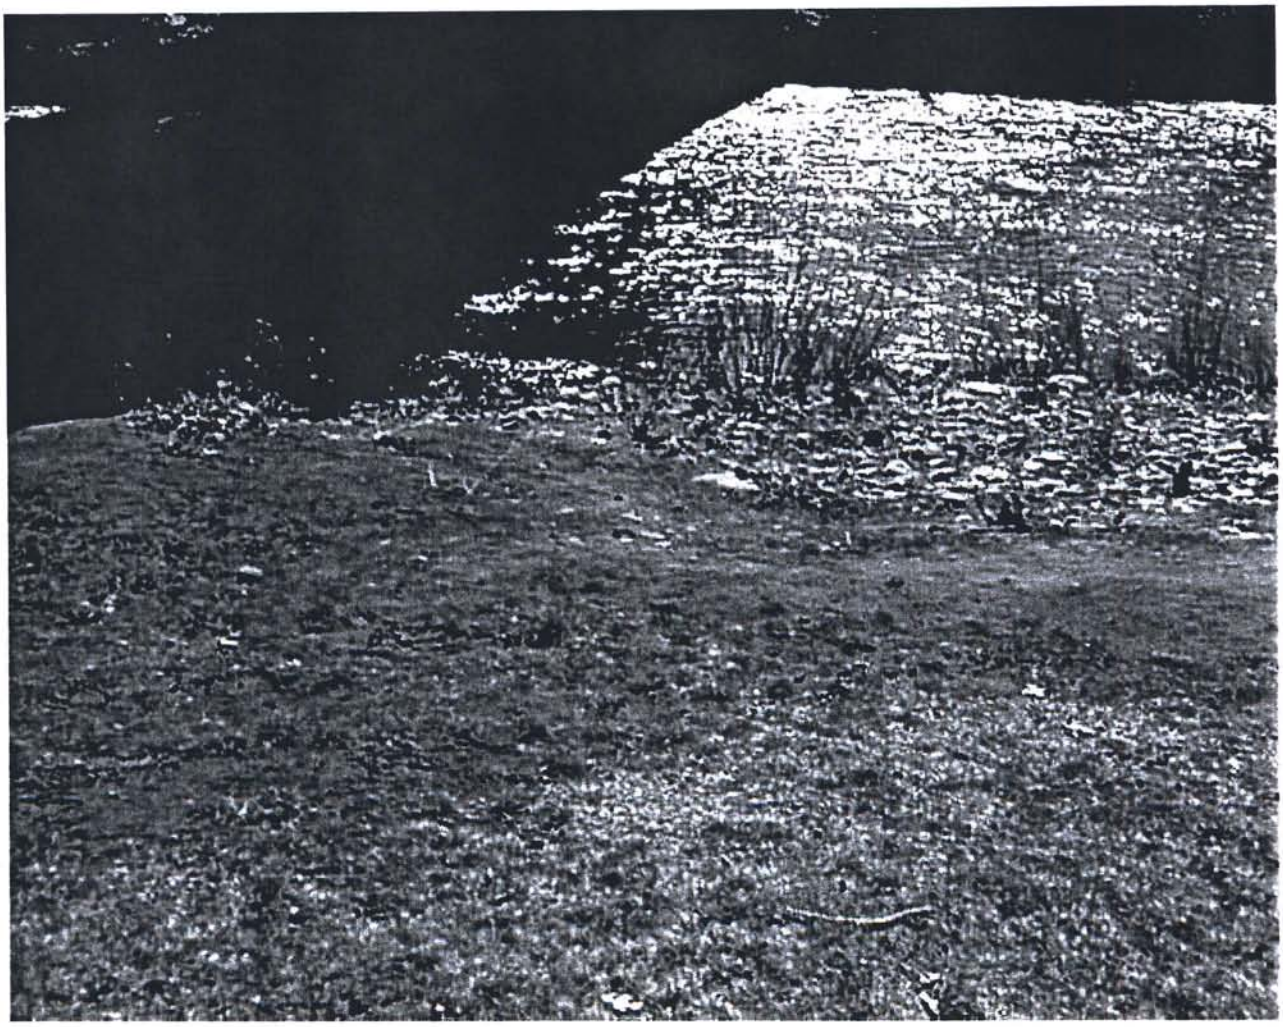
**Keystone Bridge – NW Corner (looking north)**

**Keystone Bridge – NW Corner (looking south)**

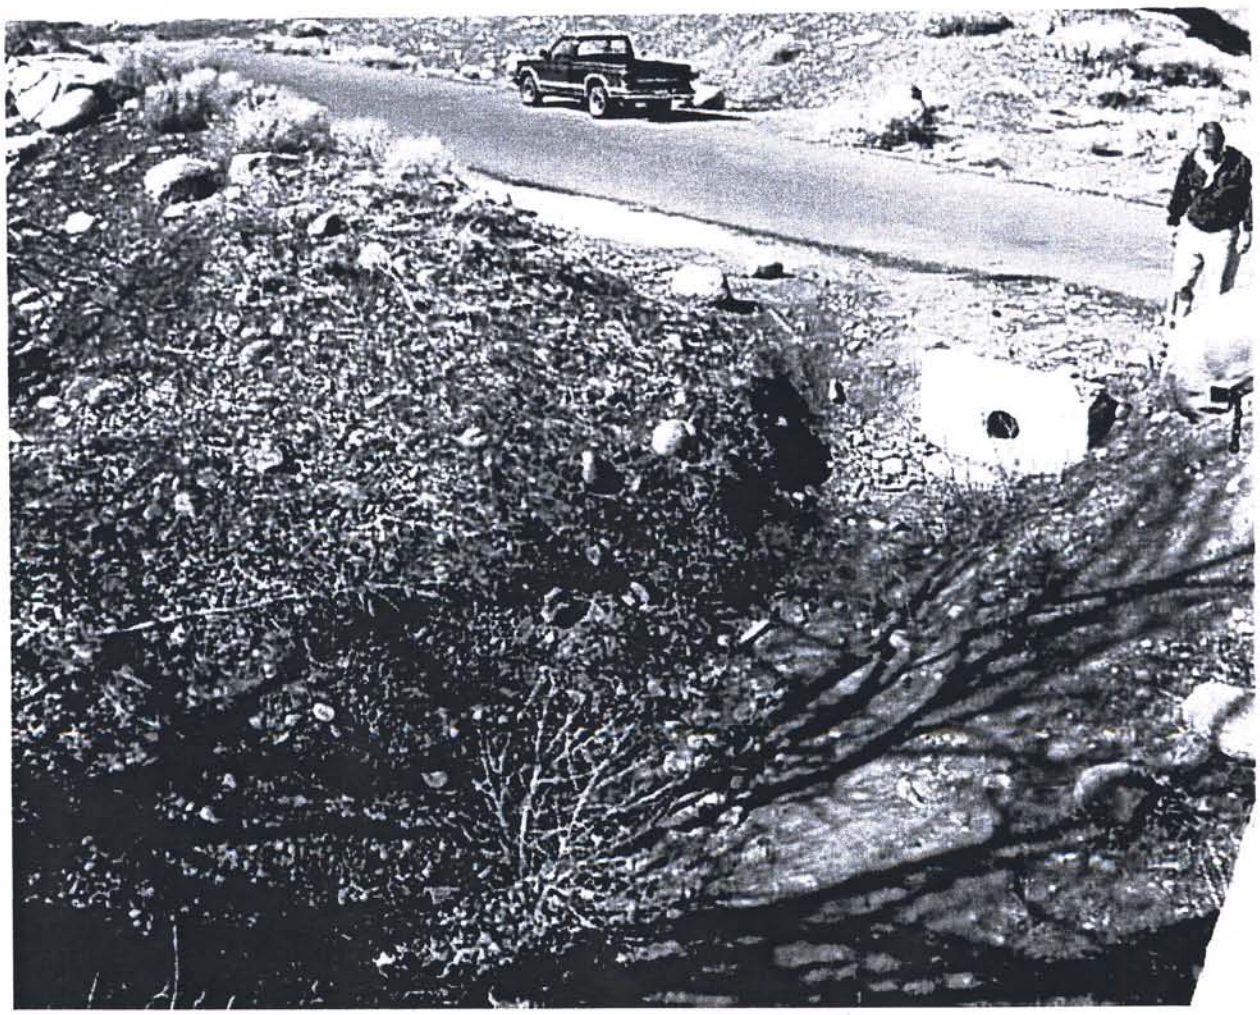
**Mayberry Bridge – NW Corner (looking south)**

**Mayberry Bridge – NW Corner (looking north)**
