74419 I-15 TRUCK CLIMBING LANE PROJECT

**STRUCTURAL FINDINGS MEMO FOR:
QUADRUPLE CELL 10ft x 6ft RCB CULVERT
NORTH AND SOUTH BOUND LANES**

**PREPARED FOR:
STATE OF NEVADA
DEPARTMENT OF TRANSPORTATION**

**PREPARED BY ATKINS
SITE OBSERVATION PERFORMED BY:
MICHAEL NA-O
ON MAY 25, 2022**

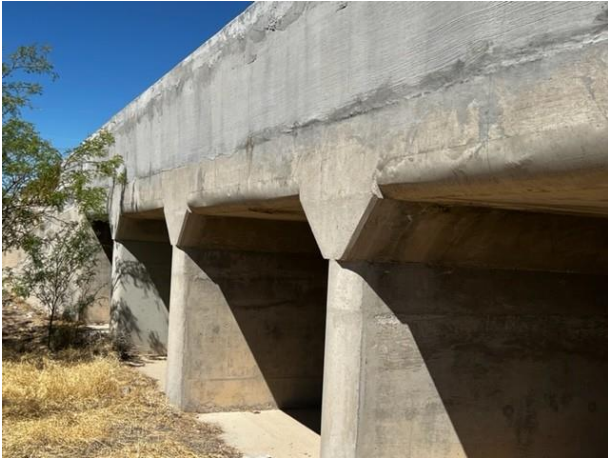
East side of culvert (Construction side)

At surface level, the asphalt was in satisfactory condition. The barrier rails and headwalls on the non-refurbish side were also in good condition. Overgrown vegetation was in obstruction of potential flow through the east opening of SB lanes and are recommended to be removed before restoration.

- Remove vegetation from east opening of RCB (SB Lane)
- Seal/Patch cracks and drill holes in culvert
- Remove and replace corroded rebar
- Seal cracks in wingwalls
- Resurface culvert floor in delaminated area
