**HEADLIGHT GLARE SCREEN PANELS
COLD TEMPERATURE PERFORMANCE
IMPACT TEST**

Dorothy J. Tate,
Engineer of Physical Research

Nevada Department of Transportation
Materials Division
Research Section

May 1993

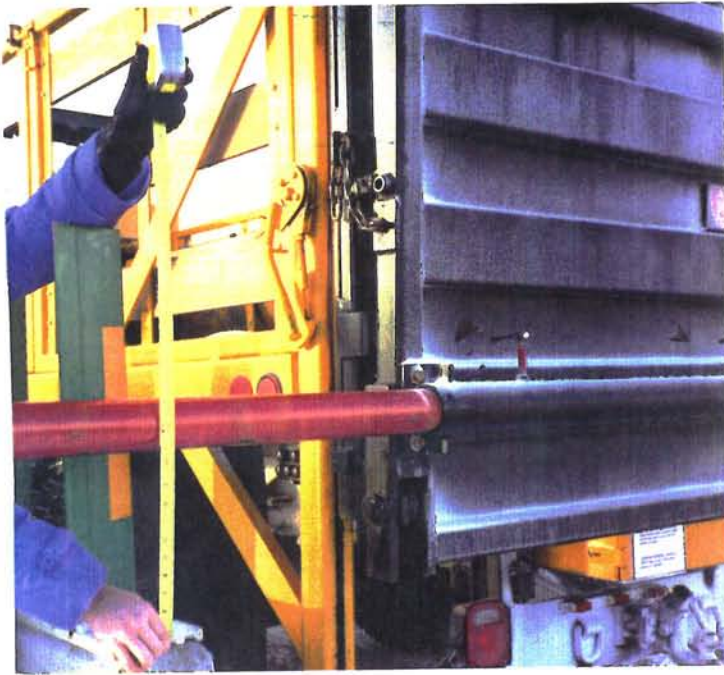
PHOTO #1

The retractable, 3 inch metal rod and method of measurement for the impact device, set at 12 inches above the portable concrete barrier rail.

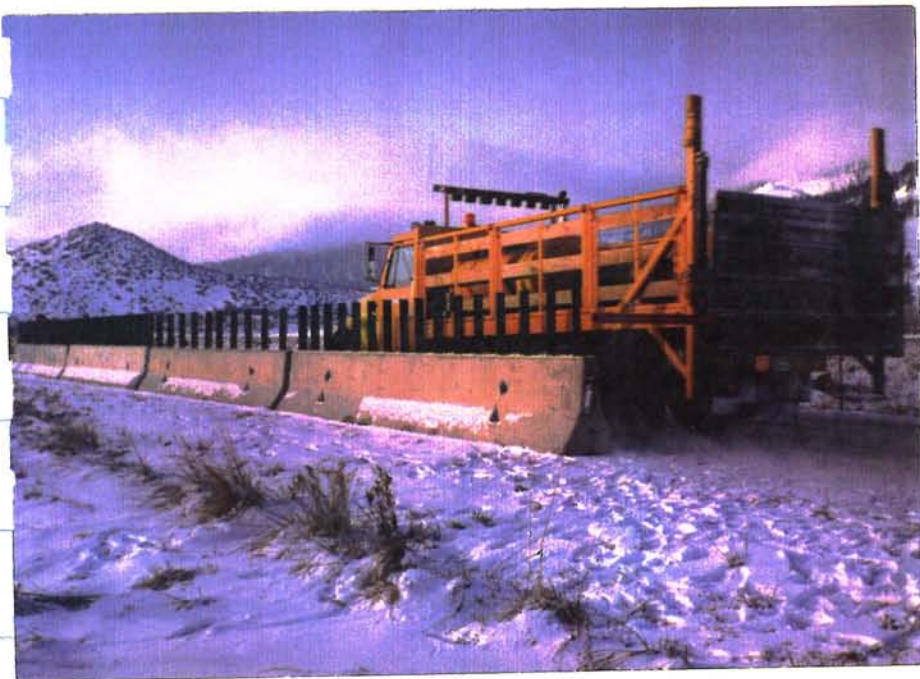
PHOTO #2

The 2 1/2 ton testing vehicle at 45 MPH, right before impact.
