GEOTECHNICAL INVESTIGATION

**ASSESSMENT OF ROCK SLOPE CONDITIONS
ALONG KINGSBURY GRADE ROAD - SR 207
DOUGLAS COUNTY, NEVADA**

MARCH 1996

Subject: Assessment of rock slope conditions along Kingsbury
Grade Road, SR 207. E.A. 72028-9.

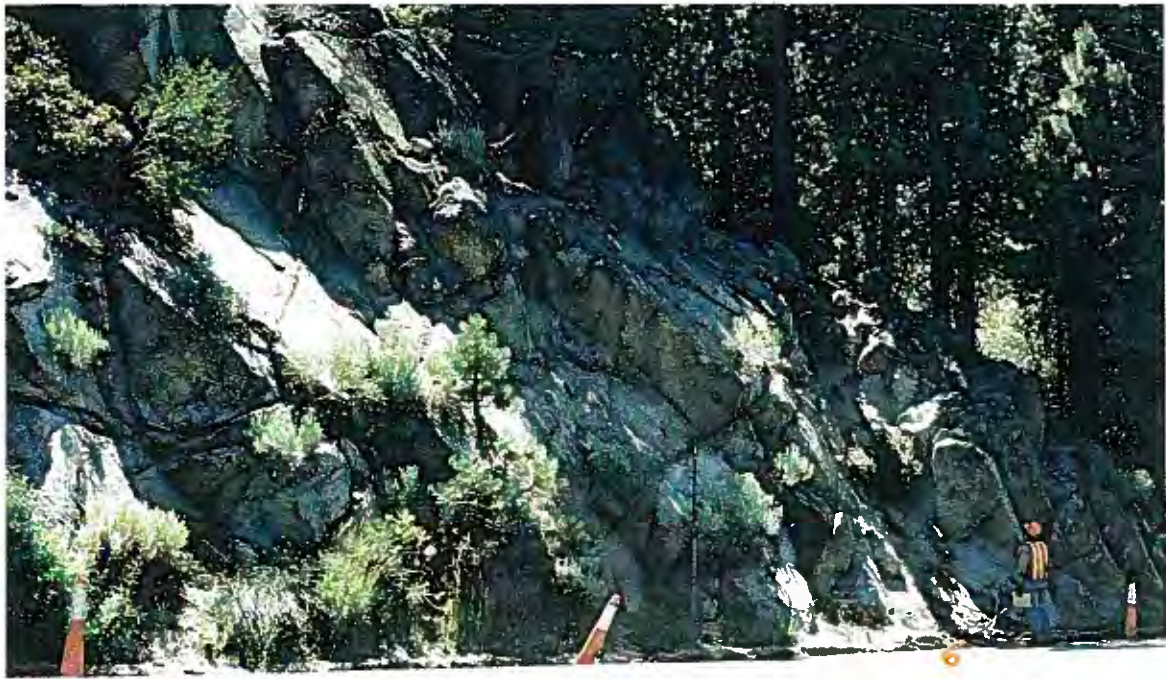
#6

Slope scale loose rocks (photo 6). Clean, reshape, and pave catchment ditch. No work needed on small cut located on northside just east of Terrace View Drive.

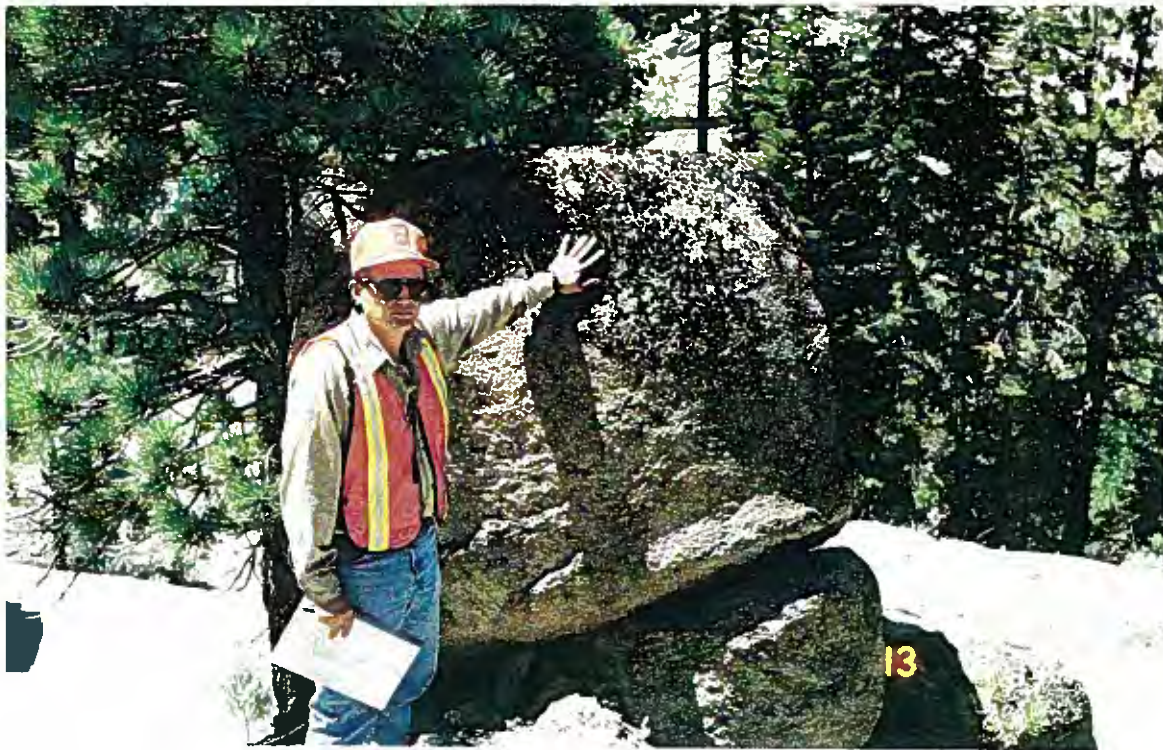
13

Scale loose rocks from slope, remove talus from catchment area. Large perched boulder should be removed (photos 12 & 13). Boulder will probably require blasting to move. A 6 to 8 inch sand cushion should be used to protect the existing roadway surface from the falling boulder. Fill slope erosion (photo 14) at the beginning of the curve on the westbound lane needs to be addressed. Should provide drainage structure to allow downslope flow without fill erosion. Hydraulics should be consulted on this design.

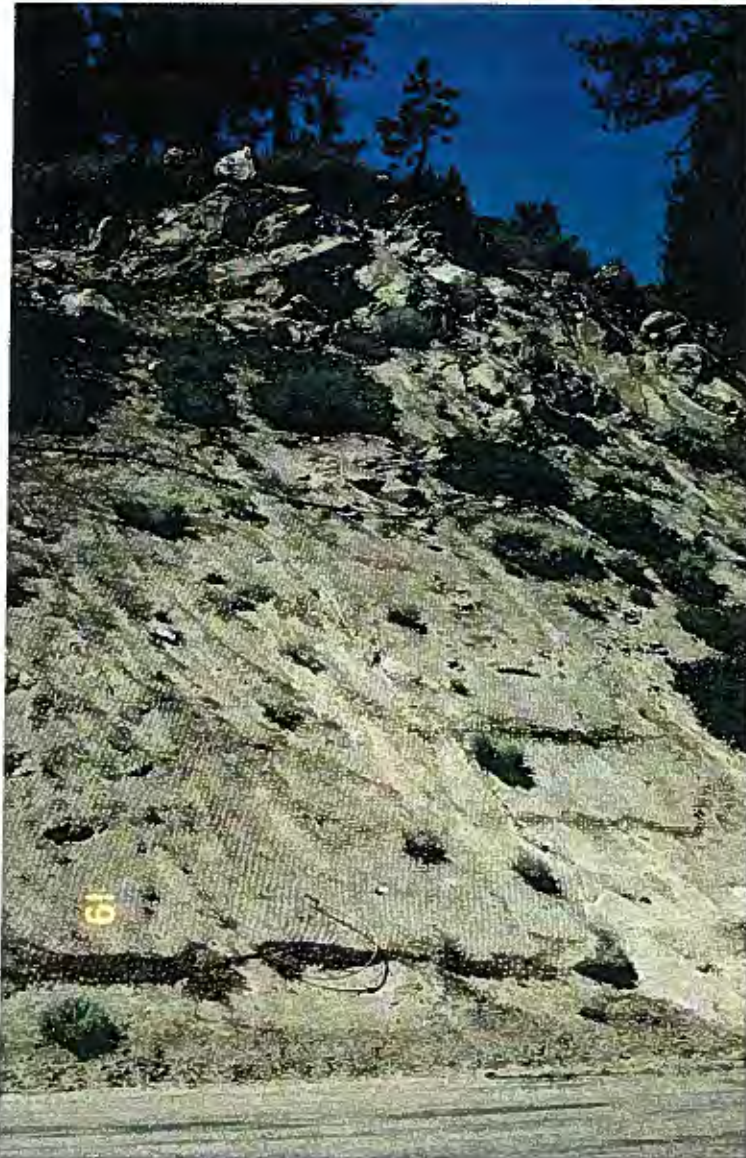
#19

Need to replace missing bottom weights to retension chain link mesh (photo 19). Alternatively, we could permanently remove mesh and scale loose rocks from slope.

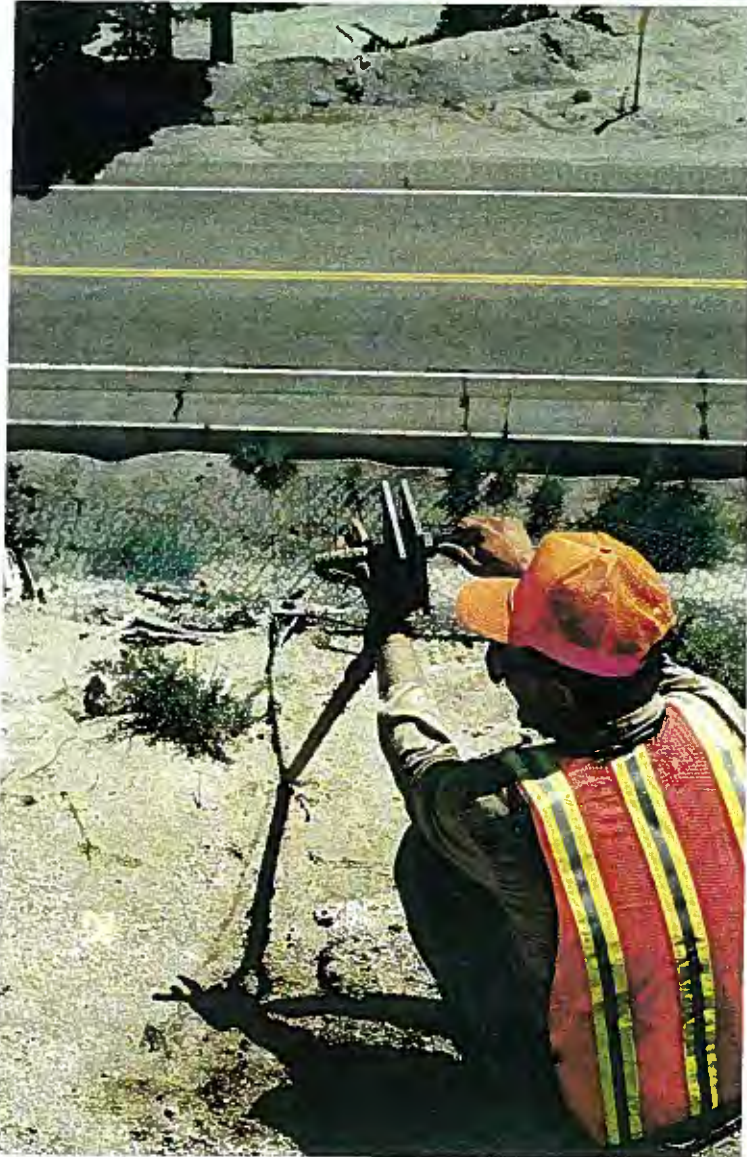
#21

Slope condition is acceptable in most areas. We need to replace missing bottom weights as needed. But from about MP 3.8 to 3.95 (photos 20,21,22) most of the upper row of anchors supporting the mesh have failed (probably due to snow and ice loads). Some of the lower row anchors have also failed. As a rule the 1" diameter anchor rebar failed in shear about 2 to 6 inches below the metal plates used to secure the wire rope tendons. None of the anchor piles experienced pullout failure. We could repair the mesh by increasing the number of anchors and retensioning the mesh. The diameter of the rebar may also have to be increased. Bridge Division would need to evaluate this. It appears that anchors are spaced on about 50' centers at least on the upper row.

A better option would be to remove the damaged mesh from this area entirely. The present condition of the slope doesn't require meshing in our opinion. We also need to clean catchment area behind jersey barriers.

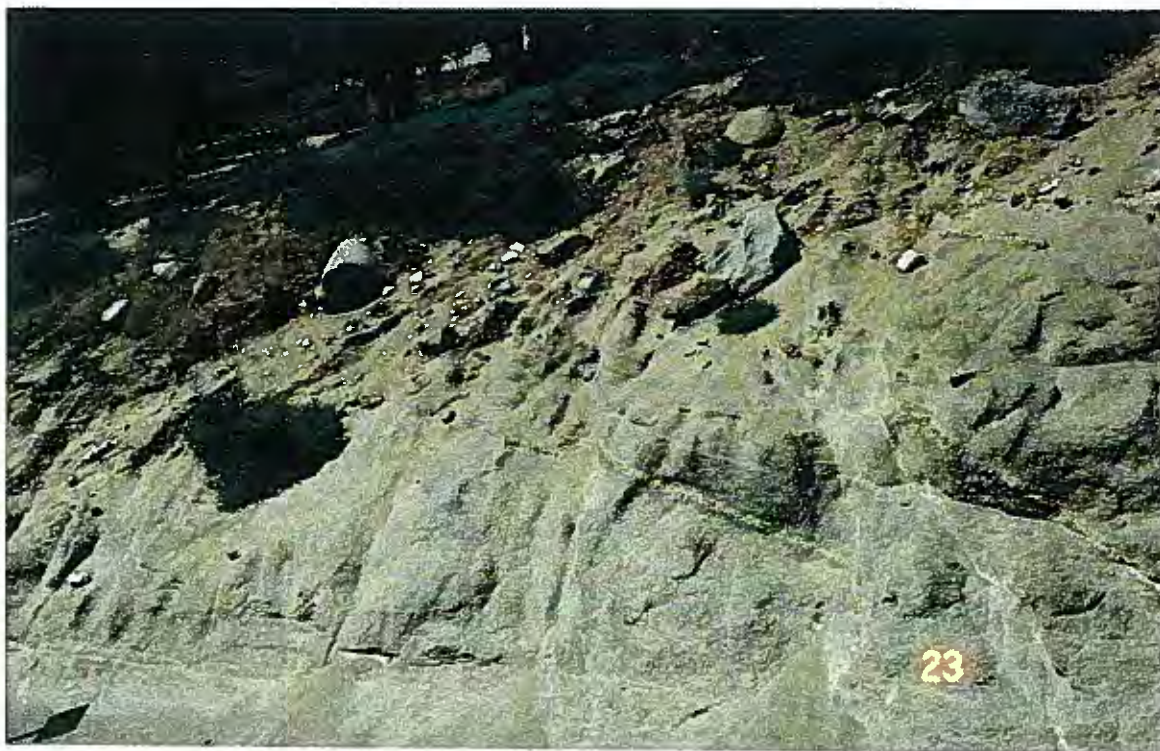
#23

Scale loose rocks from top of slope (photo 23).

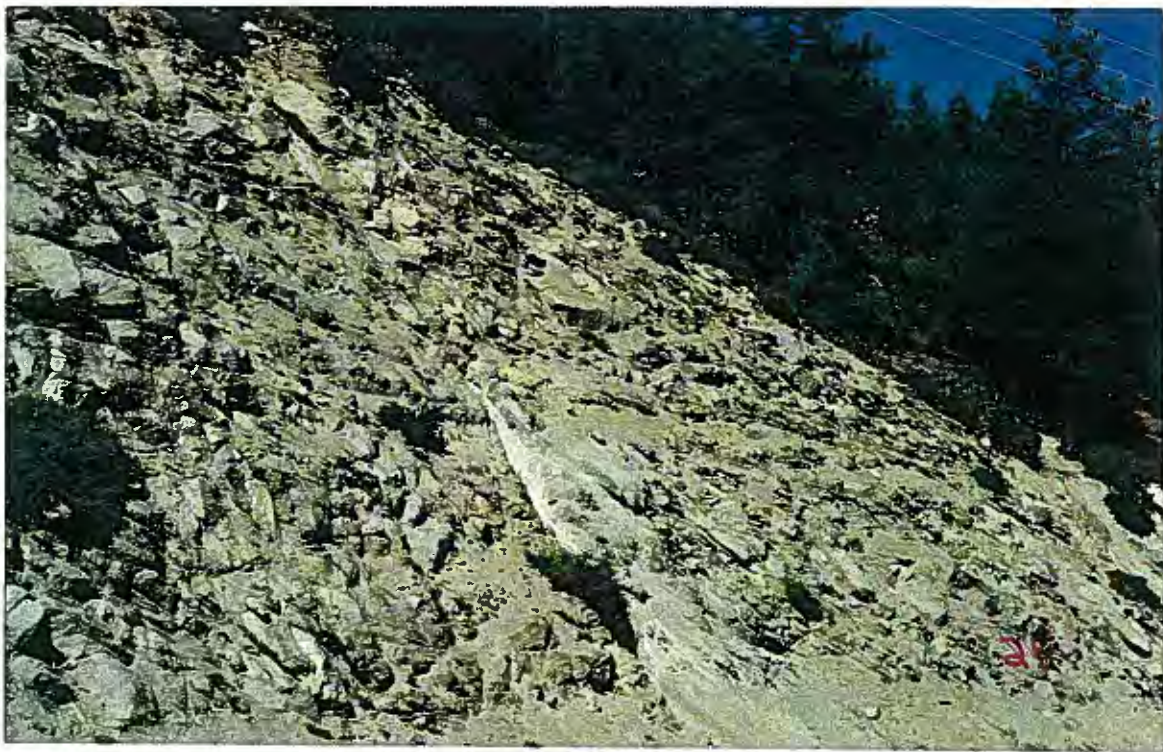
#25

Lots of loose rock, boulders, and corestones exist on this slope (photos 24,25,26). We need to scale all loose rock from slope as a minimum. Consider meshing this slope and placing jersey barriers to help control rockfalls for long term solution.

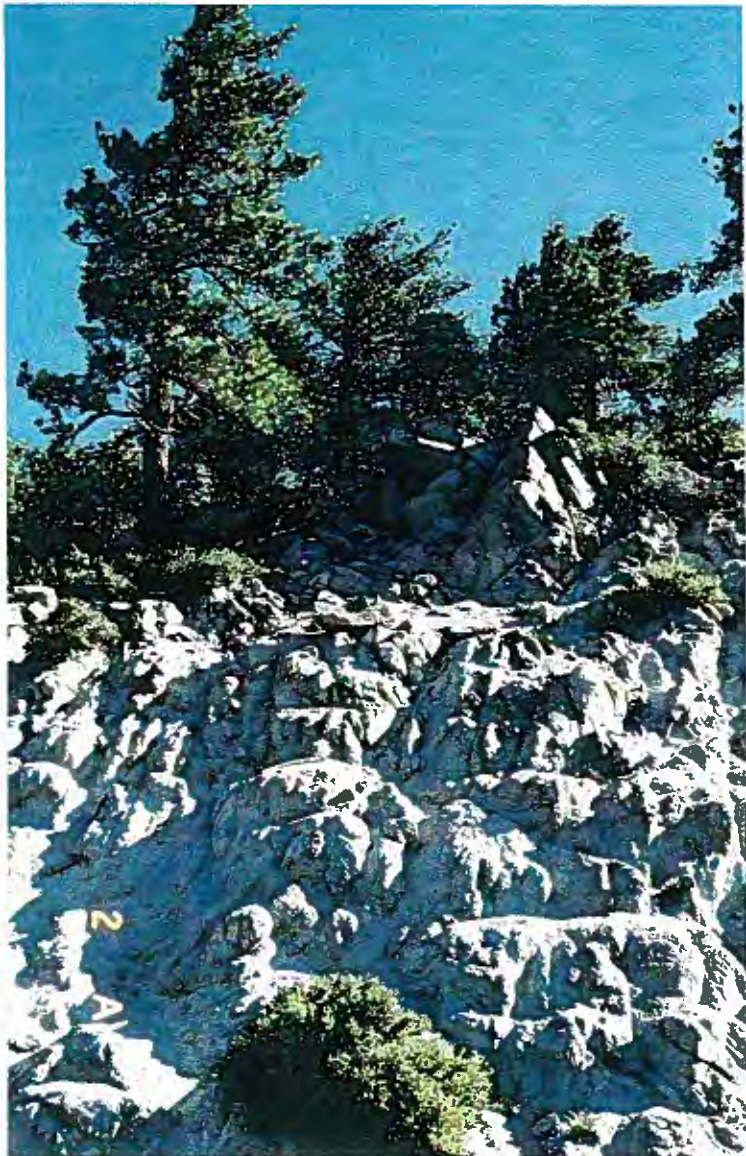
#2A

Scale loose rocks, corestones, and boulders from slope (photos 1A & 2A).
