**CONSULTANT'S REPORT
CORROSION EVALUATION OF MSE WALLS
I-515/FLAMINGO ROAD
LAS VEGAS, NEVADA**

NDOT AGREEMENT NO. P068-04-020

**The Nevada Department of Transportation
Materials Division
Carson City, Nevada**

**May 2005
File: 04-005**

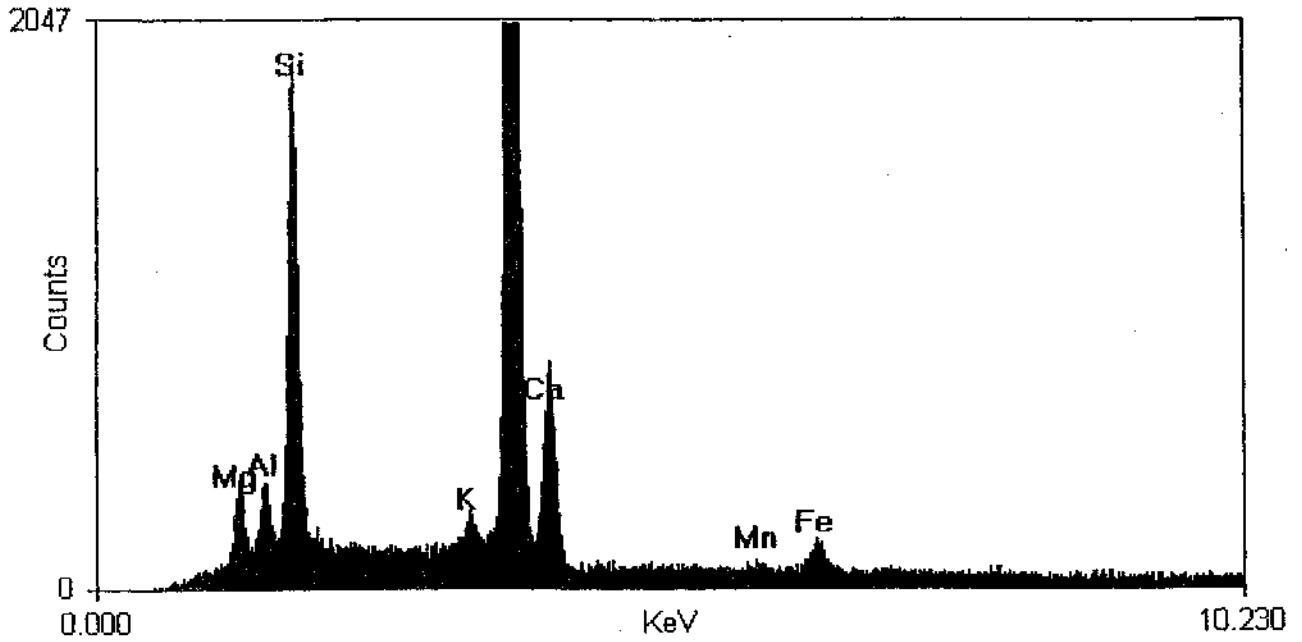
McMahon&Mann: LV Steel Wire White Corrosn.

2. The white corrosion material produced x-ray data which indicates calcium-silicate concentration with traces of magnesium, aluminum, potassium, manganese and iron. Subsequent x-ray diffraction analysis indicates this material is dolomite ($\text{CaMg}(\text{CO}_3)_2$) with some quartz (SiO_2).

SURFACE CORROSION - WHITE

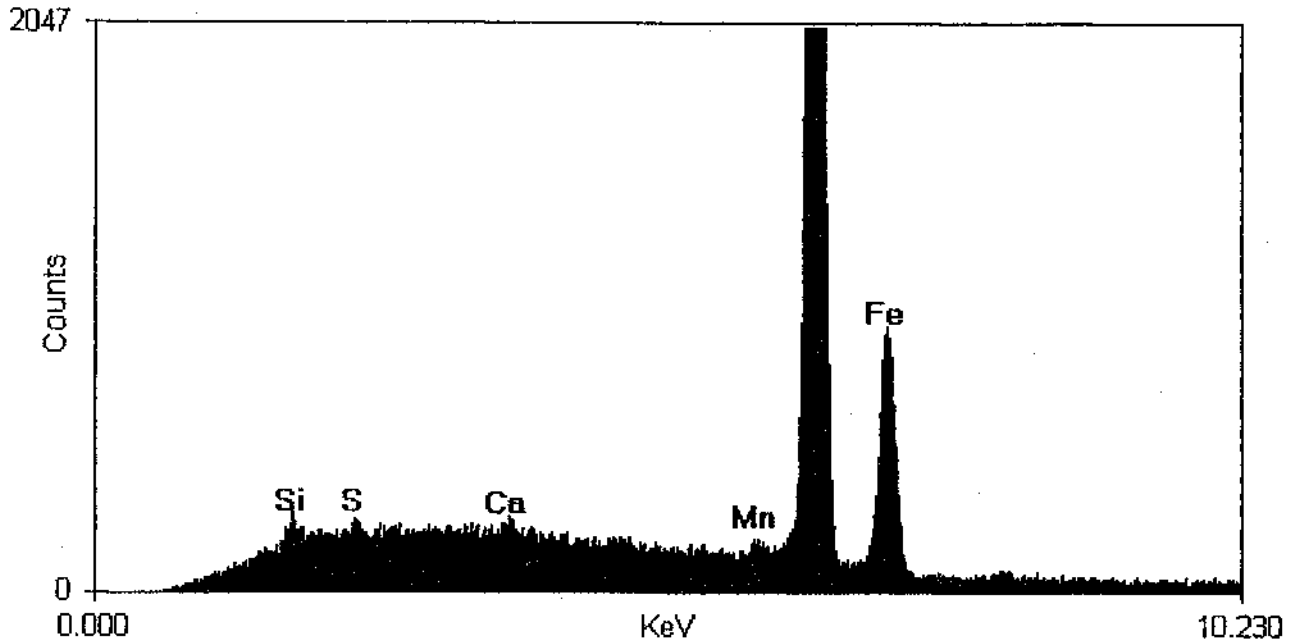
McMahon&Mann: LV Steel Wire Black Corrosn.

3. The black corrosion product is comprised of iron with traces of silicon, sulfur, calcium and manganese. The XRD profile indicates a significant amount of magnetite (Fe_3O_4) attributed to the black corrosion product.

SURFACE CORROSION - BLACK

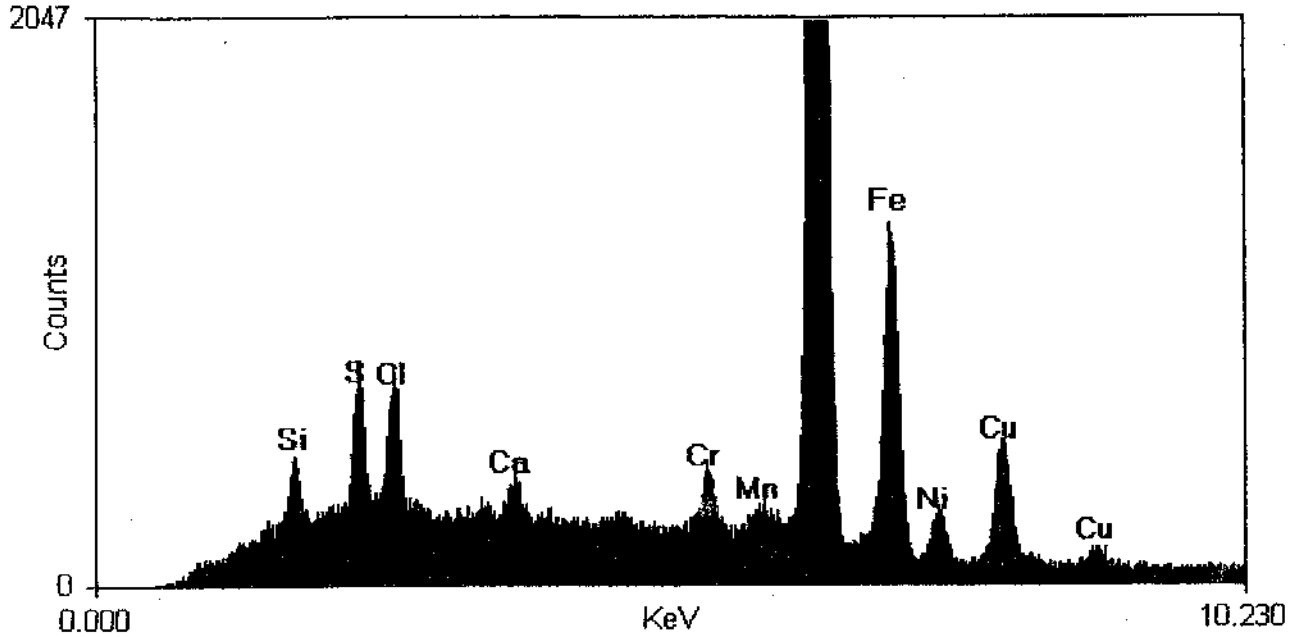
McMahon&Mann: LV Steel Wire Red Corrosn.

4. The x-ray data obtained during analysis of the red corrosion material reported concentrations of iron and copper with traces of silicon, sulfur, chlorine, calcium, chromium, manganese and nickel. The crystalline component of this red scale material has been identified as hematite (Fe_2O_3).

SURFACE CORROSION - RED

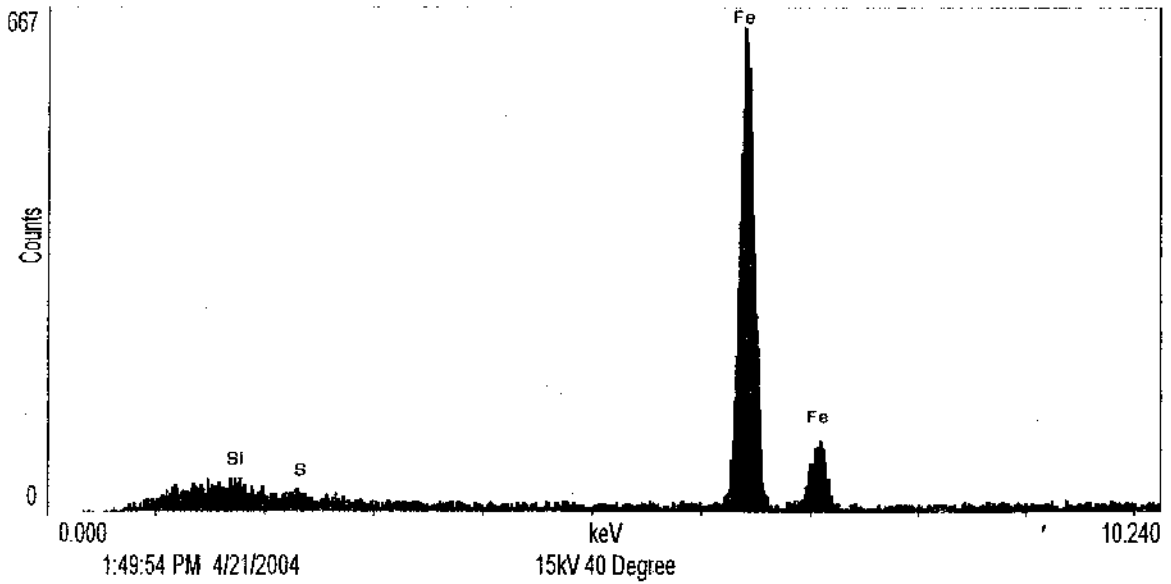
SEM: 35X

5. The SEM/EDXRF examination of the longitudinal cross-section of a corroded wire section reported an iron oxide scale approximately 1 to 2 millimeters thick.

LONGITUDINAL SECTION - SCALE

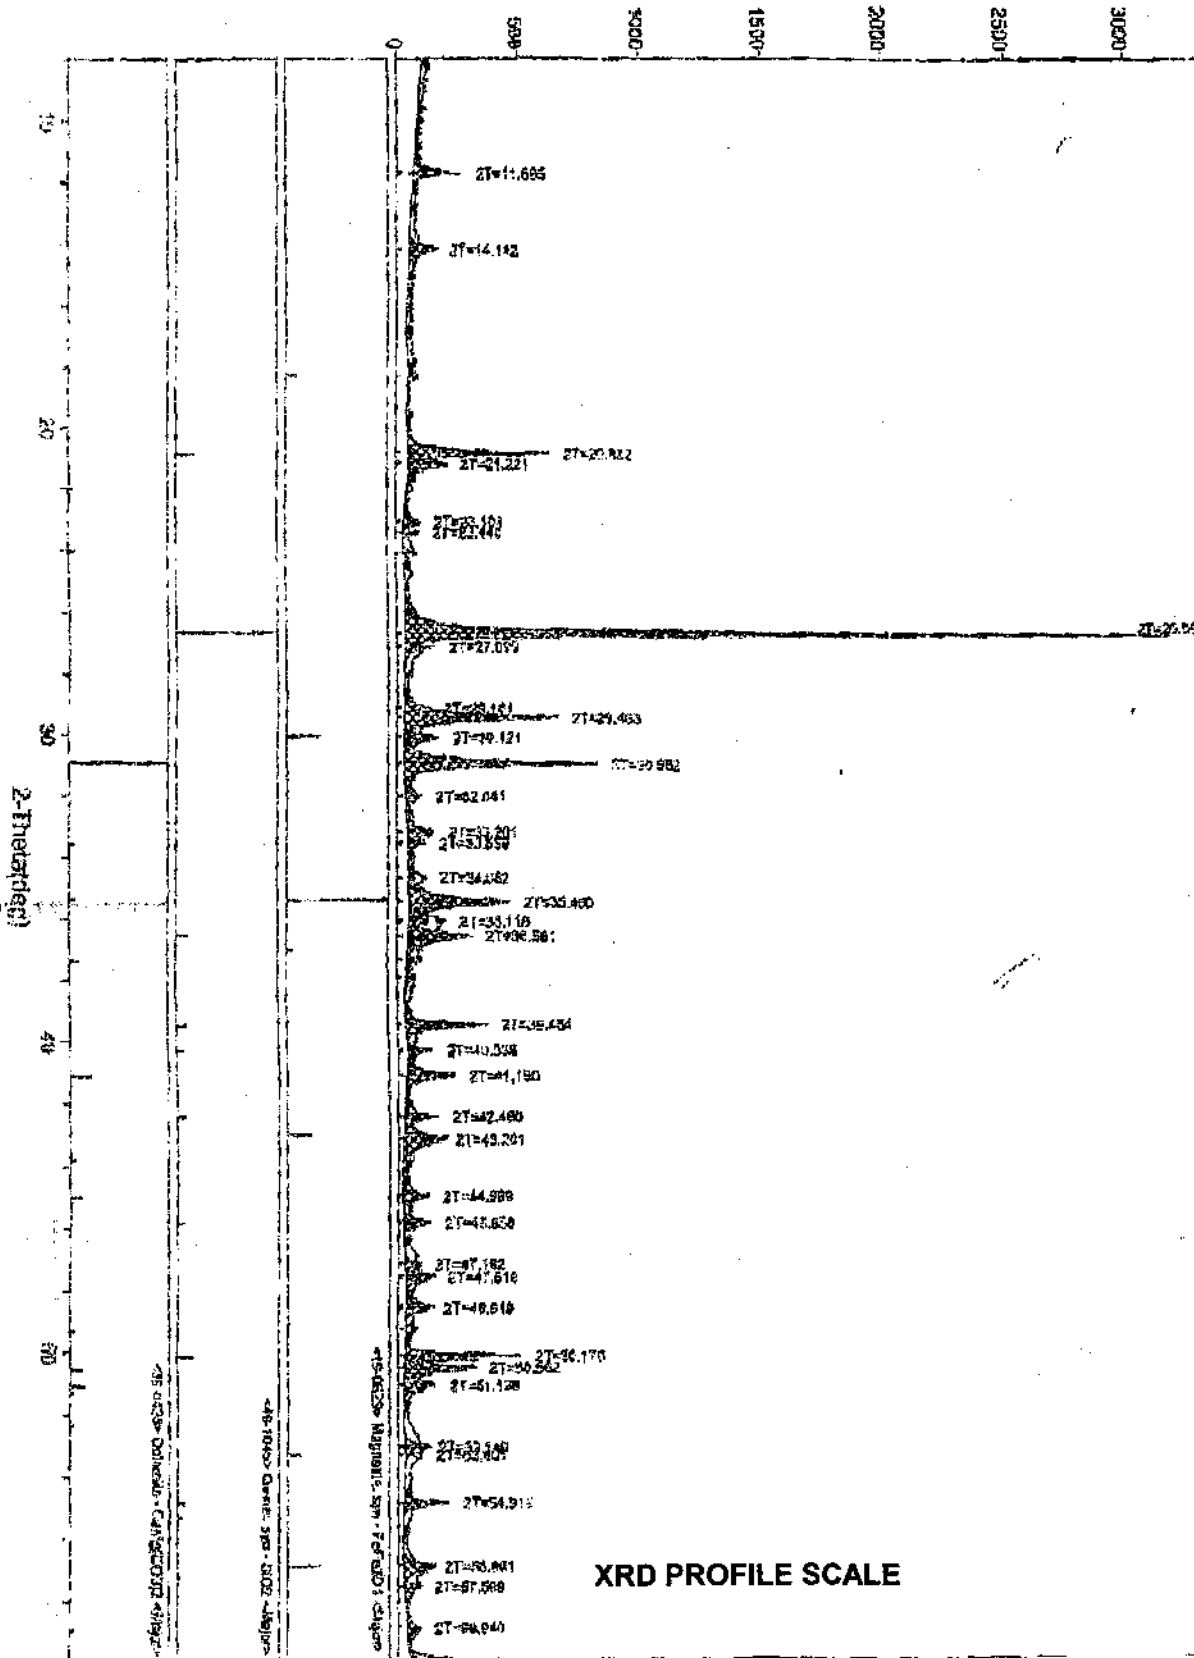
XRD PROFILE SCALE

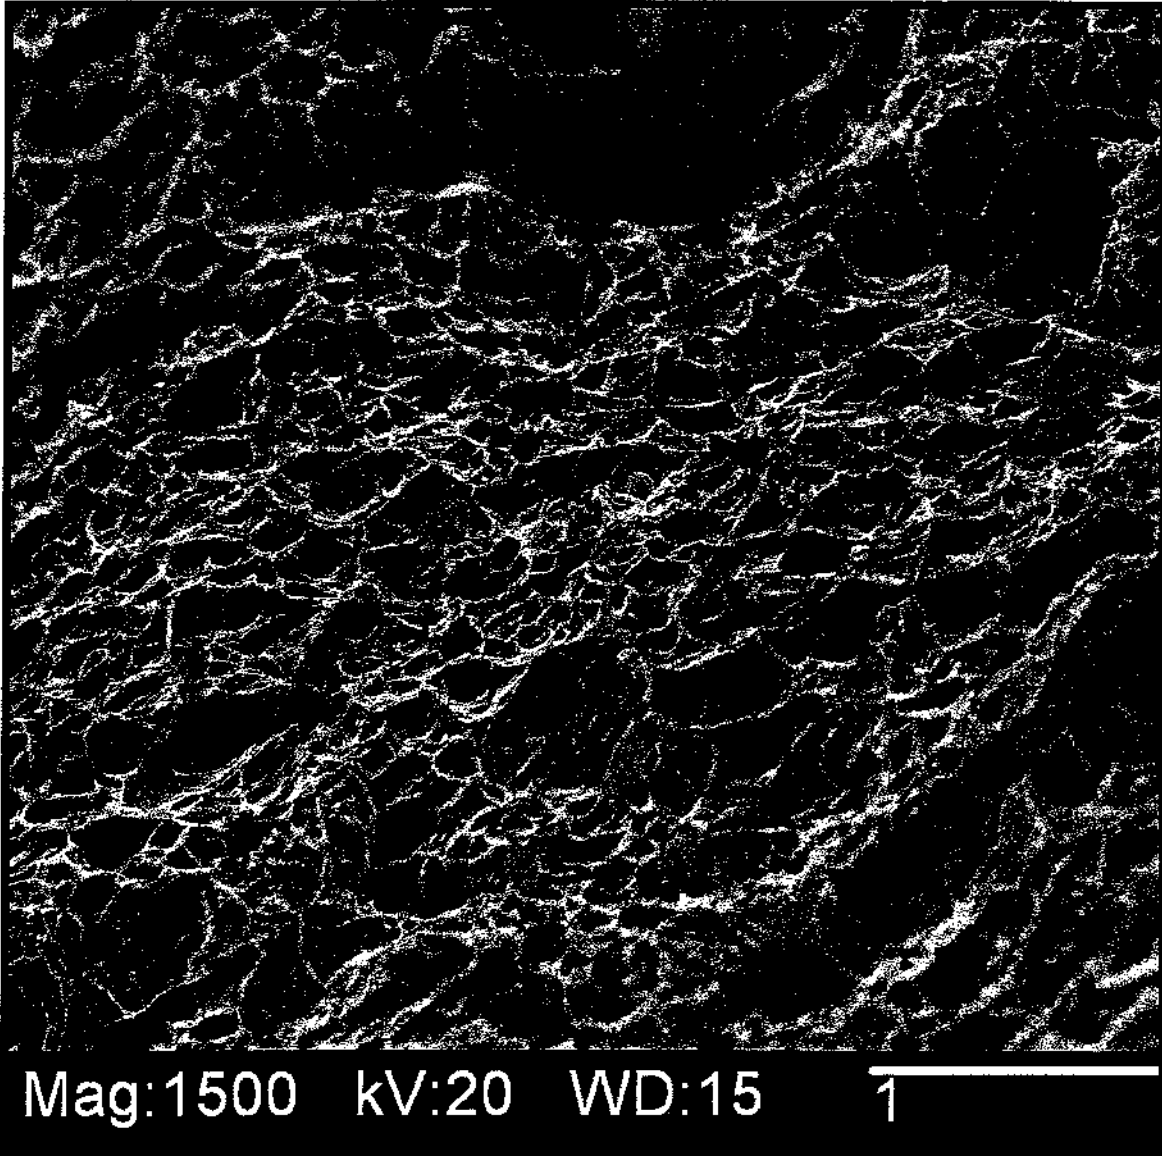
SAMPLE TENSION TEST # 3

The SEM digital beam interface was used to collect secondary electron images of the two tension test specimens designated as SAMPL 3 and SAMPLE 5. Both samples provided images from fracture surface areas which are indicative of ductile fracture mode.

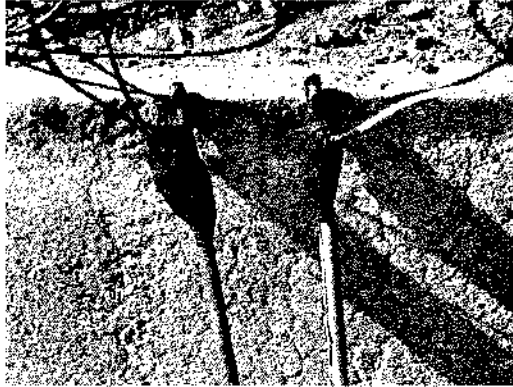
Steel and galvanized coupons cleaned for soldering.

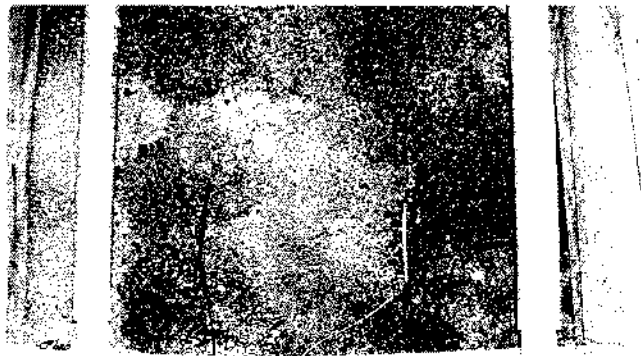
Soldering complete on coupons and connection sealed with epoxy putty and liquid electrical tape.

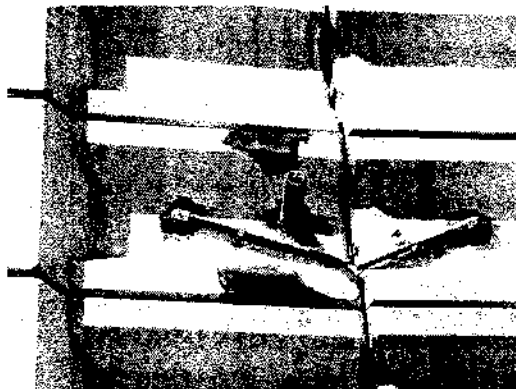
Steel and Galvanized coupons in place for burial in MSE backfill.

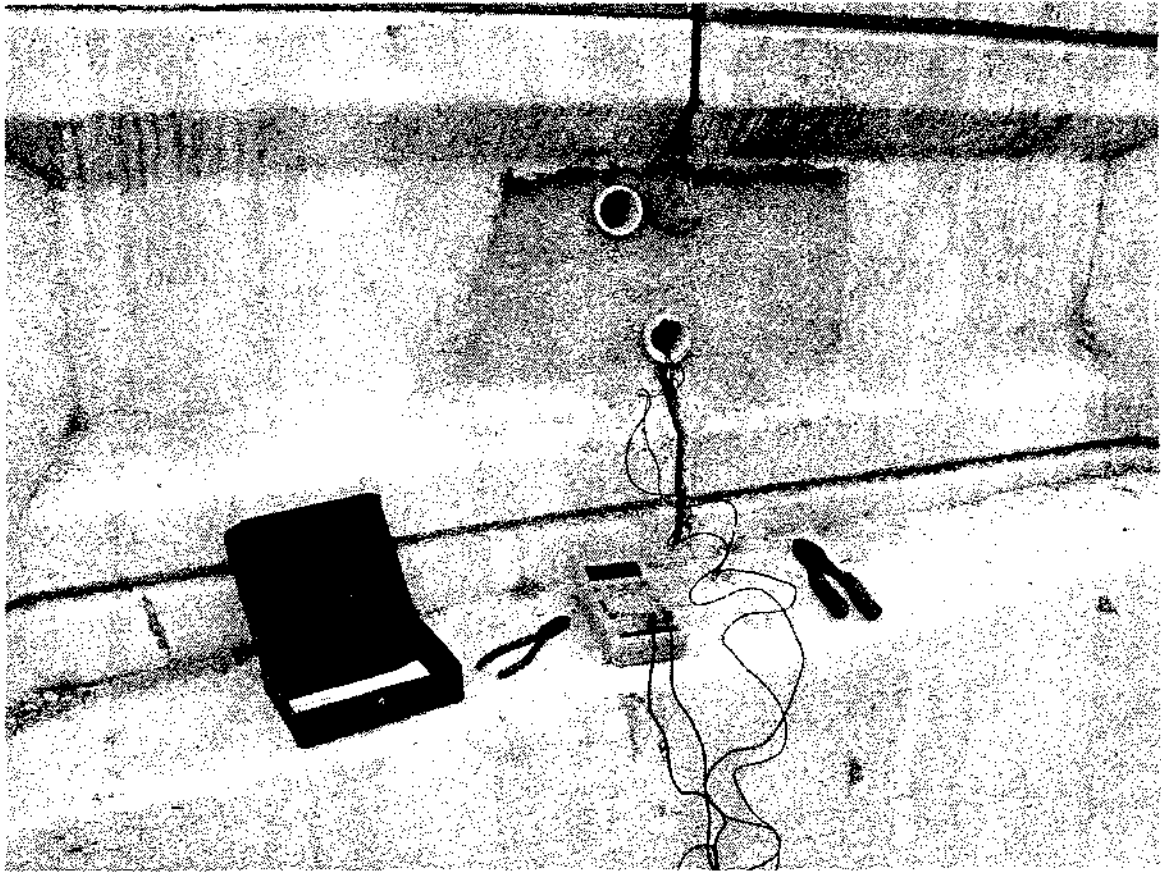
Complete installation with half cell access, and conduits protecting coupon wires.

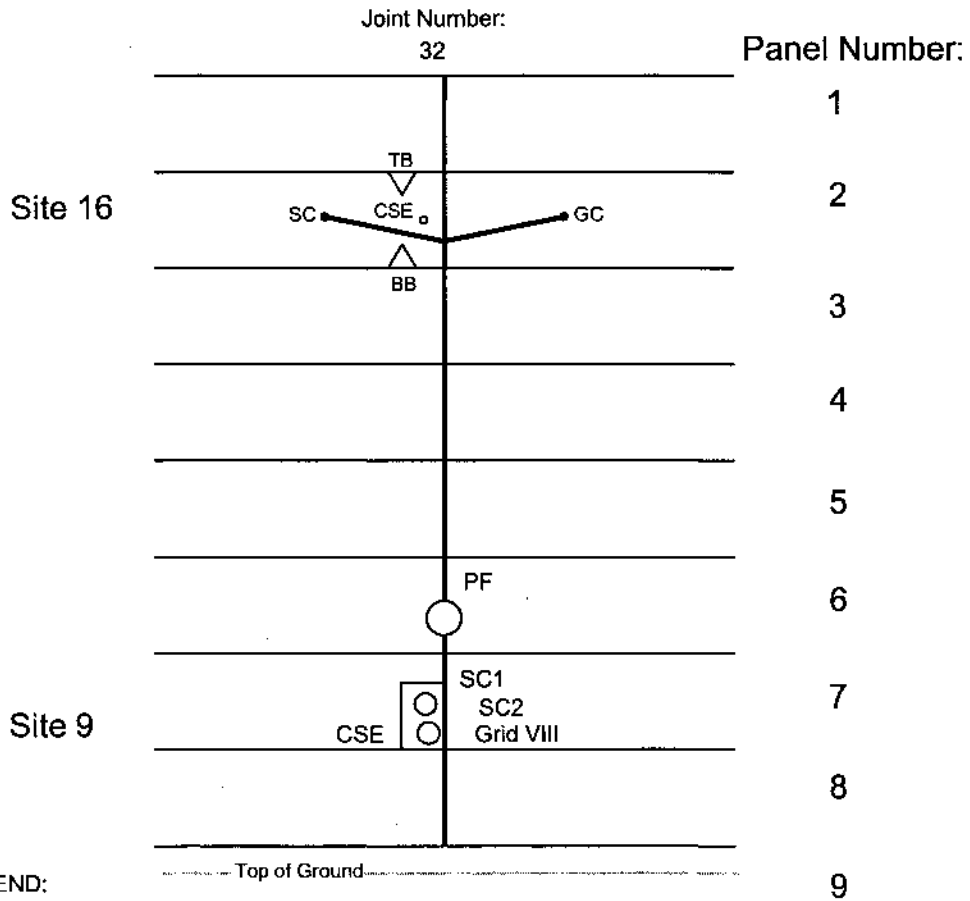
Station 9	CORROSION STUDY Interstate 515 and Flamingo Rd. Las Vegas Nevada	McMahon & Mann Consulting Engineers, P.C.
DWG. NO. 04005-G9		<small>2495 MAIN STREET, SUITE 432 BUFFALO, NY 14214</small>
FIGURE IV-G-9		<small>(716) 834-8932 FAX: (716) 834-8934</small>

Two of the corrosion rate measurements made along Wall # 2, Stations 9 and 10, in August were higher than observations made in March by more than a factor of two. The reason for the increase may be related to the presence of a drainage inlet in this vicinity (DI-4). The observation of higher corrosion rates in these areas is consistent with direct physical observations made on reinforcements exhumed from Test Pits #8 and #9.

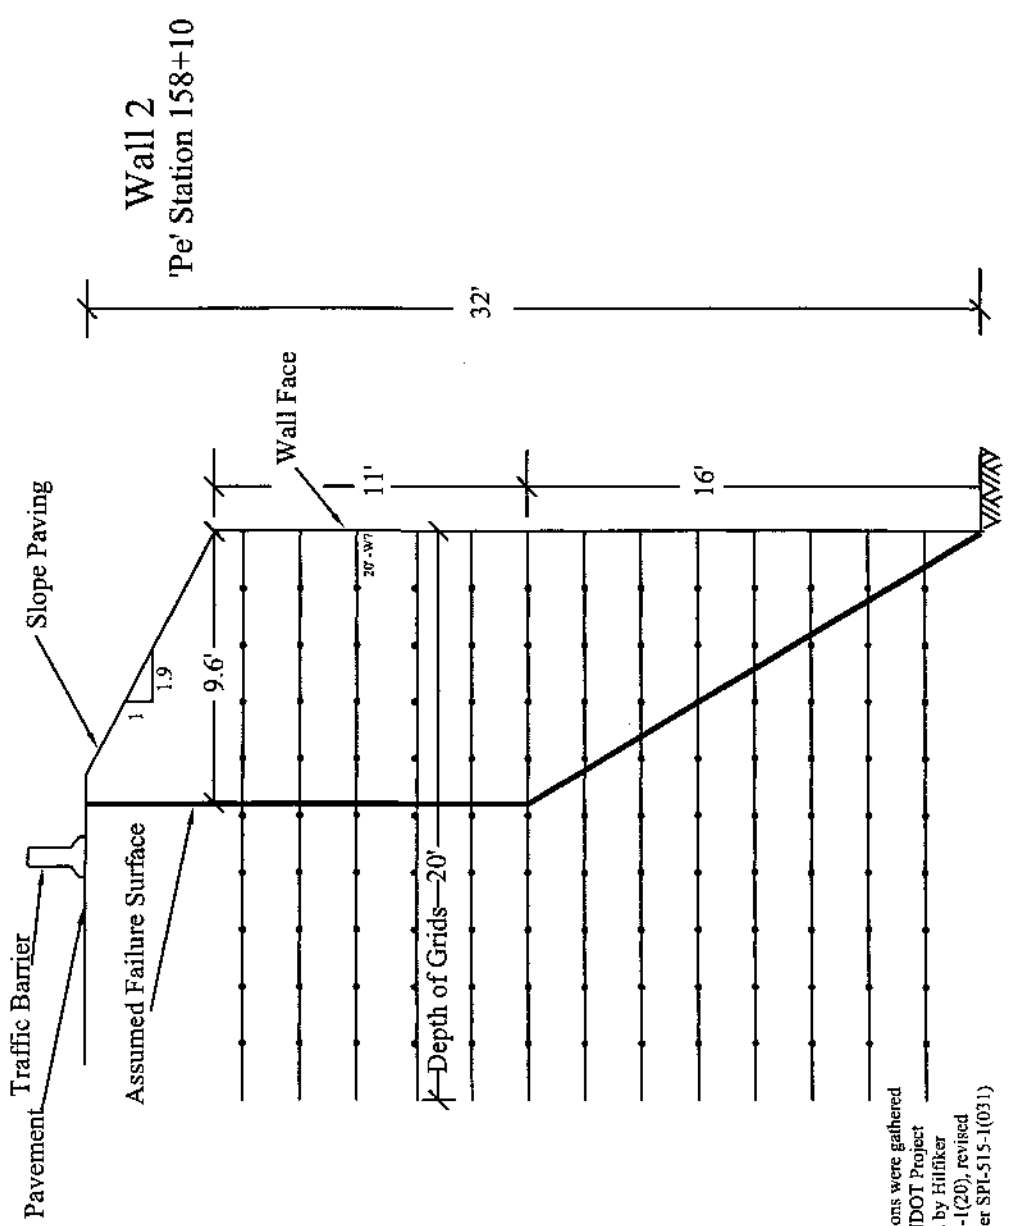
Cross Section MSE Wall 2
DWG. NO. 04005-20
FIGURE V-1

¹ Shaded results indicate reinforcements are overstressed compared to the allowable load of 0.48 f_y . T_{all} increased by 33% for seismic loading case
