**Geotechnical Investigation for  
Lake Tahoe Environmental  
Improvement Program**

**Phase III**

**US 50**

**January 2010**

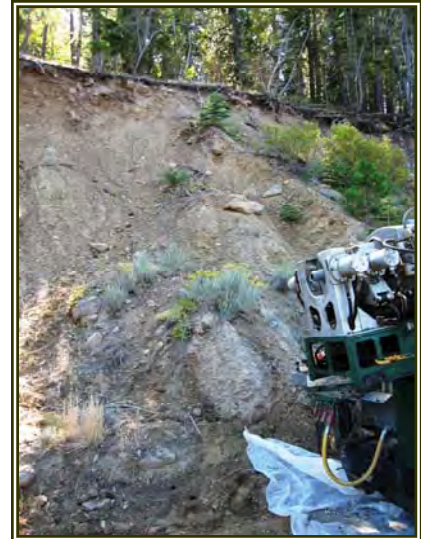
**Figure 3** – Slope 21, West End

**Slope 21** lies within a thin band of exposed metamorphosed tuff and flows. These units had a tendency to be more competent near the eastern limits of the slope. Some surface sloughing is evident near the western limits of the slope and the fine-grained nature of the native tuffs becomes apparent due to the minor rills in the slope face. The hummocky surface of the western limits of Slope 21 can be seen in Figure 3.

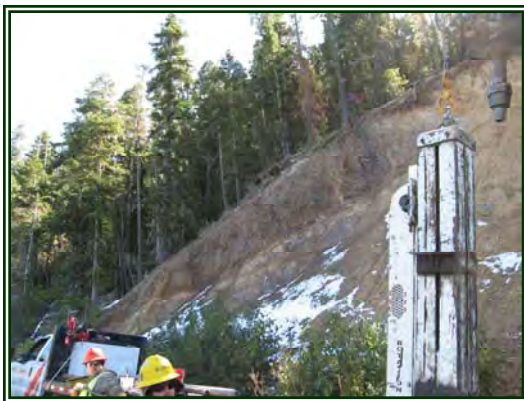
**Figure 4** – Slope 27, East End

**Slope 27** lies within altered and decomposed biotite monzogranite of North Logan House Creek which can give

rise to the significant variation in weathering and competency within the unit. Although not readily apparent in Figure 4, the ground surface has raveled and slumped within the western limits of Slope 27 while the cornice shown in Figure 4 depicts a more competent bedrock mass.

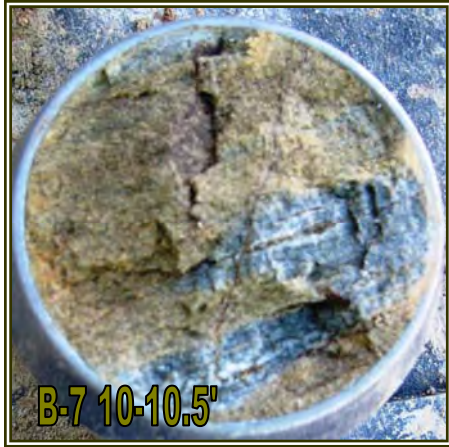
**Figure 10** – CMS Sample & Bedrock Characteristics

Based on our exploration program and the ReMi data, the Tuff units comprising the slope toe have been weathered to a very dense soil/weak rock consistency to depths approaching 30 to 40 feet below the original ground surface. Undisturbed, the subsurface unit's appearance reflects the original and relatively uncompromised characteristics of the bedrock as shown in Figure 10; however, the unit has a tendency to break down readily when exposed to mechanical effort such as advancing with the sonic core barrel or application of minor blows with a rock hammer. Blow count, and shear wave velocity data indicate that the material is overall moderately strong and capable of supporting the planned improvements. If shear wave velocities on the order

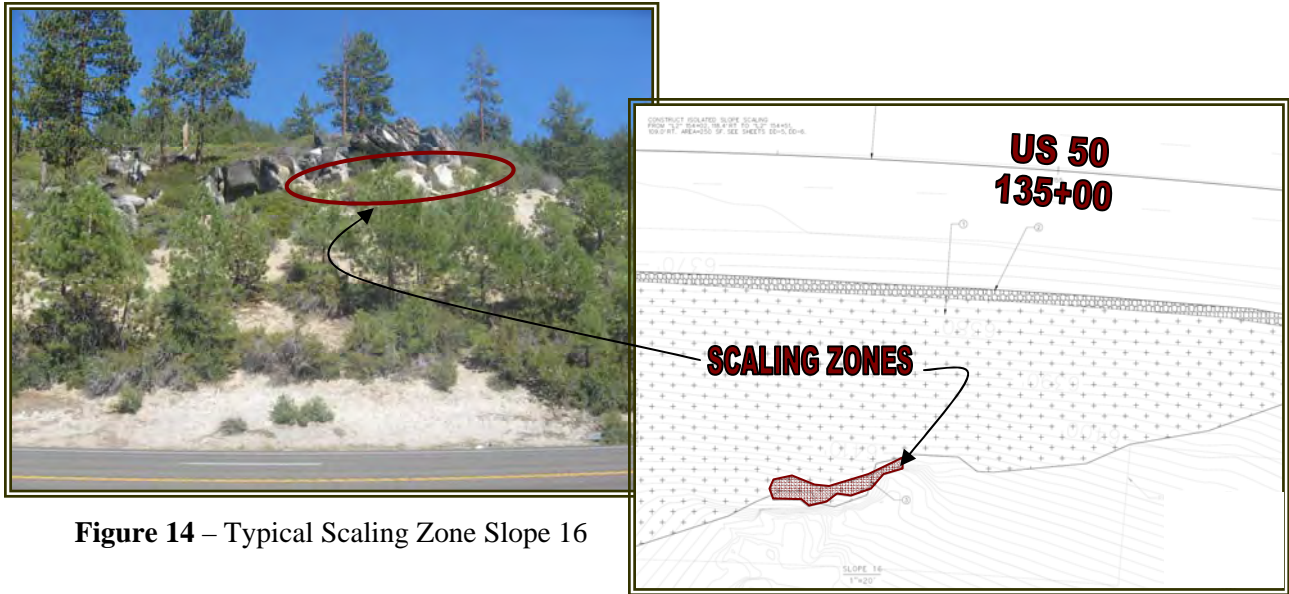
**Figure 14** – Typical Scaling Zone Slope 16

Figures 13 and 14 show areas recommended for scaling associated with Slopes 13 and 16. In addition scaling areas have been designated on the project plans. Figures 13 and 14 are presented to indicate the type of condition to be addressed by scaling and approximate scaling locations, but do not present the entire slope face. Some rocks that have been circled, or are consistent with the conditions presented in Figures 13 and 14, may stay in place if during scaling attempts it is determined that the rock is a secure outcropping of bedrock. In addition, other rocks not indicated or circled may require scaling if the long term stability of the rock is questionable. Caution must be exercised during scaling to preclude otherwise stable rocks from becoming loosened, dislodged, or otherwise destabilized. Scaling required outside the limits depicted on the project plans or inconsistent with the conditions shown in Figures 13 and 14 may be determined during construction and shall be approved by the NDOT Engineer prior to scaling.

The approximate volume of material expected to be generated during the scaling of Slope 16 is on the order of 20 to 25 cubic yards. Estimated scaling quantities associated with Slopes 13 and 16 are also presented in the project bid documents. It is the contractor’s responsibility to protect existing improvements, personnel, and the travelling public during scaling operations.

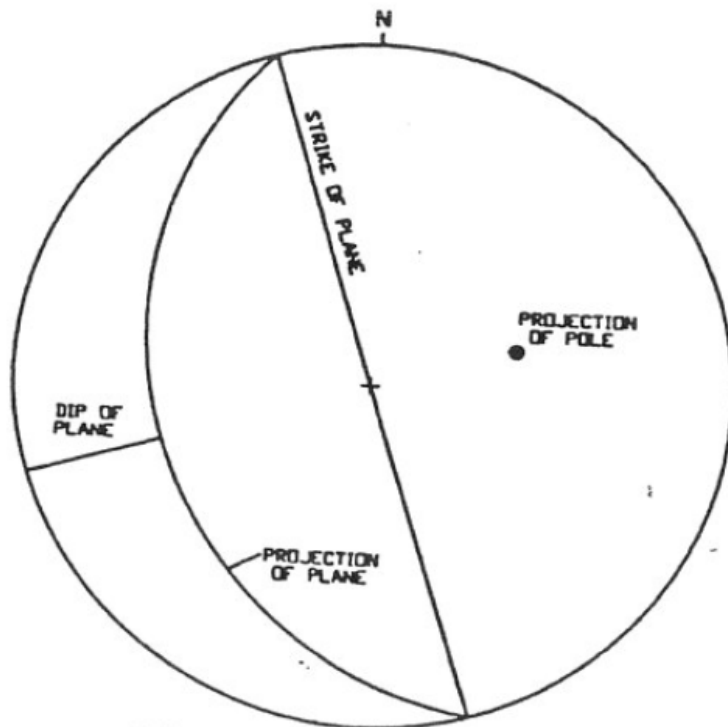
Figure 4 - Schematic Diagram of Lower Hemisphere - Equal Area Stereographic Projections

Slope 27 bedrock structure was analyzed with the aid of the RockPack™ III computer program. The analysis is based on lower hemisphere stereographic projections of sliding features. Planes can be represented as curved lines of intersection with the hemisphere or points representing the intersection of lines normal to the planes through the origin of the sphere intersecting the hemisphere. The curved lines are called great circles of the planes and the points are called poles of the planes. A schematic example showing planes and poles is shown on Figure 4 – Schematic Diagram of Lower Hemisphere - Equal Area Stereographic Projections.

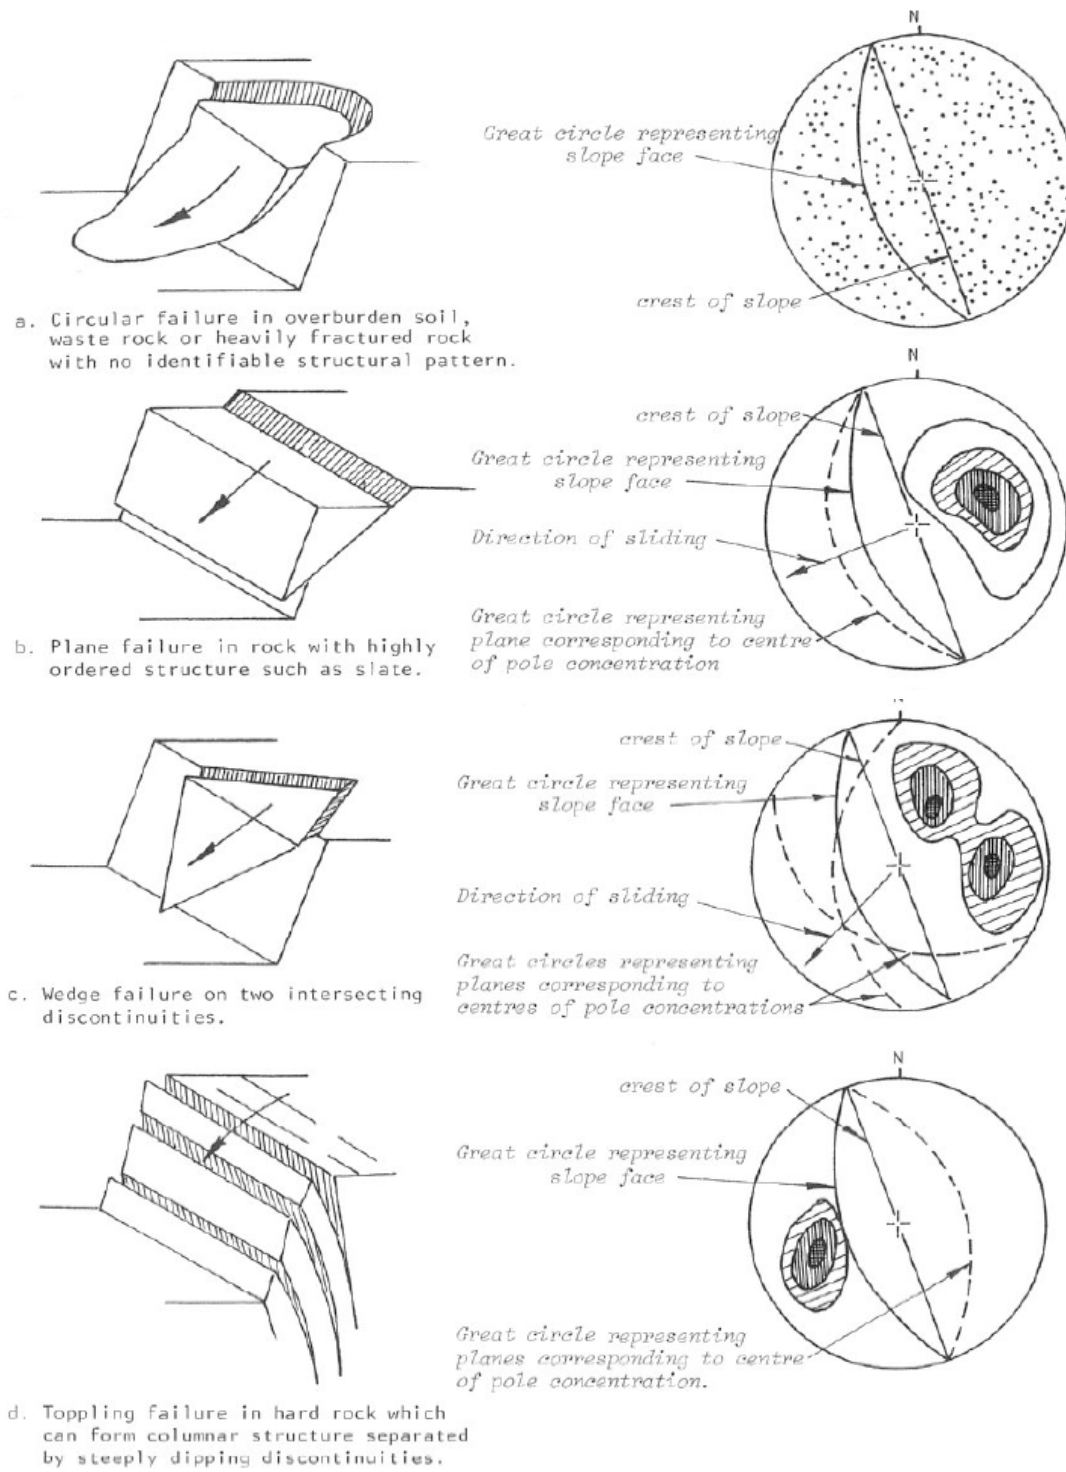
**Figure 5: Rock Mechanics Failure Types in relation to the Stereo Plots**

The stereo analysis considers the orientations of joint planes and the orientation of the rock outcrop face. Four modes of rock slope failure are possible: circular (in heavily decomposed rock), slide, wedge and toppling failure (Figure 5 – Rock Mechanics Failure Types). Sliding is expected on joint surfaces and intersecting joint surfaces (wedges) which are inclined steeper than the angles of friction. The NDOT Rockfall Hazard Rating System report identifies the internal friction angle for host rock as the following: the Monzogranite at 32°; and the Trachyte between 36° to 37° (E. Hoek & J.W. Bray in “Rock Slope Engineering”, 3<sup>rd</sup> edition 1981, approximate the internal friction angle of granite at 29°-35° for fine grained and 31°-35° for coarse grained) therefore an internal friction value of 32° was used in this stability analyses. The 32° friction angle (Appendix D) is represented on the stereo net diagram by a circle 32° from the center of the stereo net.

The potential for rock slope failure within the central portion of Slope 27 is based on the orientation of the joints. Joint planes and wedge intersections which fall between the center of the stereonet and the 32° internal friction circle are potentially unstable, depending on the dip orientation of the joint in relation to the cut slope. Sliding or plane failure will occur if the projections of joint planes or wedges fall on the 32° internal friction circle and outside/down dip of the cut slope; this condition is called "daylighted joint" or "daylighted wedge" because the joint planes or wedges are exposed in the existing cut slope. Joint planes which fall directly opposite to the slope or rock outcrop face may be subject to toppling failure even though the joints dip into the rock outcrop face. Circular failures are not represented in the stereo nets, but are rather a function of the raw point count (Figure 5) as collected from the field data.

Joint intersections within the central portion of Slope 27 do not follow a set pattern similar to a shale, sandstone or dolomite type rock. The host rock(s) at Slope 27 are volcanic in origin that has been altered or metamorphosed. Evidence of all four types of rock failure (wedge, sliding, toppling and circular) can be observed within the central portion of Slope 27. It can be assumed that the difference in failure types is a result of heavy weathering (decomposition) and selective break-down of the weaker microcrystalline matrix of the monzogranite and trachyte. Subsequently, in areas where these host rocks have experienced moderate to extreme weathering, rock debris can range from inches to several feet (<2 feet) in diameter. Calculating the factor of safety for the existing rock outcrop(s) indicates that at best, these slopes have a factor of safety of approximately one (1) under dry joint/fracture conditions. When water is added to the joint or fracture system, localized factors of safety fall under one (1) and rockfall event occurs. The highest potential for rock outcrop failure is in the spring and fall seasons, when both moisture and frost are combined. It should be clarified that failure mechanism noted for the central portion of Slope 27 are confined to near surface or surface manifestations resulting in isolated and localized rockfall events. No failure mechanism (large fracture sets extending several 10's of feet), commonly associated with a catastrophic or global event were noted in Slope 27.

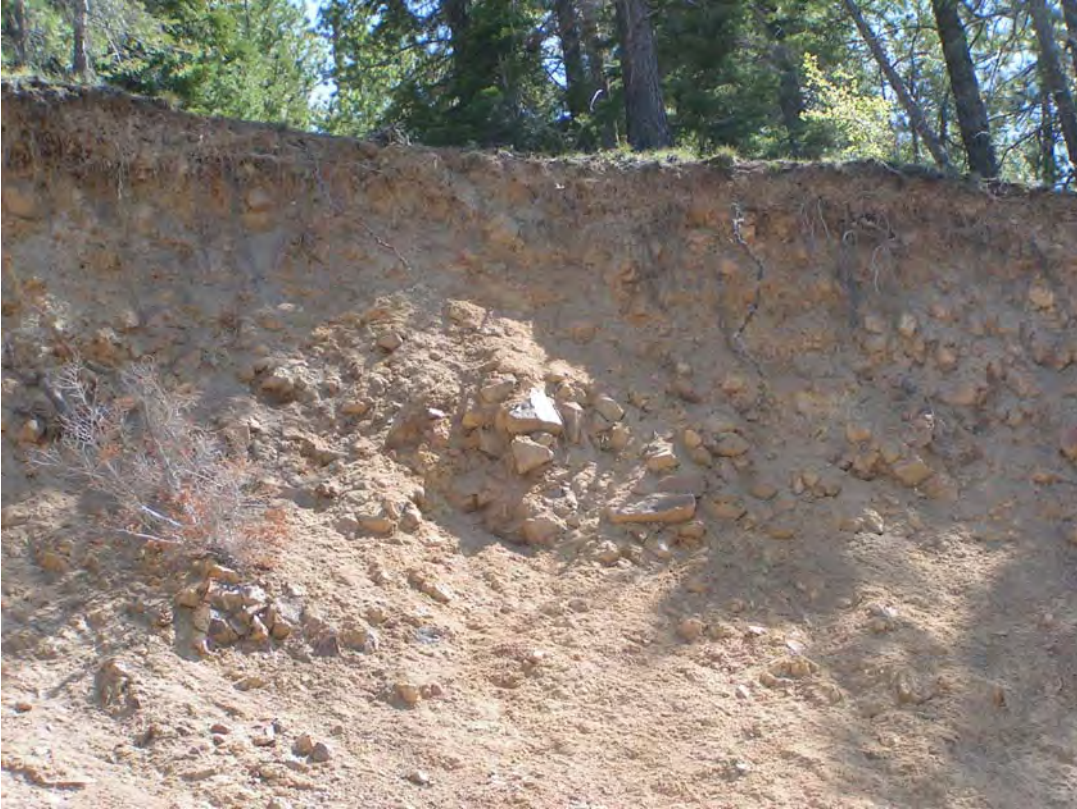
Upper portion of Slope 27 is a mix of soil and rock and undercuts the soil

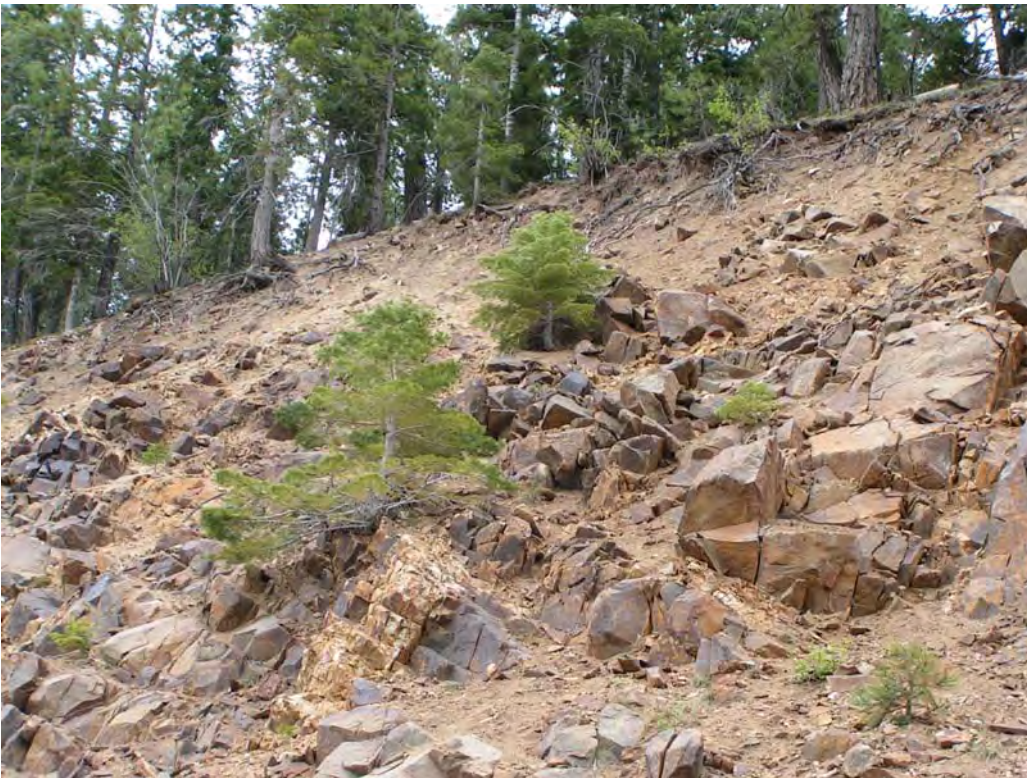
Portions of Slope 27 have some mature vegetation starting to grow

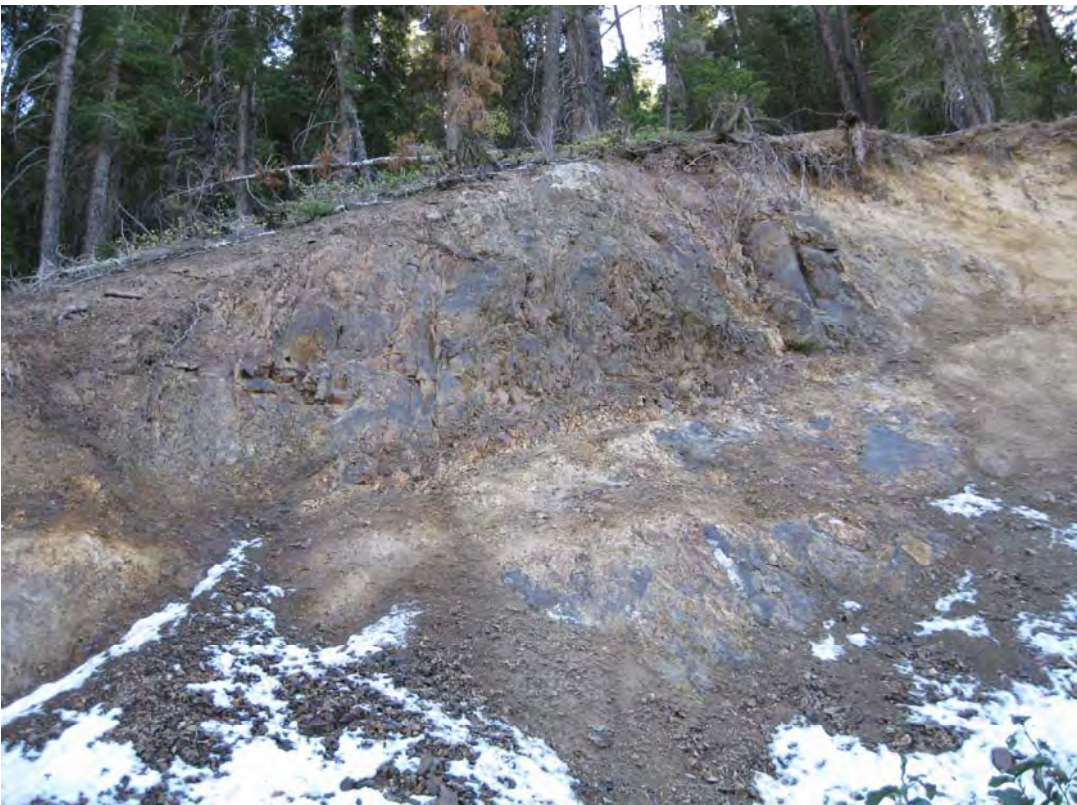
From 498 to 650 feet (Approximate Status “L2” 334+58 Rt to “L2” 336+10 Rt), the slope consists of rock outcrop(s) having a angle of repose of 45 to 52 degrees. The altered Trachyte located on the eastern edge has wide to very wide fracturing, is intact to blocky and appears to be very competent in the field. The altered Trachyte is Slope 27 structurally exhibits both sliding and wedge failure type(s).

Altered Trachyte in the eastern side of Slope 27. The Trachyte is blocky to massive.

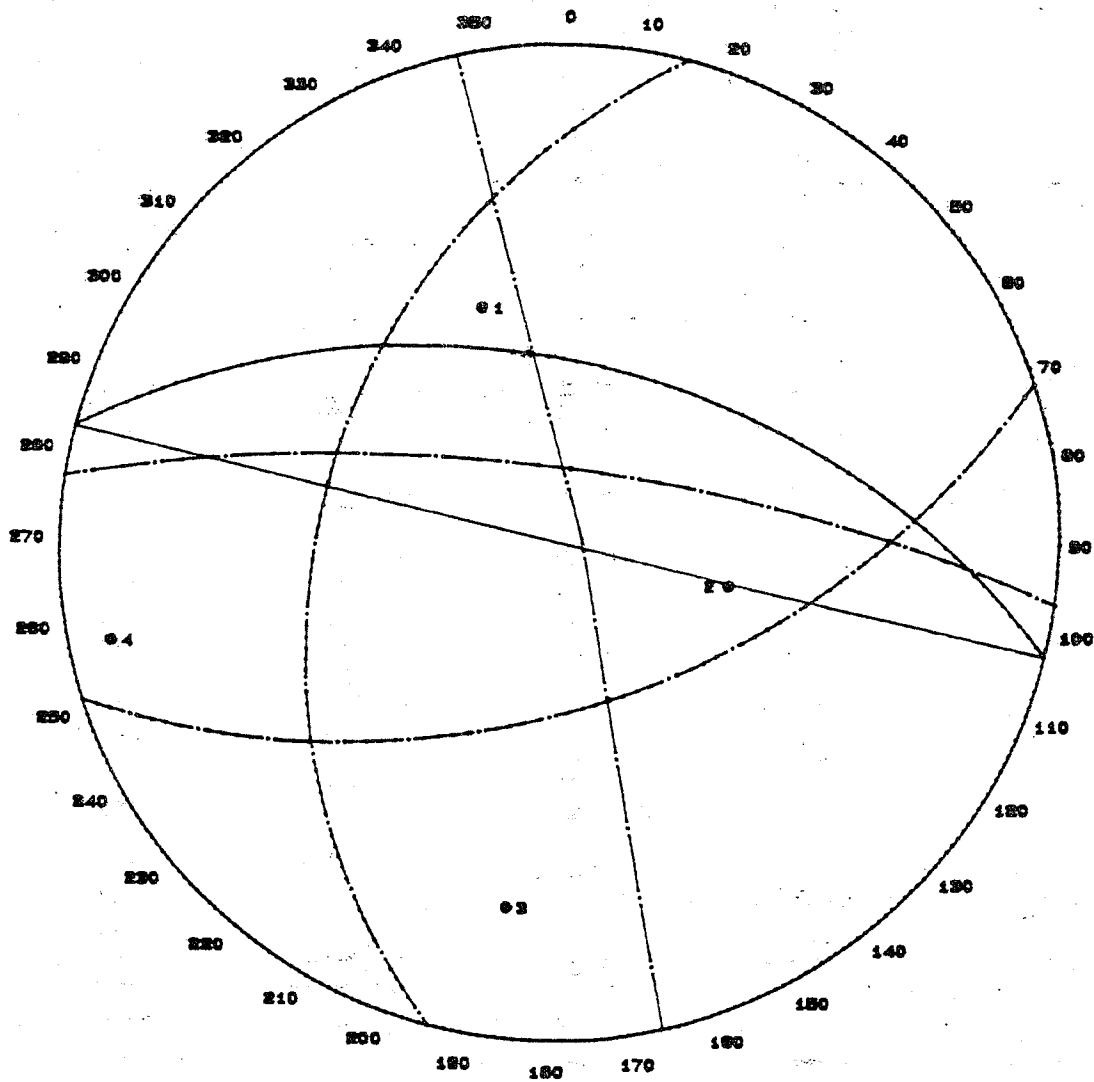
SLOPE 27  
PROJECTION OF PLANES REPRESENTING MAJOR JOINT ORIENTATIONS

#	DIP AZIMUTH	DIP	FRICTION ANGLE	POTENTIAL FOR PLANAR FAILURE
1.	161	53	32	NO
2.	284	39	32	NO
3.	7	73	32	NO
4.	77	85	32	NO

AT SLOPE ANGLES STEEPER THAN 73.00, A POTENTIAL FAILURE PLANE  
 WILL DAYLIGHT IN THE FACE OF A SLOPE WITH THE GIVEN ORIENTATION

AT SLOPE ANGLES STEEPER THAN 73.19, A POTENTIAL WEDGE FAILURE  
 WILL DAYLIGHT IN THE FACE OF A SLOPE WITH THE GIVEN ORIENTATION

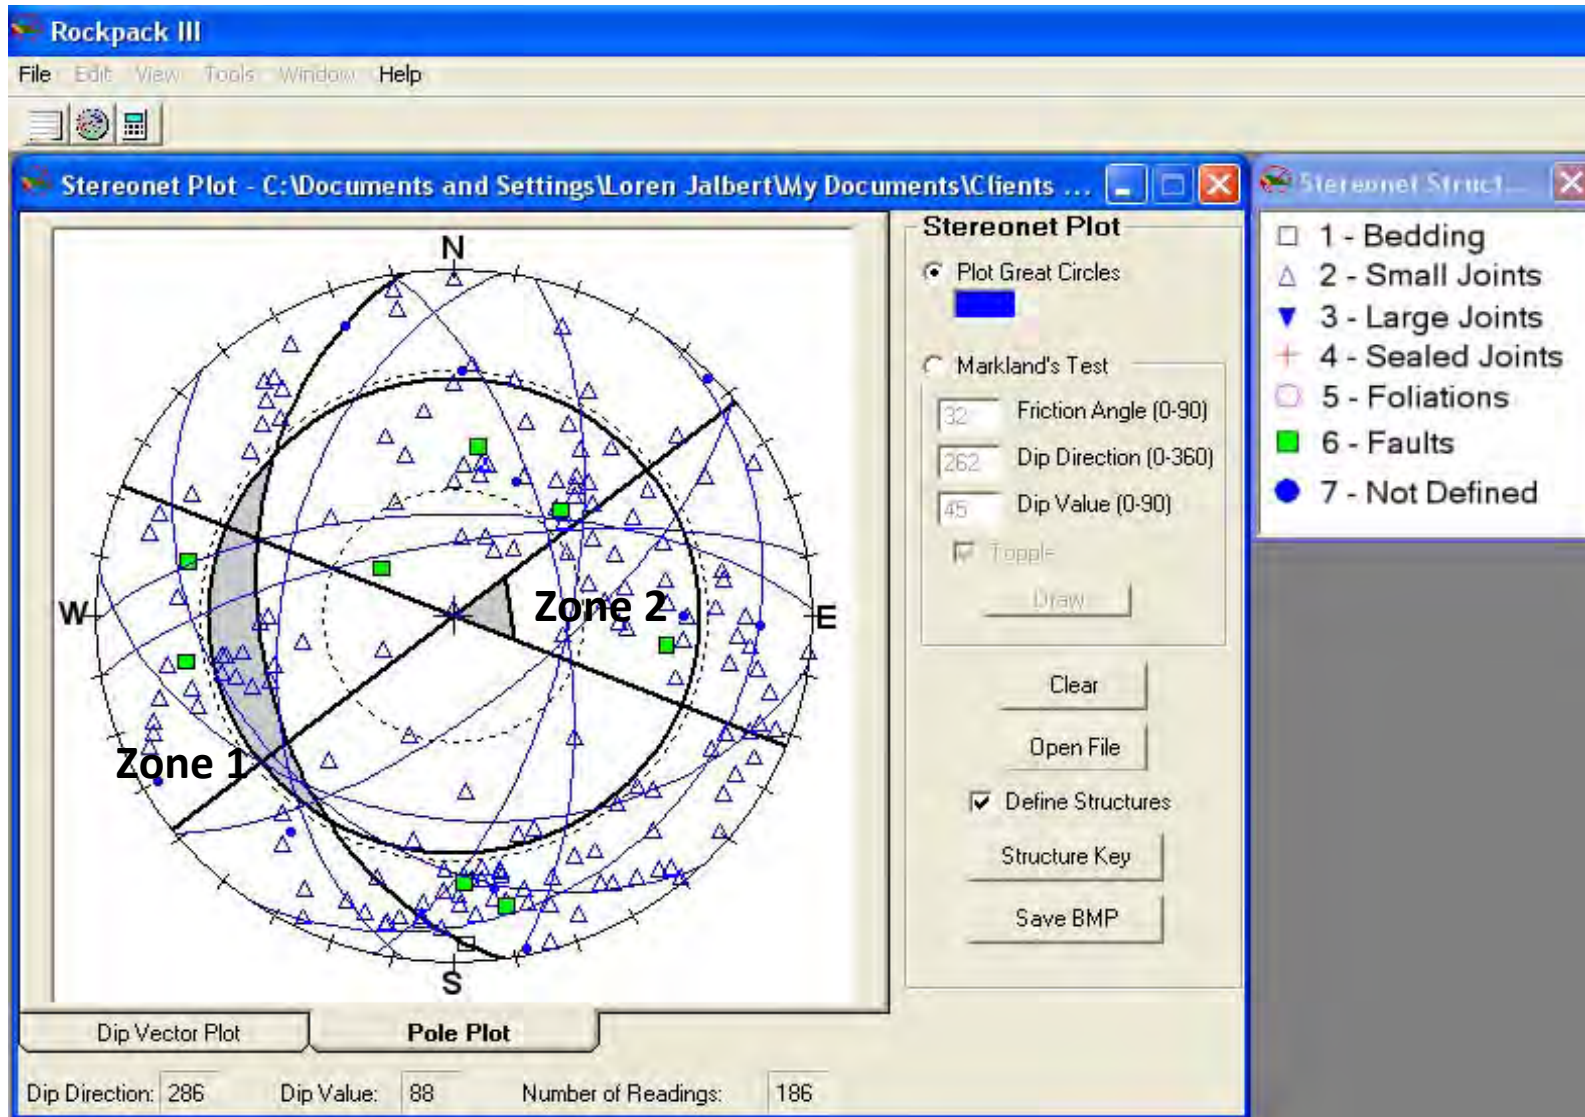
## Slope 27: Major Fault Intersections (Green Squares)

Fault intersections in Zone 1 represent wedge and plane failures.

Fault Intersections in Zone 2 represent toppling failures.

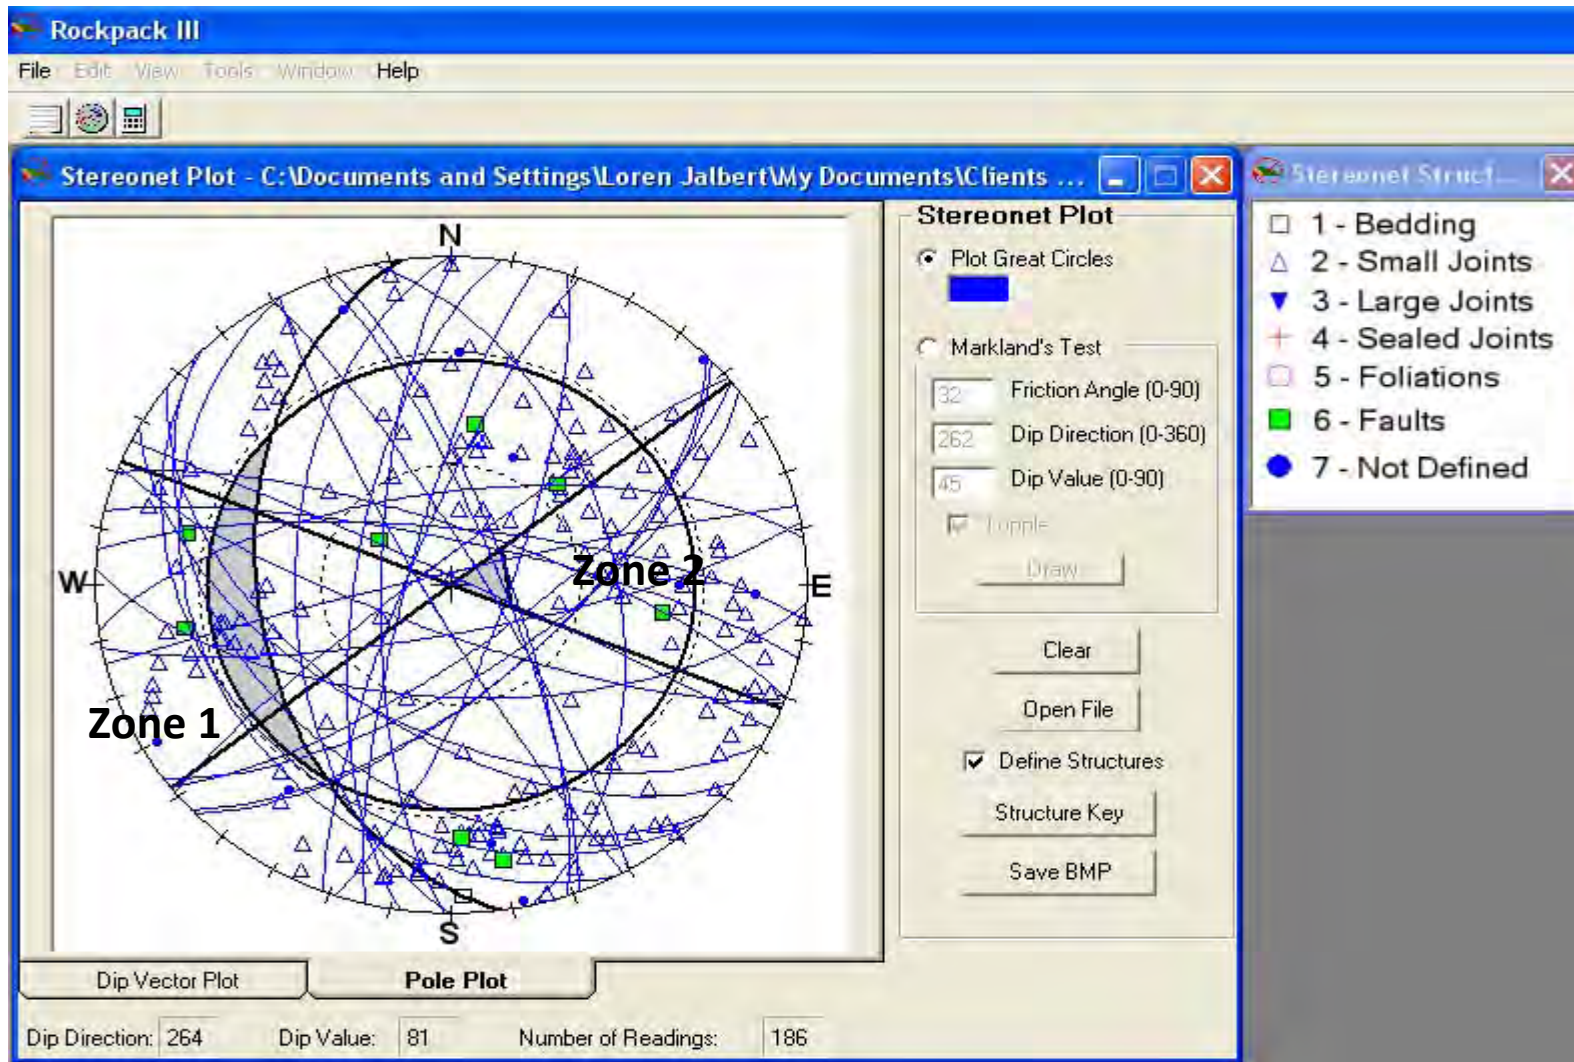
## Slope 27: Small Joint Intersections (Blue Triangles)

Small Joint intersections in Zone 1 represent wedge and plane failures.  
Small Joint Intersections in Zone 2 represent toppling failures.

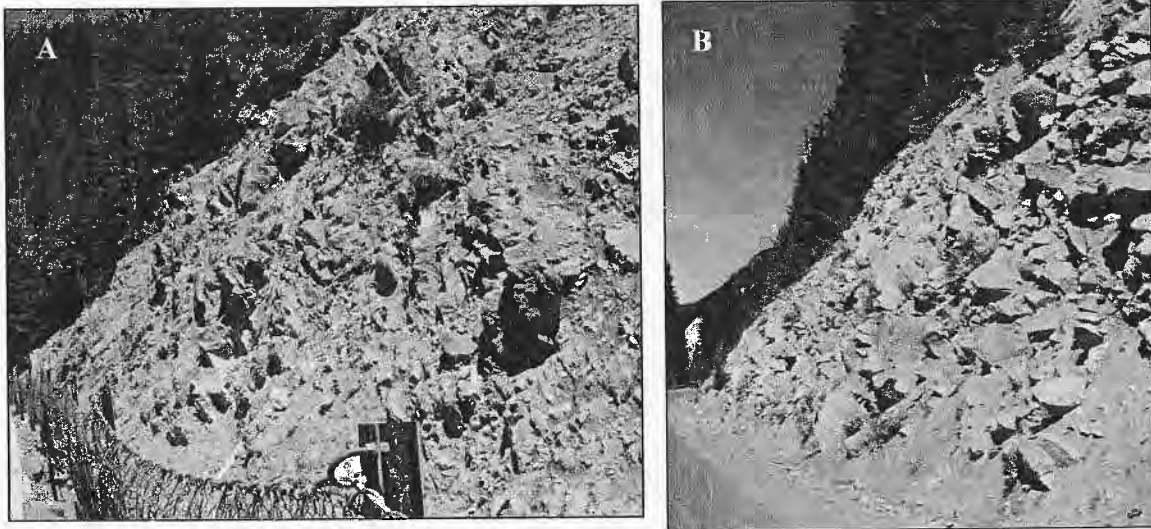
**Figure 4. Rough slopes exhibit a high degree of surface roughness with planar, uniform profiles.**

- i. *Rough*: The slope surface is very irregular and undulating and/or has many prominent protrusions on the surface (Figure 4). For such cases, the interface friction angle is assumed to be above  $60^\circ$ .

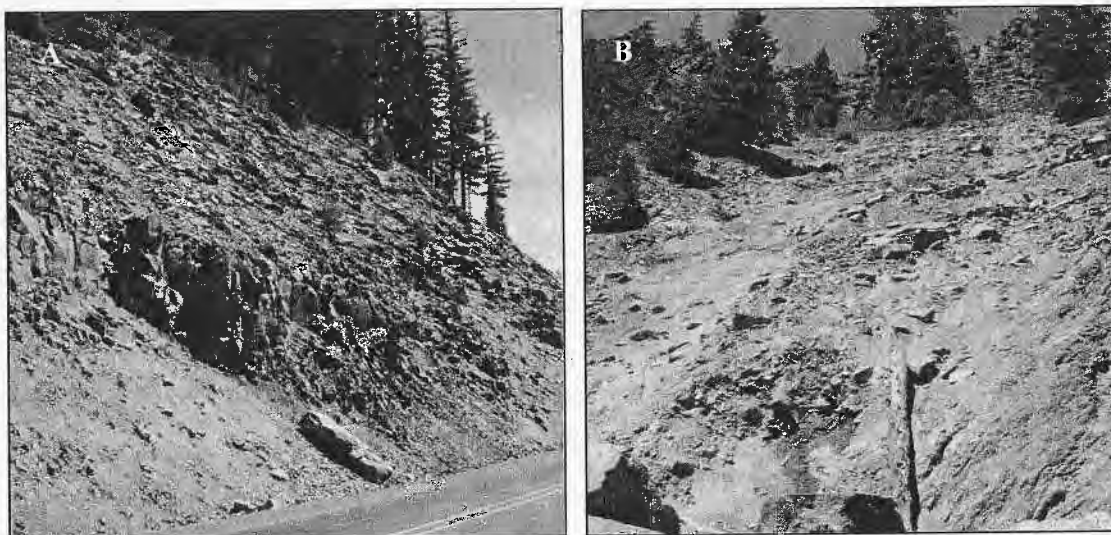
**Figure 5. Undulating slopes exhibit profiles with (A) somewhat uniform particle distribution with limited overall roughness, and (B) numerous localized protrusions.**

- ii. *Undulating*: The slope is undulating, and the surface contains some minor protrusions (Figure 5). The interface friction angle is assumed to be between  $36^\circ$ - $59^\circ$ .
