**Geotechnical Engineering Design Report
I-80 Bridge and Tunnel Rehabilitation –
Scope B
Rock Stabilization Analysis
Elko County, Nevada**

October 5, 2012
Kleinfelder Project No. 124637

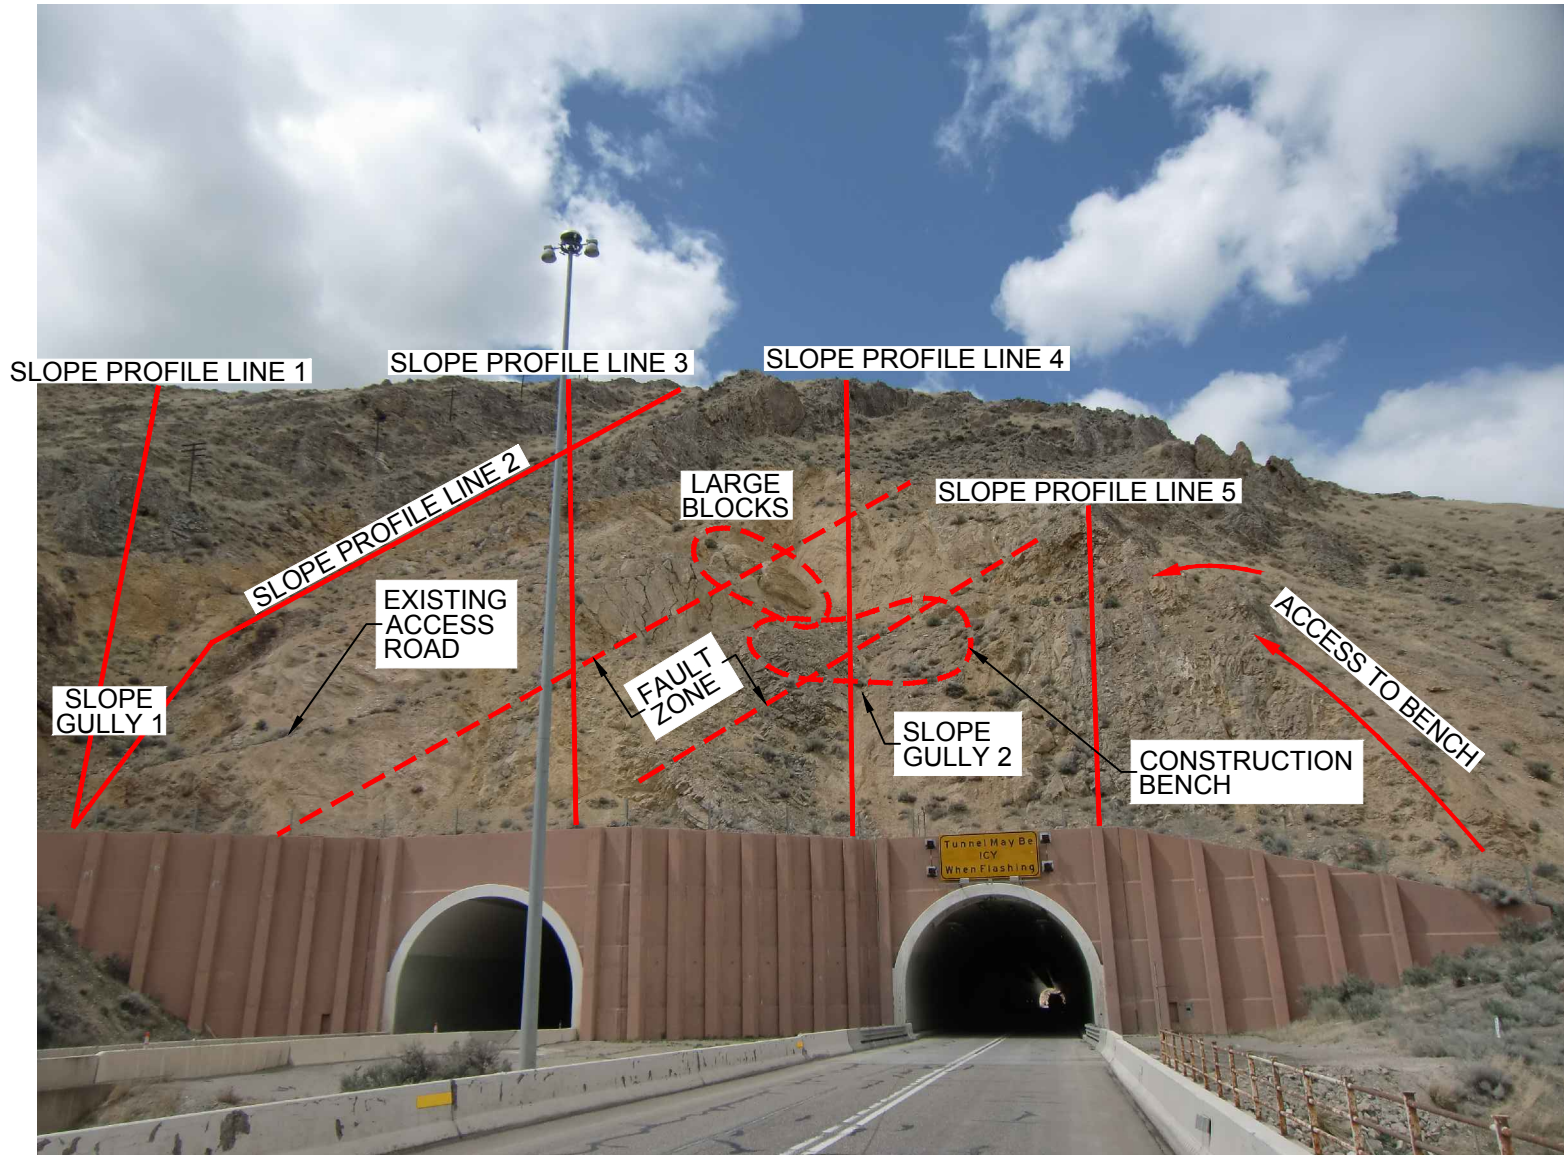
FIGURE
3
PAGE: 3 of 14

The east end portal cut slope is composed of limestone of varied weathering and fracturing occurring as part of the Strathearn Limestone. A near vertical fault zone strikes across the cut slope from southeast to northwest and is shown on Figure 3. The rock mass within the fault zone and to the south end of the cut slope is highly to moderately weathered and intensely to highly fractured. The rock mass to the north of the fault zone is moderately to slightly weathered and highly to moderately fractured. A construction bench is located about 50 to 75 feet above the catchment area (Figure 3). The bench is sub-horizontal to slightly declined towards the east tunnel entrance at an inclination of about 3H:1V to 4H:1V (Figure 10). The bench is partially covered with talus, grasses, soil, and rock blocks. The construction bench is accessible on foot up the natural slope to the north of the portal cut slope area. A former construction access road is visible on the portal cut slope face, but is not safely accessible because of erosion on the slope face (Figure 3).

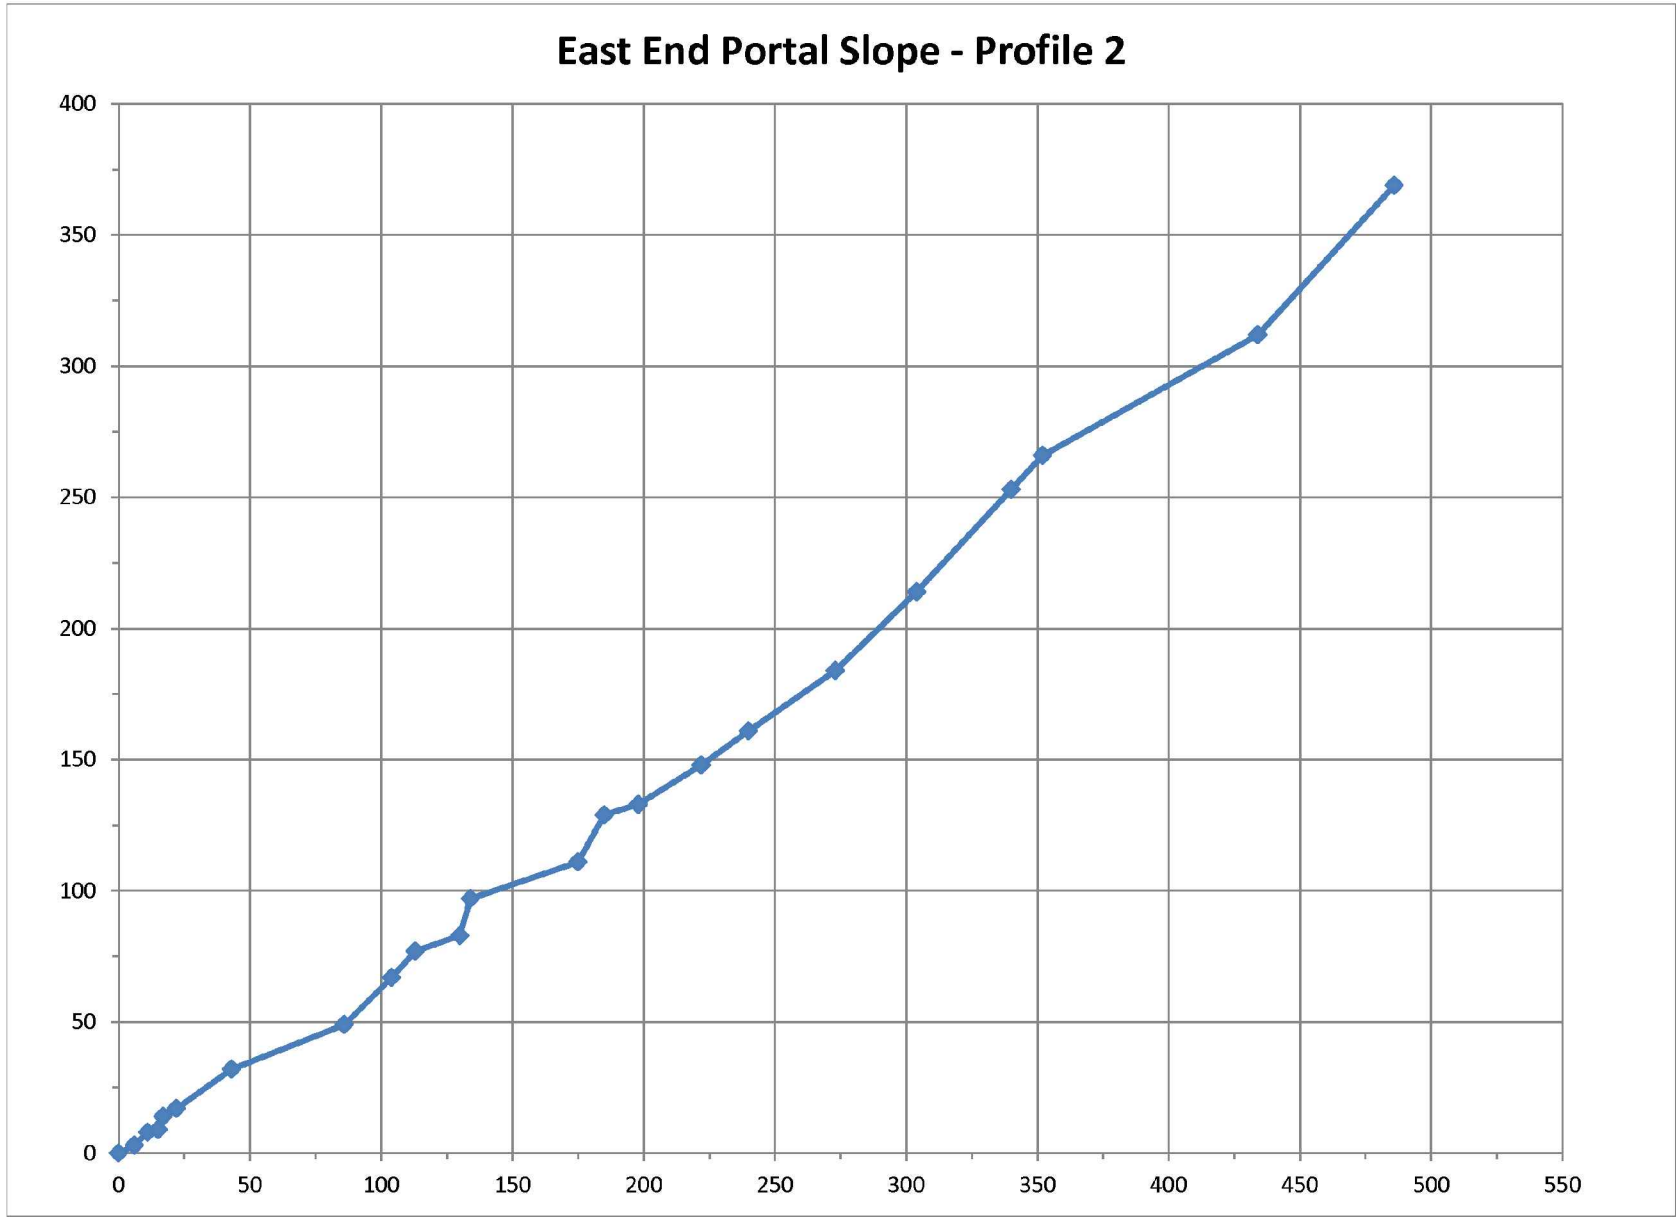
East End Portal Slope - Profile 2

The cut slope face is intersected by two large gullies that may act as rockfall chutes. One gully is at the south end of the cut slope, is slightly curved and extends to near the top of the slope (East End Portal Slope Profile 2 – Figure 8). The second gully is located near the center of the cut slope and extends up to the construction bench (East End Portal Slope Profile 4 – Figure 10). The second gully is represented as the lower portion of East End Portal Slope Profile 4 downslope of the bench. The gully does not extend above the bench. Some rockfall has occurred from this gully near the center of the cut slope.

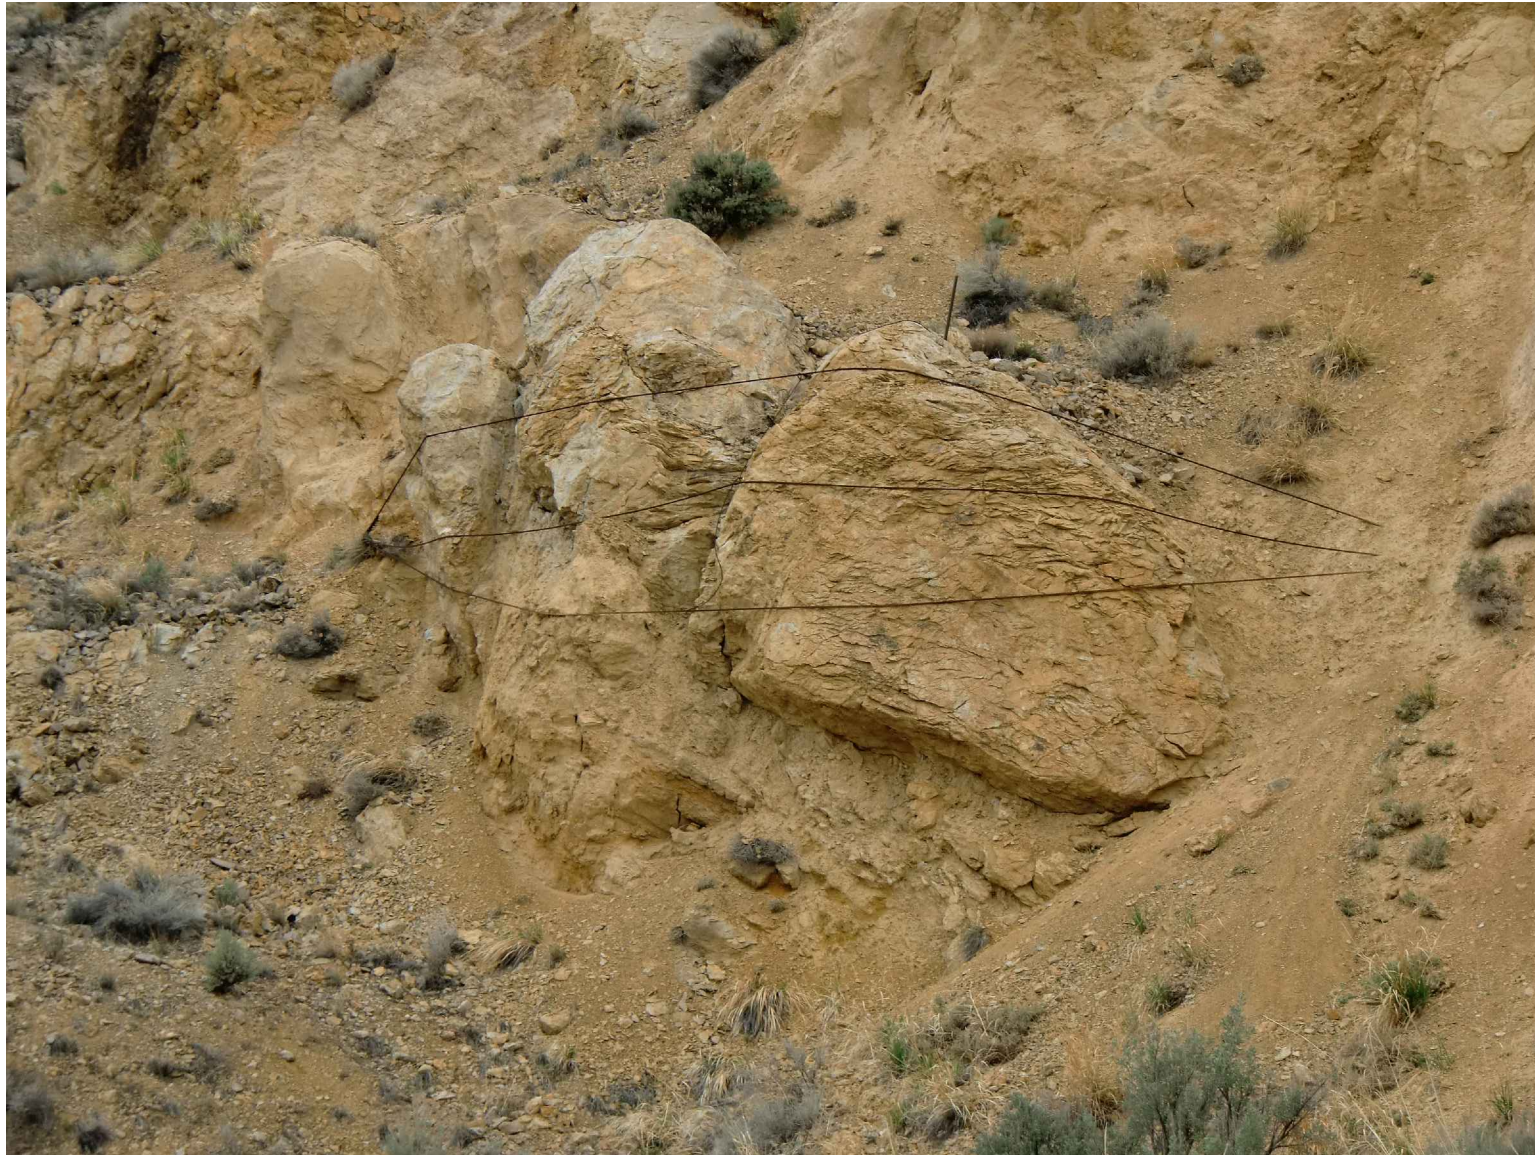
FIGURE
12
PAGE: 12 of 14

Three large blocks are perched above and behind the east end portal wall and are shown on Figure 12. The blocks are located on the inside edge (upslope side) of the construction bench located a height of about 75 to 80 feet above the catchment area. The three blocks (from right to left in Figure 12) have the following approximate dimensions:

The blocks appear to have been left in place during construction and have weathered in place and become potentially unstable. The blocks have previously been strapped with three approximately one-inch diameter cables stretched across the face of the blocks and the ends secured to the adjacent cut slope with one rock anchor on each end. Two of the cables are tight around the blocks and one has some slack. Information was not available about the installation method or length of the rock anchors supporting the cables. We did not observe tension cracks behind the blocks. However, the area behind the blocks is fine grained material that has eroded from the cut slope and cracks may have been covered.

The stability of the existing large blocks cabled in place above the east end portal has not been quantitatively evaluated. The blocks are slightly inclined out of slope, down towards the road and east tunnel entrances. We did not observe tension cracks behind the blocks. As can be seen in Figure 12, the block on the right is undermined apparently due to erosion. We observed that two of the three cables were very tight indicating potential loading on the cables and anchors. Additionally, all three cables appear to be supported by one anchor on each end. The current block stability appears to depend on the integrity of the existing anchor / cable system. Kleinfelder has no information regarding the construction history of the support anchors or the types of anchor and cables used. Our opinion is that the blocks may be temporarily stable in the current condition, but should be remediated for long-term slope stability. The following stabilization options could reduce the potential for failure of the large blocks from the cut slope:
